Issued May 17, 2022

MIR-22/17

# Engine Room Fire aboard Towing Vessel *Mary Lynn*

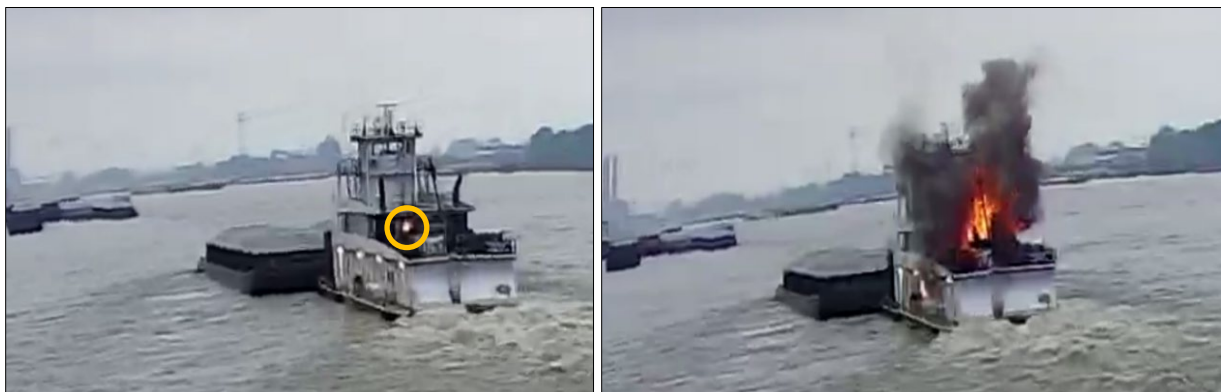
At 0652:46, the captain heard a call on the VHF radio stating, “Hey *Mary Lynn*’s on fire.” Shortly after, the chief engineer announced the fire over the handheld radio, and the vessel’s centralized fire-detection system alarmed in the wheelhouse. The captain looked aft of the wheelhouse and saw flames and black smoke shooting up from the deck. He then activated the general alarm to muster the crew to emergency stations. All crew responded and were accounted for.

**Figure 3.** The *Mary Lynn* at 0652:40 when the first open flame, circled in yellow, was visible on the second deck port side exhaust stack (left). The *Mary Lynn* at 0652:45 (right). (Source: ARTCO)

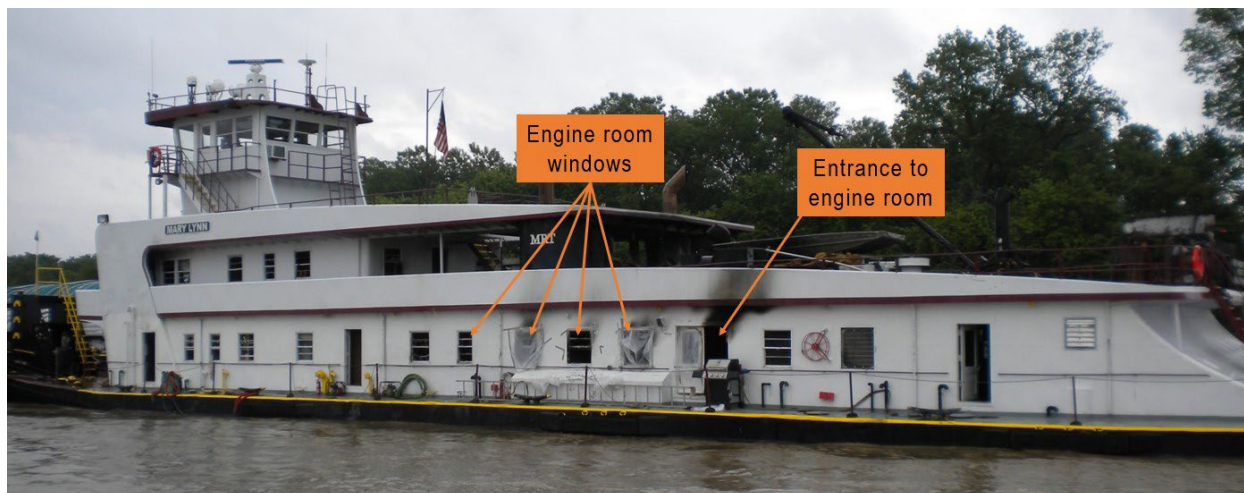
About 0655, Good Samaritan towing vessels began to assist the *Mary Lynn*. At 0657, the *Crimson Glory* arrived with charged fire hoses, and the crew sprayed water into the *Mary Lynn*'s blown-out portside engine room windows and the second deck engine room ventilation intakes. Additional towing vessels assisted with firefighting efforts or held the *Mary Lynn* and its barges in place. Based on onboard image recording footage, about 0705, smoke from the engine room began to dissipate. Crewmembers from the *Mary Lynn* and Good Samaritan vessels taped plastic coverings over the blown-out engine room windows and intake fans to limit the supply of air to the engine room. With no mechanical means to isolate the engine room ventilation, they placed tarps over the engine room ventilation openings on the second deck.

**Figure 4.** The *Mary Lynn*'s port side, postcasualty, with some of the plastic window coverings remaining over the engine room windows. (Source: US Coast Guard)

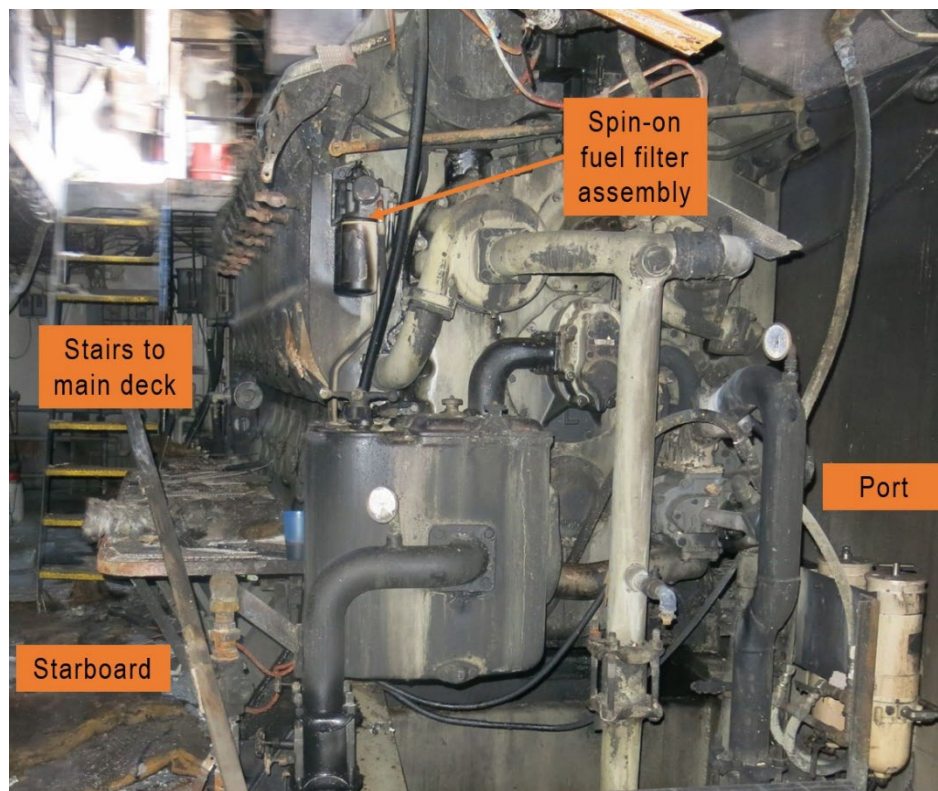
The *Mary Lynn* sustained heat, smoke, and water damage to the engine room, with the most intense heat, soot, and charring damage at the forward port side of the engine room, at the overhead directly above the port main engine and on the forward inboard side of the port main engine. Adjacent machinery spaces below the main deck sustained little to no heat, smoke, or water damage. The galley, forward of the main engine room on the main deck, sustained heat, smoke, and water damage, while all other accommodation areas had minor smoke damage. The starboard main engine and both generators showed no signs of damage from the fire.

**Figure 5.** The front of the *Mary Lynn's* port main engine, looking aft, from the forward lower engine room, postfire.

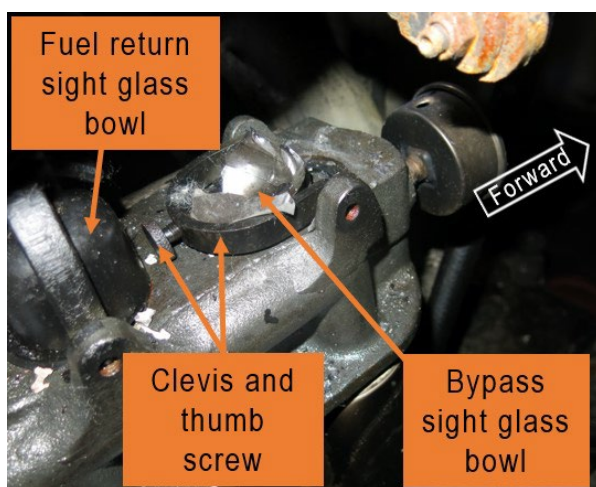
During the postcasualty examination of the *Mary Lynn*, the chief engineer showed investigators the area of the port main engine spin-on fuel filter assembly where he heard a pop and saw the fuel spray from the engine's forward end. The fuel supply bypass sight glass bowl was found in pieces, and the fuel return sight glass bowl was still intact. The chief engineer recalled the last change of the port main engine's spin-on fuel filters was about 4 days before the casualty, and the engine had been running since then without any problems. He described that after replacing the spin-on fuel filters, he would unscrew the thumb screw of the clevis assembly (which the chief engineer described as a c-clamp) and then remove and clean both sight glass bowls. Once cleaned, he would check the gaskets on each sight glass bowl fitting before placing them back. He would then replace the clevis and tighten the thumb screw on the assembly. The chief engineer

said that although the sight glass bowls were thick, he always tightened them by hand only. He noted that some people tightened the clevis thumb screws with pliers or wrenches, which he believed could fracture (crack) the glass.

**Figure 6.** Top of the port main engine fuel filter assembly after the fire, with broken fuel supply bypass sight glass bowl and intact fuel return sight glass bowl.

The resulting pressure increase caused the weakest part in the system to fail first, which, in this case, was the bypass sight glass bowl that tied into the return line (as witnessed by the chief engineer). The two sight glass bowls on the spin-on fuel filters were known to be sources of failure and could potentially contain hairline cracks from overtightening. Once the system reached a high enough pressure (likely exceeding

60 psi), and with no other means to relieve the pressure, the fuel supply bypass sight glass bowl on the port main engine spin-on fuel filter assembly broke. The breakage and separation of the sight glass bowl caused hot, pressurized, and atomized fuel to spray into the engine room.

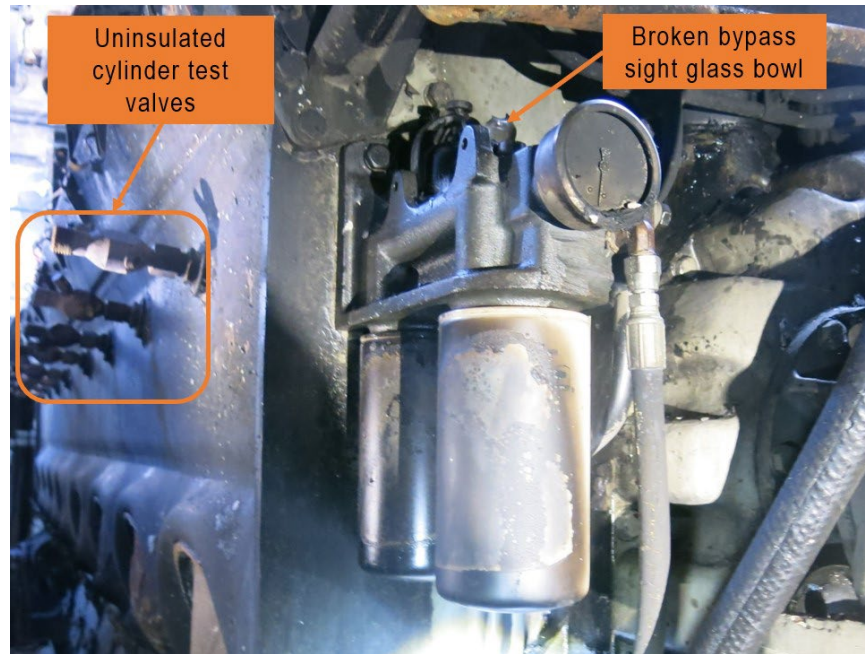
The port main engine exhaust manifold was lagged with insulation, but the section of exhaust header between the engine block and the horizontal portions of the exhaust manifold were not shrouded, insulated, or lagged. Additionally, the cylinder test valves, located on each side of the engine at each individual cylinder, had no insulation. Regulations require that piping and machinery components that exceed certain temperatures be insulated.<sup>2</sup> The last logged cylinder exhaust gas temperatures for the port main engine were recorded on March 31, while the engine was operating at a similar load as on the morning of the fire, and were above 500°F.

have been a result of fuel contact with a cylinder test valve near the fuel header on the side of the engine, since he thought it was the hottest “uncovered” (uninsulated) part of the exhaust system.

**Figure 7.** Inboard side of the port main engine showing the uninsulated cylinder test valves and their proximity to the broken sight glass bowl.

The fuel used in the engine at the time of the fire was marine diesel fuel, a highly combustible liquid with an average autoignition temperature of 428°F. To prevent combustible liquids, such as marine diesel fuel, from contacting piping and machinery components that exceed temperatures of 428°F, regulations require that such components be insulated. Logs showed that cylinder exhaust gas temperatures for the port main engine operating at a similar load as on the morning of the fire were above 500°F. However, after the fire, investigators found a section of exhaust header between the port main engine block and horizontal portions of the exhaust manifold with no thermal protection. The nearby cylinder test valves were also uninsulated. Based on the postcasualty examination of the vessel by investigators, the fire likely originated at or near the forward port main engine—either on the inboard side or directly above it—where these uninsulated components were located.

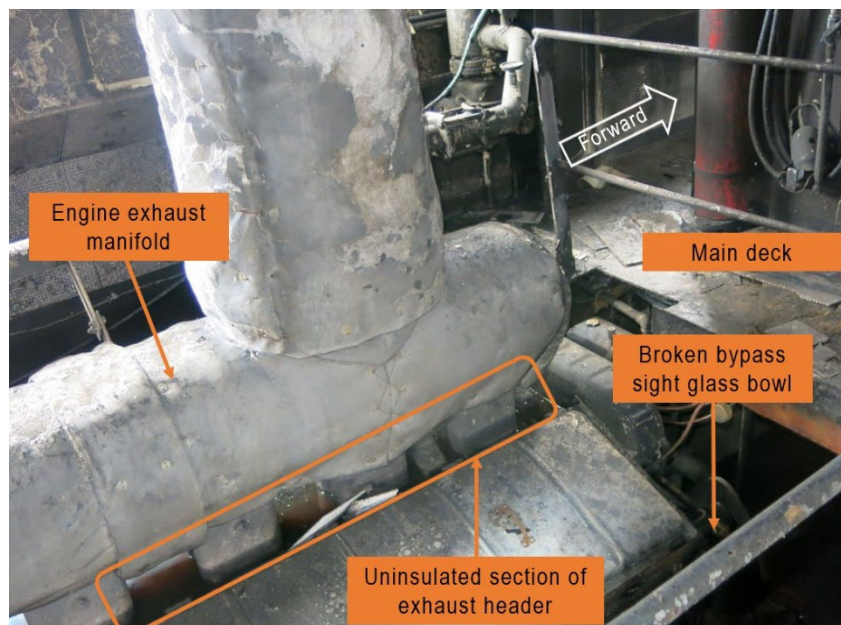
**Figure 8.** Front inboard side of the port main engine showing the uninsulated section of the exhaust header.

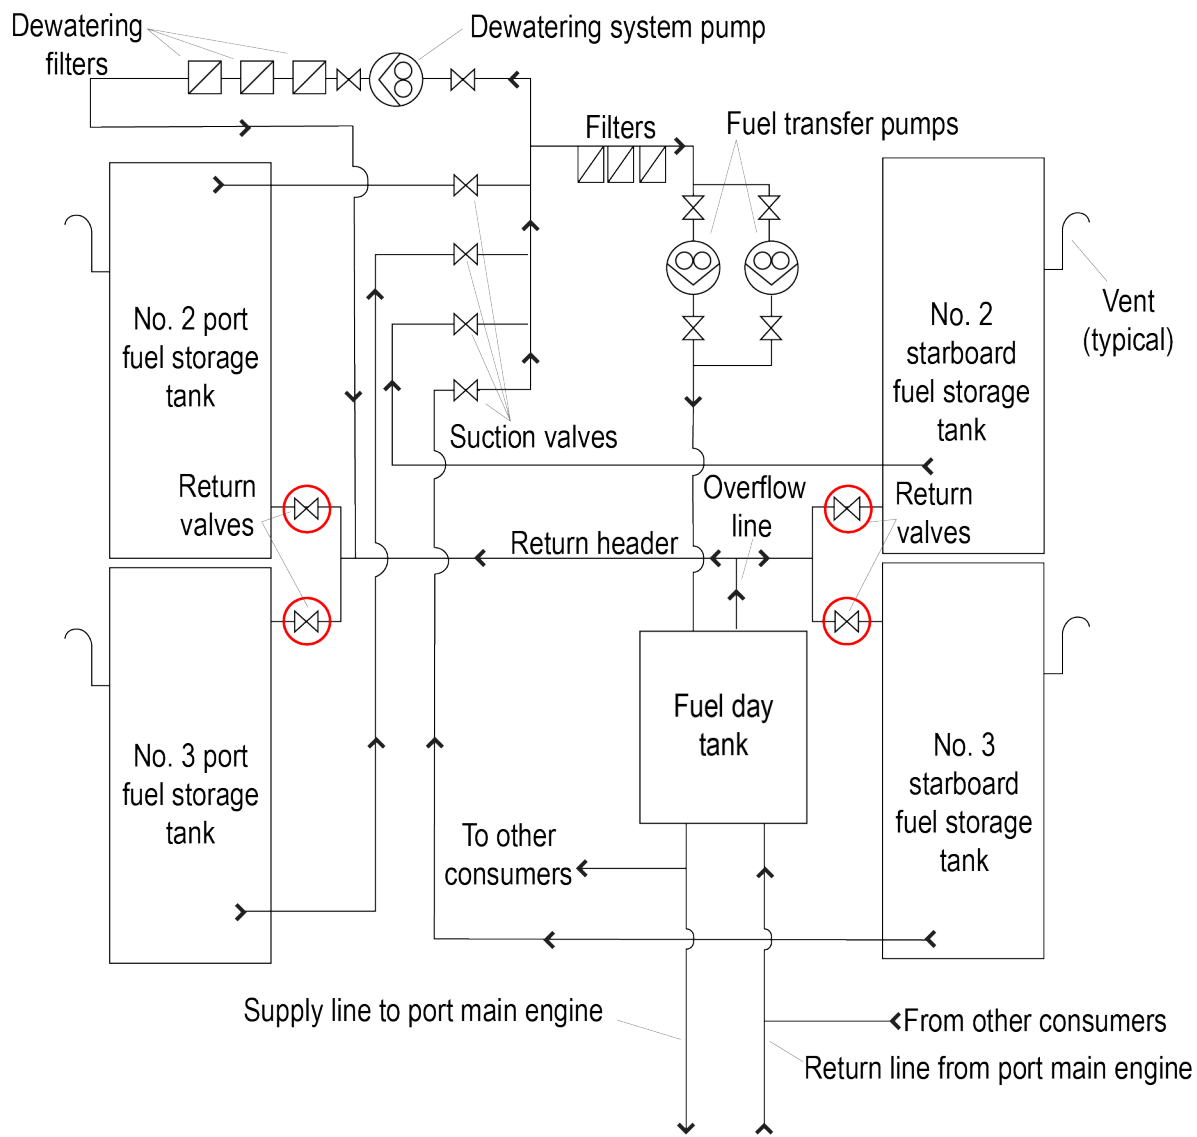
The chief engineer confirmed to investigators that on the day of the fire, all four fuel system return valves from the main engines and generators were closed and one suction valve from fuel storage no. 3 starboard tank was open. He said he "didn't put hands" (check the position) on the return valves for the no. 2 fuel storage tanks after operating the dewatering filtration system, noting that he thought the valves were open. According to the president of Hermann Sand and Gravel, who had experience operating the *Mary Lynn*, it was common practice to have return valves for both no. 2 fuel storage tanks in the same position (open or closed), and to have both return valves for the no. 3 storage tanks in the opposite position of the no. 2 fuel storage tank return valves (open or closed).

**Figure 9.** Fuel piping diagram for the *Mary Lynn*. Fuel return valves, circled in red, were inadvertently left closed when a fuel transfer pump was started and the no. 3 starboard suction valve was opened.

On the morning of the casualty, the chief engineer awoke and began preparations for taking on fuel, lube oil, and potable water. The fuel delivery tug and barge arrived about 2.5 hours earlier than expected, while he was dewatering the fuel storage tanks. He secured the return and suction valves for the tank he was dewatering and went on to prepare for the transfer of fuel, lube oil, and potable water. Although he thought that the two no. 2 fuel storage tank return valves were open, the chief engineer said he did not physically verify their position, and thus, he inadvertently left all return valves to the fuel storage tanks from the fuel day tank overflow line closed.

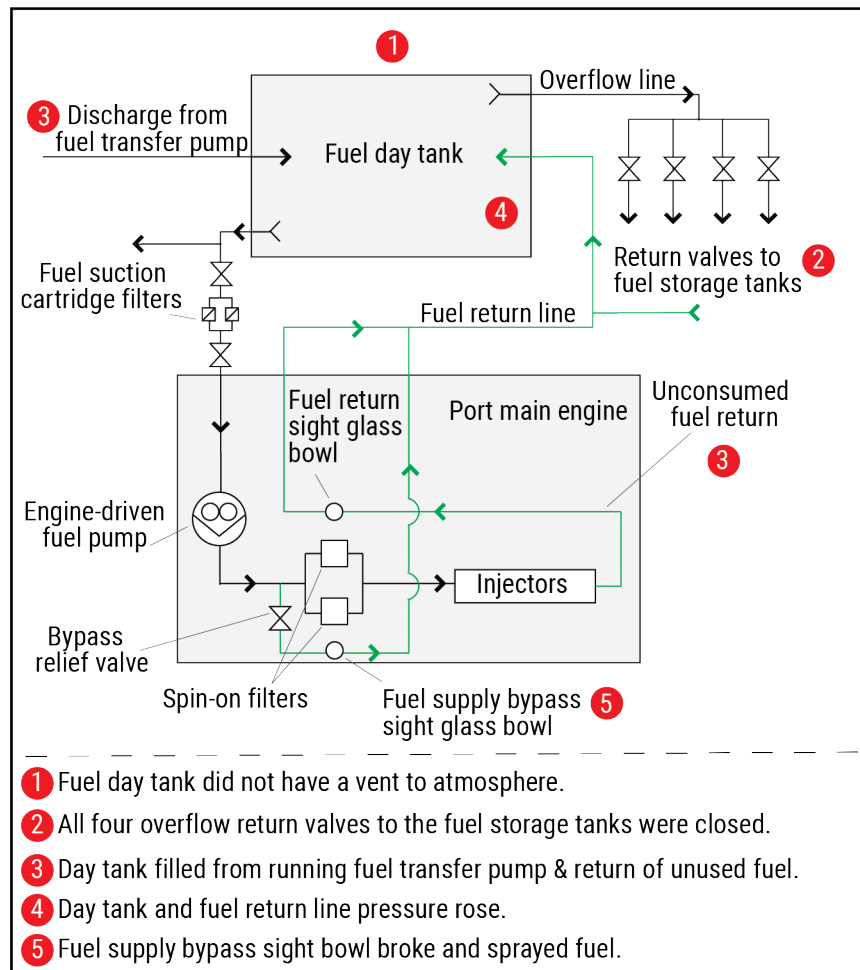
Almost immediately after the *Mary Lynn* got under way on May 18, the starboard main engine failed to meet the ordered rpm, and the captain brought the *Mary Lynn* back to the fleeting area to troubleshoot the issue. The chief engineer found that the fuel suction cartridge filter housings for the starboard main engine were “sucked dry,” an outcome that he attributed to a damaged O-ring. While the chief engineer was troubleshooting the fuel pressure issue with the starboard main engine, he opened the no. 3 fuel storage tank suction valves and started one of the fuel transfer pumps, which had been turned off during fueling and had not been restarted before getting under way, as was the vessel’s standard procedure. After the chief engineer started the fuel transfer pump, the fuel day tank level began to rise. Because the fuel day tank did not have its own independent atmospheric vent, tank venting was dependent on the four fuel storage tanks’ vents via the overflow line, return header, and opened fuel return valves. Since the chief engineer had not opened any of the four storage tanks’ return valves during or after the fueling process, the day tank essentially became unvented while the engines were running and consuming fuel. Once the day tank filled to capacity, the operating positive displacement transfer pump began overpressurizing the day tank, the supply lines from the day tank to the engine-driven fuel pump, and the return lines from the engine-driven pump to the day tank (entire main engine fuel system). The day tank and return line pressure would have also risen based on the pressure the positive displacement engine-driven pump could produce and the rate the engine was consuming fuel—with the engine-driven fuel pump directing excess fuel not consumed (not injected into cylinders) back to the day tank.

**Figure 10.** Simple main engine fuel supply/return system diagram for the *Mary Lynn* and sequence of events leading to the casualty.

design of the *Mary Lynn's* system allowed for the potential pressurization of the day tank to exceed atmospheric pressure if a crewmember secured valves on other tanks. Had the *Mary Lynn's* day tank been fitted with its own vent line, even with the fuel return lines inadvertently left closed, the overpressurization of the return line would have not occurred.

Subchapter M regulations for towing vessels require vessels built after 2000 to have vents for each fuel tank. Regulations for vessels ranging from small passenger vessels to cargo ships require that fuel tanks be independently vented from the highest point of the tank to atmosphere on a weather deck. Tank ventilation is important to ensure a valve line up error does not lead to the overpressurization of or vacuum in a fuel tank. Operators should be aware of their fuel tank ventilation system arrangements. On vessels without independent fuel day tank ventilation, it is critical to ensure proper valve position during transfer and operation of the fuel system.
