Transport Accident  
Investigation  
Commission

# **Final report**

***Marine inquiry MO-2020-205***  
***General cargo vessel Kota Bahagia***  
***Cargo hold fire***  
***Napier Port***  
***18 December 2020***

**August 2022**

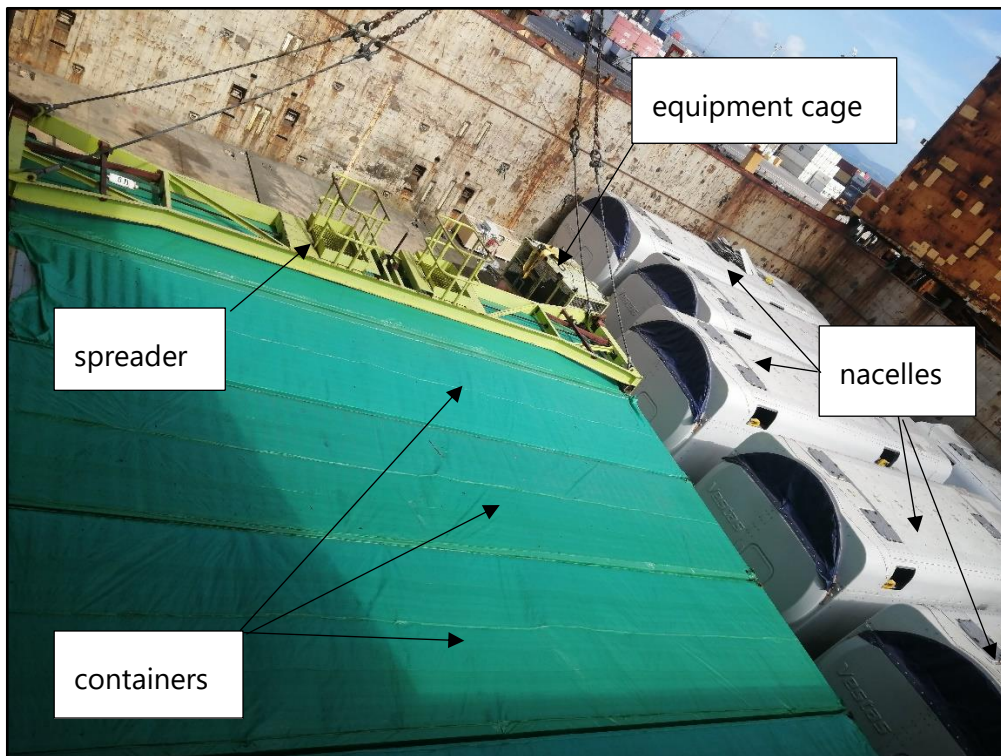
**Figure 5: Number 2 cargo hold 'tween deck cargo at about 1012 on 18 December 2020 (Credit: Pacific International Lines)**

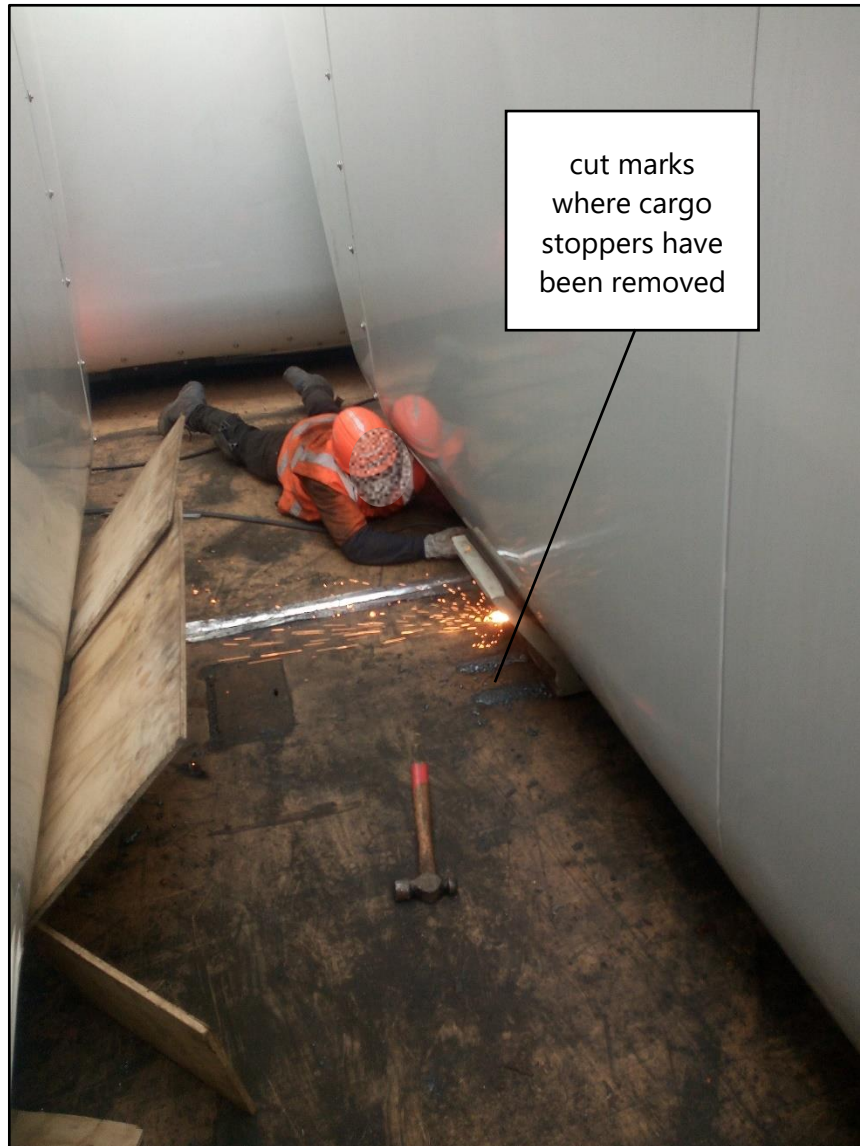
2.5 Specifically, the fitters' task was to remove the cargo stoppers<sup>8</sup> that had been welded to the 'tween deck pontoons<sup>9</sup> for securing the cargo. The removal of the cargo stoppers required oxygen/acetylene gas-cutting. One of the fitters carried out the

**Figure 6: Gas-cutting removal of cargo stoppers  
(Credit: Used with photographer's permission)**

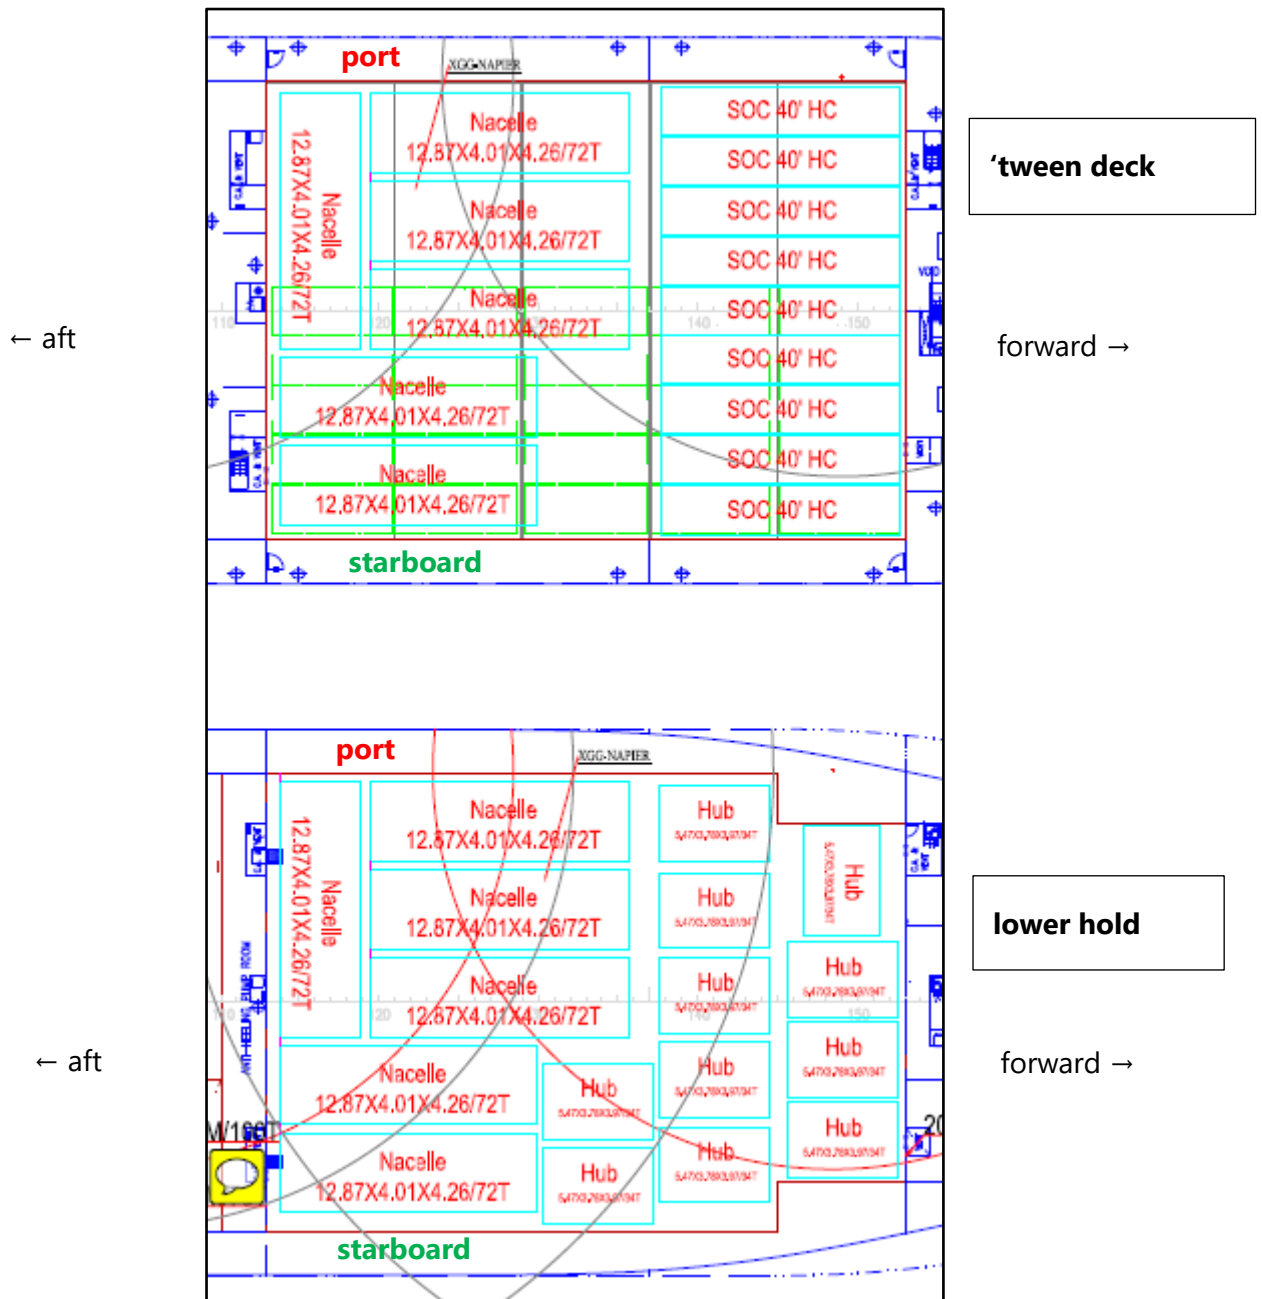
**Figure 8: Cargo stowage in number 2 cargo hold (Supplied by Pacific International Lines)**

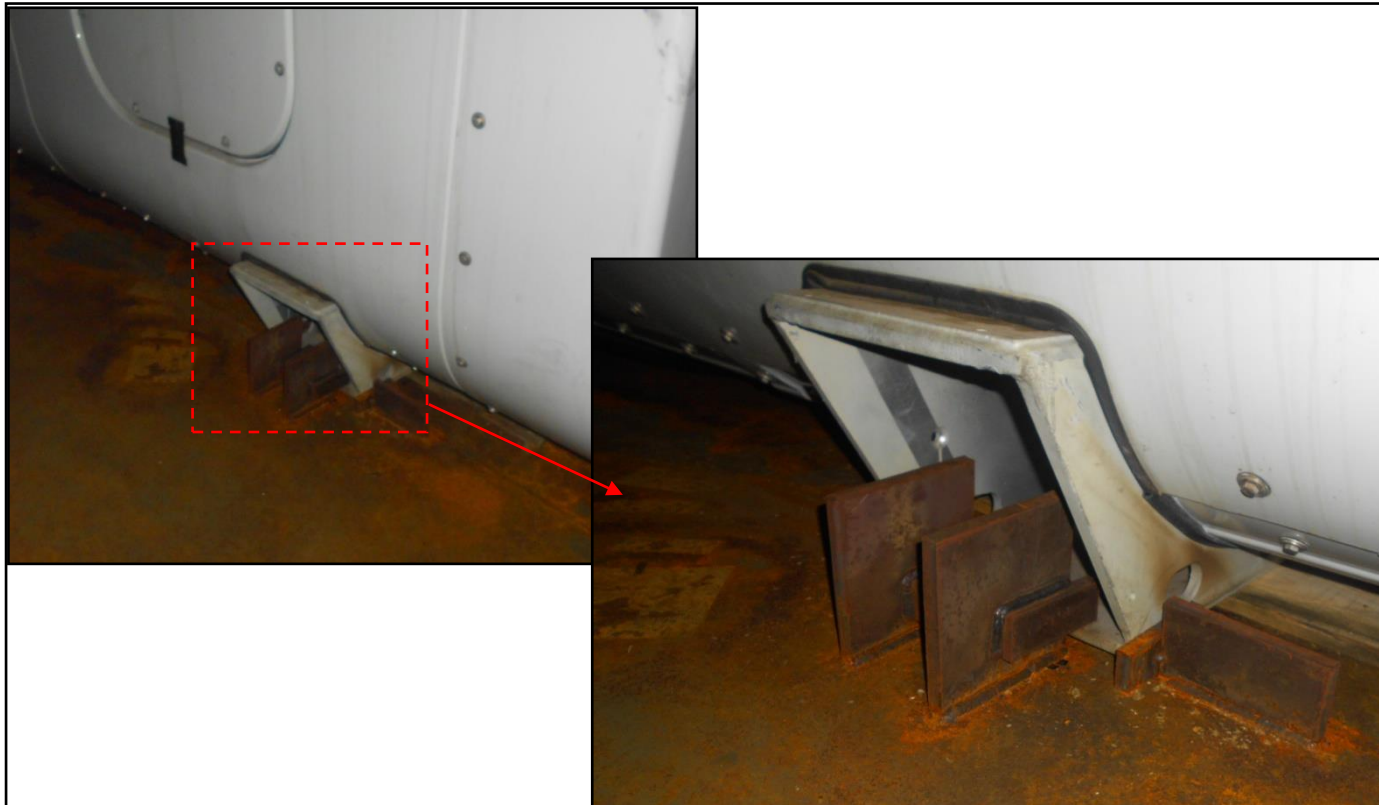
cannot be placed suitably. Cargo stoppers/sea lashings, such as those used on the *Kota Bahagia* (see Figure 9), are commonly used to secure non-standardised heavy cargoes.

- 2.30 For the sea voyage between China and New Zealand, the cargo was secured using a combination of cargo lashing chains and strops along with sea lashings (cargo stoppers) (see Figure 9).

**Figure 9: Cargo stoppers applied to wind turbine nacelle unit**

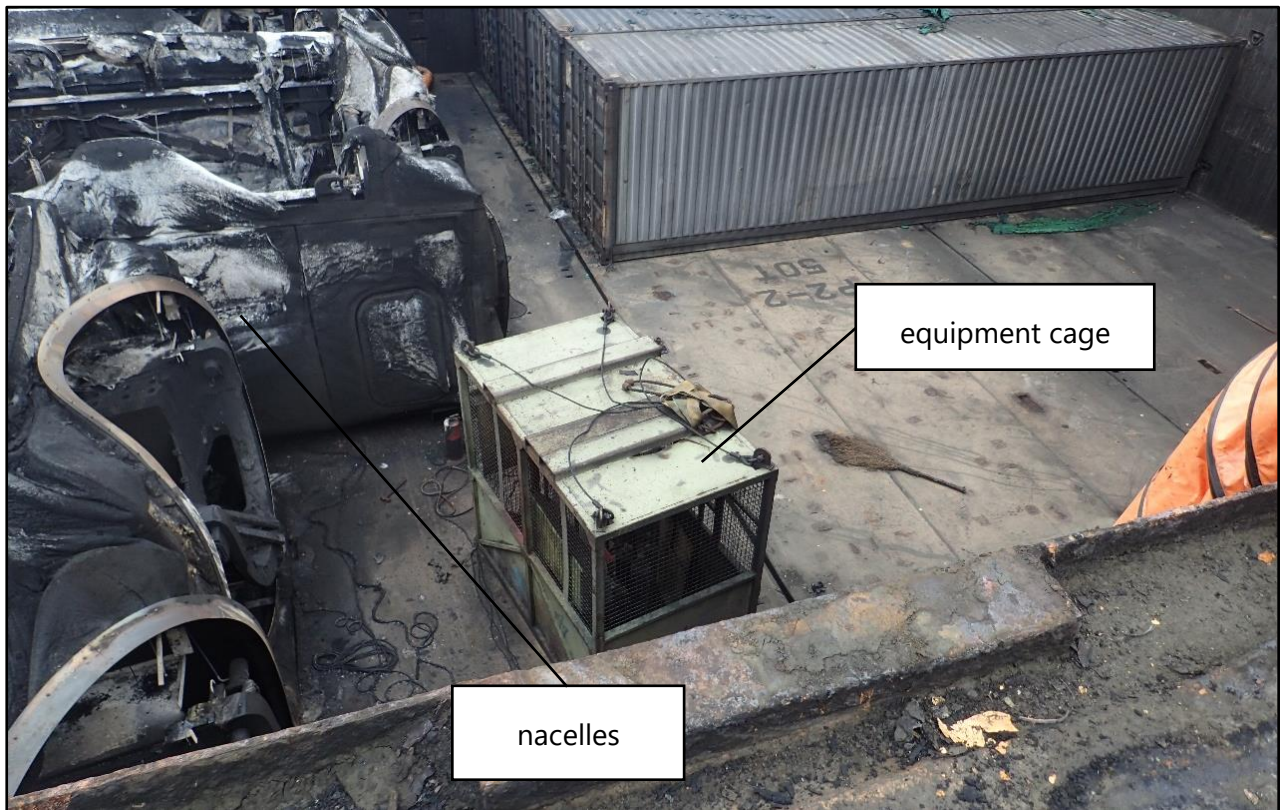
- 2.33 Low-melting-point items in number 2 cargo hold, such as plastic fittings on electrical cables, suffered heat damage. The welding equipment was mainly undamaged and timber items further away from the seat of the fire were also relatively undamaged (see Figures 10, 11 and 12).

**Figure 10: Number 2 'tween deck cargo damage looking from starboard<sup>23</sup> to port<sup>24</sup>**

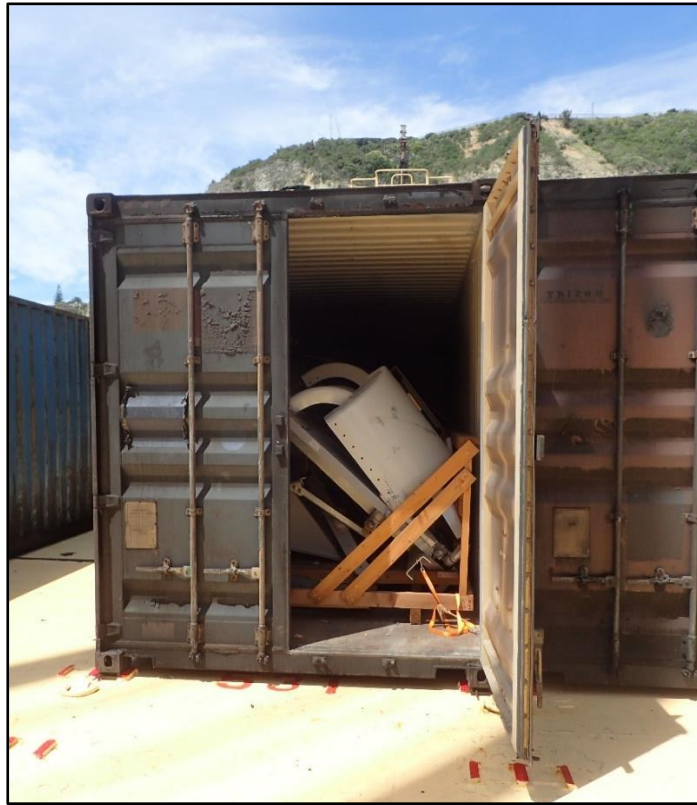
**Figure 11: Container contents after removal from number 2 'tween deck**

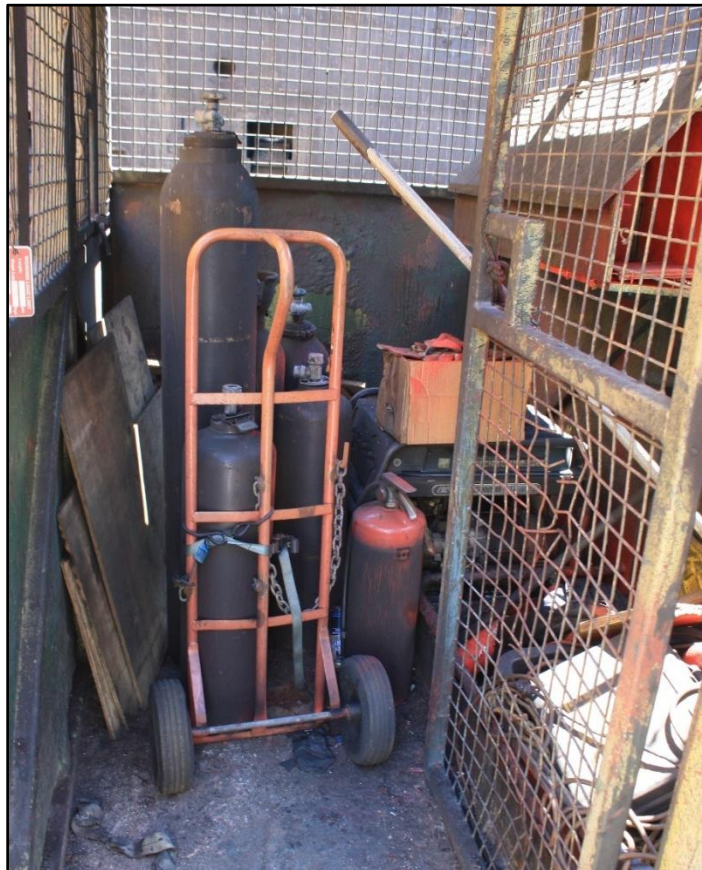
**Figure 12: Equipment cage and gas bottles that were in number 2 cargo hold during the fire**

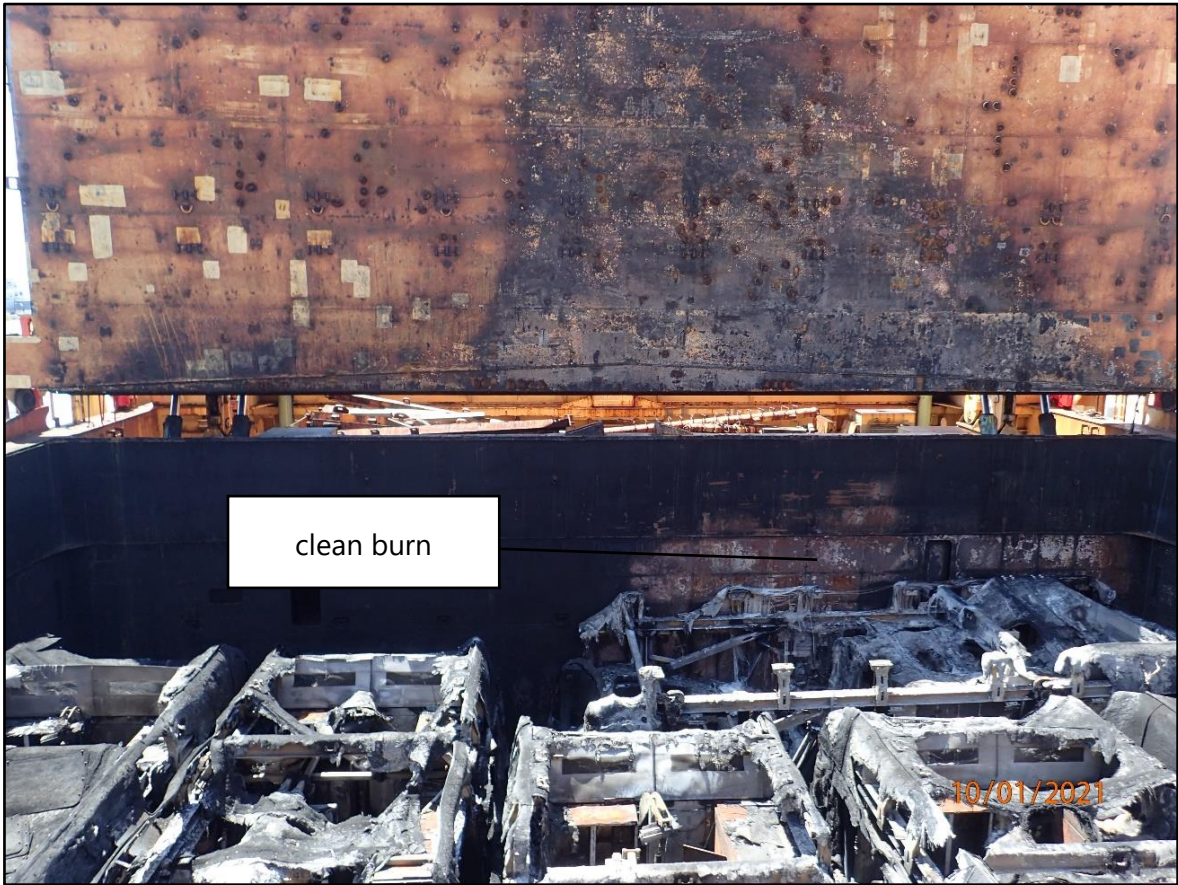
- 3.4 The nacelle that was stowed athwartship<sup>32</sup>, port side, at the aft end of the 'tween deck sustained the most damage (see Figures 13 and 14) and it is very likely that the fire originated either underneath this nacelle or between the nacelle and the side of the cargo hold. The presence of clean burn<sup>33</sup> on the side of the cargo hold showed that the fire was so hot in this location that the soot deposits were burnt off.

**Figure 13: Number 2 cargo hold looking aft**

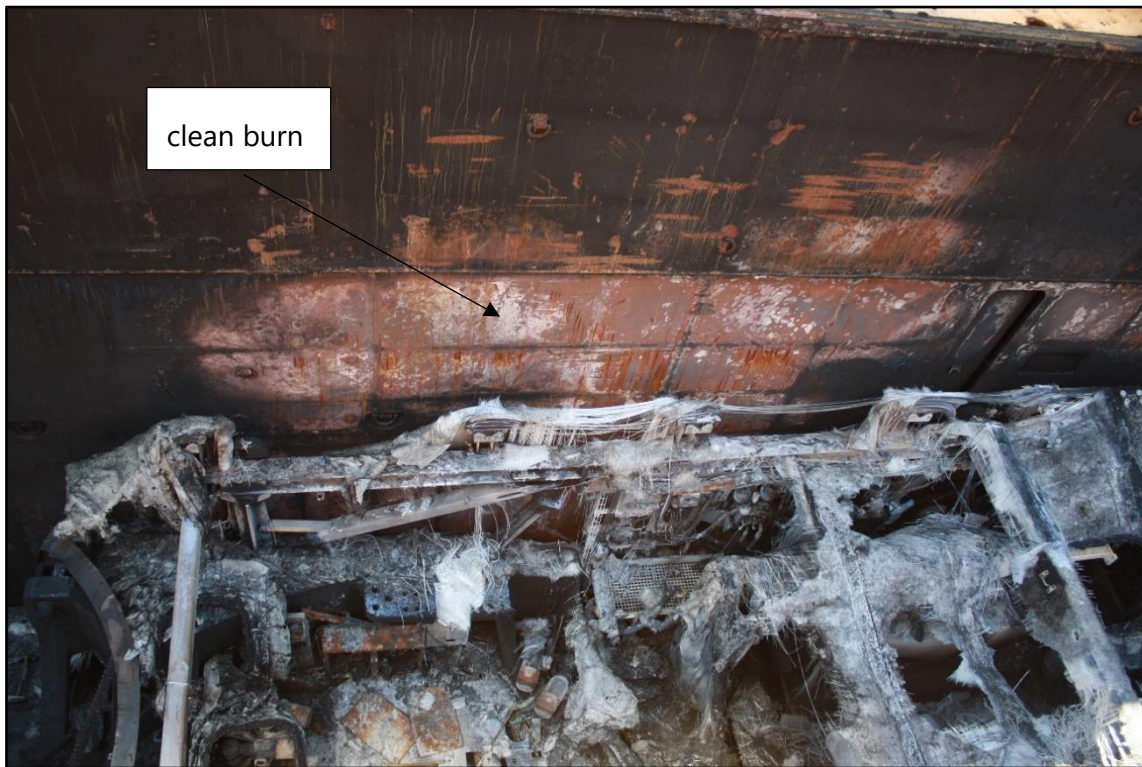
- 3.5 The Transport Accident Investigation Commission (Commission) engaged the services of a specialist fire investigator to complete a report on the origin and cause of the fire. The fire investigator's conclusion was that the most likely ignition sequence was a hot slag bead from the gas-cutting igniting the sawdust from the dunnage that was used between the cargo and the steel deck, resulting in a smouldering fire.

**Figure 14: Fire-damaged nacelle and clean burn pattern, port side aft number 2 'tween deck**

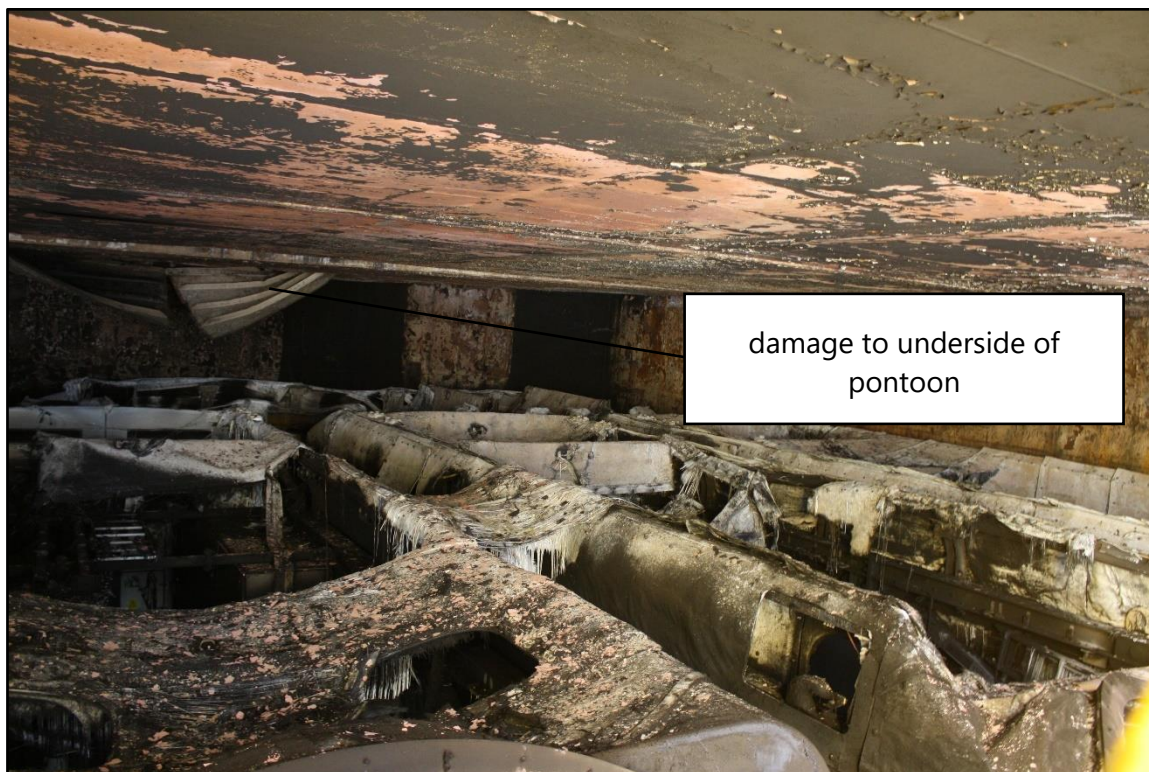
**Figure 15: Damaged wind turbine components in number 2 lower cargo hold**

the pontoon beneath the seat of the fire, weakened by the extreme heat and rupturing as the air inside the structure heated and expanded. The resulting damage to the pontoon can be seen in Figure 15.
