Published September 2022

REPORT MARINE 2022/10

***Fall overboard from the cargo ship
'MV Titran' east of Stigen in Lurøy
municipality on 6 March 2022***

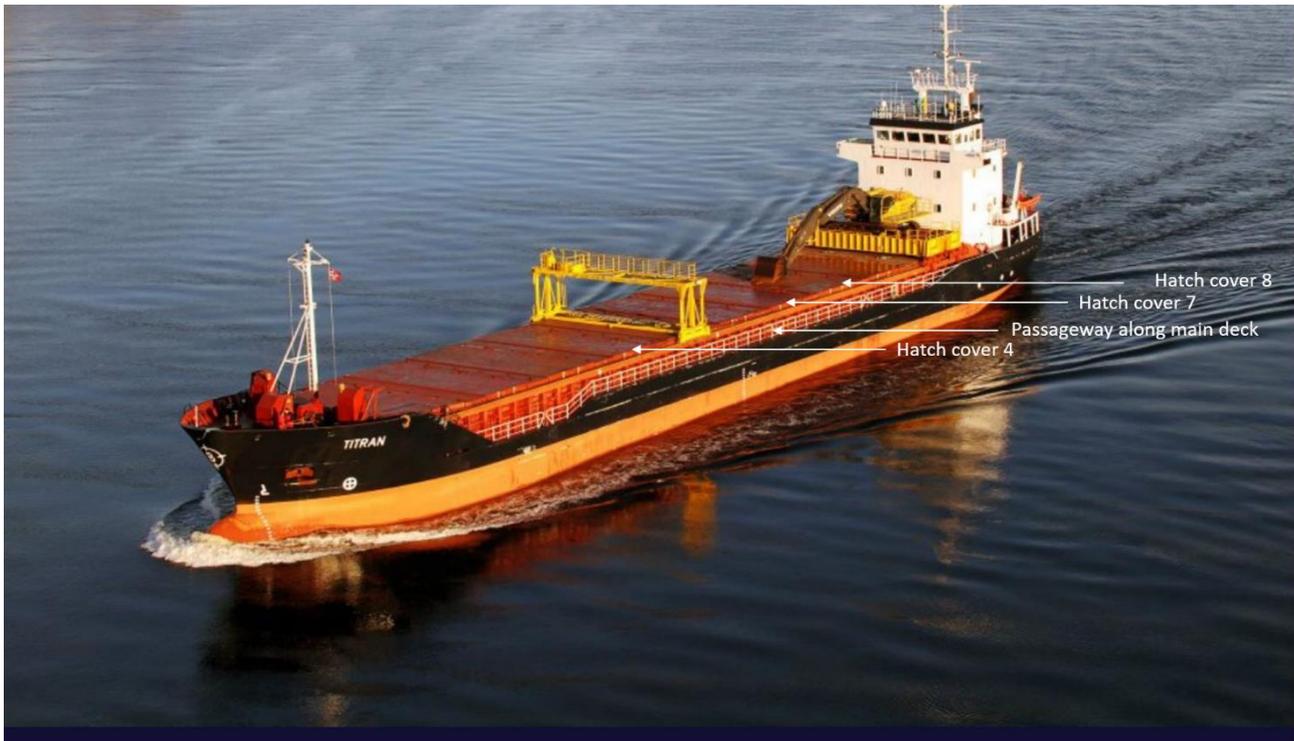
At 10:43, three members of the deck crew went to the port side together to commence the work. The photo in Figure 3 shows the cargo hatches, the passageway on the main deck alongside the cargo hatches, and the excavator on the aft deck section, among other things.

Figure 3: Passageway along the main deck and cargo hatches. Photo: Berge Rederi AS. Illustration: The NSIA

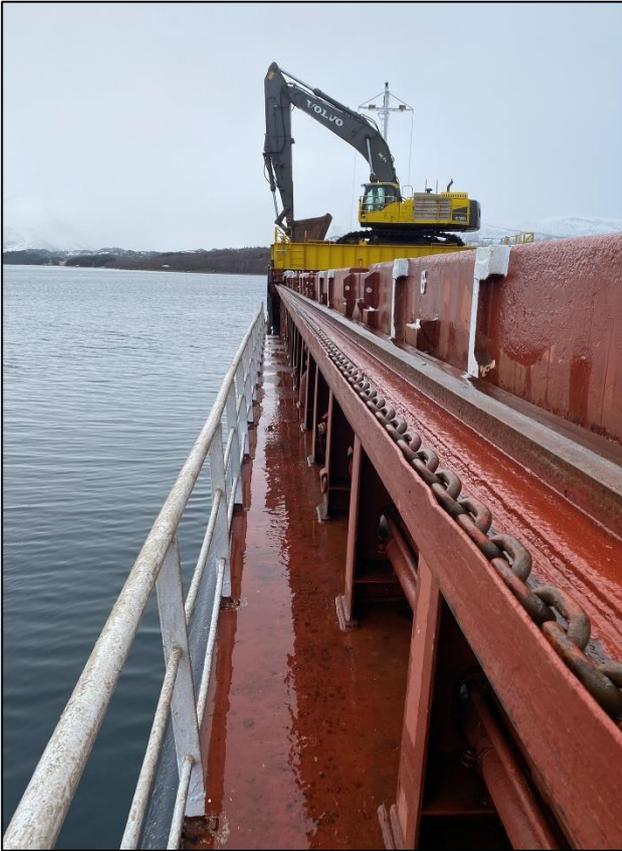
Figure 4: Passageway on the main deck along the cargo hatches. Photo: NSIA

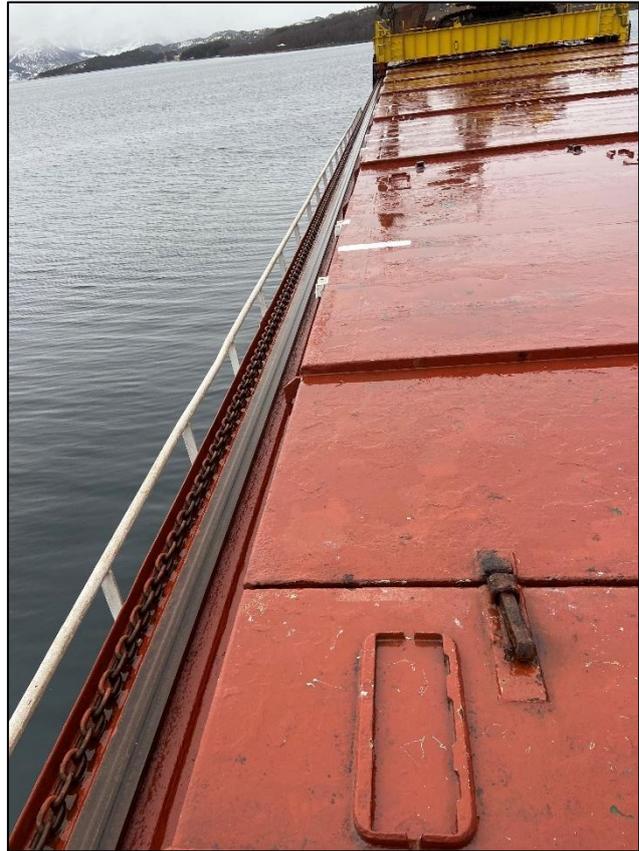
Figure 5: Rail track along the cargo hatches. Photo: NSIA

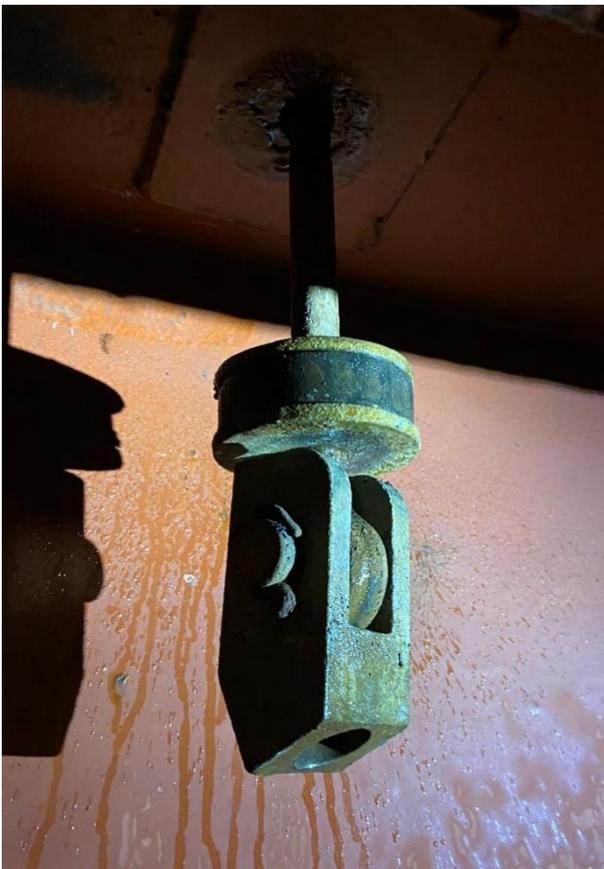
Figure 9: Cleat placed under the rail track to secure the cargo hatches to the coaming. Photo: NSIA

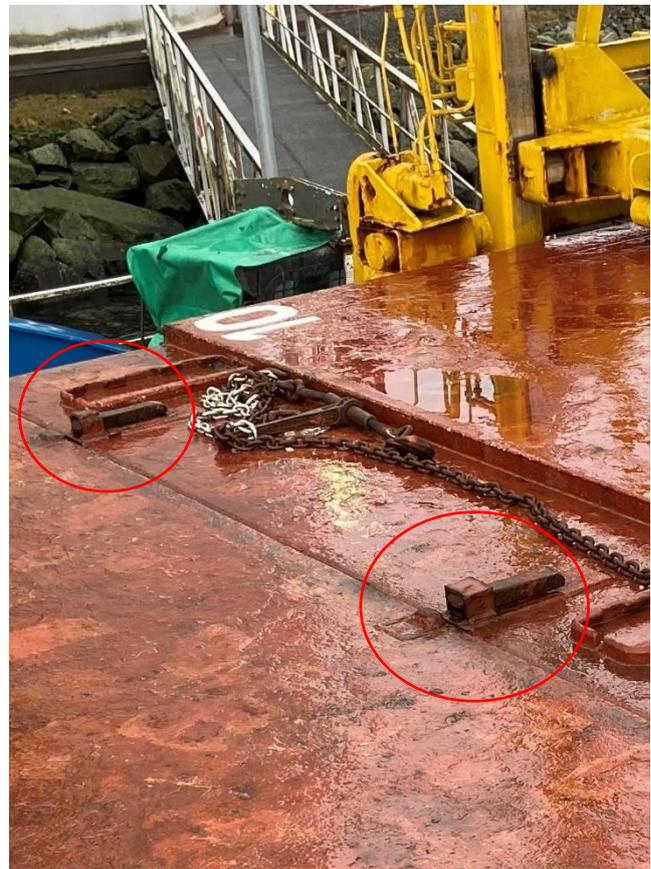
Figure 10: Wedges (see red circle) that ensure that each cargo hatch is fastened to the adjacent hatch. The chain was used to fasten the bucket to the excavator. Photo: NSIA

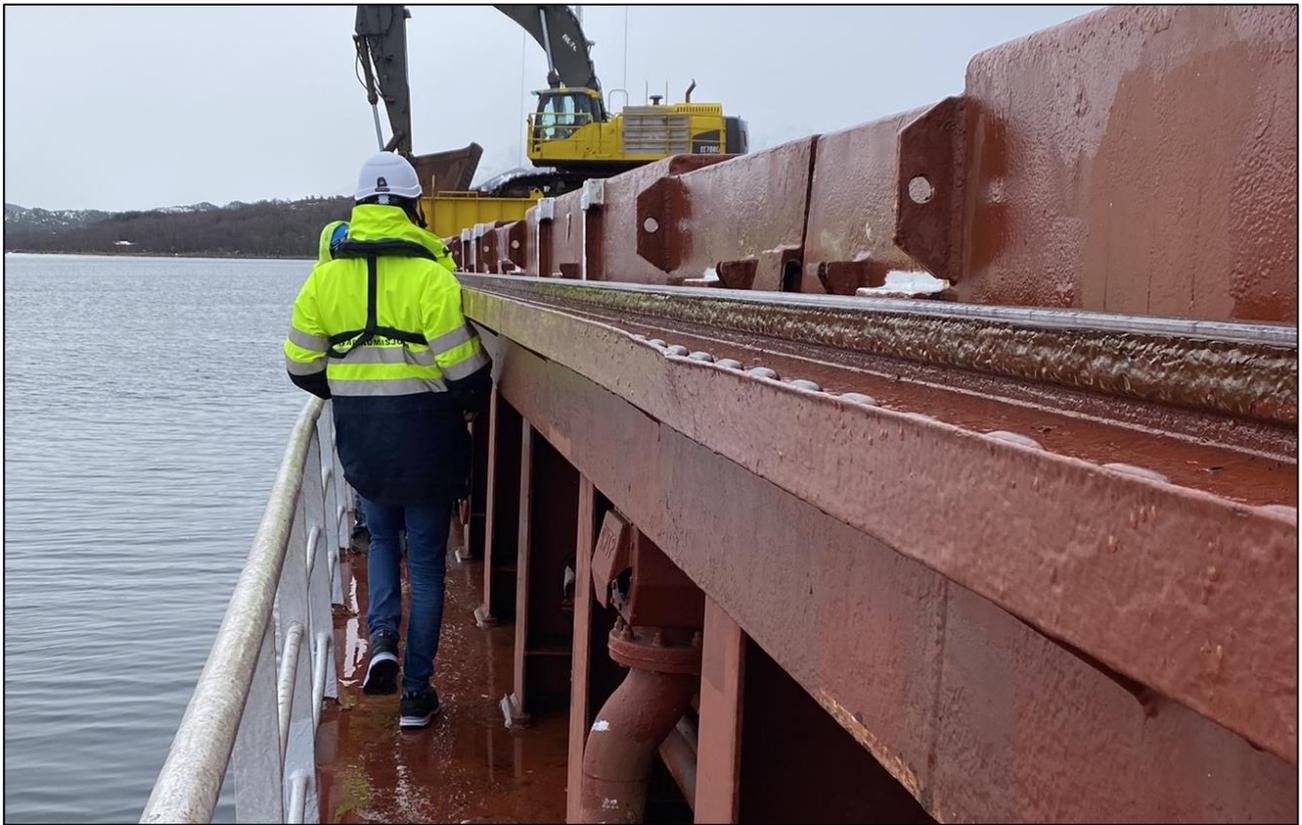
Figure 11: The main deck relative to the hatch deck. Photo: NSIA

The level of the hatch deck was 45 cm above the rail track, and from the track there was another 144 cm down to the main deck, where it was possible to walk along the hatch coaming; see Figure 12 and Figure 11. The 110 cm railings were intended as a safety barrier against falling overboard. There were ladders forward and aft for access from the main deck to the hatch deck.

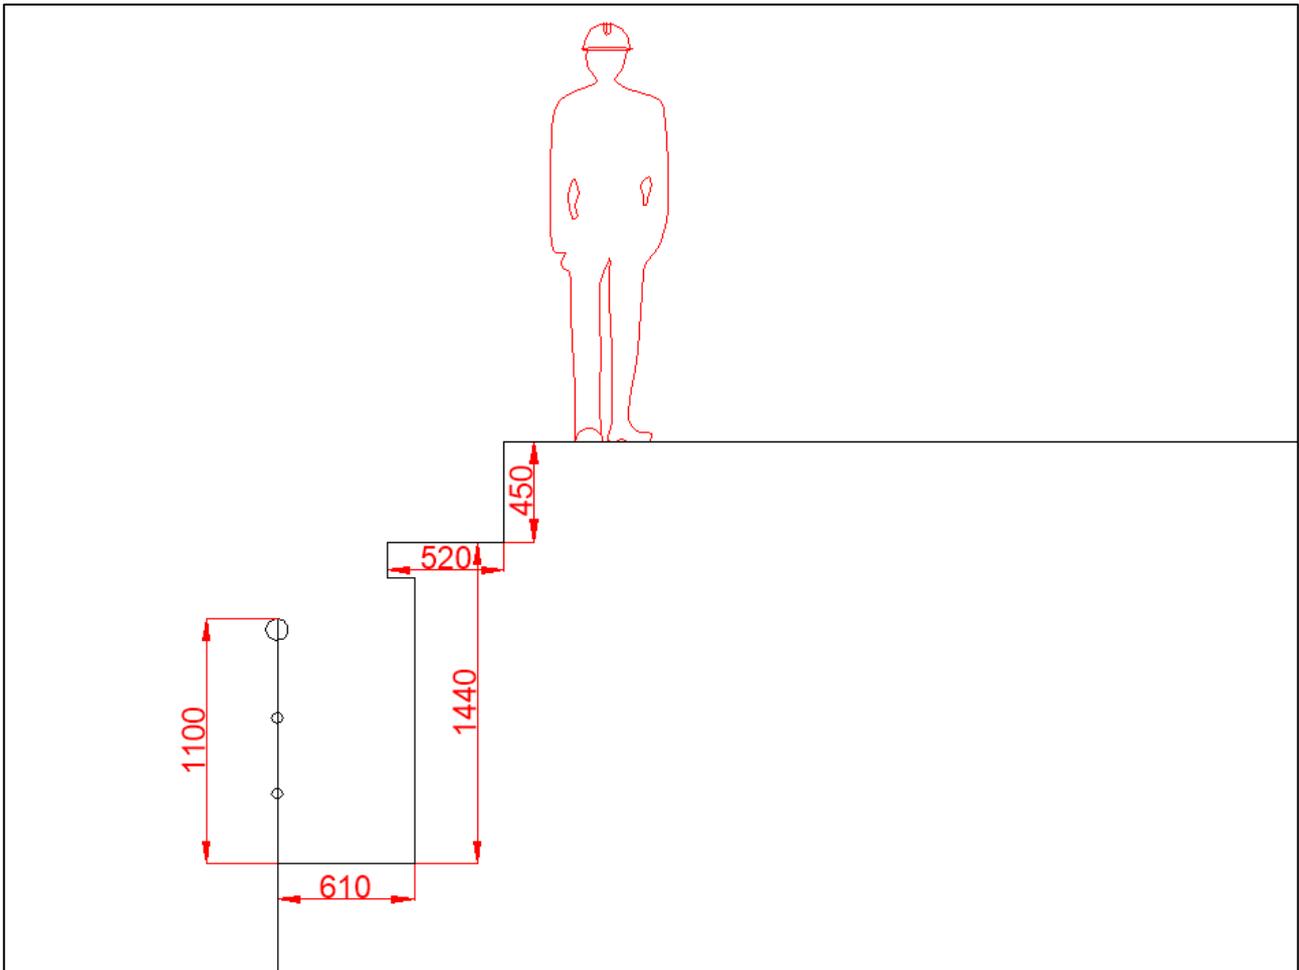
Figure 12: Cross section of the deck design, with measurements in mm. The person in the illustration is standing on top of the hatch deck. Illustration: NSIA

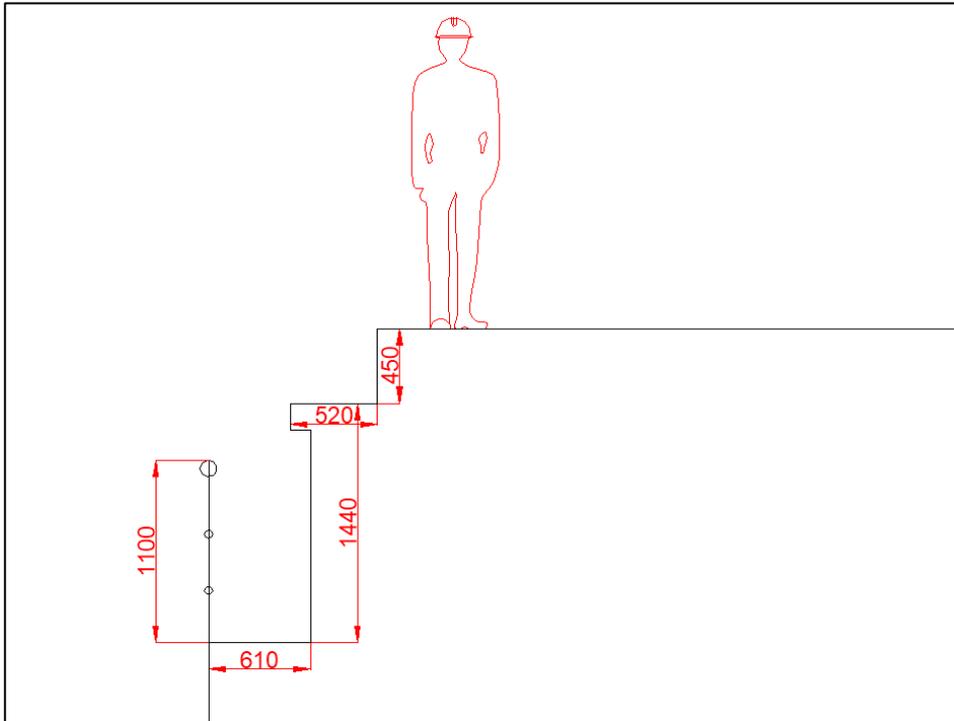
The NSIA considers that the way the deck was designed, with a short distance from the outer edge of the cargo hatches to the railings at a considerably lower level (see Figure 17) was inexpedient in relation to the work to be performed and that it entailed a risk of falling overboard.

Figure 17: Cross section of the deck design, with measurements in mm. The person in the illustration is standing on top of the cargo hatches. Illustration: NSIA

Furthermore, the investigation has shown that the crew's use of this 'shortcut' was a well-known practice. The NSIA considers it unfortunate that the design enables crew to move up and down on the hatches using the track and railings.
