Issued October 4, 2022

MIR-22/25

## Grounding of Passenger Ferry *Commodore*

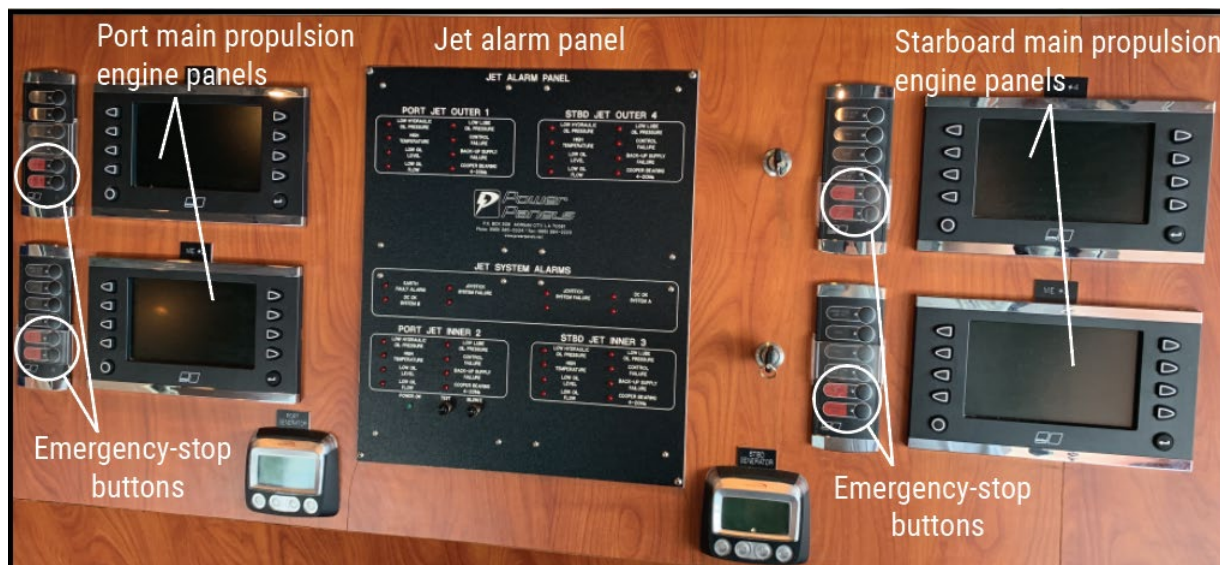
**Figure 4.** *Commodore's* main control station main propulsion engine panels, jet alarm panel, and emergency-stop buttons, located to the left of the captain's chair.

Inspected passenger vessels are required to have emergency main propulsion engine stops that are independent of the control system, and the *Commodore* was fitted with them. The captain could have pushed the emergency-stop buttons on all engines, rapidly reducing speed and stopping the vessel, giving him and the mate time to assess the loss of control situation. Or, had the captain or mate recognized that they had lost primary control of the port engines and water jets, the captain could have pushed the emergency-stop buttons for just the port engines and maneuvered the vessel with the two starboard water jets.

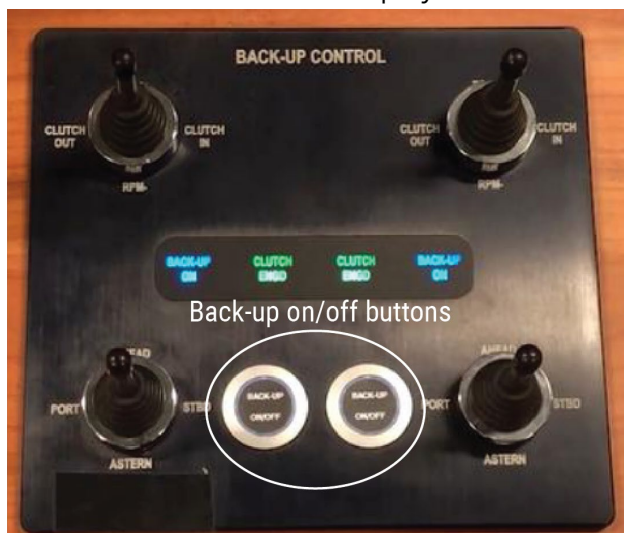
**Figure 5.** One of *Commodore's* back-up control panels, with back-up on/off buttons illuminated showing that back-up control is on. (Background source: Kongsberg Maritime)

To shift to back-up control mode on the *Commodore*, the operator had to simply depress buttons on the back-up control panels. During this casualty, the captain could have used the back-up control panel to reduce rpm on all four engines, steer with the nozzles, and reverse thrust. Training records for the captain and mate reflected the back-up control mode was an area of their training, but neither had to demonstrate application or proficiency to the trainer. The captain's unfamiliarity with operating the back-up control system indicates that his training had been ineffective. He told

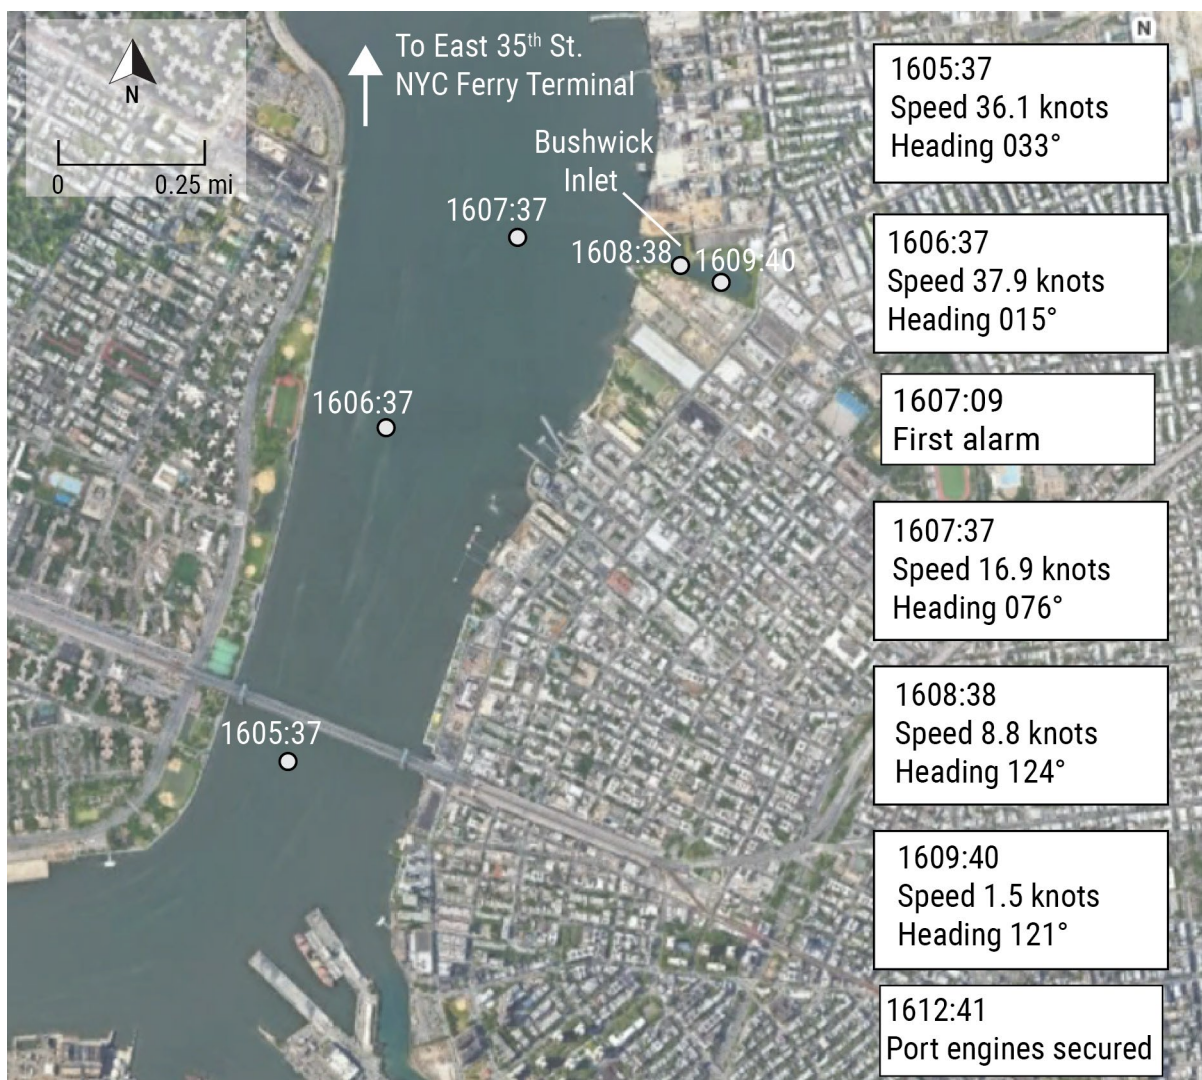
The captain told investigators that he then placed the throttles and steering controls in “harbor [auto] mode.” At 1608:08, both starboard engines reduced from 1,400 rpm to 750 rpm after the captain pulled the joystick backward, attempting to reverse the thrust direction on all water jets to stop the vessel’s forward movement. The main A display screen was still blank. About 10 seconds later, the captain left the main control station and ran to the port wing station. At 1608:40, the captain transferred control to the port wing station via the port wing touchscreen display and tapped on one of the red triangles, again attempting to reconnect the water jet controls. However, the captain told investigators that the system would not reconnect. The captain placed both thrust levers in the full reverse position and pushed the steering tiller hard to port. He told investigators that he believed he received the same nonresponse that he had received at the main control station.

**Figure 7.** *Commodore's* position, speed, and heading in the minutes surrounding the grounding (from AIS). (Background source: Google Earth)

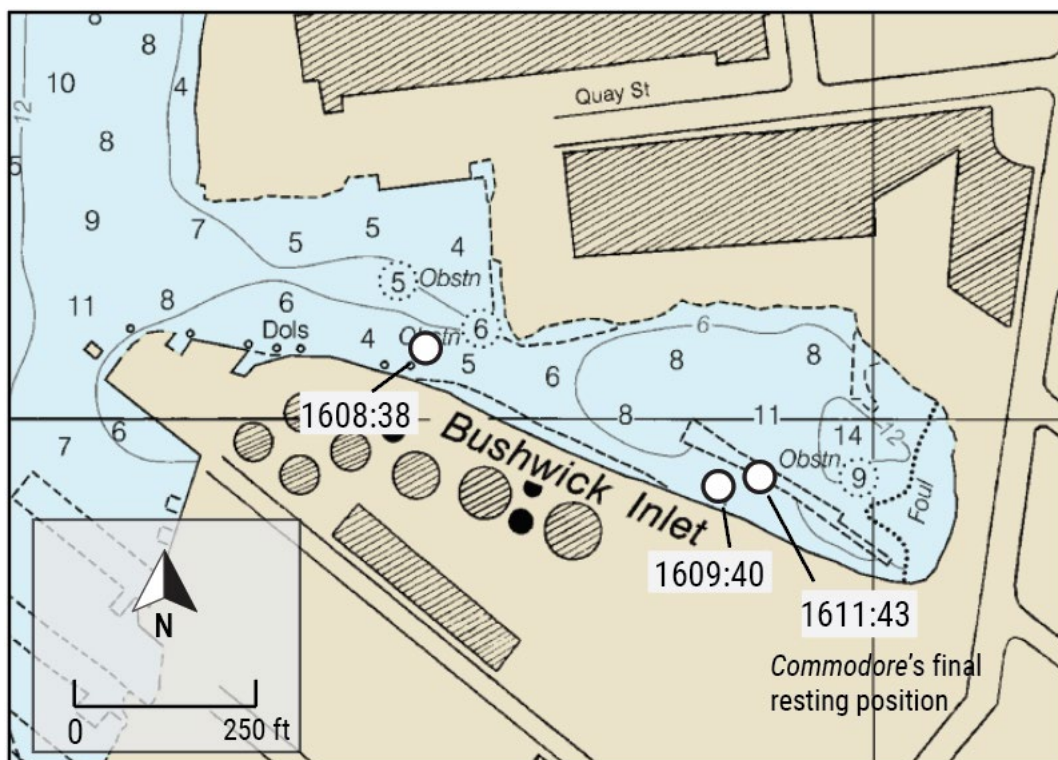
The vessel came to a stop along the southern shoreline of the Bushwick Inlet about 1612. The port hull was breached, and seawater quickly entered the port engine room. The bilge alarms sounded, and the engineer started the engine room bilge pump but observed that the inflow of water exceeded the pump's capacity. At 1612:41, the engineer secured the port main engines followed by the port generator (the starboard generator remained online, and the starboard engines were secured at 1630). The engineer and a deckhand then inserted a portable emergency bilge pump to remove the flood water, but the combined pumping could still not keep up with the inflow of water. The vessel began to list to port.

**Figure 8.** *Commodore's* positions within the Bushwick Inlet as the vessel grounded and came to rest. (Background source: National Oceanic and Atmospheric Administration)

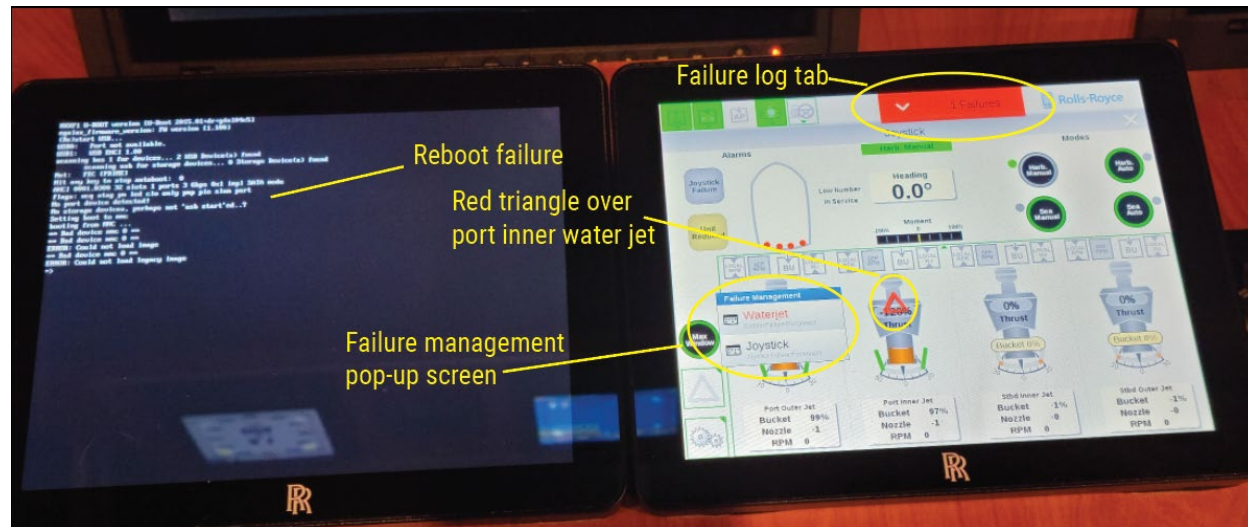
Kongsberg determined that before the casualty, the Can Man Touch software system was generating an unprecedented number of error messages (the GUI logs showed about 200,000 failure messages from June 1 to June 5). The log file section had reached maximum file size, which meant that any older entries would have been overwritten. A side effect of generating these error messages caused the software to write two large configuration files to the attached SD card every minute or so. Data could only be written to the flash memory in the SD card a limited number of times before the SD card would fail.

Kongsberg found that the system recorded failure codes from June 1 to June 5 (system failure messages would have been displayed as active). The vessel was not in service from June 1 to June 4. On June 5, the day of the casualty, in accordance with Seastreak's Ferry SMS, the crew completed "Checklist 1," a startup checklist containing checks of propulsion, power, and steering systems, including engine and jet alarms. The crew did not note any active failures.

**Figure 9.** *Commodore's* main control station during postcasualty examination, showing the main A display screen's reboot failure (left) and the red failure log tab, red triangle over the port inner water jet icon, and the failure management pop-up screen on the main B display screen (right). (Background source: Coast Guard)

On July 7, Kongsberg issued a service letter mandating that vessels with CanMan Touch control system software receive a necessary update. The background to the letter stated the following:
