Bundesstelle für Seeunfalluntersuchung
Federal Bureau of Maritime Casualty Investigation

Investigation Report 285/20

Serious Marine Casualty

**Allision with a lock gate at Kiel-Holtenau on the
Kiel Canal (NOK) by the multi-purpose vessel ELSE
on 29 August 2020**

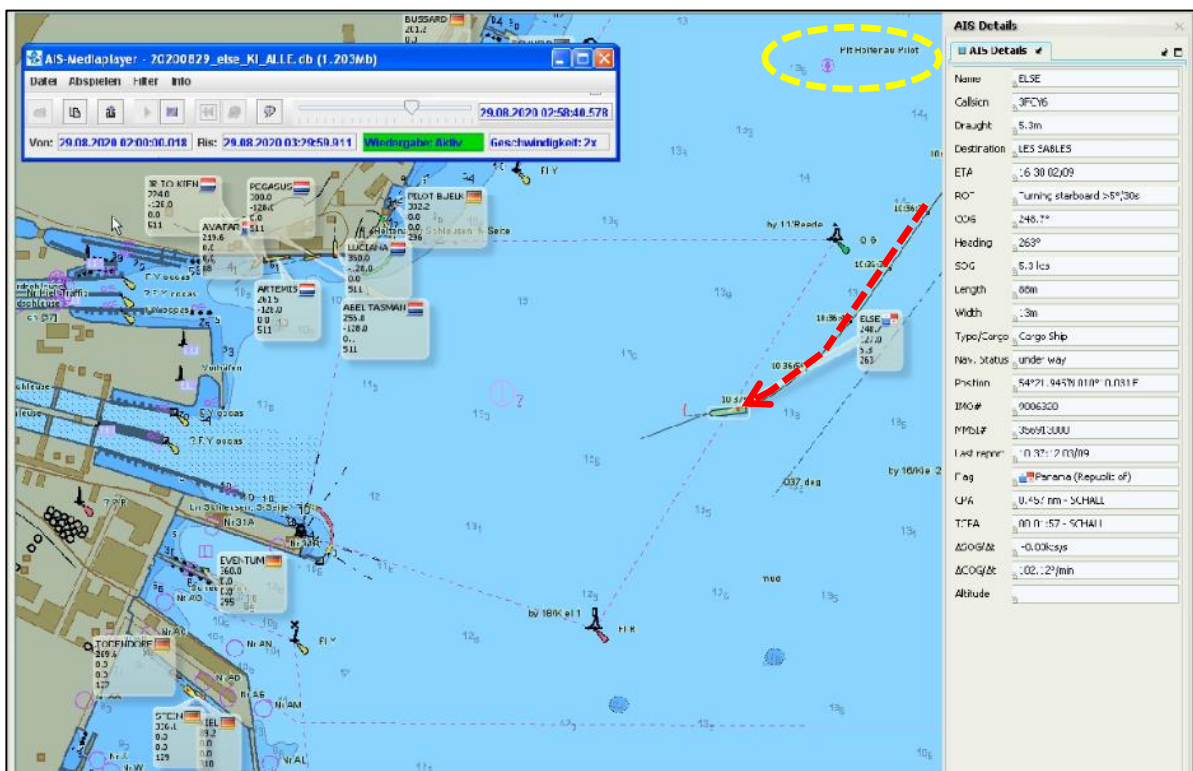
The ELSE passed the navigational chart position of the pilot boarding point (see yellow highlighting below in **Figure 3**) abeam at about **0453** but continued her voyage without making any significant course or speed alterations and without reporting in to VTS NOK or the pilot station.

The ship then began to leave her aforementioned general course at about **0457** and turned purposefully towards the Kiel-Holtenau lock entrance, maintaining a speed of just under 6 kts (see red highlighting in **Figure 3**). It was not possible to verify whether this course alteration was carried out by a helmsman – as claimed on the ship – or the chief mate personally. However, the sources of information evaluated by the BSU indicate that the master was not on the bridge at that time.¹⁷

Figure 3: The MV ELSE alters course towards Kiel-Holtenau (0458)¹⁸

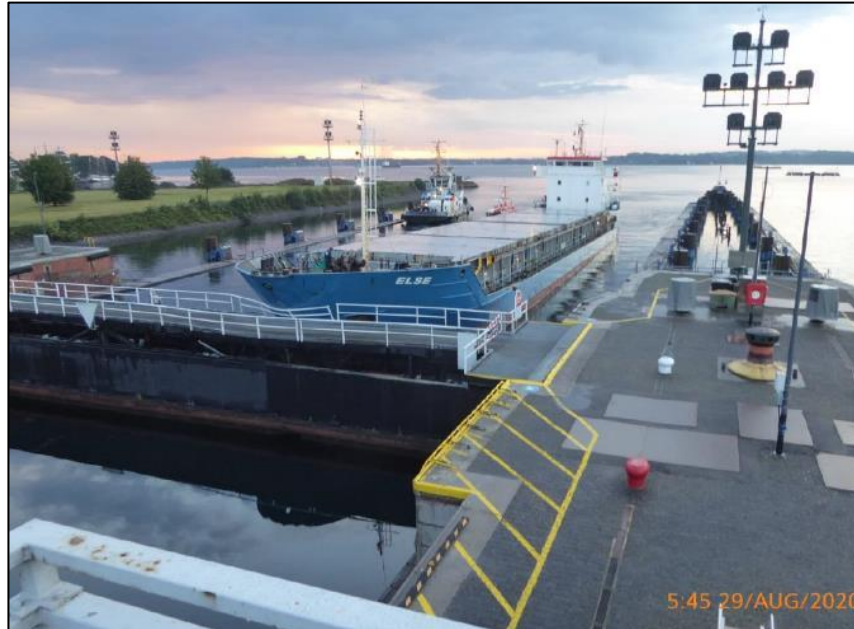
Instead, the ELSE's bow remained trapped there (see **Figure 4 f.** below) and this condition persisted until the arrival of the tugs **STEIN** and **HOLTENAU**.

Figure 4: MV ELSE with her bow in the lock gate (1)²¹

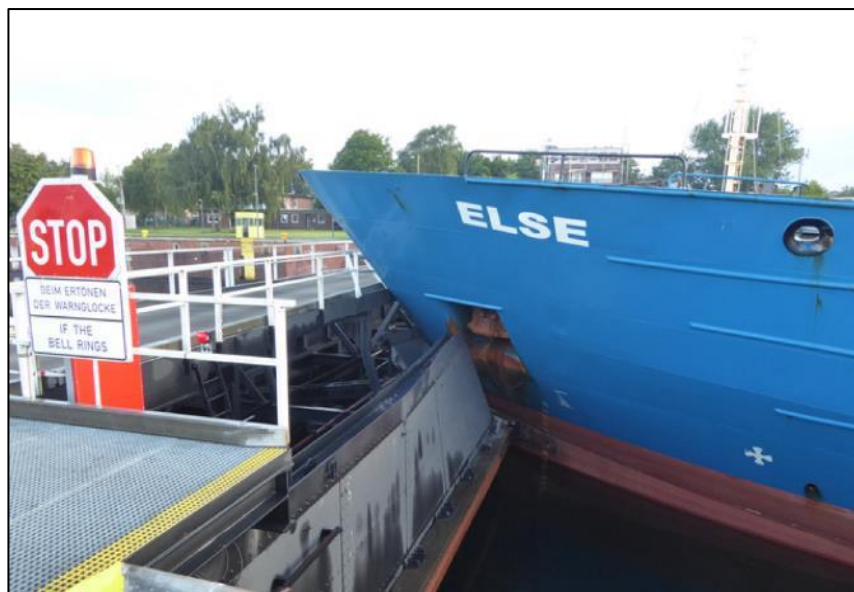
Figure 5: MV ELSE with her bow in the lock gate (2)

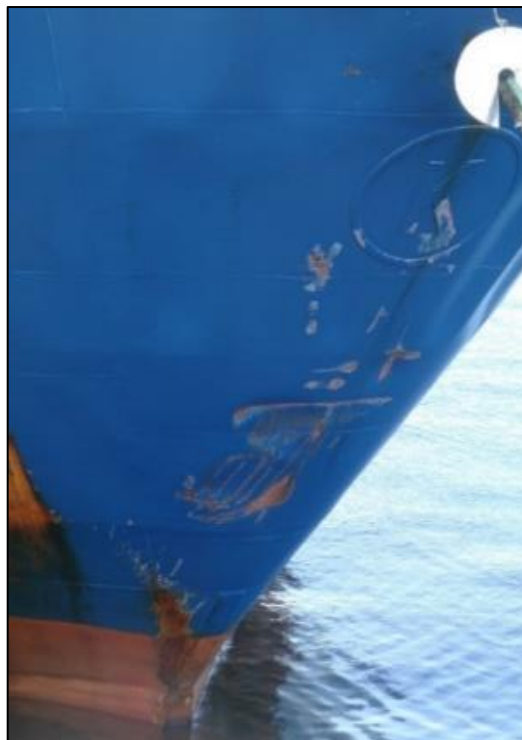
The ELSE suffered damage to the fore section during the allision between her bow and the lock gate. Damage above the waterline was confined to paint abrasions and small dents in the shell plating (see **Figure 6** below). There was a roughly 180 m long and 0.40 m wide crack in the forepeak below the waterline. The ballast tank located there (capacity: 88 t) thus flooded with seawater (quantity: about 60 t) up to the waterline.²² This damage did not result in a significant reduction in the ship's buoyancy or stability. No pollutants escaped.

Figure 6: Damage to the MV ELSE's bow above the waterline

Divers carried out an examination there and detected a hole in the ship's forepeak tank. The corresponding repair necessitated dry-docking but since the damage had not significantly impaired the ELSE's seaworthiness, the classification society issued an interim class certificate (so-called 'Interim Cargo Ship Safety Construction Certificate'). Subject to certain conditions listed in the certificate, it granted the ship permission to call at the French port of destination to unload her cargo there. The classification society also instructed the ELSE to call at a repair yard in Brest (France) immediately afterwards to have the damage to the forepeak repaired in dry dock.

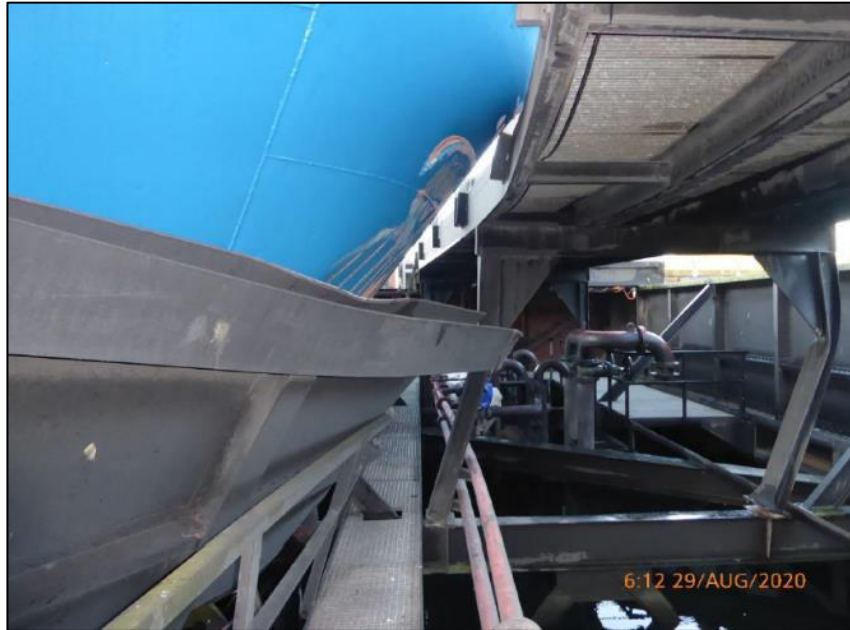
The fjord-facing sliding gate 3 of the north chamber of the 'Neue Schleuse' lock, which was fully closed at the time of the accident, was severely deformed by the impact of the ELSE's bow. The ship's bulbous bow pushed forward about 2 m to the tank deck of the gate, damaging the gate's structure and the steel girders in the area of the accident (see **Figures 7 ff.** below) in the process. The gate had to be dismantled for extensive repairs and replaced by a spare one.

Figure 7: Damage to the lock gate (close-up 1)²³

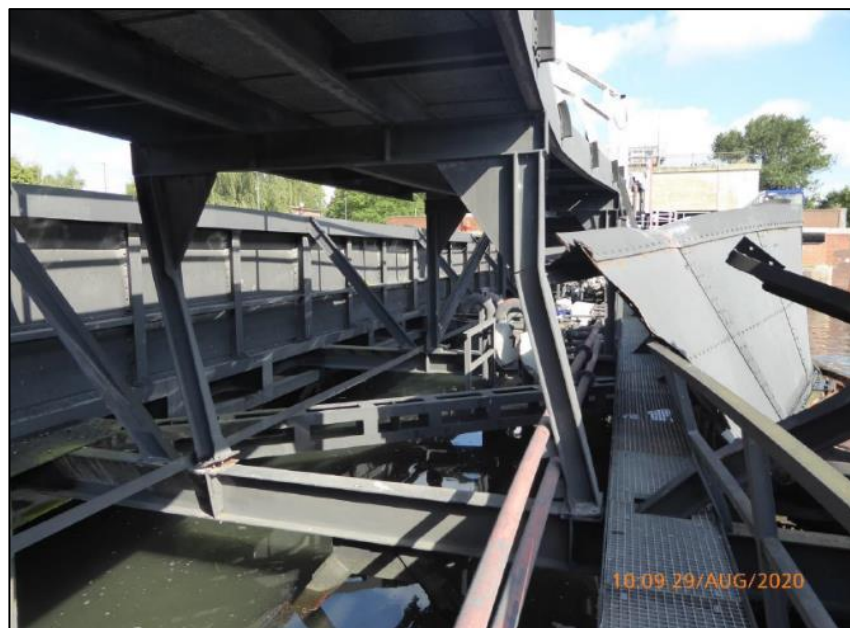
Figure 8: Damage to the lock gate (close-up 2)

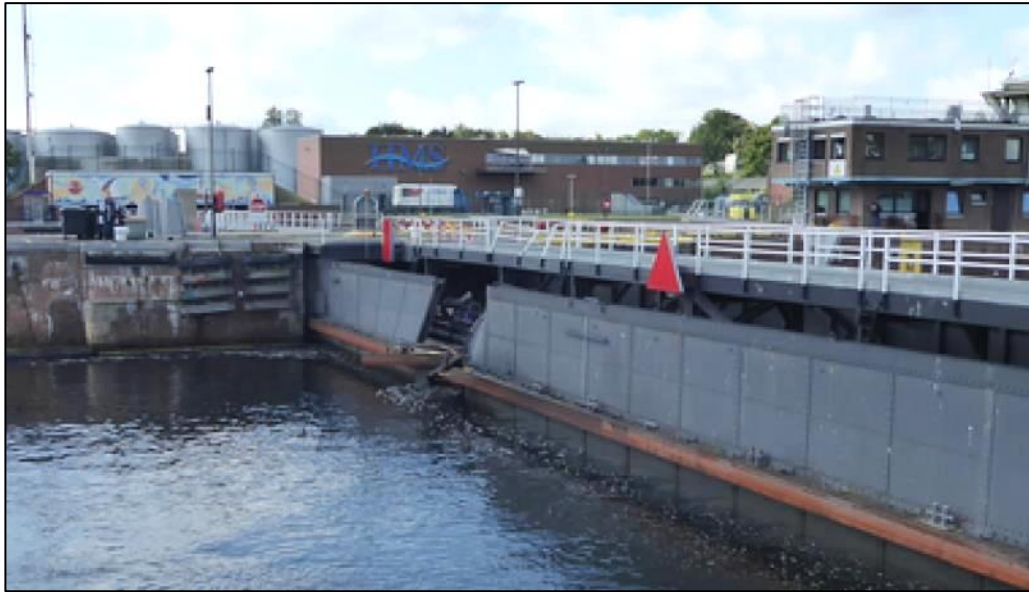
Figure 9: Damage to the lock gate (general view)²⁴

VTS NOK took the lock's north chamber out of service and the south chamber was used for incoming and outgoing NOK traffic in the days that followed. The damaged gate was dismantled and replaced by a spare one.

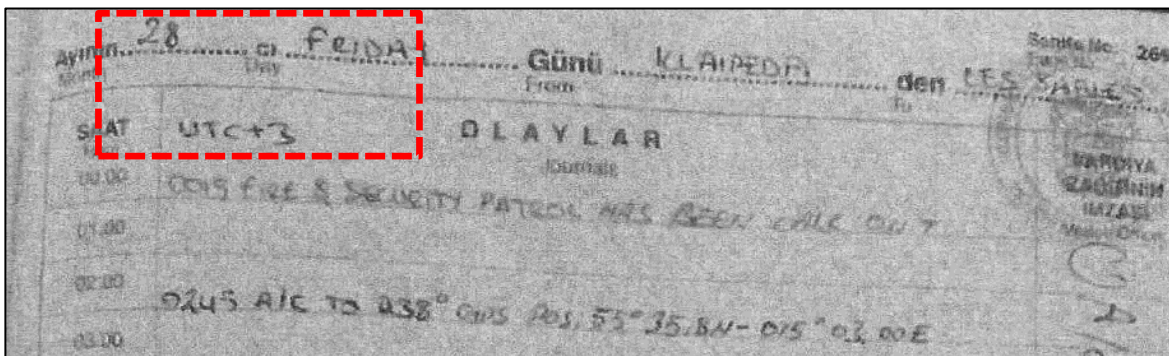
A review of the entries in the ELSE's deck log book confirmed the suspicion that ship time, which originally corresponded to local time in Klaipėda, had not been adjusted since they left the port of departure. In the log entry for 28 August, "UTC + 3" is still noted as the time on board (see **Figure 22**).

Figure 22: Extract from the MV ELSE's deck log book, 28 August 2020

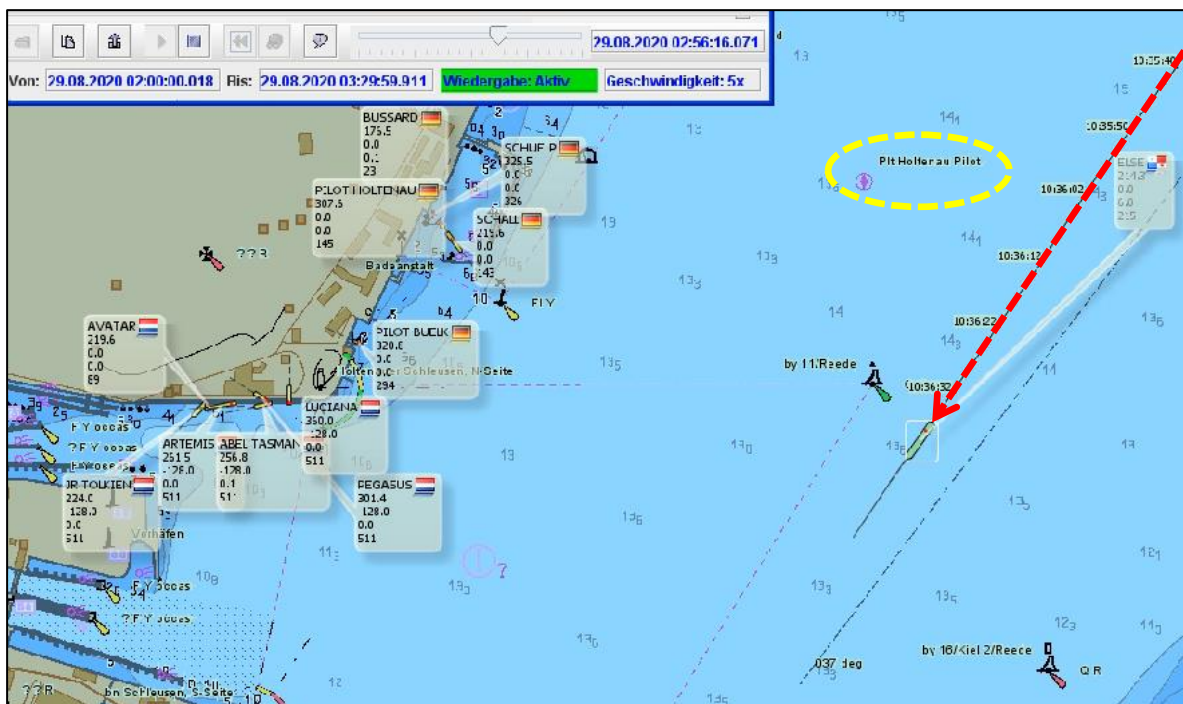
The ship then passed the Holtenau roadstead on the starboard side without any further course alterations but then passed the pilot boarding point marked on the navigational chart at about **0453** without reducing speed (see **Figure 27** below).

Figure 27: The ELSE sails past the pilot boarding point (track here until 0456)

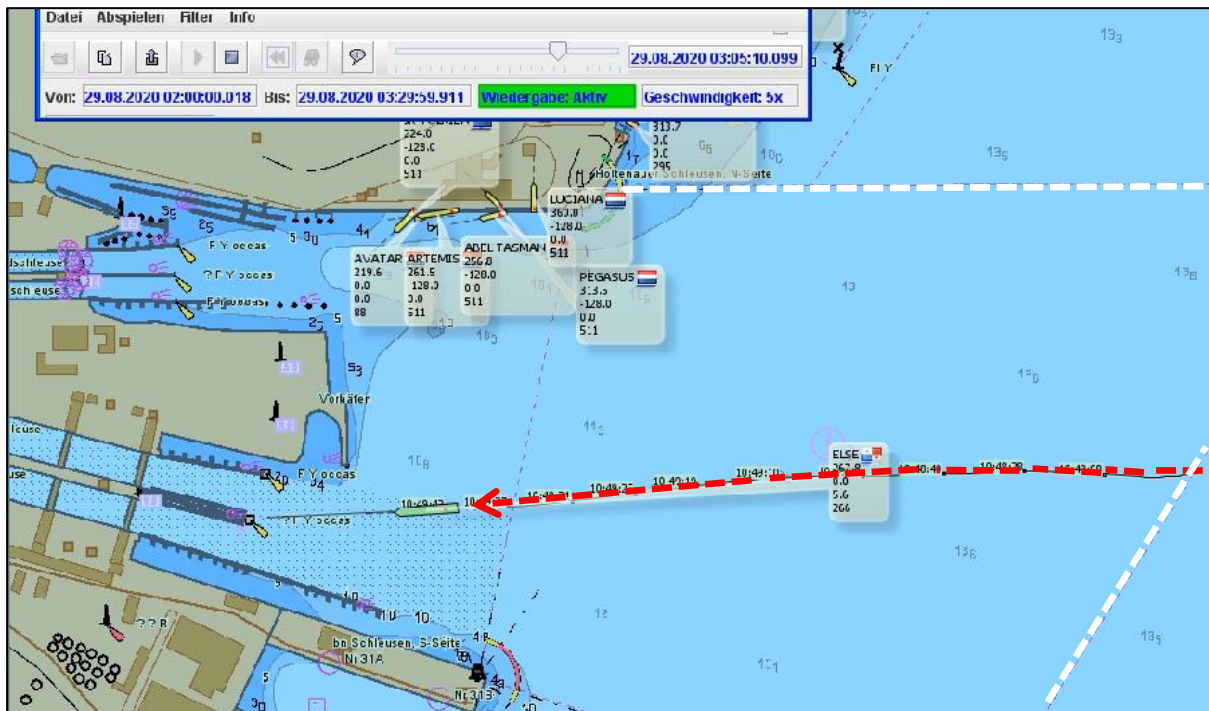
Figure 29: The ELSE approaches the lock chamber without any reduction in speed (track here until 0505)

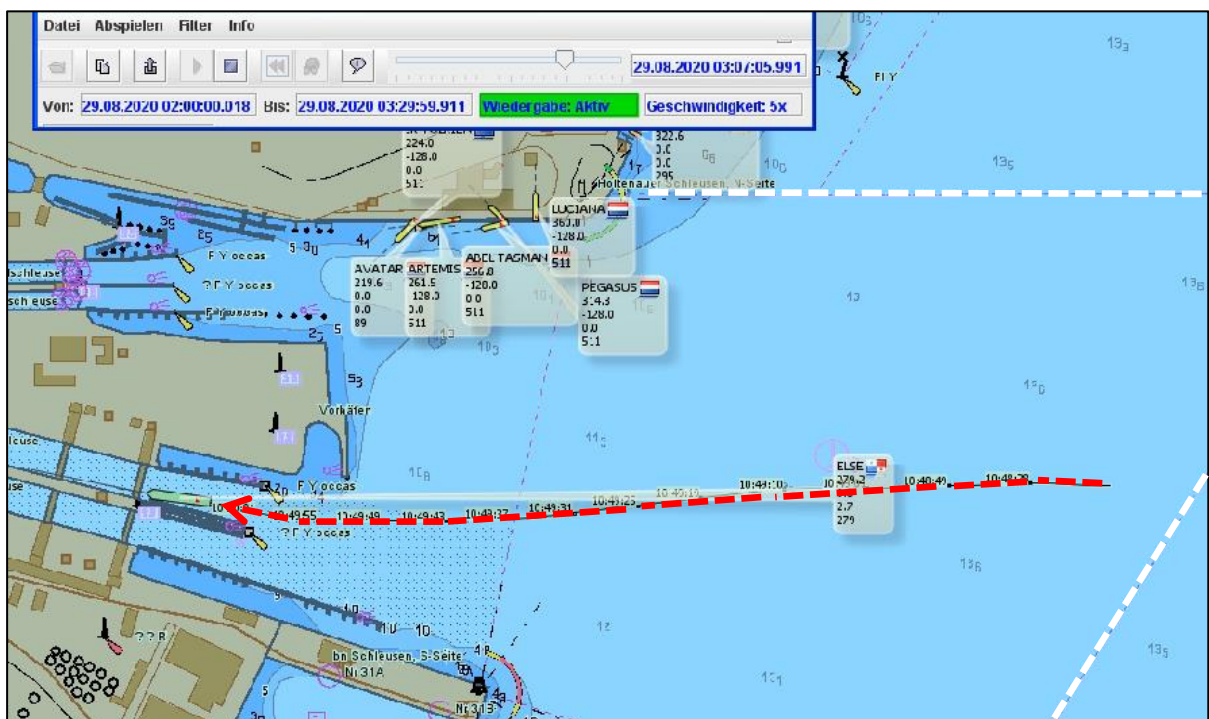
Figure 30: The ELSE just before the allision with the lock gate (0507)

The AIS recordings imply that the ELSE reduced speed immediately before the allision with the lock gate, i.e. an emergency stop manoeuvre was presumably made on board. This is probably why the gate was not breached but rather absorbed the energy of the impact and thus brought the ship to a standstill.

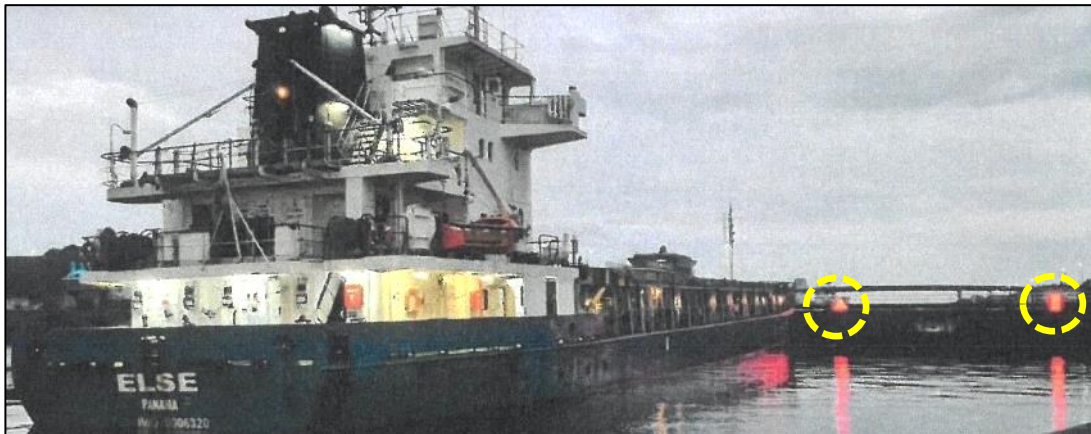
In addition to the traffic control signal installations, three large red warning lamps are mounted on the upper edge of the respective lock gate on its right-hand side, in the middle and on the left-hand side (left and right in the form of a rectangle in vertical format and in the middle in the form of a triangle; see **Figures 41 f.**). This warning system informs ship's commands and pilots clearly and unambiguously that the lock gate is closed if, for example, the above-mentioned signal installations have failed and/or the closed gate's contours cannot be clearly identified in the dark or due to other visual restrictions.

Figure 41: MV ELSE in front of the closed lock gate (red illuminating warning lamps visible)⁶⁸
