Issued October 27, 2022

MIR-22/27

Collision Between Liquefied Petroleum Gas Carrier *Gas Ares* and Moored Tug *Sabine*

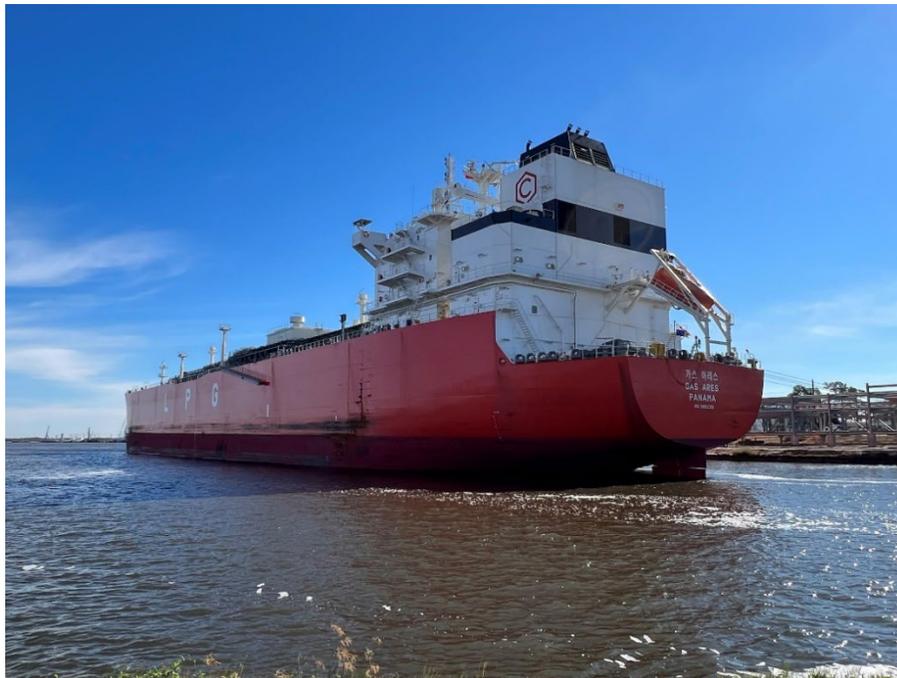
Figure 1. *Gas Ares* after the casualty. (Source: US Coast Guard)

The *Gas Ares*'s port bow sustained minor damage consisting of an indentation and scratch in the shell plating above the waterline. No postcasualty survey was conducted.

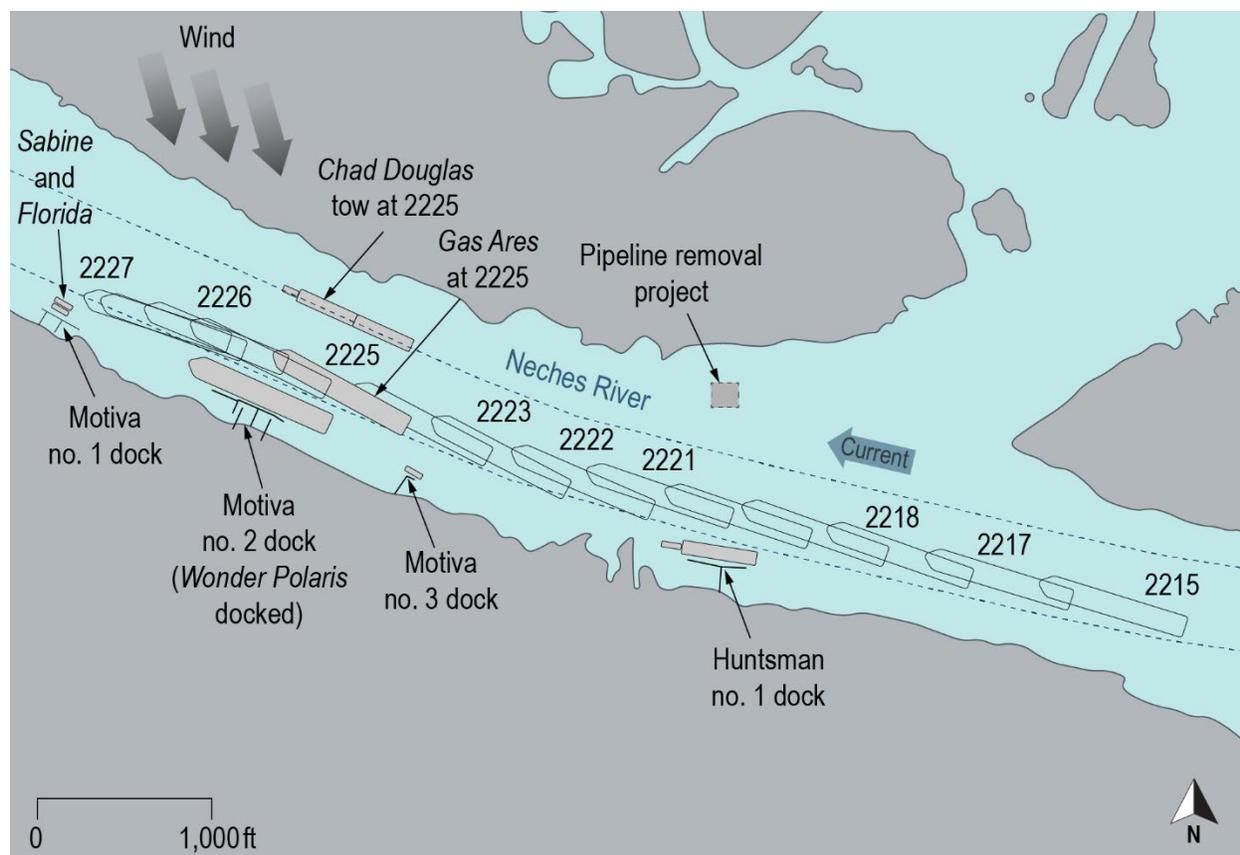
Figure 3. Path of the *Gas Ares* before it collided with the moored tug *Sabine* at the Motiva no. 1 dock. (Vessel data source: *Gas Ares* VDR)

The *Gas Ares* continued ahead at 4.1 knots, and the pilot saw that the vessel's bow was moving toward the tugs moored at the Motiva no. 1 dock. Consequently, she issued the following orders in quick succession: 1) the *Hayley Moran* pull full to starboard; 2) rudder amidships; 3) again sound "five short blasts" of the ship's whistle; 4) let go the starboard anchor; and 5) engine emergency full astern. The bridge team complied with her orders.

On the *Gas Ares's* bow, a crewmember released the starboard anchor at 2227, and at the same time, as the bow continued to fall to port, the *Gas Ares's* port bow collided with the *Sabine* on its starboard side. The *Sabine's* mooring broke, and the tug was pushed into the adjacent tug *Florida* and moved up river. The *Florida*, which had

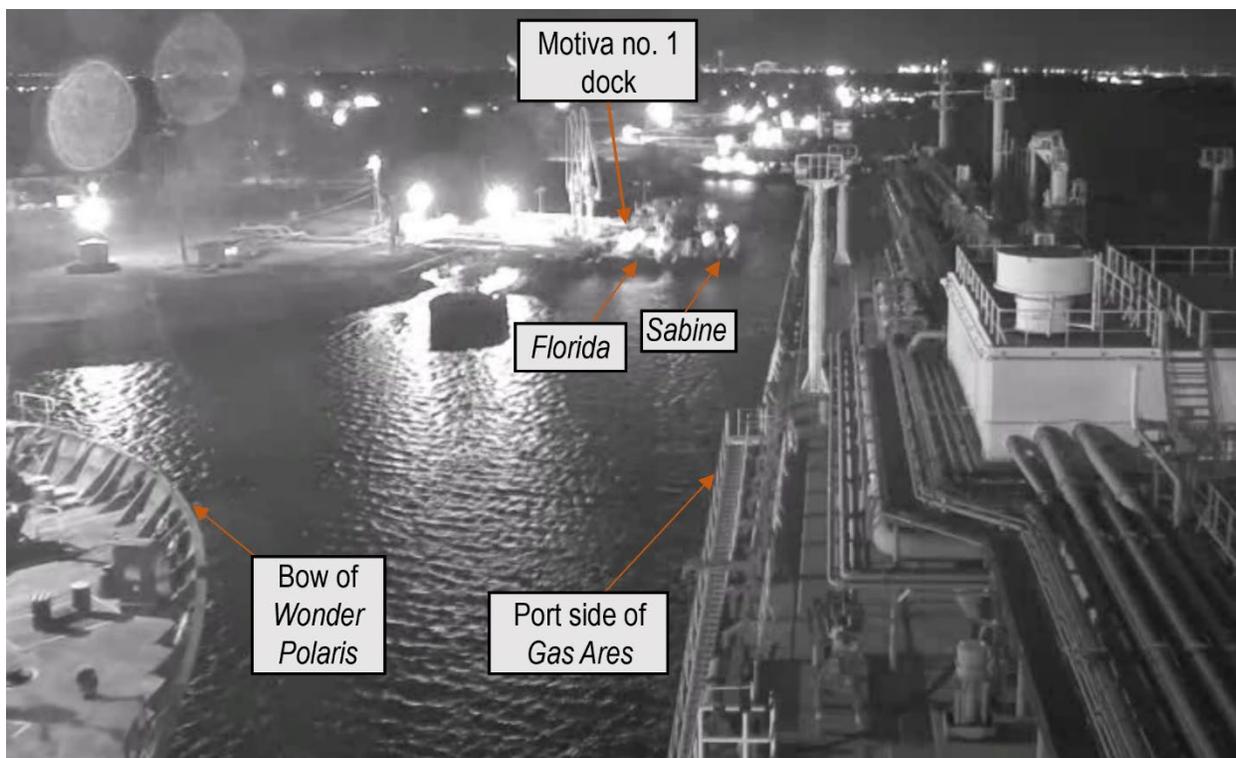
Figure 4. Onboard image recording system view from the portside forward-looking camera of the *Gas Ares* at 2226. (Background source: KSS Line)

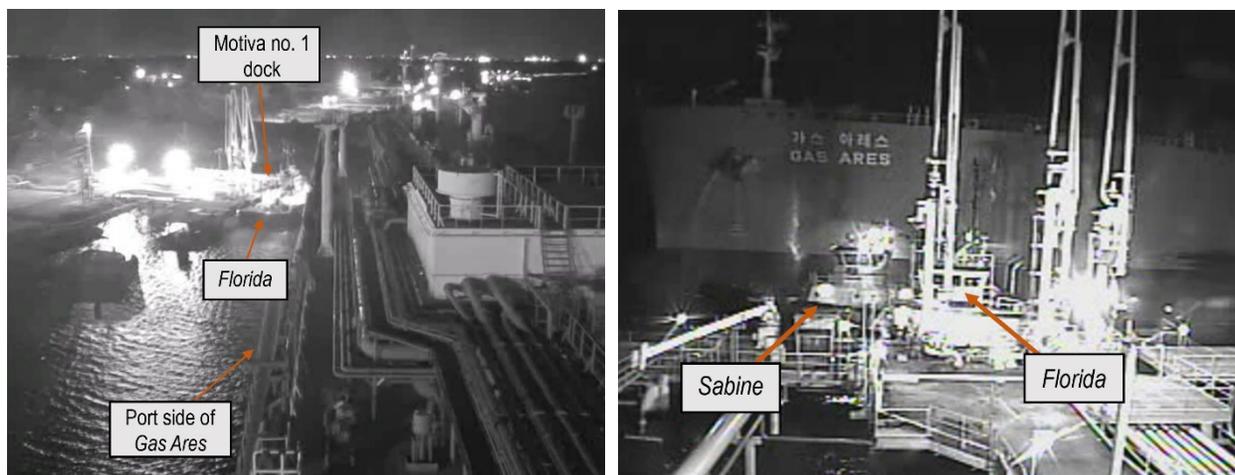
Figure 5. Image recording system views from the *Gas Ares*'s portside forward-looking camera at 2227, the time it collided with the tug *Sabine* (not visible in image) (left) and from the Motiva no. 1 dock seconds after the *Gas Ares* collided with the *Sabine*, which broke from its moorings (right). (Background sources: KSS Line [left] and Motiva Port Neches Terminal [right])

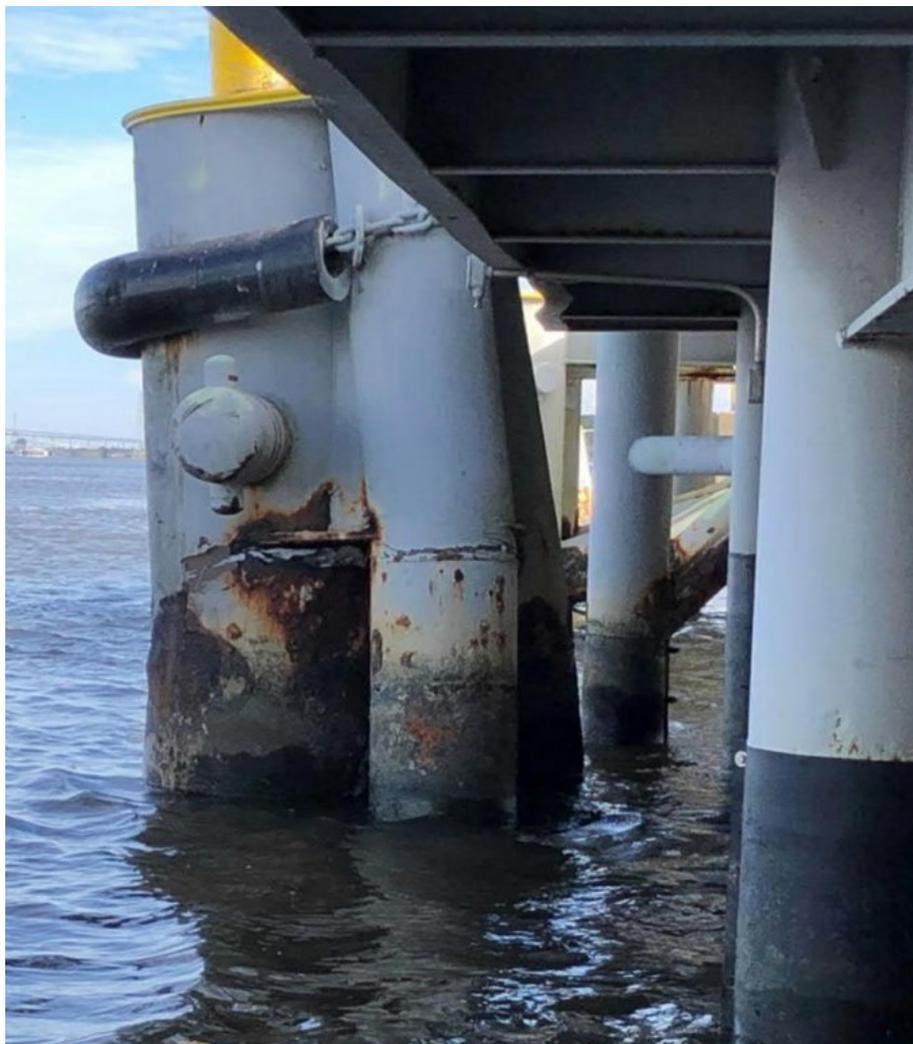
The Motiva no. 1 dock sustained damage to its pilings, steel beams that supported the concrete deck, the concrete surface, and mooring dolphins.² The cost of repairs was estimated to be \$967,000.

Figure 6. Damage to one of the steel mooring dolphins, looking down river. (Source: Lanier and Associates Consulting Engineers)
