Investigation Report 301/21

Very Serious Marine Casualty

Foundering of the fishing vessel RAMONA in the mouth of the River Elbe on 21 September 2021

20 December 2022

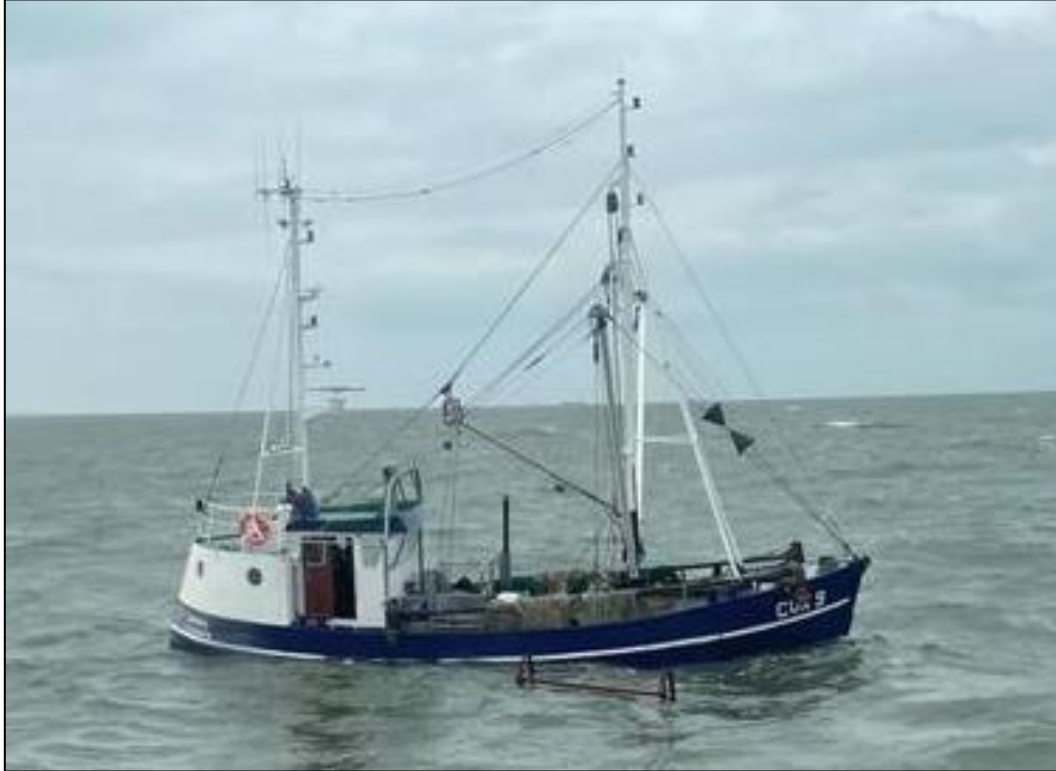
Figure 1: RAMONA already in the process of foundering.²

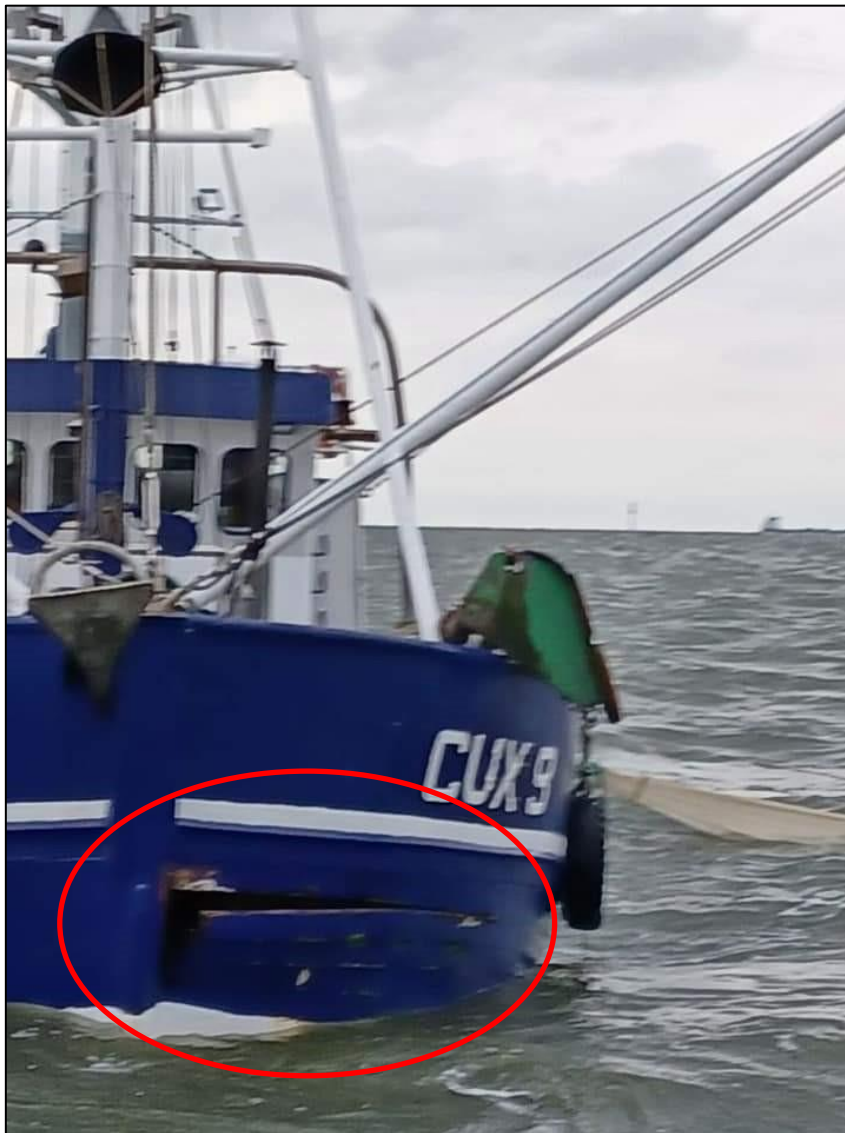
Figure 3 shows the protruding planks on the bow of the RAMONA. The image is unfortunately not available in better quality but the BSU is nonetheless grateful to the crew of the rescue cruiser ANNELIESE KRAMER for having the presence of mind to take photographs during this emergency. Accordingly, pointers as to the cause of the accident were at least available for the investigation.

Figure 3: Loose planks at the bow of the RAMONA⁴

Due to the total loss of the fishing vessel, the BSU was unable to determine the cause of the damage that occurred. It appears likely that there must have been a barely noticeable collision with an obstacle in the water, which caused the planks on the bow to loosen, followed by rapid and heavy water ingress. It seems rather improbable that the RAMONA struck an obstacle while casting off in Cuxhaven such that she remained afloat for another three hours with the unnoticed damage. However, it is possible that a minor allision occurred when she cast off, causing the planks at the bow to loosen almost unnoticeably and then continue to loosen more and more over the hours that followed due to the swell, until the water ingress became so heavy that it was noticeable.

Despite the fortuitous reality that the DGzRS took photographs of the distressed fishing vessel, the one photograph that actually shows the damage on the bow is so blurred that it is impossible to draw any conclusions from it. Inconspicuous flecks of a different colour can be seen on the loose planks, which look like minor damage and paint abrasions and could thus point to an allision. However, these flecks of colour may have been caused by other influences that are not connected with the accident under investigation. Since evidence of either possibility could not be found, the cause of the accident must ultimately remain open due to the lack of other findings.

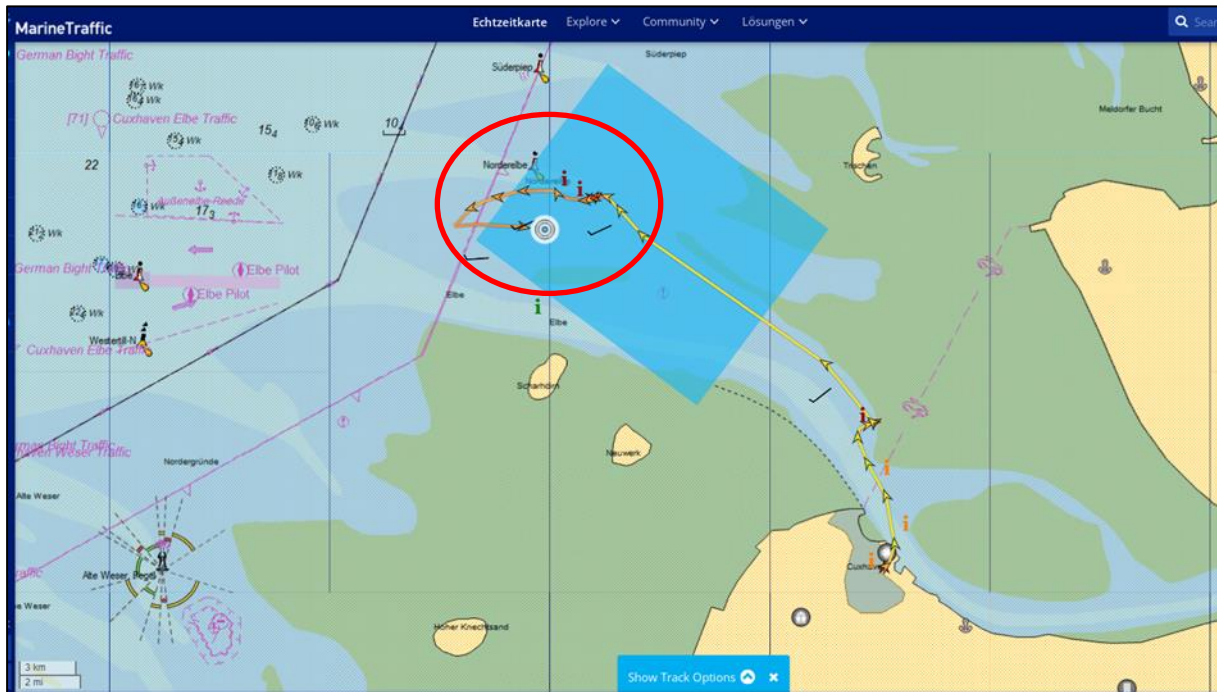
Figure 4 below shows the course of the vessel's voyage recorded by the MarineTraffic AIS portal. The voyage begins at about 0530 in the morning with the departure from the port of Cuxhaven and ends with the last AIS signal at 1008. The rescue cruiser

Figure 4: Course of the RAMONA's voyage and scene of the accident⁵

None of the five people on board the fishing vessel was able to explain how the damage to the bow occurred. In particular, no collision with a buoy or other floating object such as a partially submerged container was observed. The recorded AIS track confirms there was no encounter with a buoy. WSA Elbe-Nordsee stated that there was reportedly no knowledge of any floating containers at the time of the accident.
