MIR-22-29

## Collision between Yacht *Utopia IV* and Tank Vessel *Tropic Breeze*

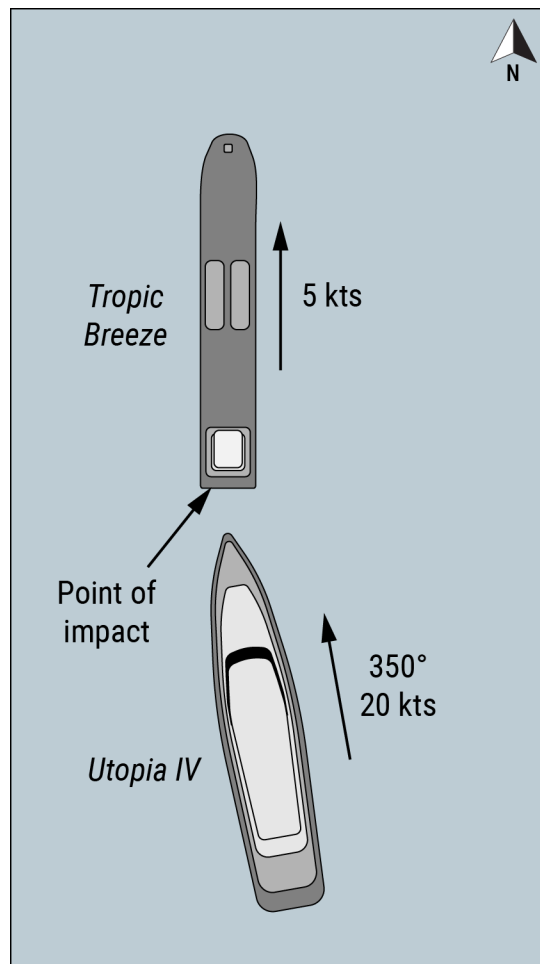
At 2200:48, a closed-circuit television (CCTV) camera in the *Utopia IV's* galley captured equipment and crew suddenly propelled forward as the bow of the *Utopia IV* (traveling at about 20 knots) struck the transom of the *Tropic Breeze* (traveling at about 5 knots) from directly astern, slightly to port of the tank vessel's centerline. Several of the yacht's crew were thrown to the deck or into bulkheads as *Utopia IV* struck the tank vessel at a relative speed of about 15 knots; three crewmembers sustained minor injuries. The *Utopia IV's* captain was in the main dining area and was thrown into the "forward bulkhead and door frame."

**Figure 3.** Approximate positions and headings of *Utopia IV* and *Tropic Breeze* before collision (not to scale).

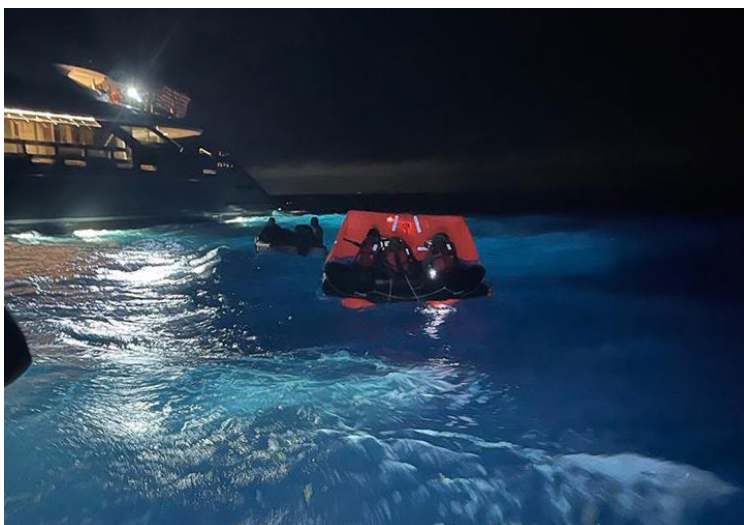
**Figure 4.** *Tropic Breeze* crew wearing lifejackets in the liferaft and rescue boat before rescue. The *Utopia IV* is in the background. (Source: *Amara*)

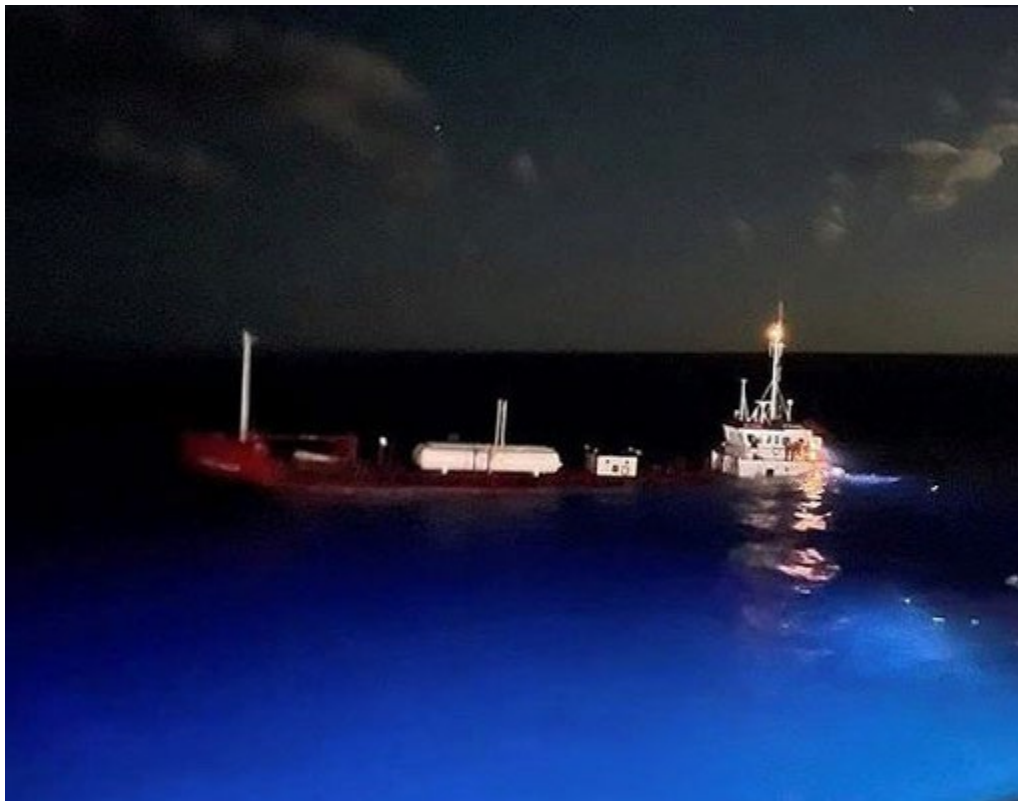
**Figure 5.** *Tropic Breeze* sinking by its stern about 15 minutes after the collision.

The *Utopia IV* penetrated through the *Tropic Breeze*'s empty aft peak ballast tank, reported by the *Tropic Breeze*'s operator to be 3.9 meters (12.9 feet) longitudinally (forward and aft), to the engine room, flooding both the tank and engine room. The *Tropic Breeze*, valued at \$5.1 million, sank in 9,300 feet of water. Lost cargo, valued at \$343,881, was not recoverable.

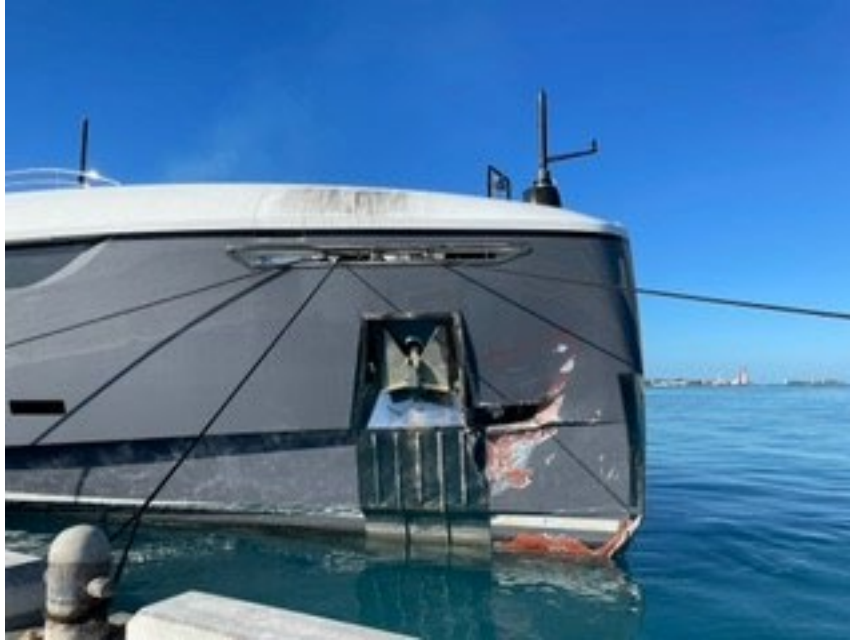
The *Utopia IV* sustained damage including ruptured hull plating above and below the waterline, fractured framing, a compromised double bottom ballast tank, damaged bridge windows, and dislodged and damaged hatches, fittings, and equipment. Total damages were estimated at \$2.4 million.

**Figure 6.** Damage to *Utopia IV*'s bow. (Source: Coast Guard)
