Issued January 12, 2023

MIR-23-01

# Contact of Offshore Supply Vessel *Elliot Cheramie* with Oil and Gas Production Platform EI-259A

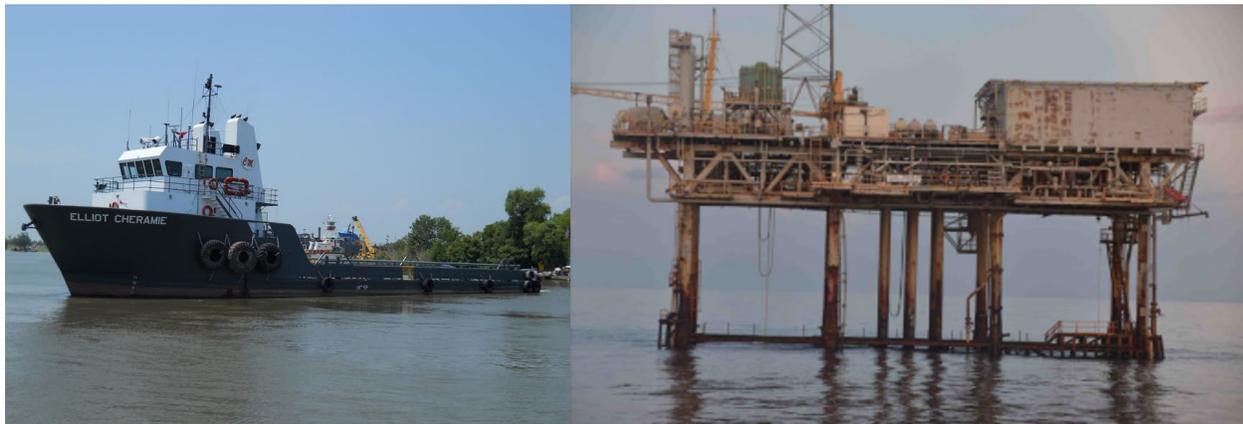
**Figure 1.** *Elliot Cheramie* underway before the casualty (*left*); EI-259A before the casualty (*right*). (Sources: Cheramie Marine [*left*]; Cox Operating [*right*])

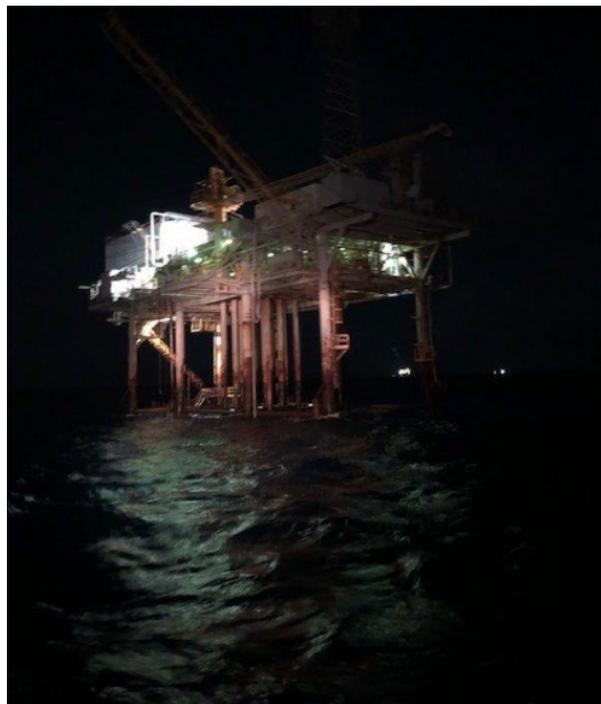
**Figure 4.** Photo of EI-259A, taken by an employee around 0500, a few hours after the casualty. (Source: Cox Operating)

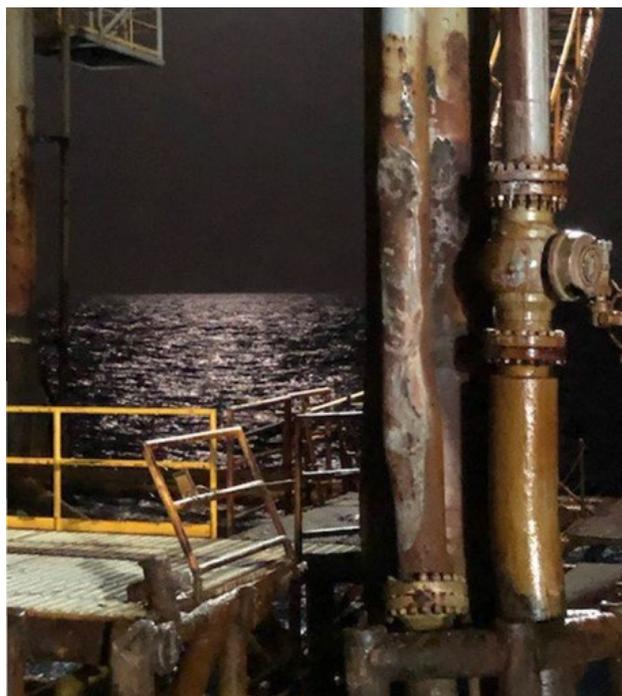
At the time of the casualty, the EI-259A platform was “shut in” (no production) with no crew on board. On the morning of June 25, the owner-operator of platform EI-259A, Cox Operating, took a boat out and noted damages to the northeast corner of the platform’s boat landing level and two vertical pipelines: the departing gas pipeline (owned by Kinetica Energy) and the crude oil pipeline riser (owned and operated by Crescent Midstream). No pollution was reported.<sup>4</sup> Cox Operating completed repairs to the platform and the gas pipeline on July 4. Total damage to the platform and gas pipeline was \$41,956. On August 24, Crescent Midstream completed repairs to the crude oil pipeline riser. Damage was \$125,648.

**Figure 5.** Photo of the damages to EI-259A, taken by a Cox employee around 0500. (Source: Cox Operating)

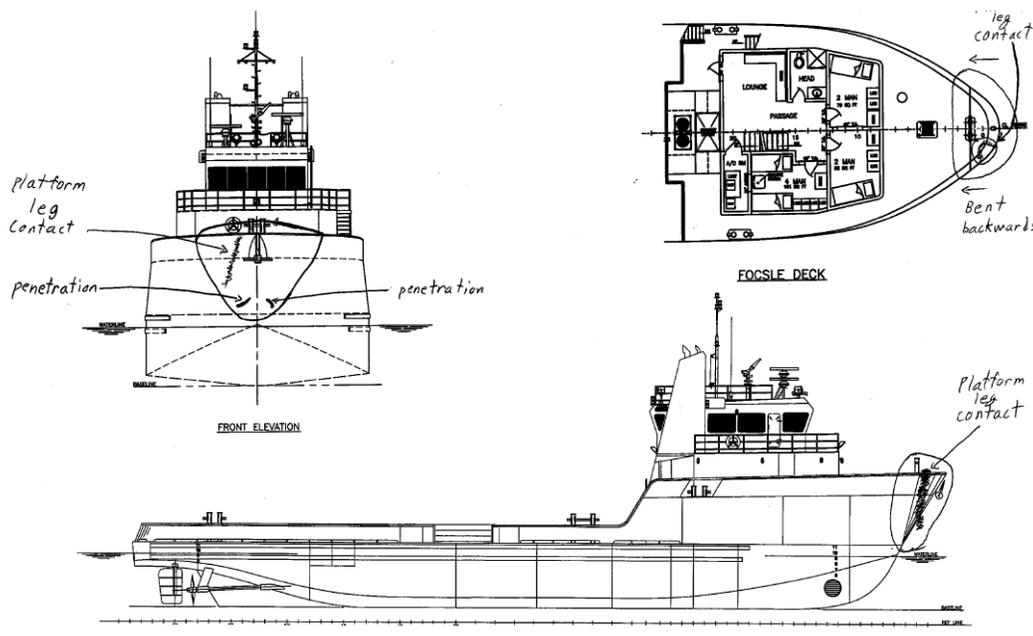
The *Elliot Cheramie* was repaired at a shipyard in Larose, Louisiana, from July 5 to August 10. The bow, focsle deck, and forepeak compartment were caved in; bow shell

plating was torn; bulwarks were buckled; and the starboard engine was knocked out of alignment. Vessel damage was \$195,210. Total damage to the platform, pipelines, and vessel was \$362,814.

**Figure 6.** Diagram of vessel damages as provided to the NTSB. (Source: Cheramie Marine)
