Investigation report

Report	
Report title Report of the investigation of the fire at Mongstad on 3 July 2022	Activity number 001902062

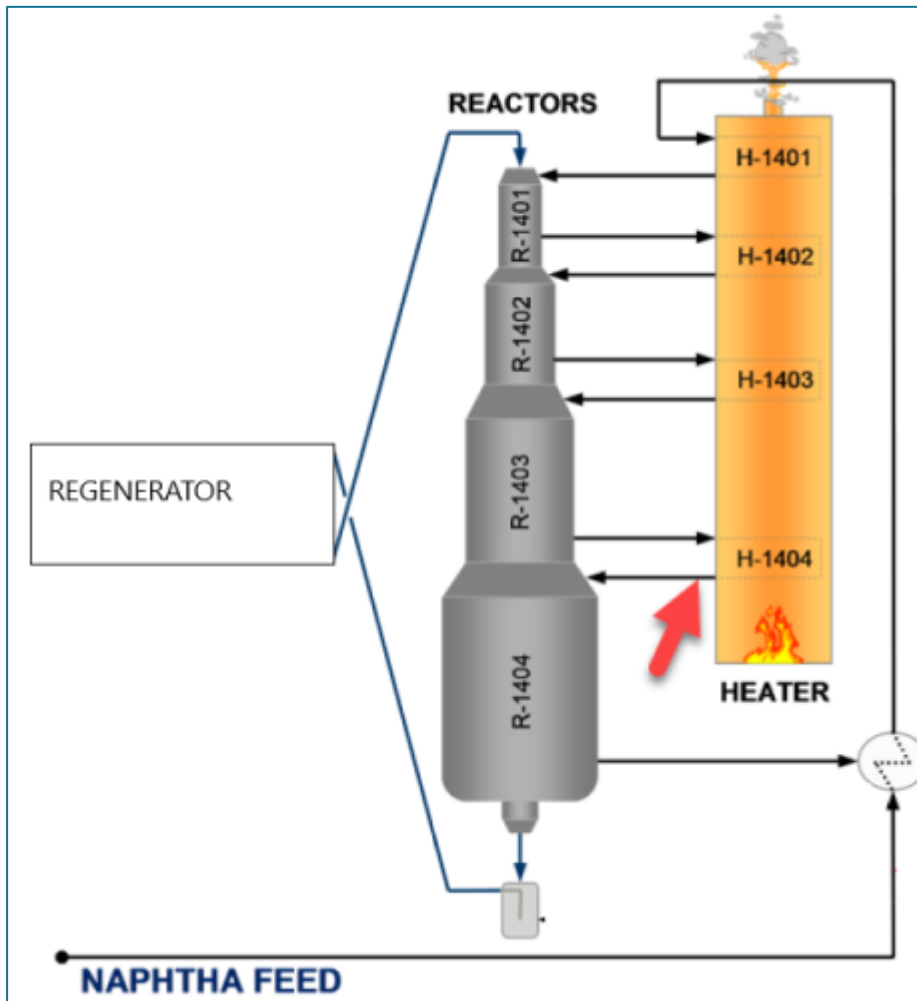
eight bar, with a temperature of roughly 520°C in the pipe. The arrow in the figure indicates where the fire broke out.

Figure 3 Schematic of reactors and heaters, with the leak site shown. Source: Equinor – presentation at kick-off meeting.

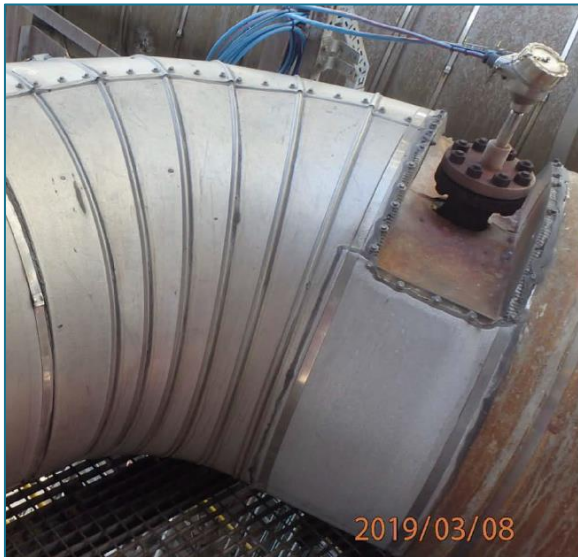
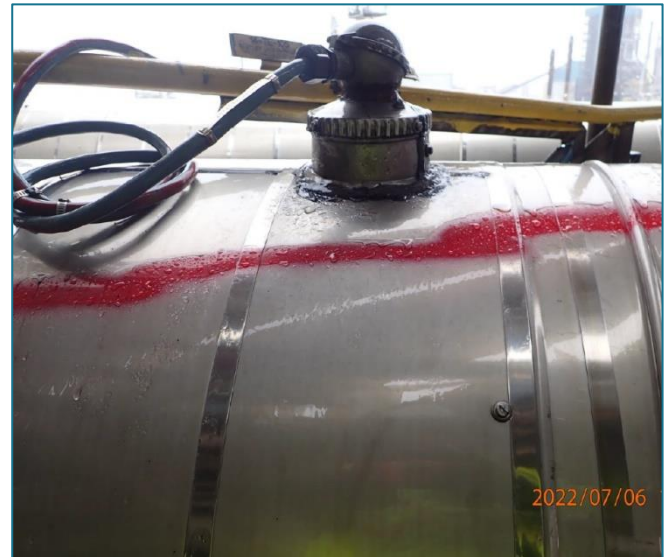
According to chapter 4.2 of Norsok R 004, 1 February 2009 edition, which is Equinor's reference standard, insulation abutting flanges in piping systems and equipment must be terminated in such a way that bolts can be undone and removed without damage to the insulation. The minimum distance from the flange to the nearest insulated component must be equal to the bolt length plus 25 mm. In this case, the flange was too close in relation to that requirement. The distance between bolts and pipe failed to provide room for insulation and bolt tensioning. In addition, the flange in question was fully insulated. See figure 10.

The investigation has revealed that all thermowell flanges on the pipe section between reactor and heater were insulated during the 2019 job. This did not accord with established requirements that flanges should not be insulated. See section 4.4.1, but was not picked up. Photographs of the pipe from before 2019 show that these flanges were not previously insulated.

Figure 10 Photographs showing that thermowells on pipes between reactors and heaters with and without insulated flanges. Photos: Equinor

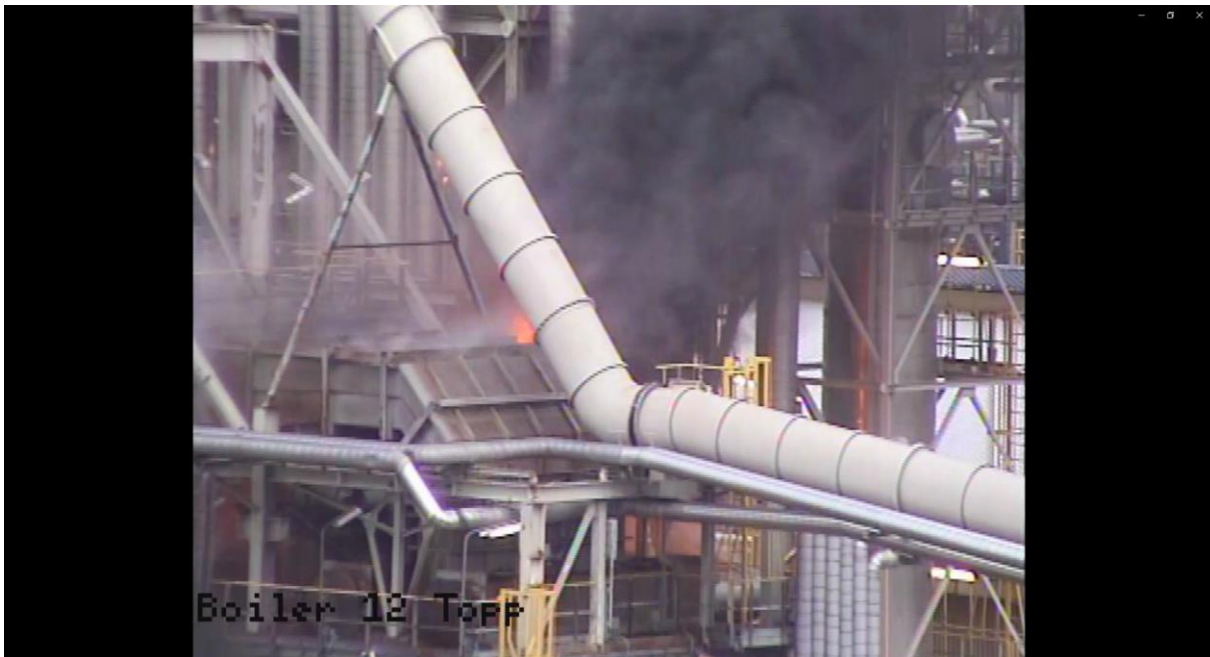
Film of the blaze, together with observations by personnel in the area, show that the flames could initially have been 10-15 metres high.

Figure 11 CCTV images of the fire. Source: Equinor

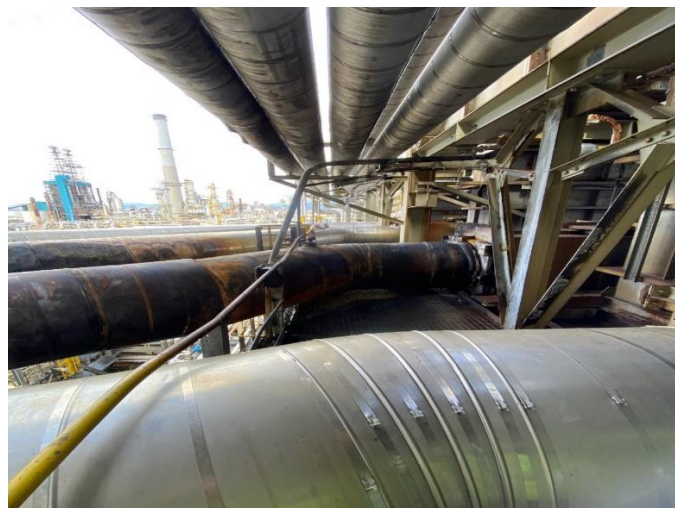
Based on observations made after the fire, the leak can be assumed to have "eroded" through the mantled insulation until the volume of air allowed the hydrogen-rich gas to auto-ignite. A jet fire probably occurred at the auto-ignition site, while fires with less flame broke out at several points along the pipe. See figure 12.

Figure 12 The fire area, with the thermowell where it started in the centre. Source: Equinor.

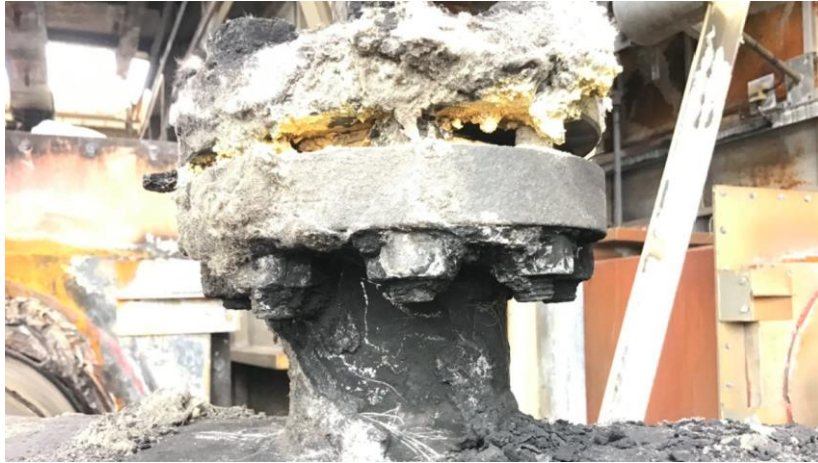
A fire broke out at 05.43 on 3 July 2022 in thermowell flange 14-TW-102 on the pipe between the A-1404 reactor and the H-1404 heater. The pipe held a mix of naphtha and hydrogen at a temperature of 520°C, which auto-ignited on contact with the air. The initial leak volume is estimated to have been 0.55 kg/s.

Figure 13 The two-inch thermowell flange after the fire. Source: PSA

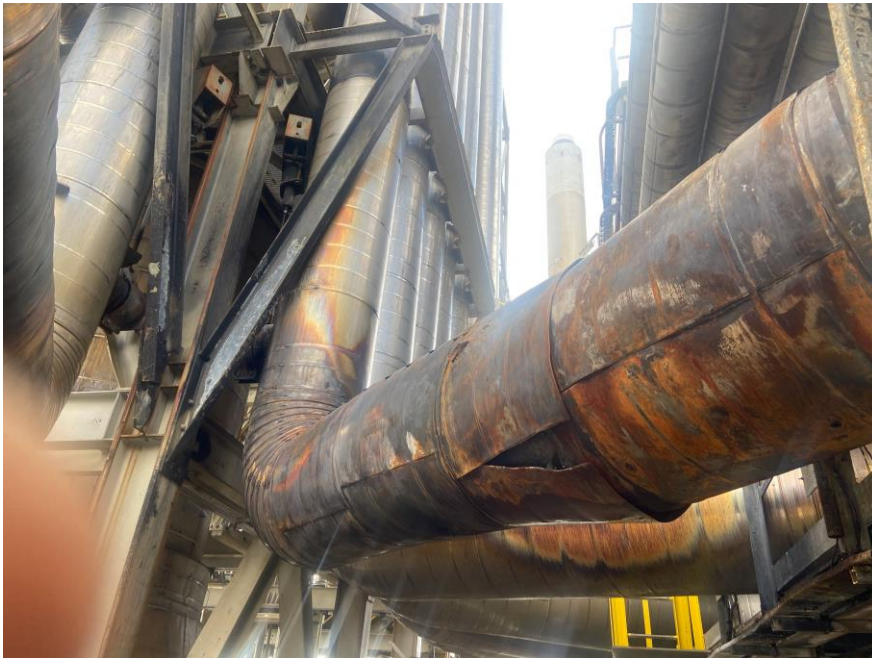
Figure 14 A hole in the mantling where the fire has presumably been more intense, but burning has occurred both inside and outside the mantling. Source: Equinor

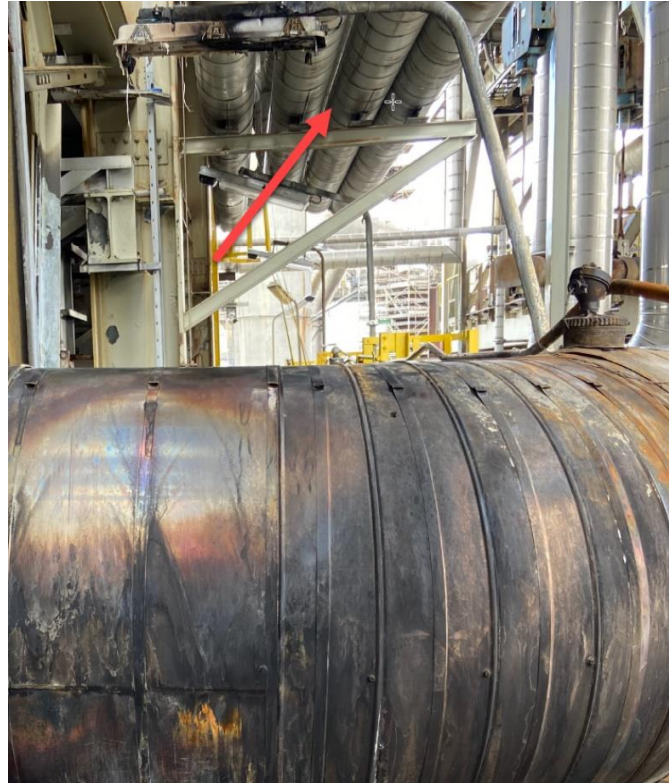
Based on assessments of the various layers of insulation on pipes affected by the fire, the OFP concluded that none of the pipes were directly exposed to temperatures above 1 000°C over time. This assumes that the insulation against the pipe would otherwise have melted, which was not observed.

Figure 17 PG-14-0204 and overlying pipe tracks immediately above the leak point. Source: Equinor

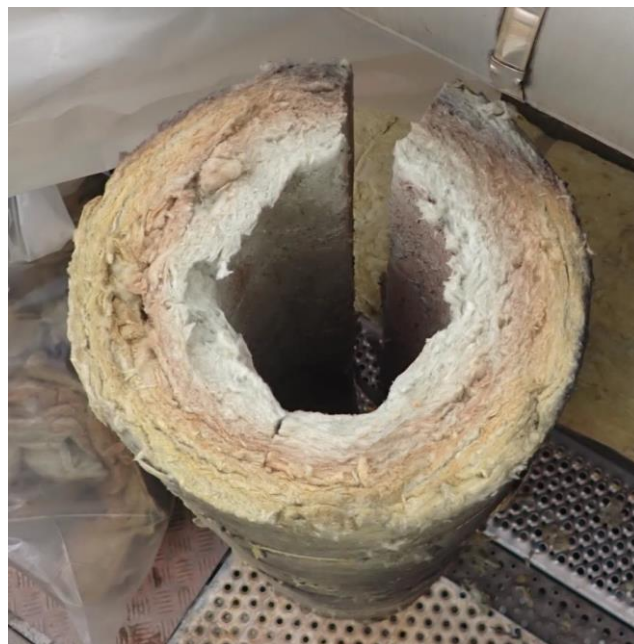
Figure 18 Cross-section of fire-affected thermal insulation on the overlying PL-13-0718 pipe. Source: Equinor
