MONTHLY SAFETY SCENARIO

JANUARY 2023

Cargo hold flooding

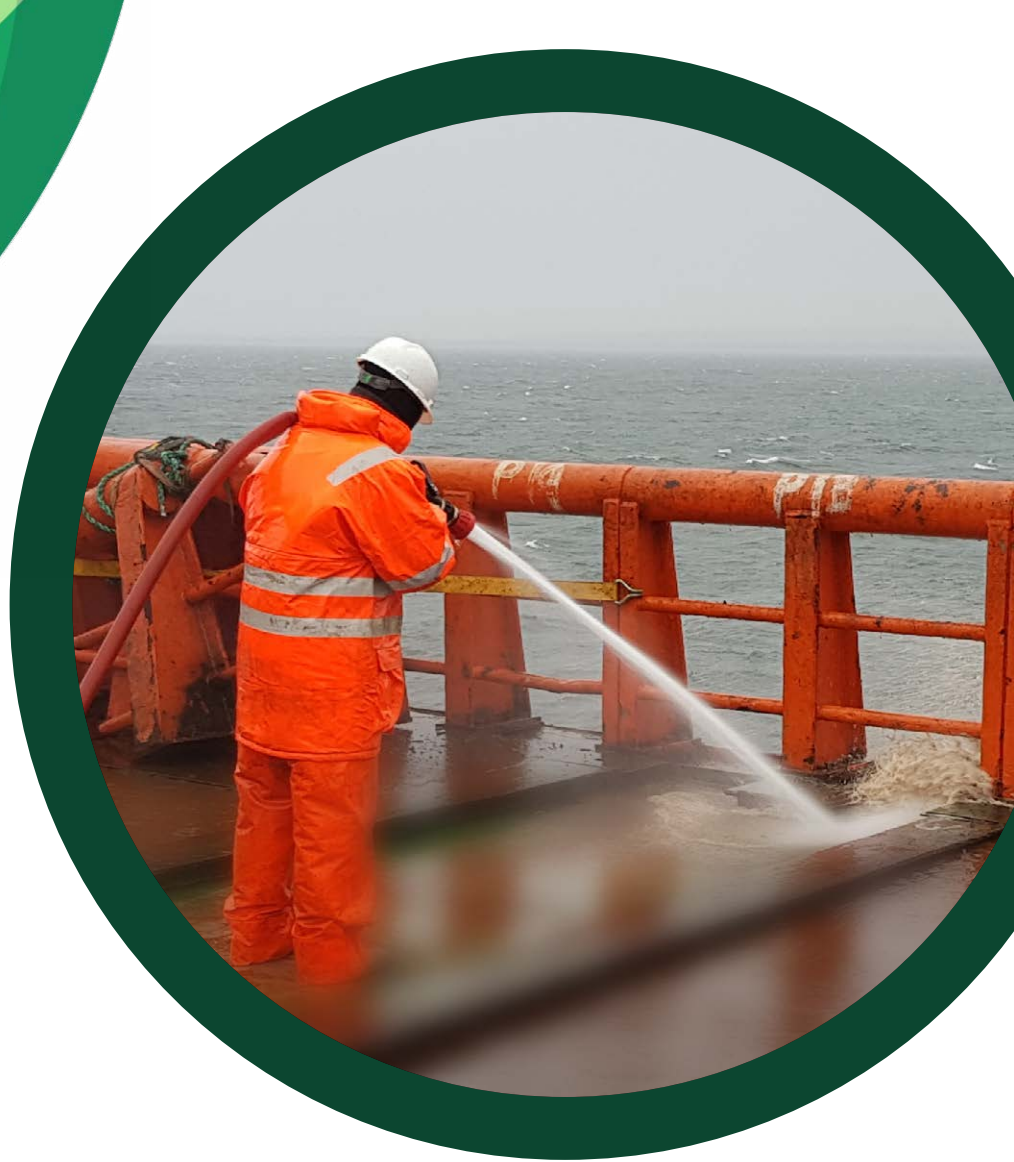
bosun to immediately investigate the origin of the leak. At the same time the Master started to discharge the water overboard. When the bosun entered the cargo hold he could see water flooding over the edge of the void space. He also noticed that water was leaking from the fire lines both port and starboard side. The fire pumps were immediately stopped.

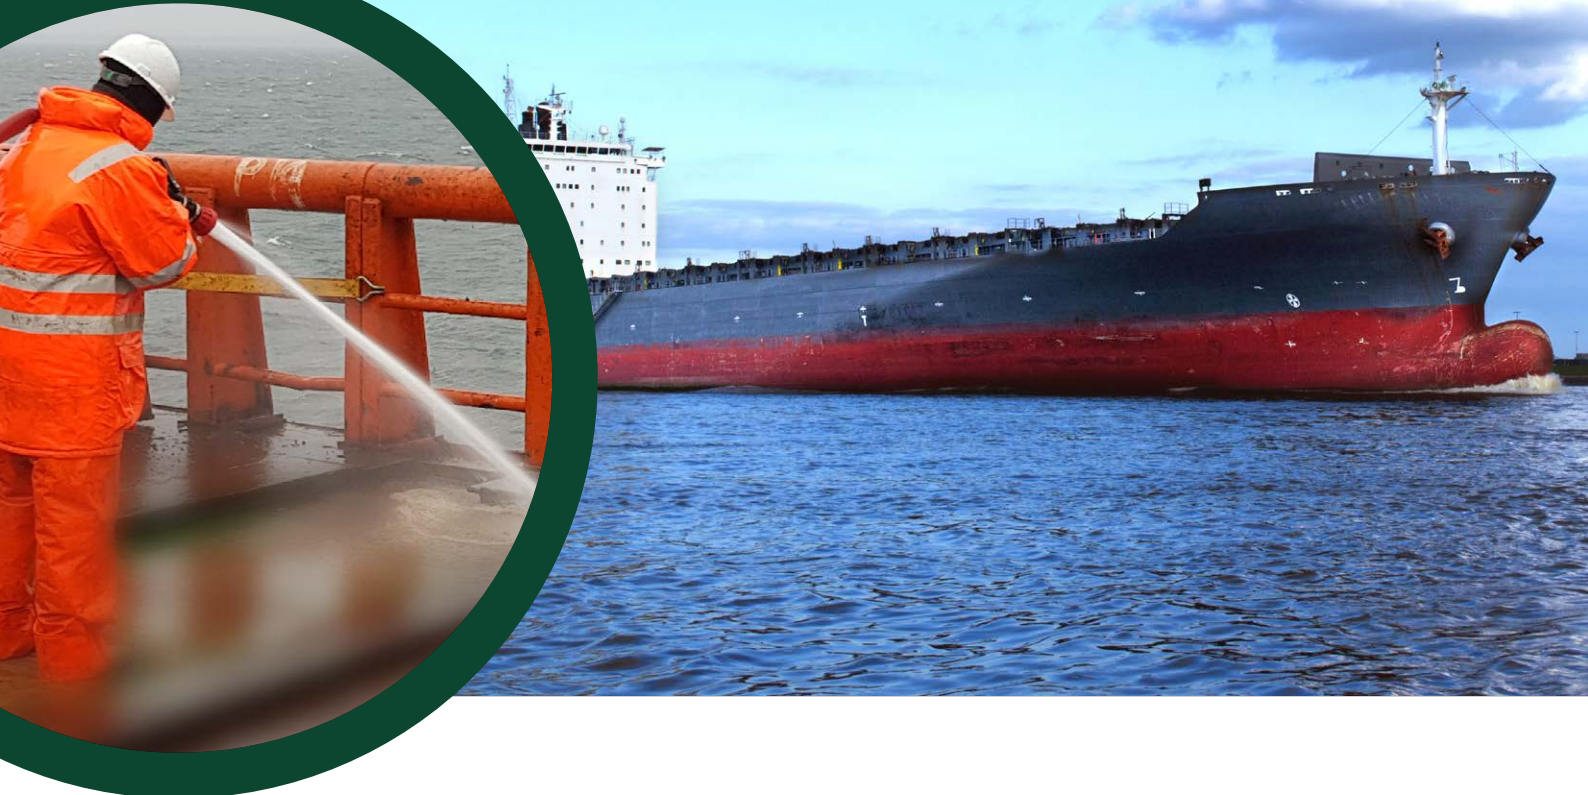
A couple of days later the crew opened up all void spaces and also found water in the void spaces adjacent to holds 3 and 4.

Inside the void spaces they also found that the rubber gaskets positioned between the sections of the main fire line were damaged.

It was evident that the closed valves had increased the water pressure so much that it had damaged the rubber gaskets and caused the water to flood the cargo holds. The crew replaced these with new gaskets made of hard plastic instead of rubber.
