Report on the investigation of
the failure of a towline pennant
and injury to the crew on board the tug

Svitzer Mercurius

in Southampton, England

REPORT NO 15/2022

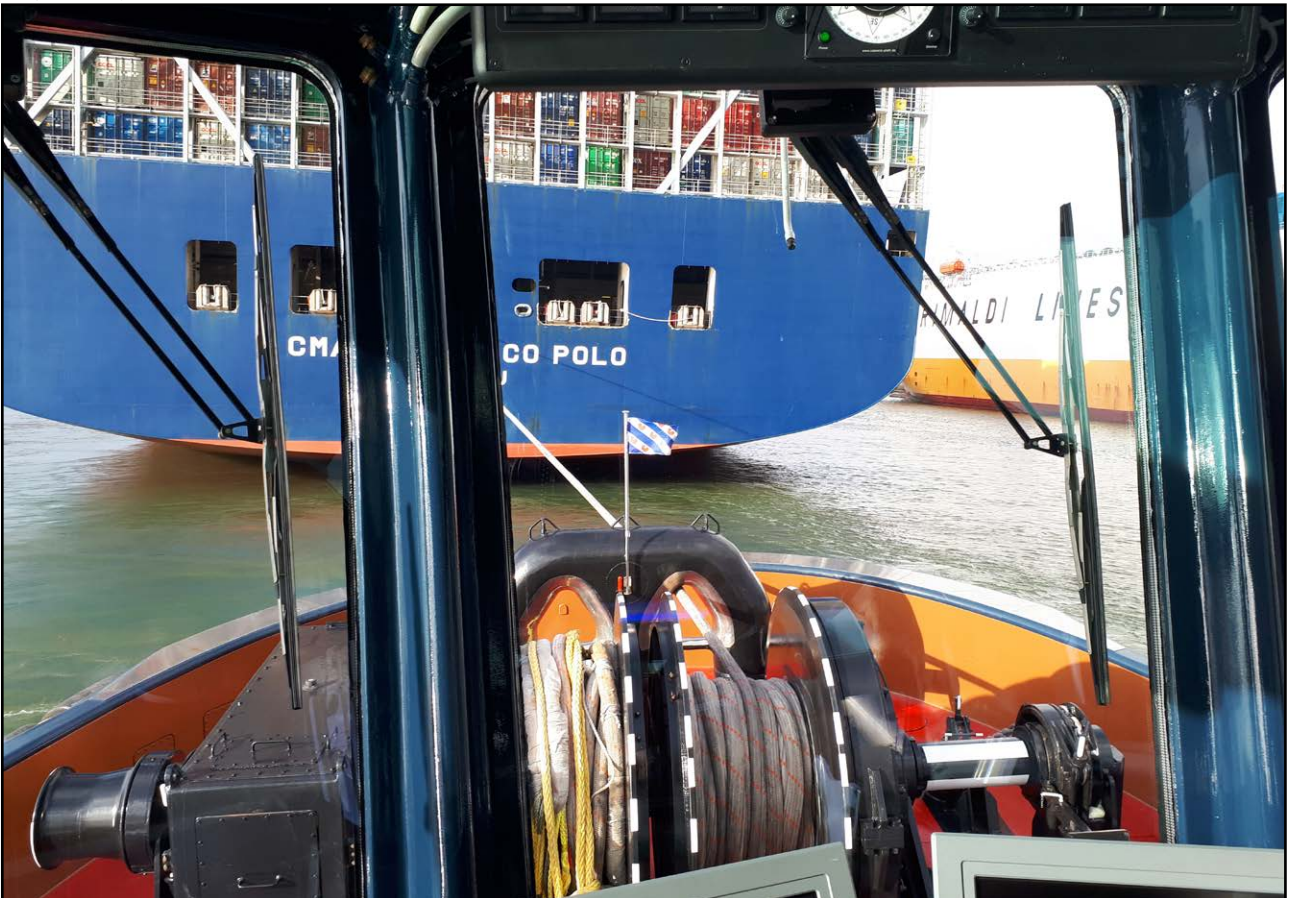
Figure 2: *Svitzer Mercurius*' starboard towline connected to *CMA CGM Marco Polo* prior to failure

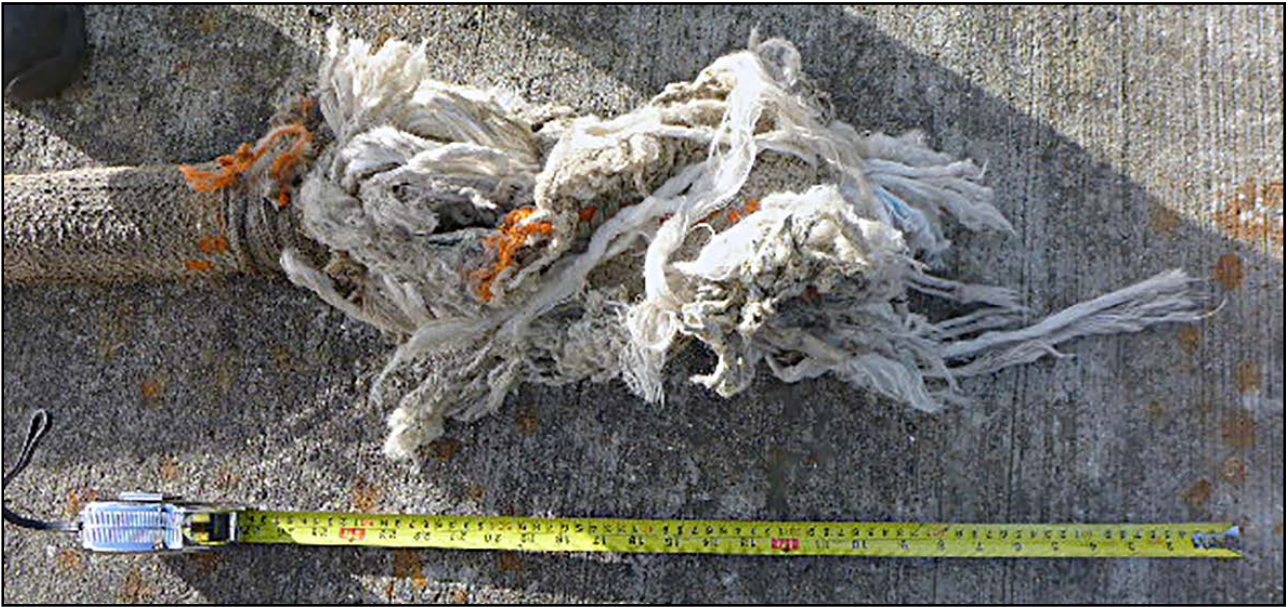
At about 1231, after the winch had slipped a second time, the towline pennant parted close to *CMA CGM Marco Polo*'s deck (**Figure 4**) and snapped back towards the tug. Part of the line struck and shattered the starboard forward wheelhouse window. It also struck the centre forward window, causing its inner pane to fracture (**Figure 5**). The remaining line landed on the wheelhouse deck and roof (**Figure 6**).

Figure 4: Parted starboard towline pennant

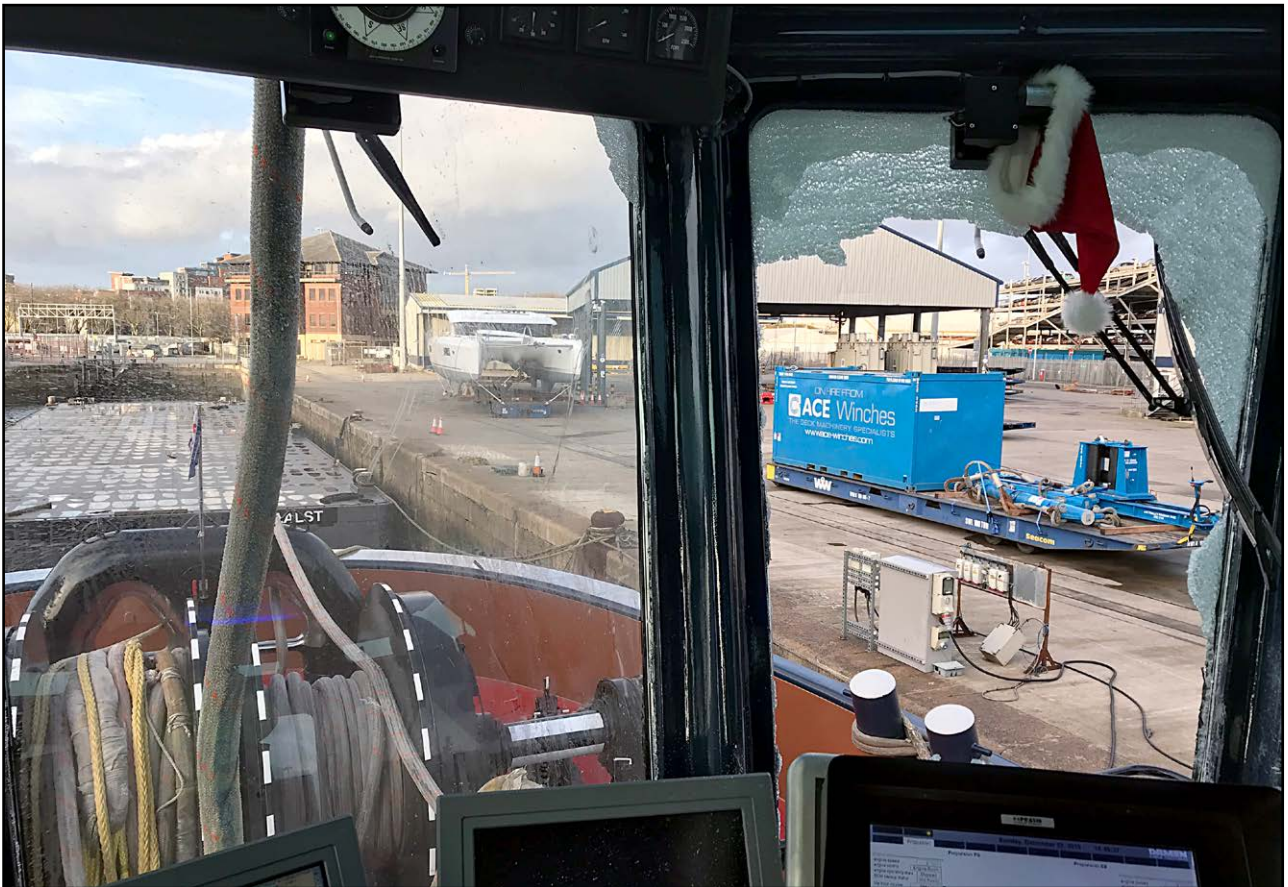
Figure 5: Broken starboard forward wheelhouse window

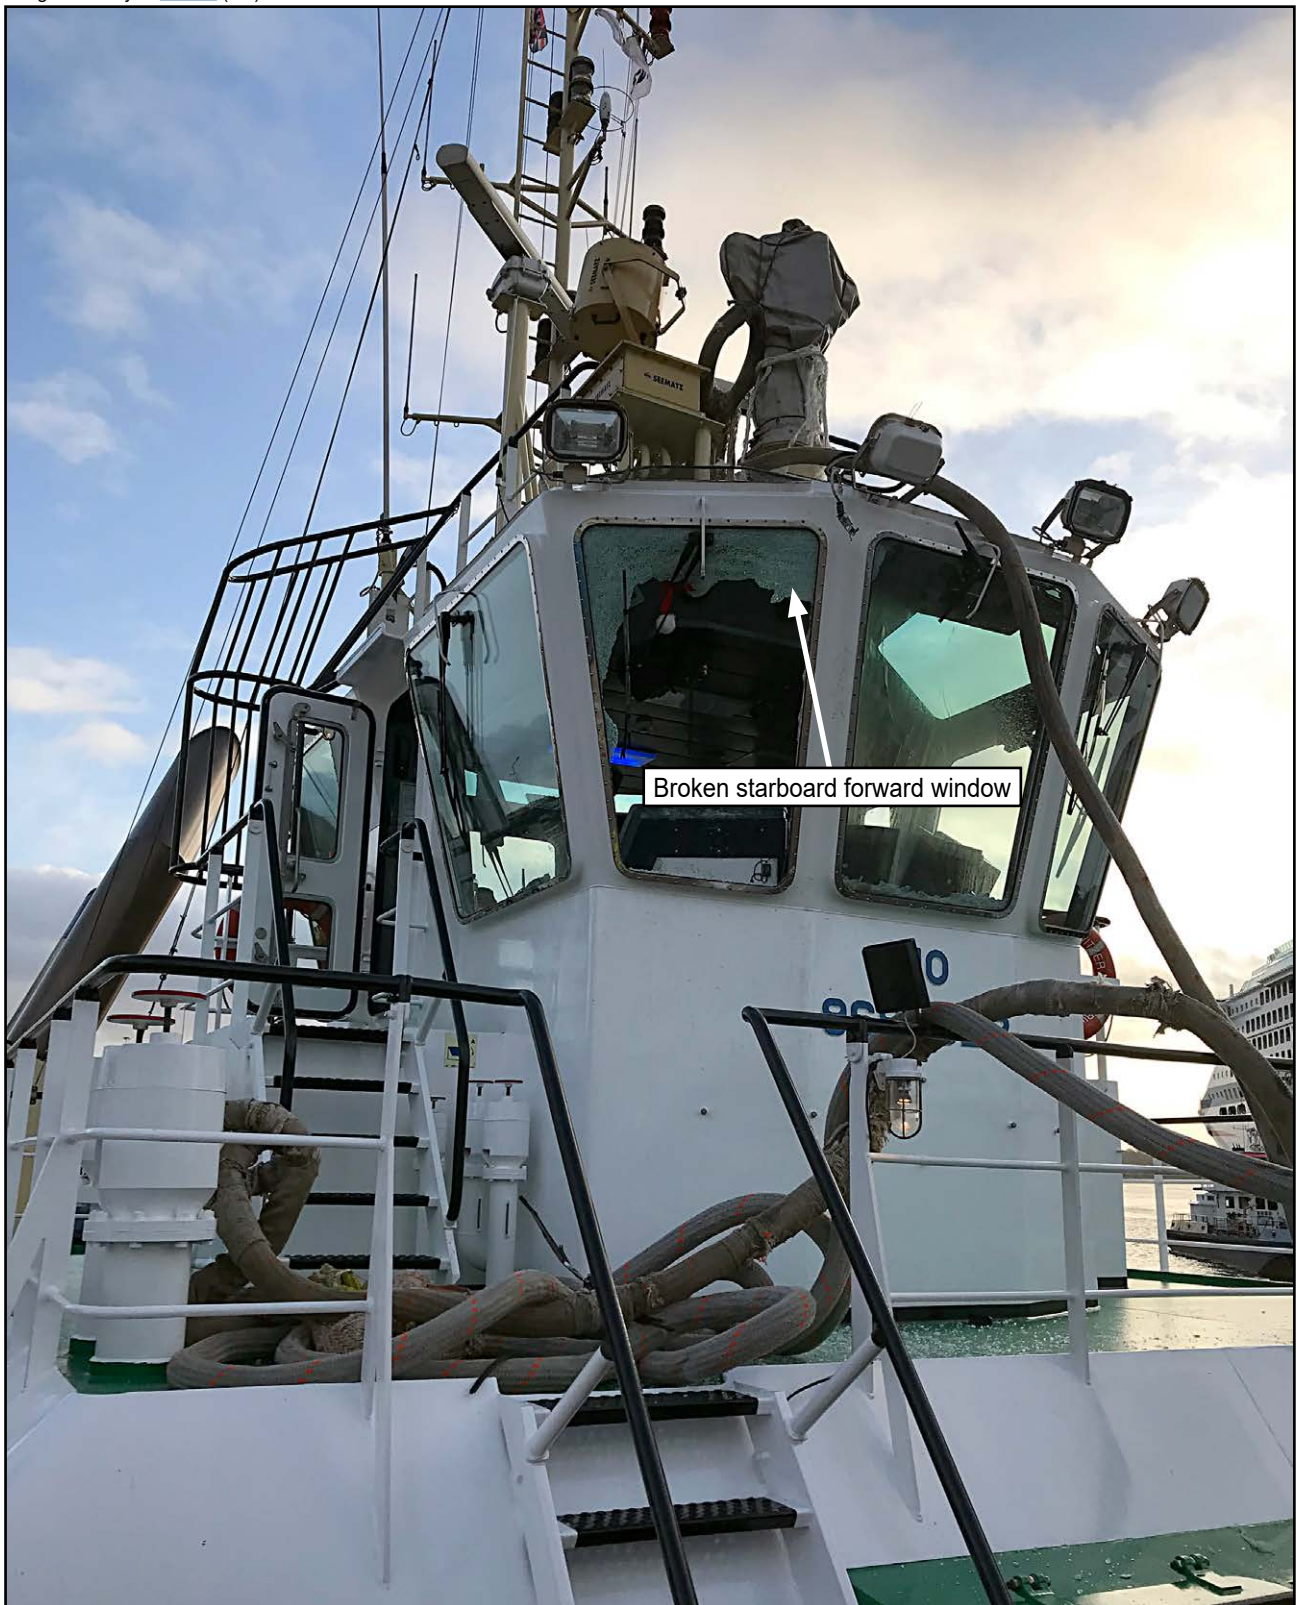
Figure 6: Starboard towline and pennant on wheelhouse deck and roof

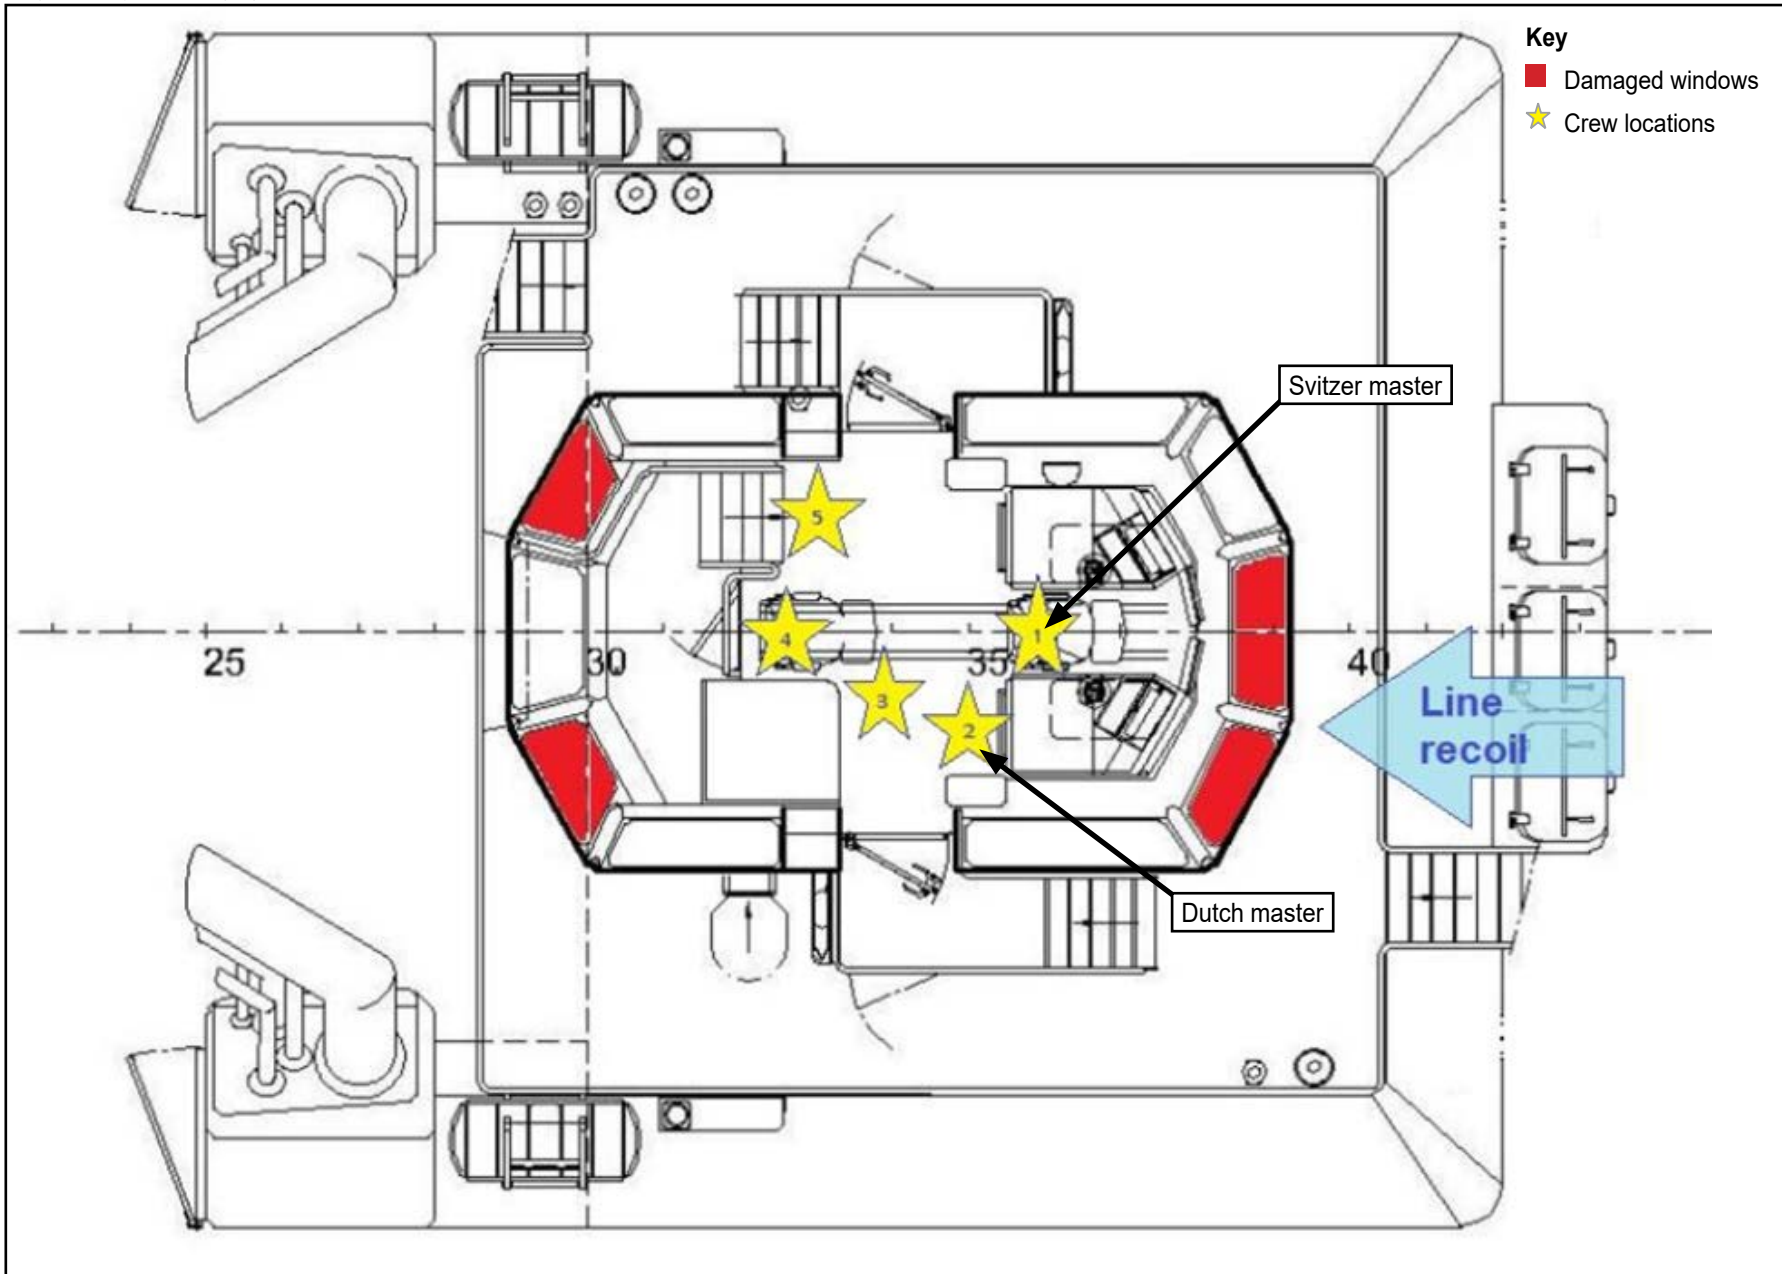
Five crew who were stood in the wheelhouse (*Svitzer Mercurius*'s master, mate and chief engineer, and the *Svitzer Alma*'s master and mate) (**Figure 7**) were struck by flying glass fragments (**Figure 8**) and suffered multiple minor facial, arm and upper body lacerations. All of the crew were wearing some form of eyewear, which prevented any eye injuries. The rest of the wheelhouse was peppered with glass fragments (**Figure 9**) and two of the inner panes of the aft-facing windows were also cracked but did not break (**Figure 10**). *Svitzer Mercurius*'s mate took control of the tug while the Dutch master went below to clean blood from his face. When the tug's master returned to the wheelhouse, he took back control.

Figure 7: Positions of crew in wheelhouse when struck by flying glass

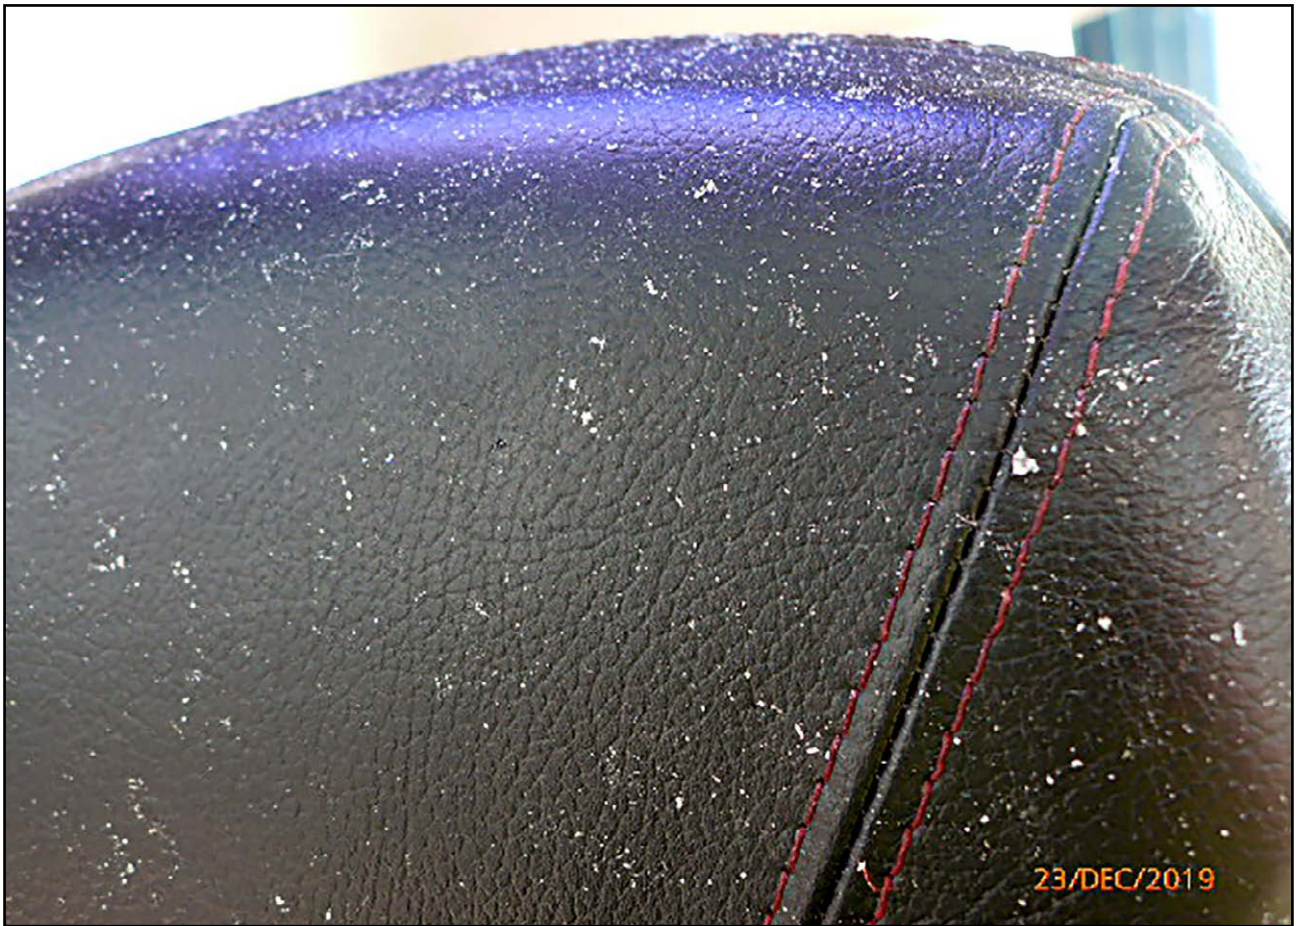
Figure 8: Glass particles embedded in wheelhouse chair

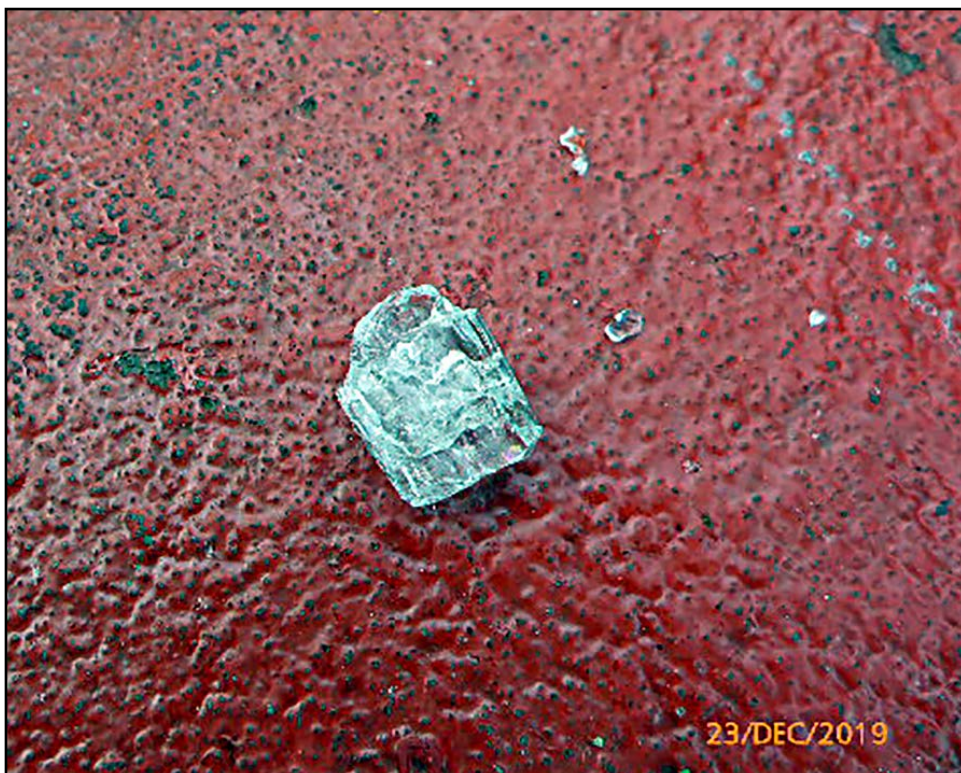
Figure 9: Starboard wheelhouse window glass fragment

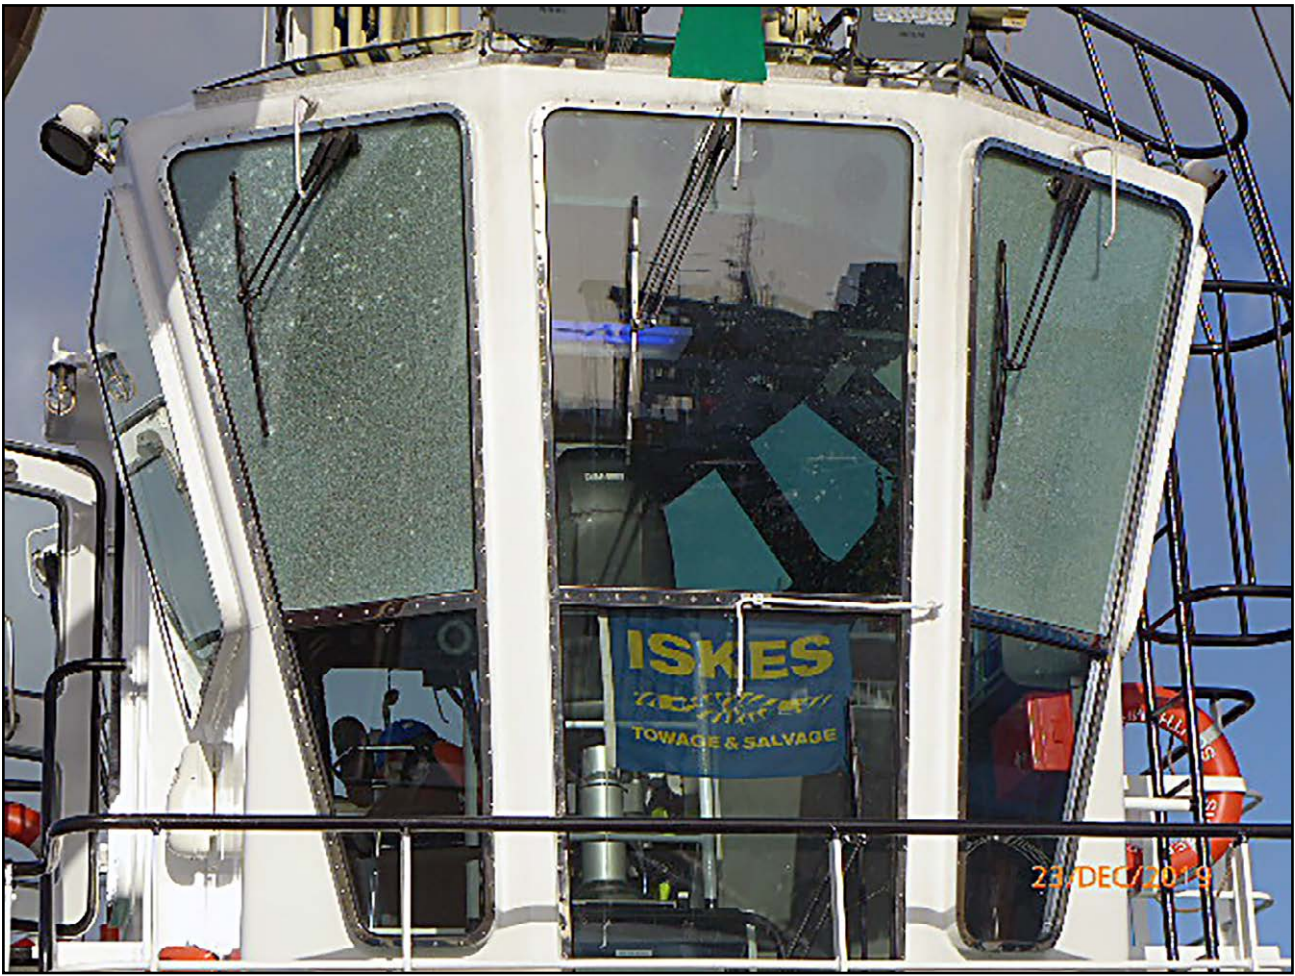
Figure 10: Cracked aft-facing wheelhouse windows

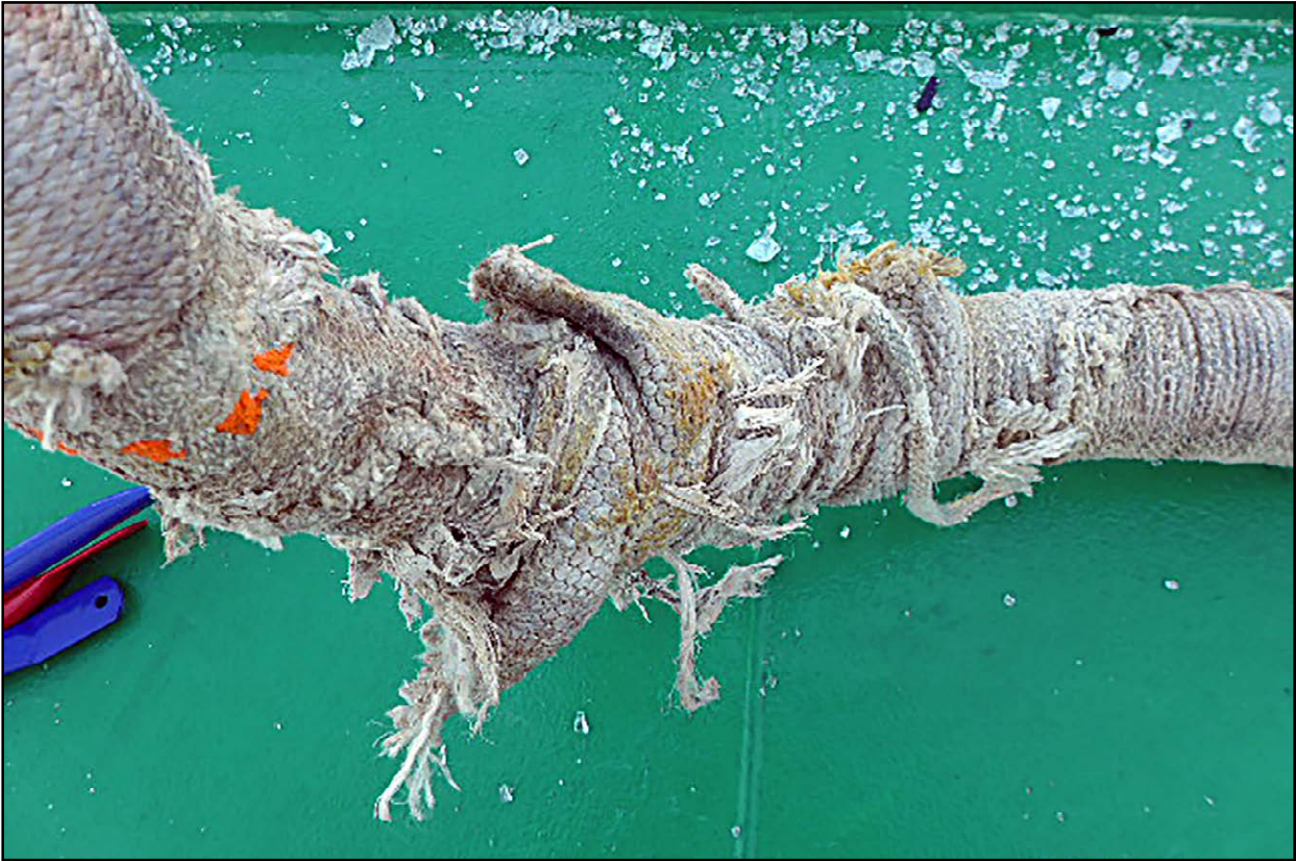
Figure 15: Towline pennant seizing repair

The pennant had suffered mechanical damage to its outer jacket that would have been visually apparent and had been repaired. TTI's examination and test report identified two main areas of damage to the rope's load-bearing core that would not have been visually apparent and would have been difficult for the tug's crew to detect. The types of damage found included core strand fusion and axial compression fatigue, both of which were attributed to previous high and/or shock loading exposure.

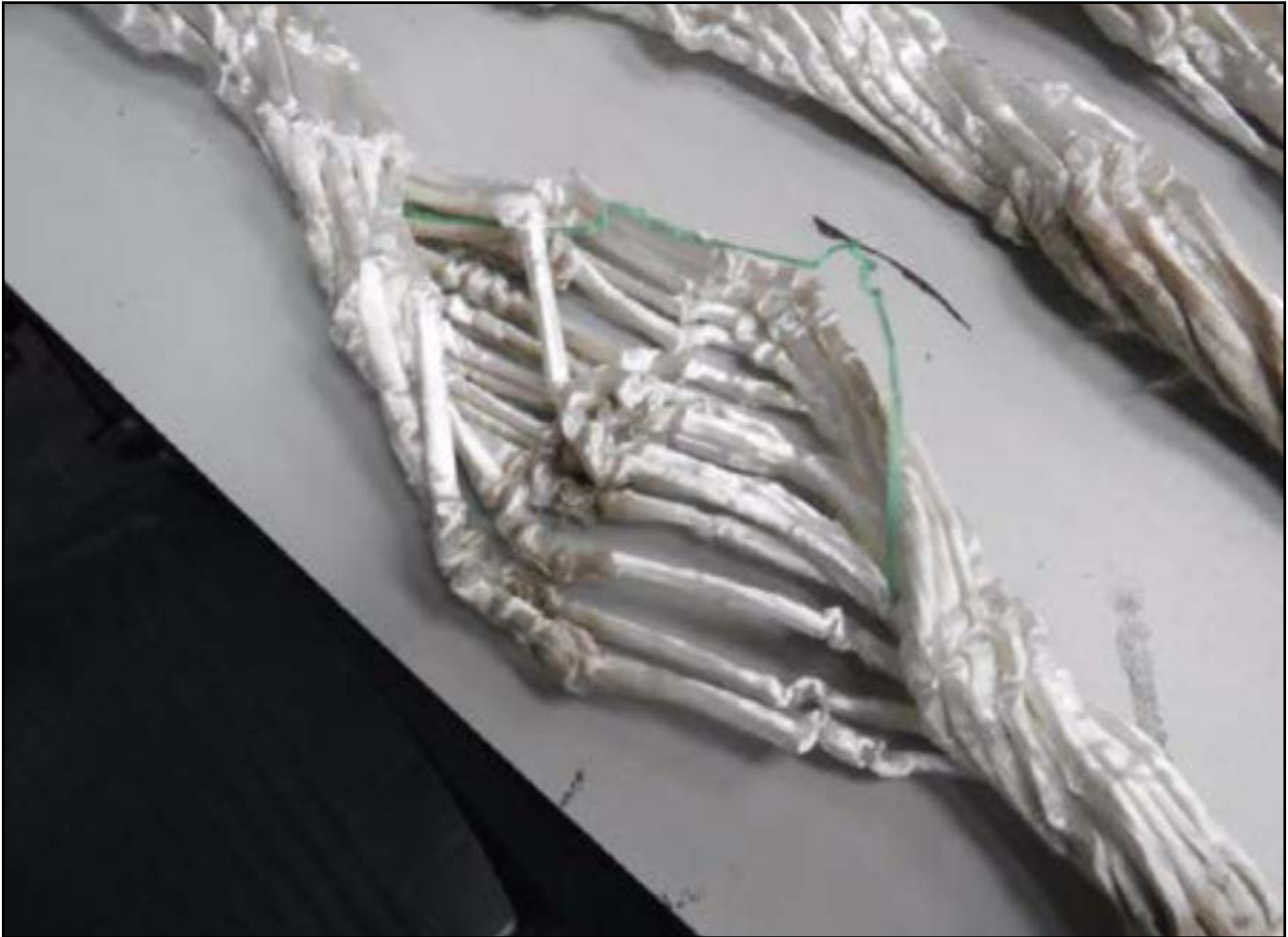
TTI identified two main areas of damage to the pennant's load-bearing core; one at the failure point and one at about 5m from the tug end of the pennant. The damage included strand fusion under the rope's tight jacket. It was assumed that the pennant had been end-for-ended after damage to the jacket was sustained.

The TTI report explained that tight jackets can cause the inner core structure to be restricted from movement during tensile loading, which in the event of sudden tensile load reduction after shock loading can cause uneven loading in the strands and yarns. Short wavelength kinks (also known as Z-kinks) associated with axial compression fatigue¹¹ were found in the yarns (**Figure 17**). Polyester is known to have excellent resistance to this type of fatigue; however, in extreme cases, axial compression fatigue can cause yarns to fail in a similar manner to being cut by a knife.

Figure 17: Failed towline pennant yarn kinks

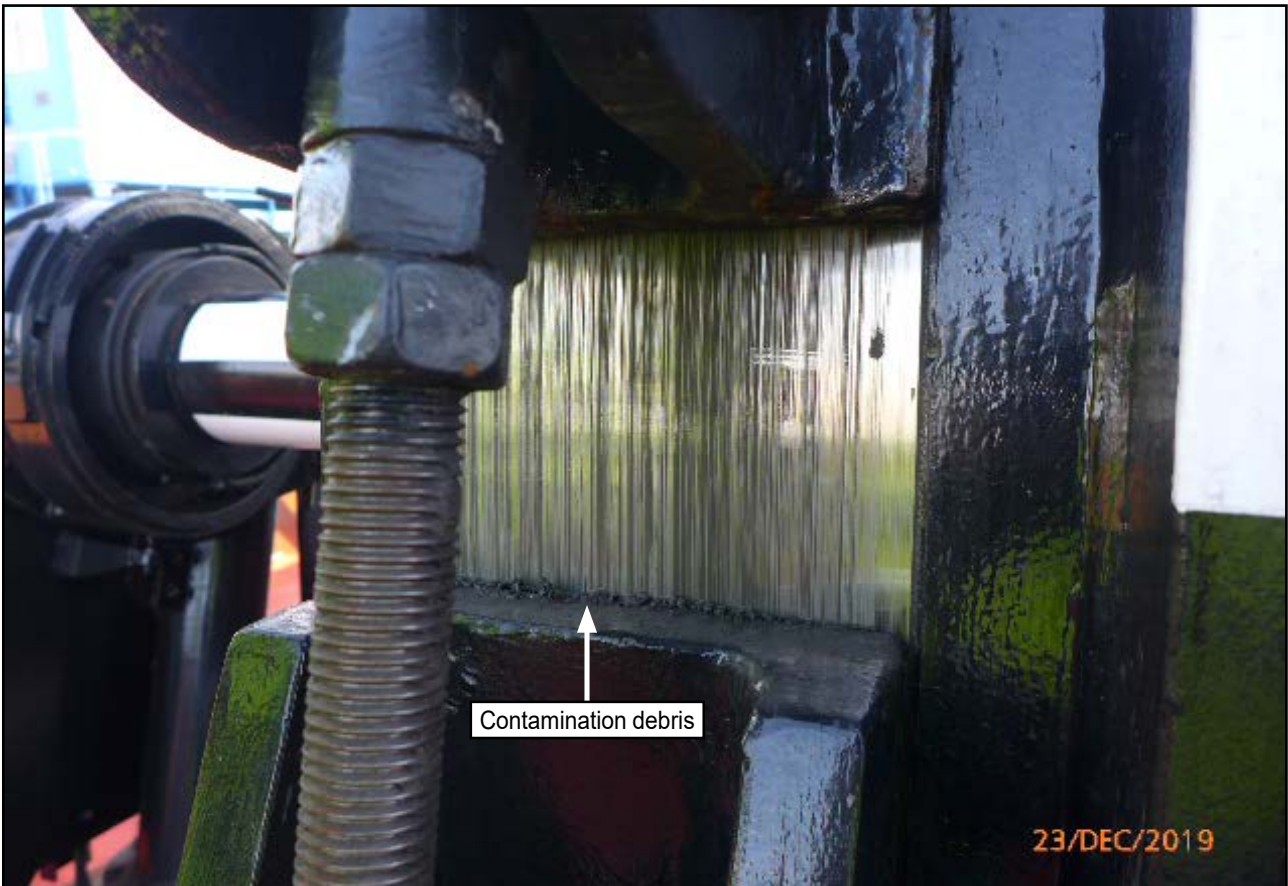
Visual inspection of the starboard drum band brake arrangement identified scoring and debris on the surface of the drum's stainless steel brake rim (**Figure 18**). On examination, Svitzer and the winch manufacturer suggested that the debris was either a combination of brake dust and water or brake dust and/or grease. No contamination was found on the surface of the port drum's band brake rim.

Figure 18: Starboard forward winch brake contamination

As *Svitzer Mercurius* was engaged in a direct towage operation, and its astern thrust was increased gradually at the request of the assisted vessel's pilot, the winch drum must have slipped at a load well below its design holding capacity. After the accident, the winch hydraulic system was found to be functioning correctly, the brake friction linings were within the manufacturer's recommended thickness and the brake pretensioner was within its specified limits. However, visual inspection of the winch drum brake surfaces identified scoring and the presence of debris on the starboard drum's brake rim. The debris, which was thought to be a combination of brake dust and water or grease, would have acted as a lubricant and reduced the holding capacity of the brake.

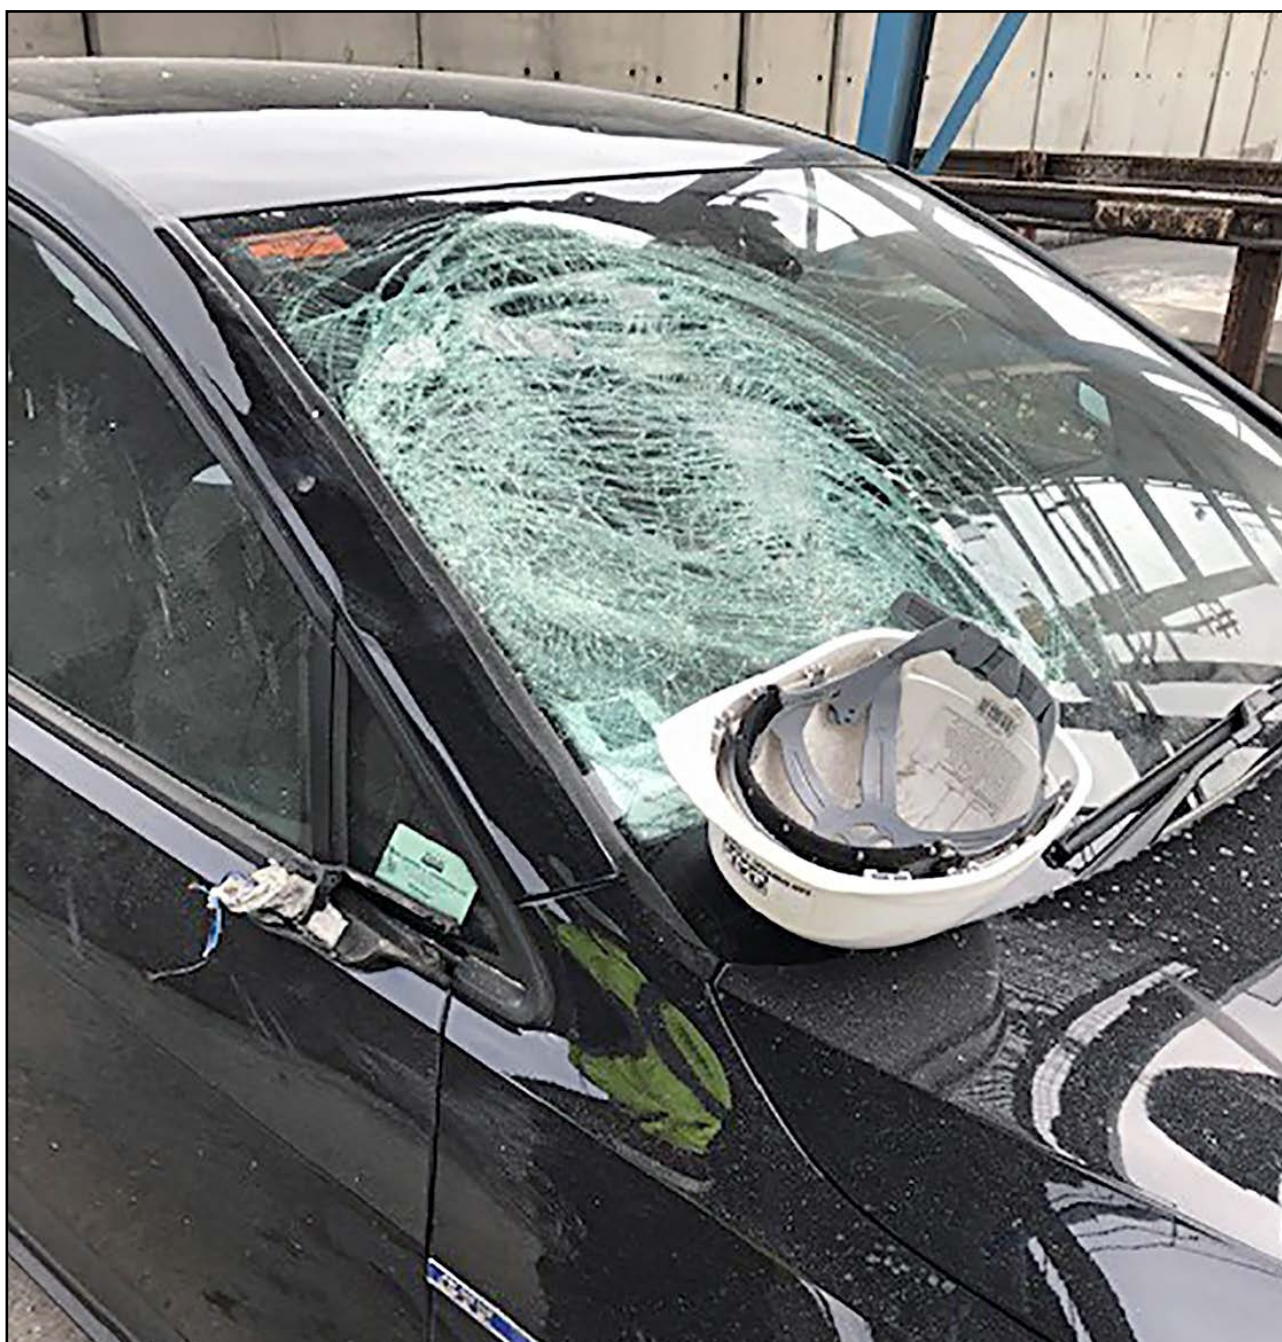
In October 2020, a car was parked on a quay in a UK port as the driver waited for a container vessel to berth. One of the vessel's mooring lines parted during the berthing operation and snapped back along the quay. The mooring line hit the parked car's windscreen while the driver was sat in the car (**Figure 20**). The windscreen, which was laminated glass, held together, resulting in the driver sustaining no injuries.

Figure 20: Vehicle laminated windscreen damage
