Gas control equipment malfunction on the gas tanker *Suiso Frontier*

Port of Hastings, Victoria on 25 January 2022

ATSB Transport Safety Report

MO-2022-001

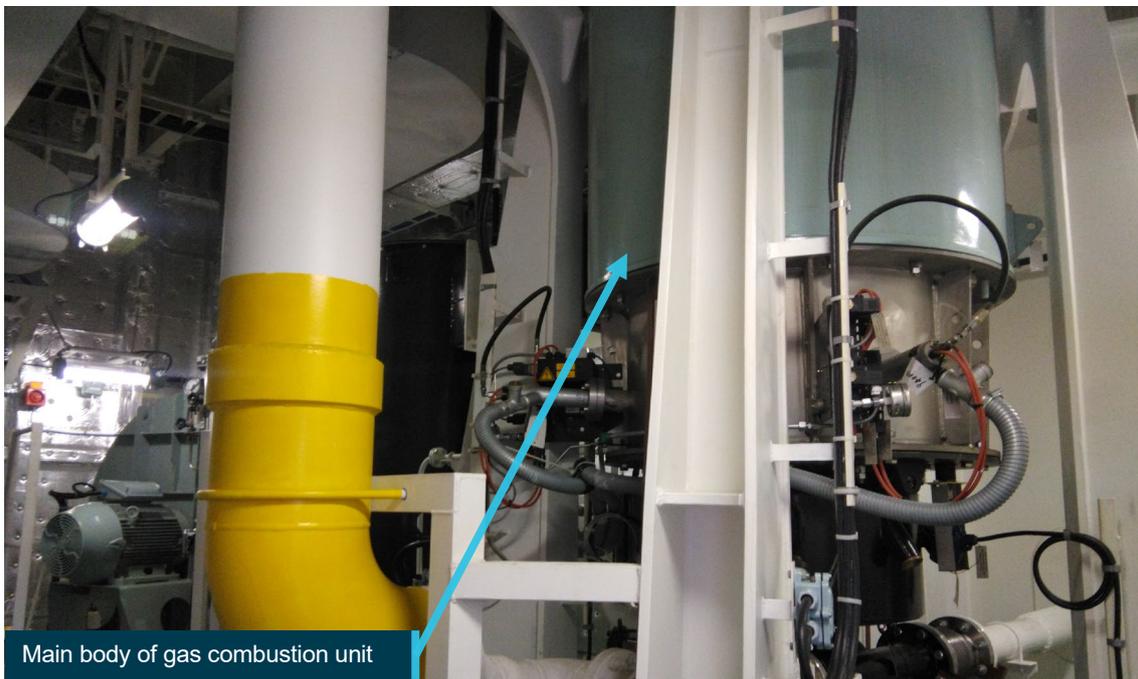
Figure 1: The gas combustion unit

While berthed on the evening of 25 January, the chief mate and cargo engineer made plans to start the ship's gas combustion unit or GCU (see the section titled *Gas combustion unit* and Figure 1) to burn excess boil-off gas (BOG) from the LH₂ cargo tank.² They notified the wharf operator and followed standard procedures for preparing the GCU, including conducting required safety checks. The ship was equipped with 2 radial fans to supply combustion, cooling and dilution air to the GCU, and fan number 1 was pre-selected for use.

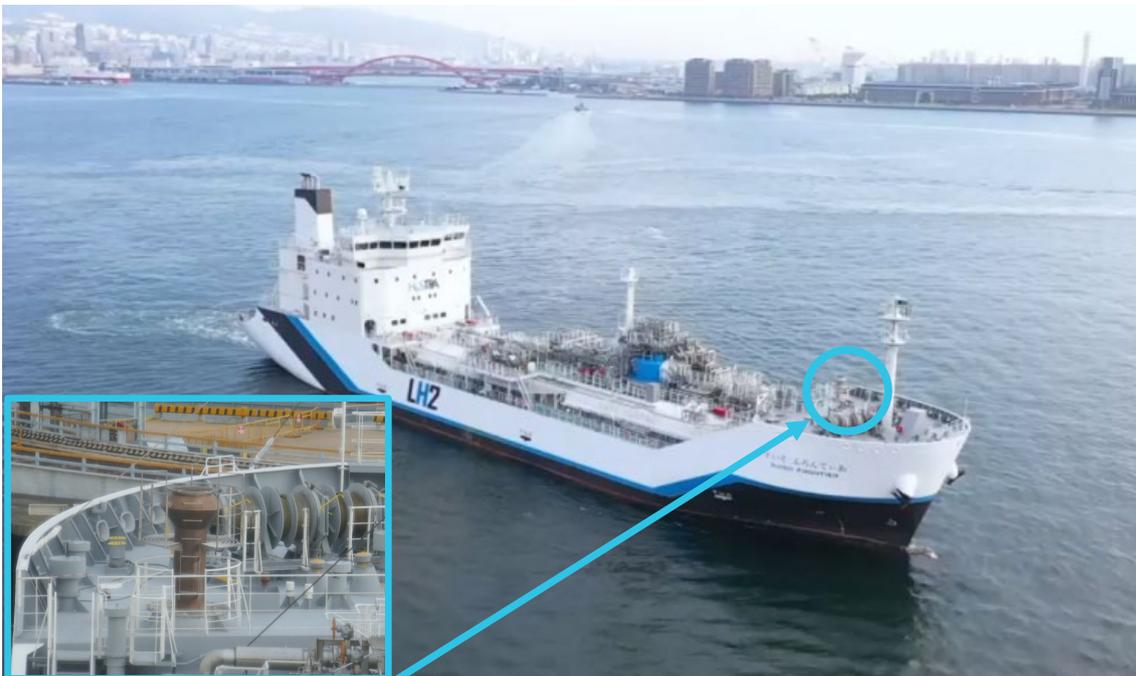
Figure 2: Location of the GCU vent stack

At about 2147, an able seaman (AB) was conducting routine safety rounds on deck when they saw a 1 m high yellow flame propagate for about 5 seconds from the GCU vent stack on the port side of the ship's foredeck (Figure 2). The AB immediately notified the third mate in the CCR via handheld radio. Seconds later, the GCU flue gas temperature reached 450°C, triggering the high flue gas temperature and common alarms in the CCR. The third mate quickly shut down the GCU and closed its main hydrogen supply valve. After confirming with the AB that there was no flame from the vent stack, the third mate telephoned the chief mate, master and cargo engineer.

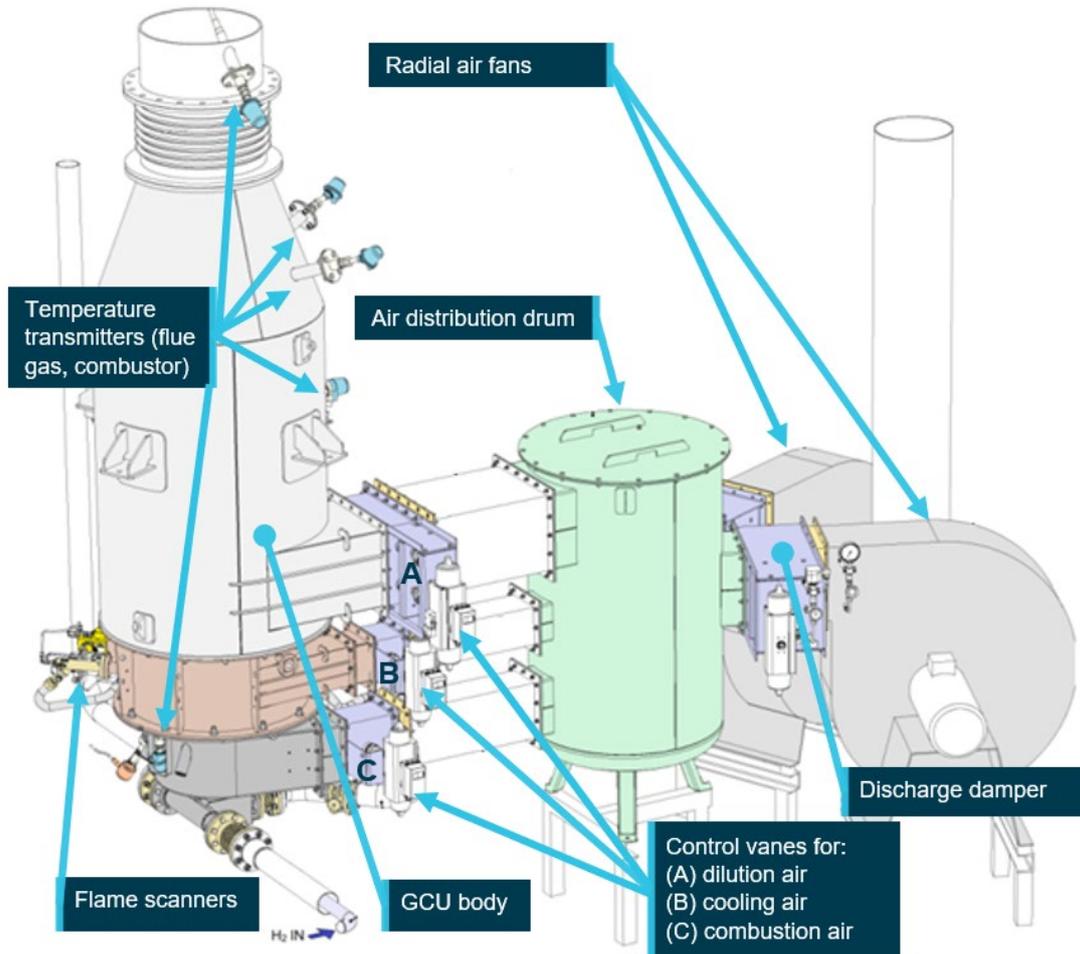
Figure 3: GCU and fan air supply

During operation, only one fan was required to be operating. The fan provided a large volume of air via a distribution drum to 3 automatically-operated control vanes which split the air supply into different parts of the GCU for the combustion, cooling and dilution functions (Figure 3).

A discharge air damper was installed between each fan outlet and the air distribution drum. The dampers were designed to be either fully open when the corresponding fan was running or fully closed when it was stopped. Each damper was controlled by an actuator equipped with a pneumatic solenoid valve. When energised by the GCU control system, the solenoid valve directed compressed air into the actuator to open the damper. When the solenoid was not energised, the valve closed and the spring-loaded damper actuator returned the damper to its closed position.

Following the failure of the damper actuator solenoid valve during GCU operation, the damper closed, significantly restricting air supply to the GCU for combustion, cooling and dilution.

The manufacturer of the GCU has advised the ATSB that limit switches have been fitted on each air fan discharge damper to monitor damper position. In addition, the system's control logic has been programmed to stop the unit if a fault is detected.

On 12 October 2022, Saacke advised the ATSB that it has installed limit switches to the gas combustion unit's air fan discharge dampers as agreed with the *Suiso Frontier*'s manager, Shell International Trading and Shipping Company. The limit switches are designed to monitor the position of the dampers and the system's control logic has been programmed to automatically stop the GCU if an 'open' signal from the dampers is not detected. The modifications were confirmed to be functioning as designed and approved by the ship's classification society.

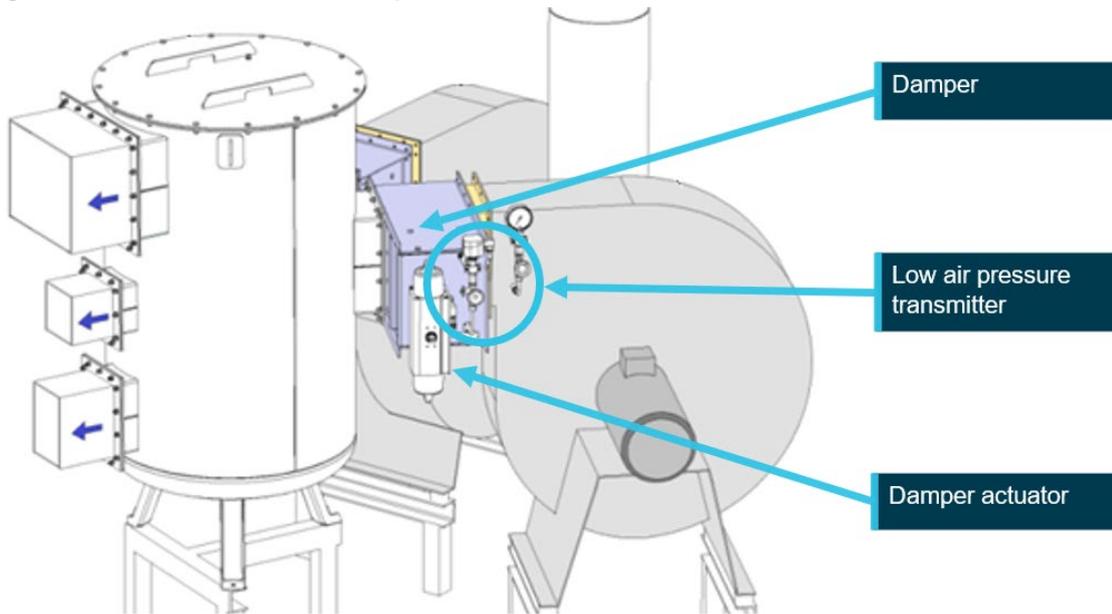
Figure 5: Location of the low air pressure transmitter

The GCU was not equipped to detect the failure of the vent damper solenoid valve or the subsequent closing of the damper. A low air pressure transmitter was fitted to the GCU but was located between the fan and the damper. As a result, it did not activate when the damper closed since the air pressure on the fan side of the damper did not drop.
