Bundesstelle für Seeunfalluntersuchung
Federal Bureau of Maritime Casualty Investigation

Interim Investigation Report

Serious Marine Casualty 37/22

Grounding of MUMBAI MAERSK while entering the Weser fairway on 2 February 2022

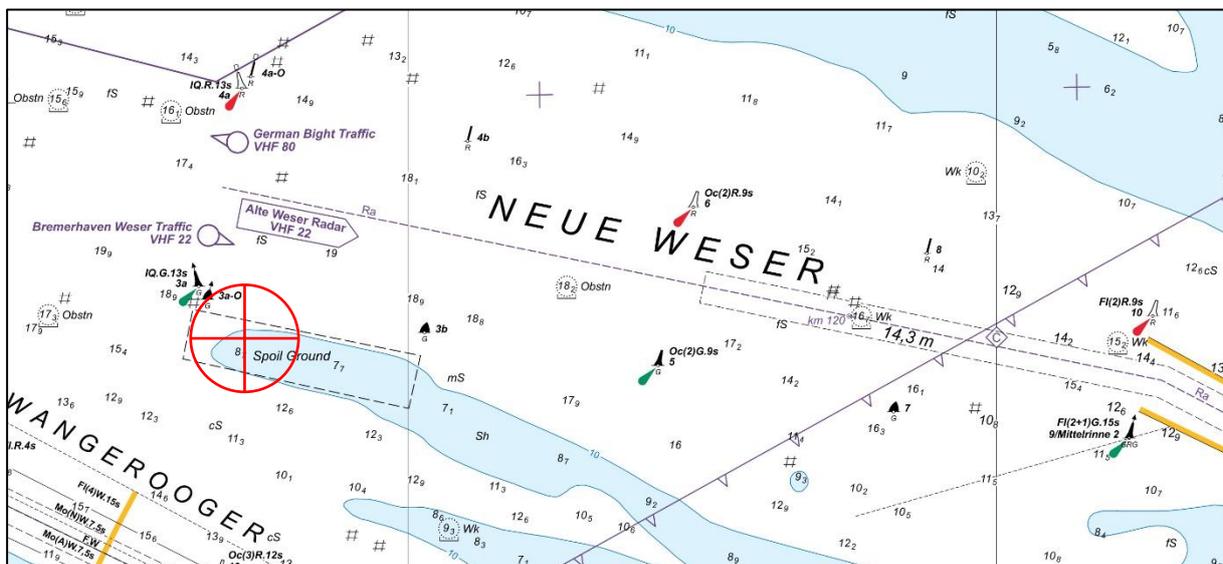
Type of marine casualty:	Serious marine casualty / grounding
Dae/time	02/02/2022, 2306 hrs (Local time = UTC + 1 hr)
Location:	A dumping ground for dredging silt in the North Sea (adjacent to the Weser fairway entry, approx. 3.5 nm north of the island of Wangerooge, south of the Weser buoys 3a and 3a-O)
Latitude/Longitude:	$\phi = 53^\circ 51,1' \text{ N}$, $\lambda = 007^\circ 53,6' \text{ E}$
Voyage segment:	Pilotage waters
Consequences:	<ul style="list-style-type: none"> - Ship remained at the scene of the accident for 26 hours - Large-scale salvage operations, coordinated by the German Central Command for Maritime Emergencies (CCME) - No damage to the ship apart from paint abrasion from the underwater hull - No personal injuries - No environmental damage - No obstruction of passing traffic

Figure 2: Scene of the accident, “Neue Weser” fairway entry.
