Issued March 7, 2023

MIR-23/05

Breakaway of Moored Mobile Offshore Drilling Unit *VALARIS DS-16* and Subsequent Collision with Cargo Vessel *Akti*

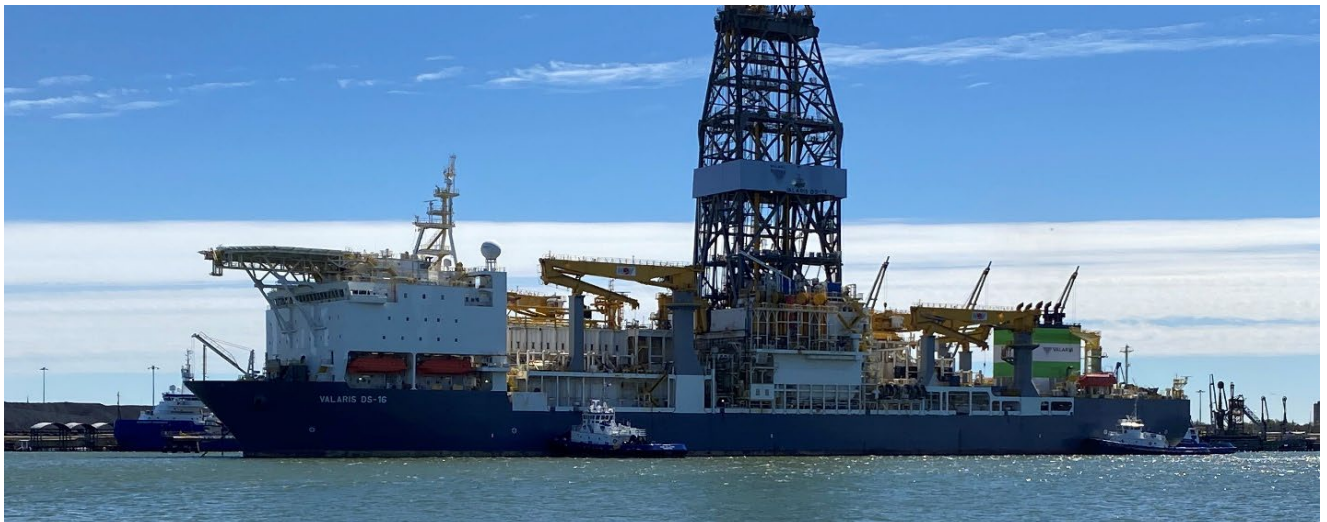
Figure 1. *VALARIS DS-16* after the casualty. (Source: US Coast Guard)

As a result of the collision, the *VALARIS DS-16* sustained damage to the riser handling system, deck fittings, transfer hose-reel system, walkways and platforms, and other equipment on board. A bulwark panel was deformed on the starboard side, and insets on the side shell plating and port stern were also noted. Divers found no damage to the underwater portion of the hull during an underwater inspection. Damages were estimated at \$4.2 million.

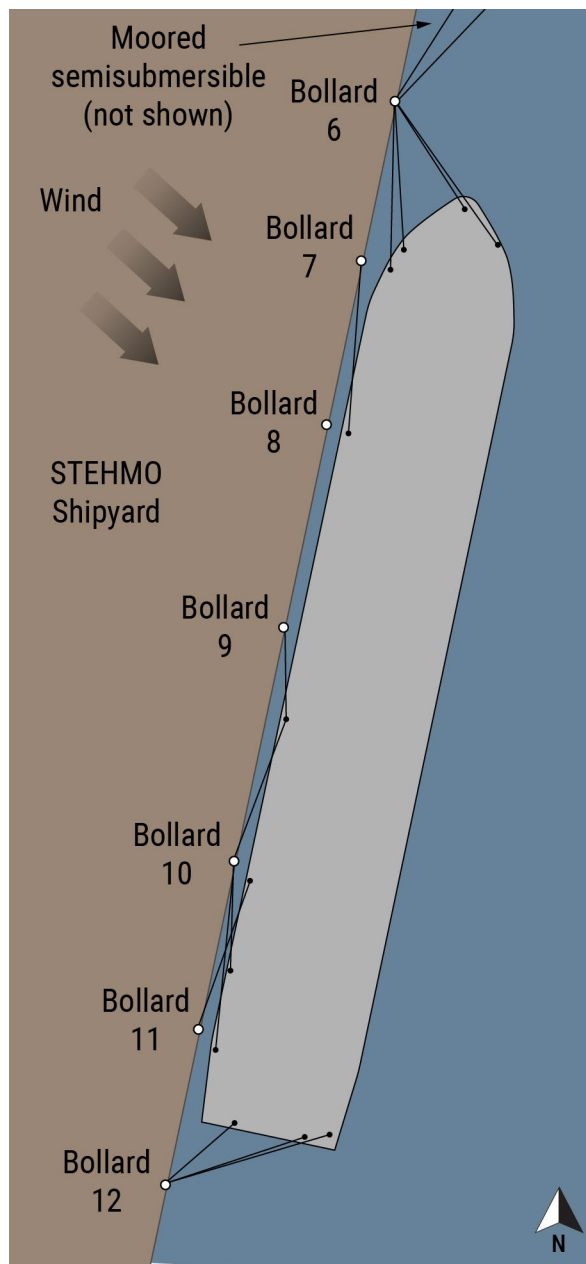
Just after the midnight shift change, about 0020 on March 12, the captain was awoken by what he believed to be the sound of a mooring line snapping and the feeling that the vessel had shuddered. He arrived on the bridge as the officer on watch was calling his stateroom. According to crewmembers, bollard 6, which

Figure 4. Representation of mooring arrangement at time of casualty. Wind direction estimated. (Scale approximate.)

secured the *VALARIS DS-16*'s four bow lines and the semisubmersible rig's two stern lines, had broken free from the dock at its base, and the bow of the *VALARIS DS-16* was blown away from the dock.

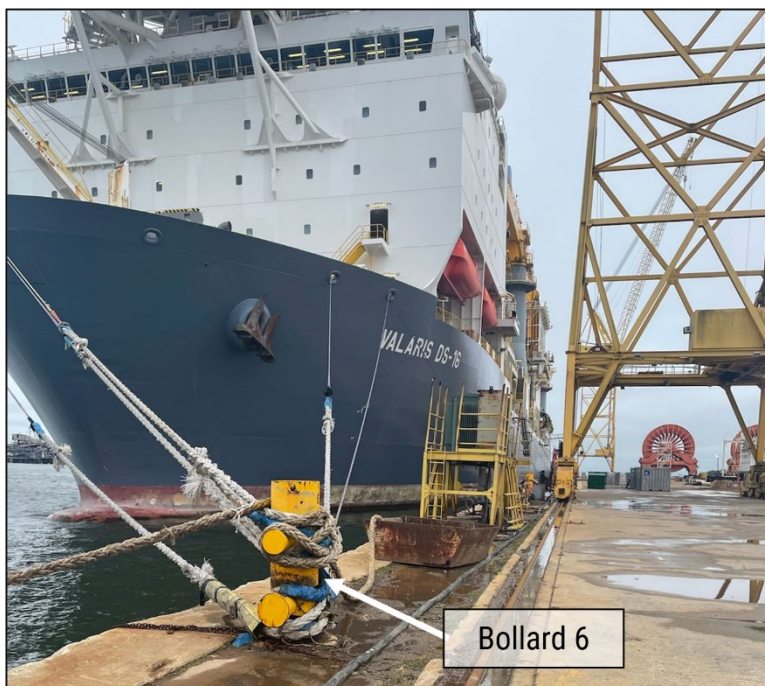
On March 8, a semisubmersible rig arrived and was docked to the north of the *VALARIS DS-16*. Two of its stern mooring lines were added onto the bottom of bollard 6, and the mooring lines from the *VALARIS DS-16* were shifted to the upper section of the bollard.

Figure 5. *VALARIS DS-16* moored at STEHMO Shipyard at unknown date before the casualty with lines secured to bollard 6 (before lines were adjusted for the March 12 strong winds). (Source: *VALARIS DS-16* captain)

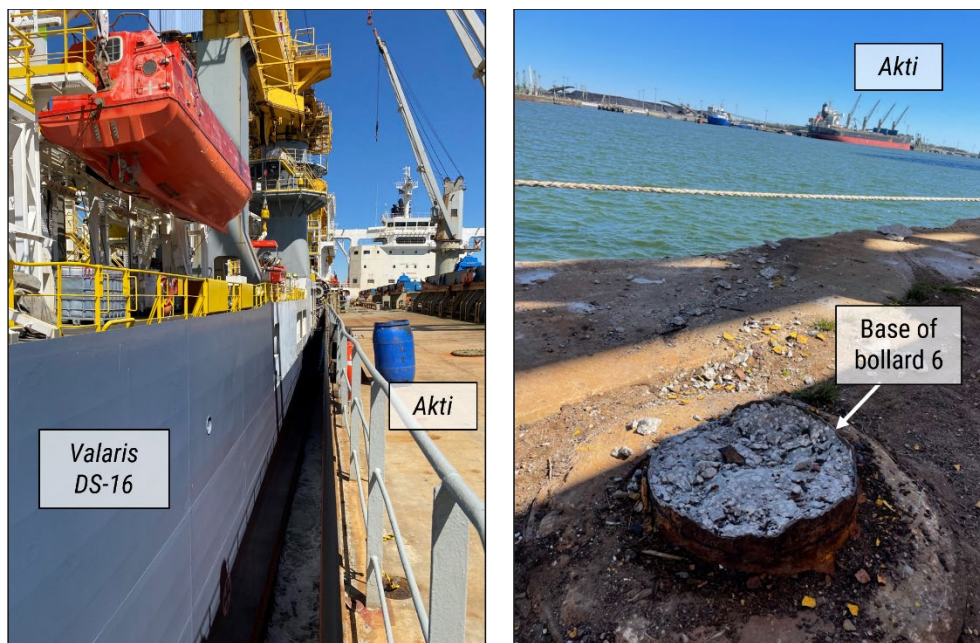
Figure 7. Postcasualty photos showing *VALARIS DS-16* alongside the *Akti* after making contact (*left*) and the remaining base of bollard 6 after breakaway (*right*). (Source: Coast Guard)

STEHMO estimated the cost to replace bollard 6 at their facility at \$20,000. The bollard was not recovered from the channel after it broke away. There were no reported damages to Chevron dock no. 6 where the *Akti* was moored.

During elevated sustained winds, bollard 6, which secured the *VALARIS DS-16*'s four bow lines and a semisubmersible rig's two stern lines, broke free at its base, and was pulled off the pier into the water. After the casualty, ultrasonic thickness tests performed on the remaining bollards in the area where the *VALARIS DS-16* was moored indicated that there was deteriorated steel at the lower portion of several bollards. The broken top of bollard 6 was not recovered from the channel and was not analyzed, but a postcasualty measurement of the remaining 18-inch-diameter base of the bollard showed that the steel wall thickness was less than 0.25 inches on the side farthest from the the edge of the pier—an apparent reduction in thickness of about 0.5 inches (original bollard design drawings showed a wall thickness of 0.75 inches). Additionally, several bollards showed signs of external corrosion and wastage: steel wires and chains were looped around the bases of bollards from which pier fenders hung, causing chafing and wear.

As of the publication of this report, the STEHMO Shipyard has replaced 10 of the 14 bollards on the pier, with plans to replace an eleventh bollard by the end of March 2023. Shipyard managers have begun evaluating the safe working load of the new bollards and scheduling a pull test using a tugboat.

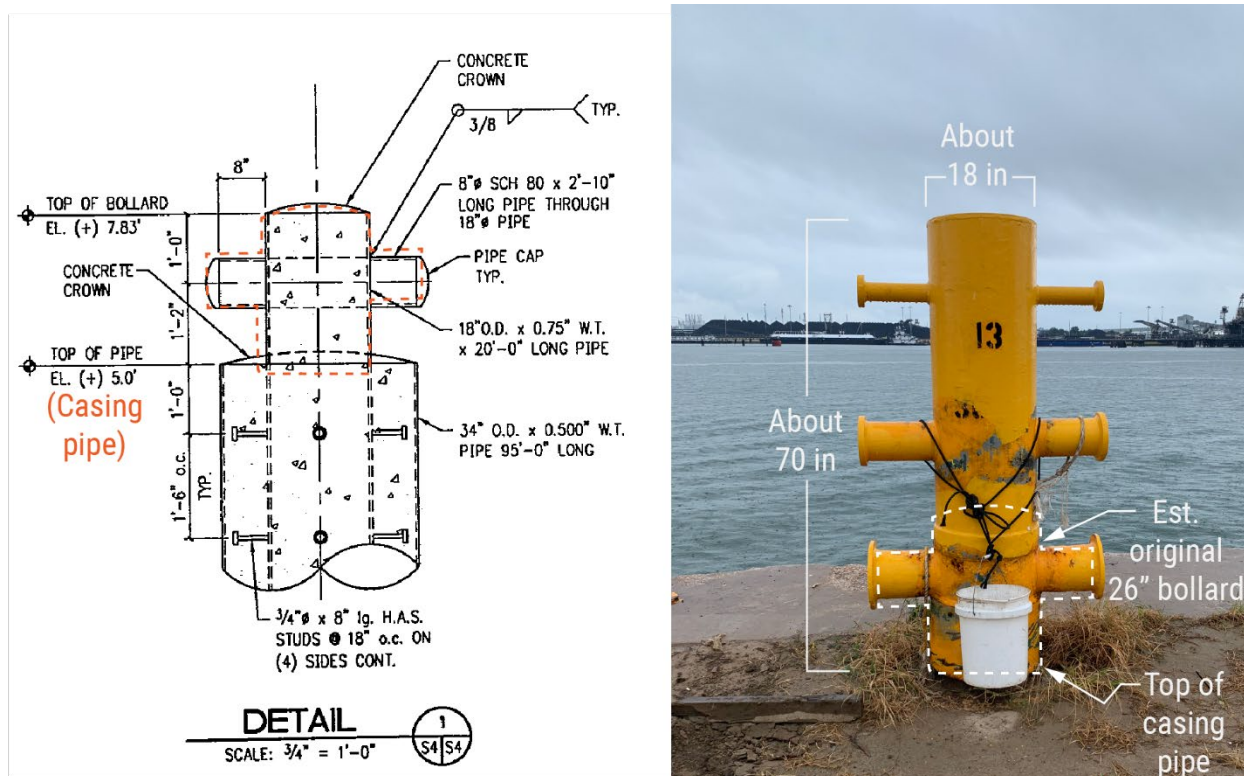
Construction drawings from 1997 showed that the bollards at the STEHMO Shipyard were to be constructed of studded steel pipe that was 20 feet long and 18 inches in diameter with a wall thickness of 0.75 inches. The pipe was then to be filled with concrete and set into another pipe that was 95 feet long, 34 inches in diameter, and 0.5 inches thick, and filled with concrete in the upper 30-foot section. The top of the bollard was designed to extend 2 feet 2 inches (bollard pipe) above the larger diameter pipe (casing pipe) with a concrete crown with a single set of 8-inch horns extending 8 inches on either side.

At unknown dates before STEHMO acquired the facility, the bollards were replaced or modified to different configurations with increased height and additional vertical sections and horns to accommodate more mooring lines. At some point, three of the bollards were replaced with larger, 24-inch-diameter bollards that had bolted, flanged bases. There were no records of these modifications. There were no policies or procedures addressing the frequency of inspections for the shipyard’s bollards, nor were there any statutory requirements for inspections.

Figure 8. 1997 construction plans for bollards (*left*) and a modified bollard in October 2022, 7 months after the casualty (*right*). (Background sources: STEHMO [*left*], Coast Guard [*right*]).

Investigators found that although each of the bollards used by the *VALARIS DS-16*, including bollard 6, was stenciled with a “300T” marking, likely to indicate they could safely sustain a working load of up to 300 tons, there were no records of any pull tests that could confirm this stenciled safe working load. Additionally, there were no records of any modifications to the bollards, nor tests, inspections, or maintenance conducted on the bollards, with the exception of a bollard pull test for a tugboat that resulted in a load of 154.5 metric tons (170.3 tons) applied to an unknown bollard in December 2020. Further, all the bollards used by the *VALARIS DS-16* had been modified from the original 1997 design, and vertical components (for which there were no engineering records) were added to each of the bollards to accommodate more lines. The bollard pipes’ overall height increased from just over 2 feet (26 inches) to anywhere from about 4 to 7 feet—about 2 to 5 feet higher than originally designed—with additional horns for mooring lines added well above the height of the horns on the original design. The additional horns allowed for mooring lines to be placed higher on bollards than planned for in the original design. As the height of a bollard (or its horns) increases, the horizontal or up-leading pull on the upper portion of the bollard significantly increases the moment of force applied to the base of the bollard.⁵ Therefore, bollard 6—and many of the other bollards used to secure the *VALARIS DS-16*’s mooring lines—were likely incapable of sustaining the working loads of their original design.

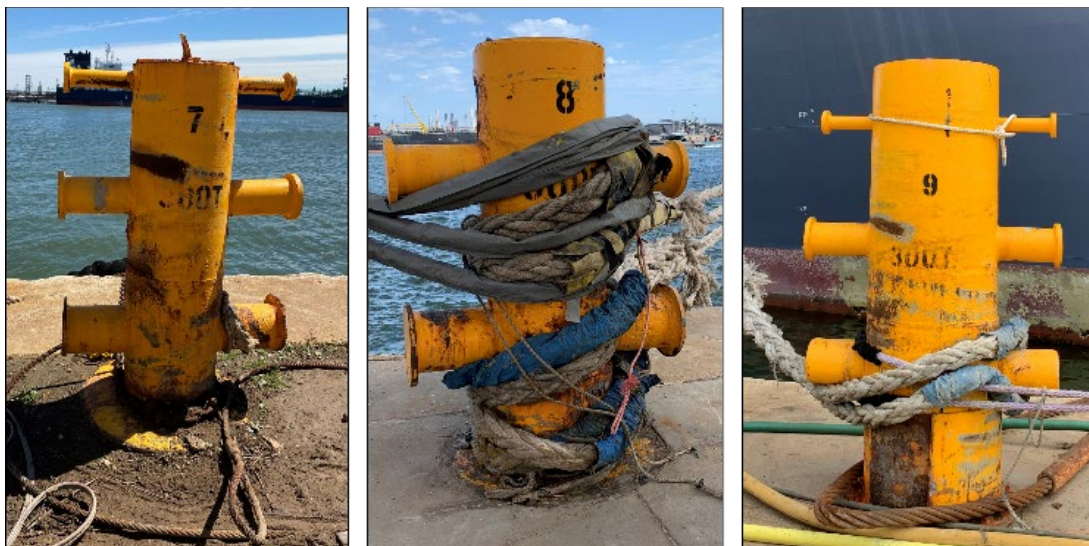
Each of the bollards used by the *VALARIS DS-16* was stenciled with its corresponding number and "300T," indicating an assumed safe working load of 300 tons. According to shipyard managers, the bollards were stenciled before STEHMO acquired the shipyard. Before the casualty, on December 24, 2020, a static pull test was performed to determine the bollard pull capacity of a tugboat using one of the bollards at the STEHMO shipyard; the test was witnessed by a surveyor. The resulting certificate for the tug did not indicate which bollard was used for the pull test. The rated static bollard pull of the tugboat was calculated to be 154.5 metric tons (170.3 tons). As stated earlier in this report, this test certificate was sent to the engineers at the *VALARIS DS-16*'s operating company for docking analysis.

Figure 9. Bollards 7, 8, and 9 at STEHMO Shipyard after the casualty.

Following the casualty, on March 23, 2022, ultrasonic thickness tests were completed on 13 bollards at STEHMO Shipyard. Testers attempted to take eight measurements in 45° increments 12 inches from the top and 2 inches from the bottom of each bollard. Several bottom measurements could not be taken due to obstructions. Fifteen measurements at the bottom of the bollards were less than 0.25 inches thick. Investigators measured the steel of the remaining base of bollard 6 and found it to be less than 0.25 inches on the side farthest from the the edge of the pier. Additionally, investigators found many of the bollards exhibited signs of wastage and external corrosion: bollard 9 had a steel doubler patch around a portion of the base over a smaller-diameter steel pipe showing signs of external corrosion, and bollards 7 and 9 had steel wire and chains around their bases from which fendering equipment was hung.

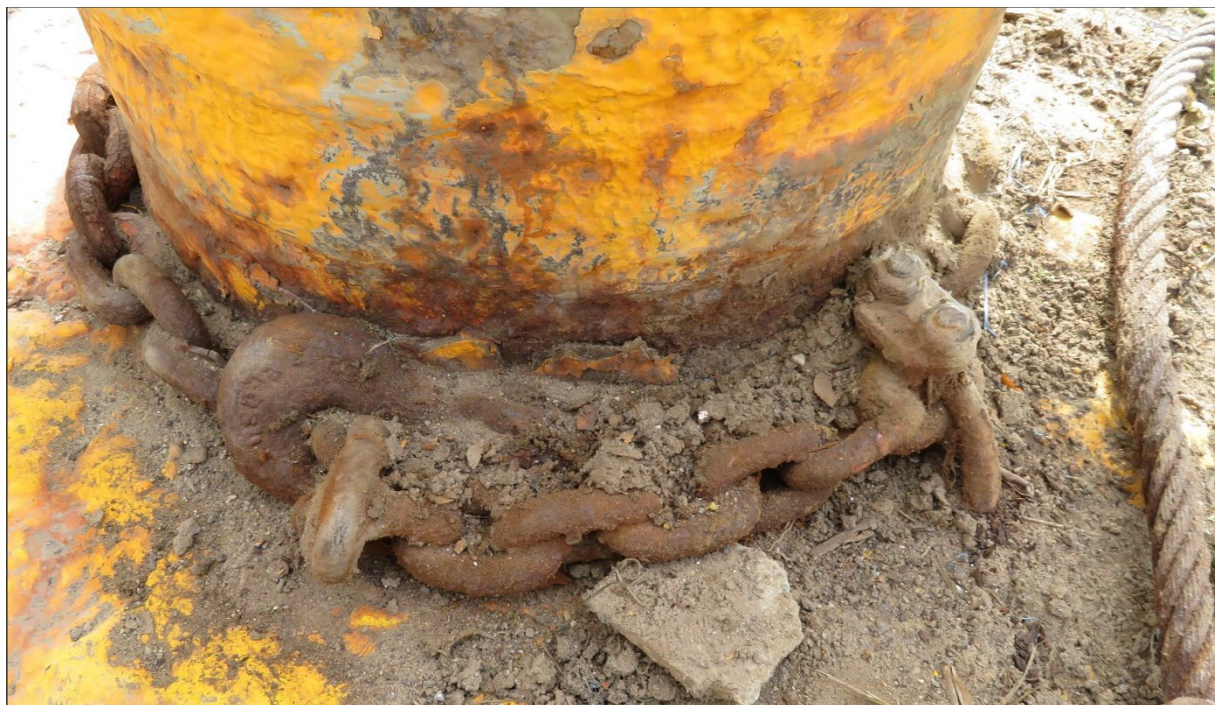
Figure 10. Steel chain wrapped around base of bollard 7 after the casualty. (Source: Coast Guard)
