Issued March 8, 2023

MIR-23-06

Contact of *Robert Cenac* and Tow with Houma Twin Span Bridge

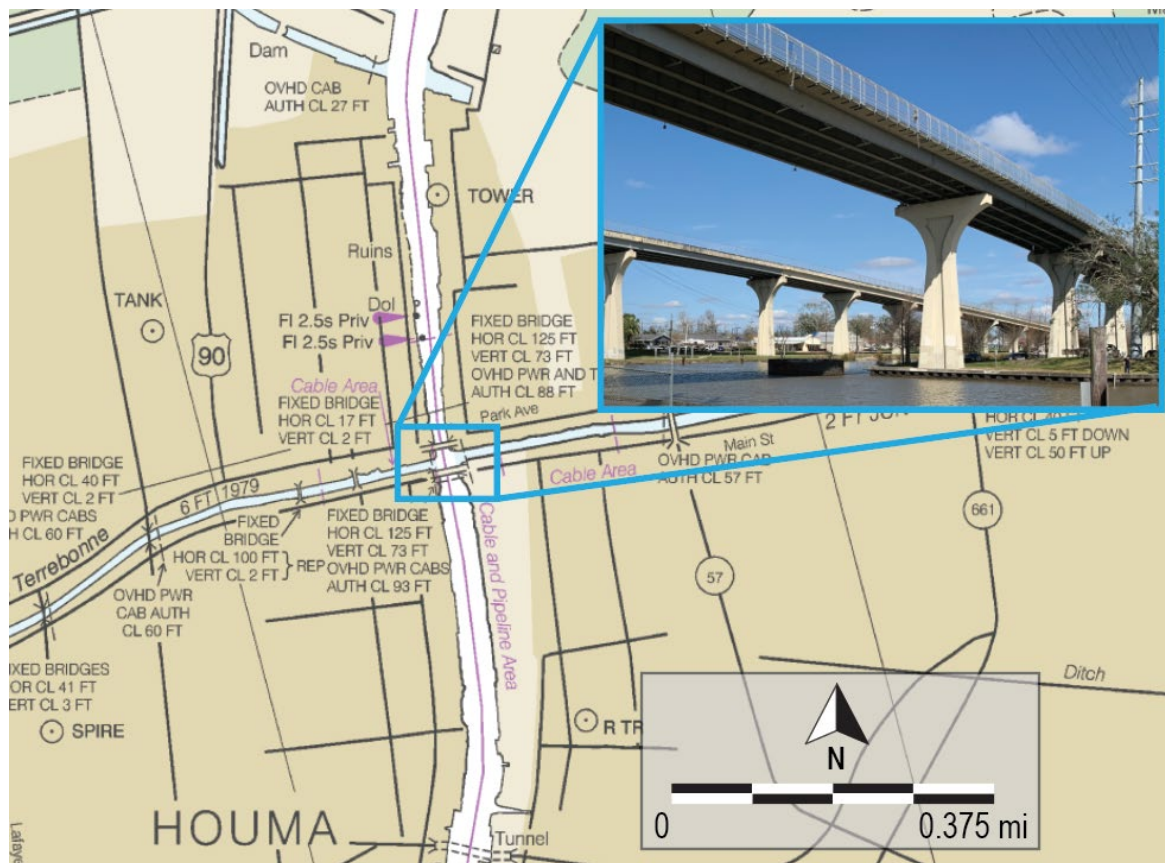
Figure 4. Extract of National Oceanic and Atmospheric Administration chart 11355, annotated by NTSB. Inset: photo of the Houma Twin Span Bridge.

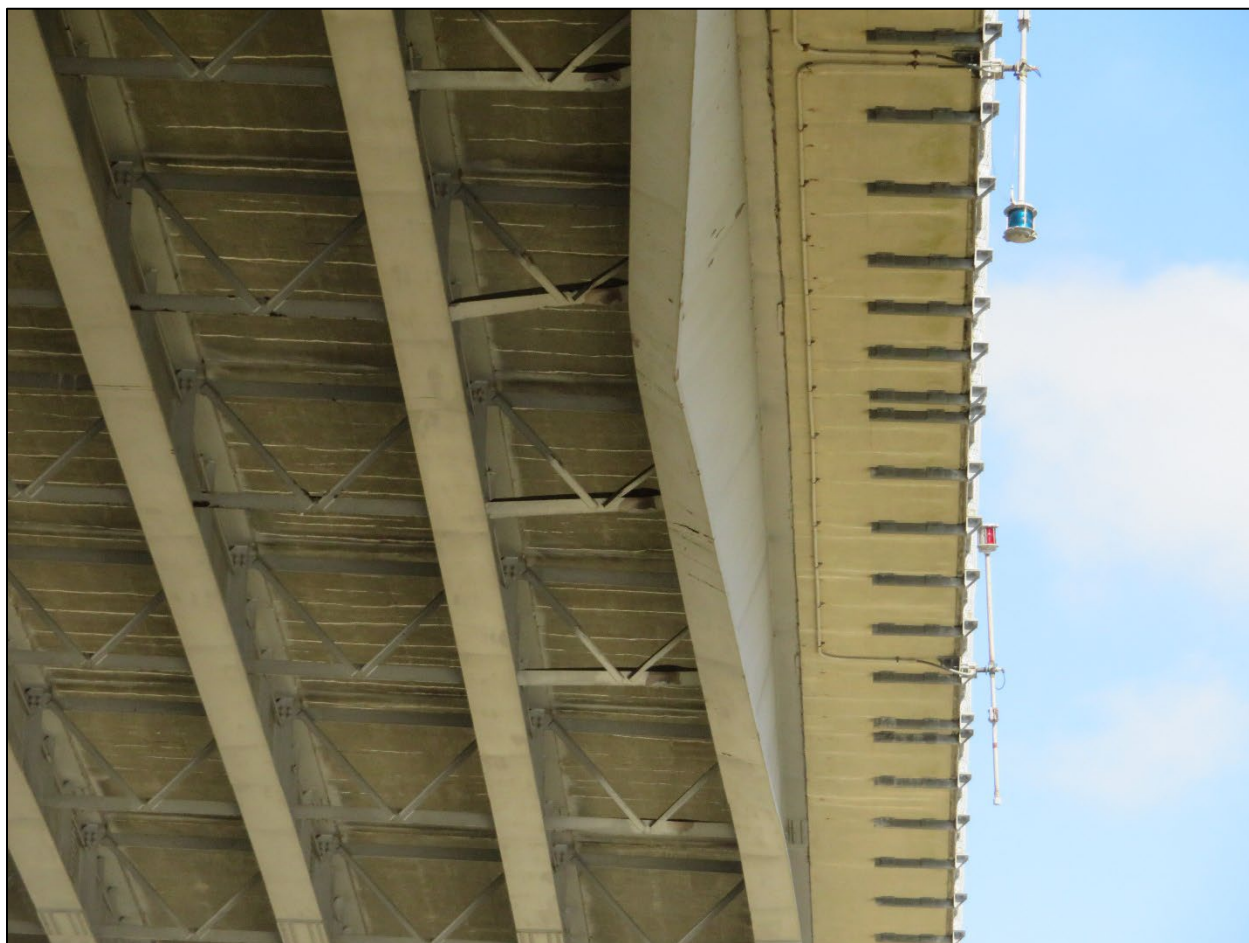
At 0038, the head of the crane boom struck the outermost stringer of the eastbound bridge. The tow was moving at a speed of 4.3 mph. When the crane made contact, the *HMT 26* broke away from the tow and had to be resecured.

The bridge sustained a bent girder, a damaged deck, and fractures to the pier caps and was completely closed to vehicular traffic until 1100, when one lane was reopened. The second lane was opened on March 16.

Figure 5. Eastbound span of the Houma Twin Span Bridge showing damaged stringer.
