**Potential fire hazards from flexible hose installations  
identified following a fire on board  
the roll-on/roll-off cargo ship  
*Finnmaster*  
in Hull, England  
on 19 September 2021**

## MAIB SAFETY BULLETIN 1/2023

The Marine Accident Investigation Branch is carrying out an investigation into the fire on board the roll-on/roll-off cargo ship *Finnmaster* in Hull, England, on 19 September 2021.

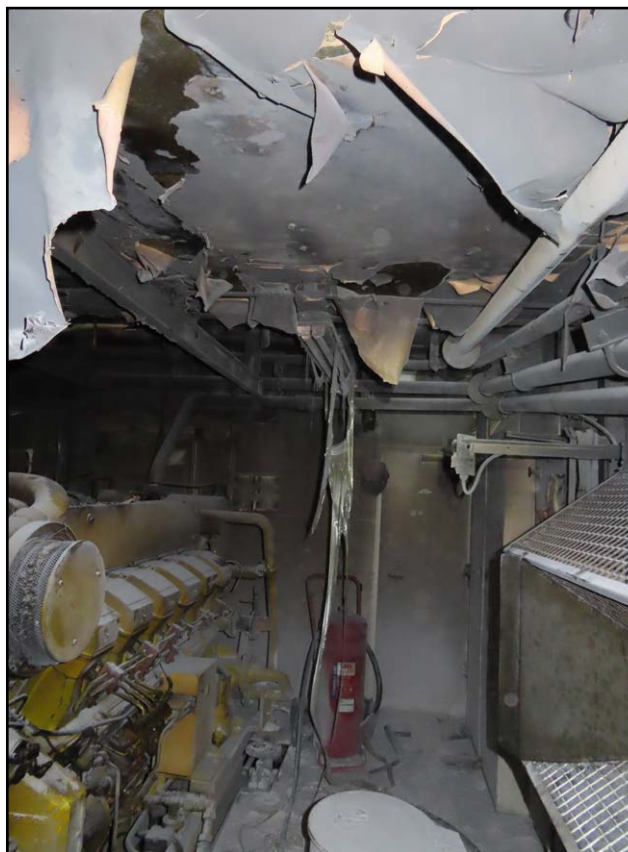
*Finnmaster's* fire-damaged compartment

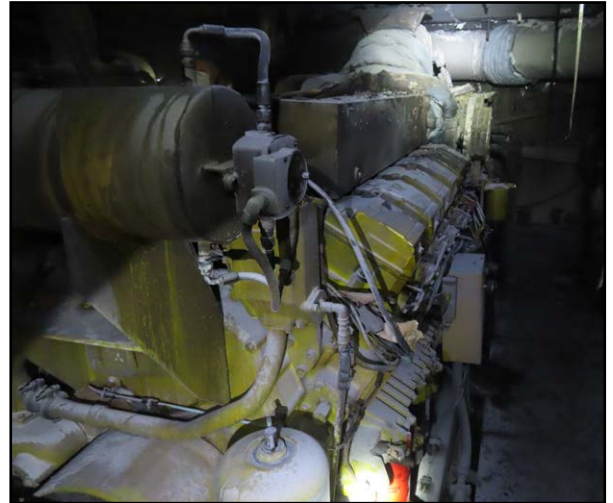
On 19 September 2021, a fire broke out in the auxiliary engine room on board the Finland registered roll-on/roll-off cargo ship *Finnmaster* while departing Hull, England. The fire was contained and subsequently extinguished without injury to the crew, but the equipment in the auxiliary engine room suffered serious damage (**Figure 1**).

**Figure 1:** Damage sustained to auxiliary engine room

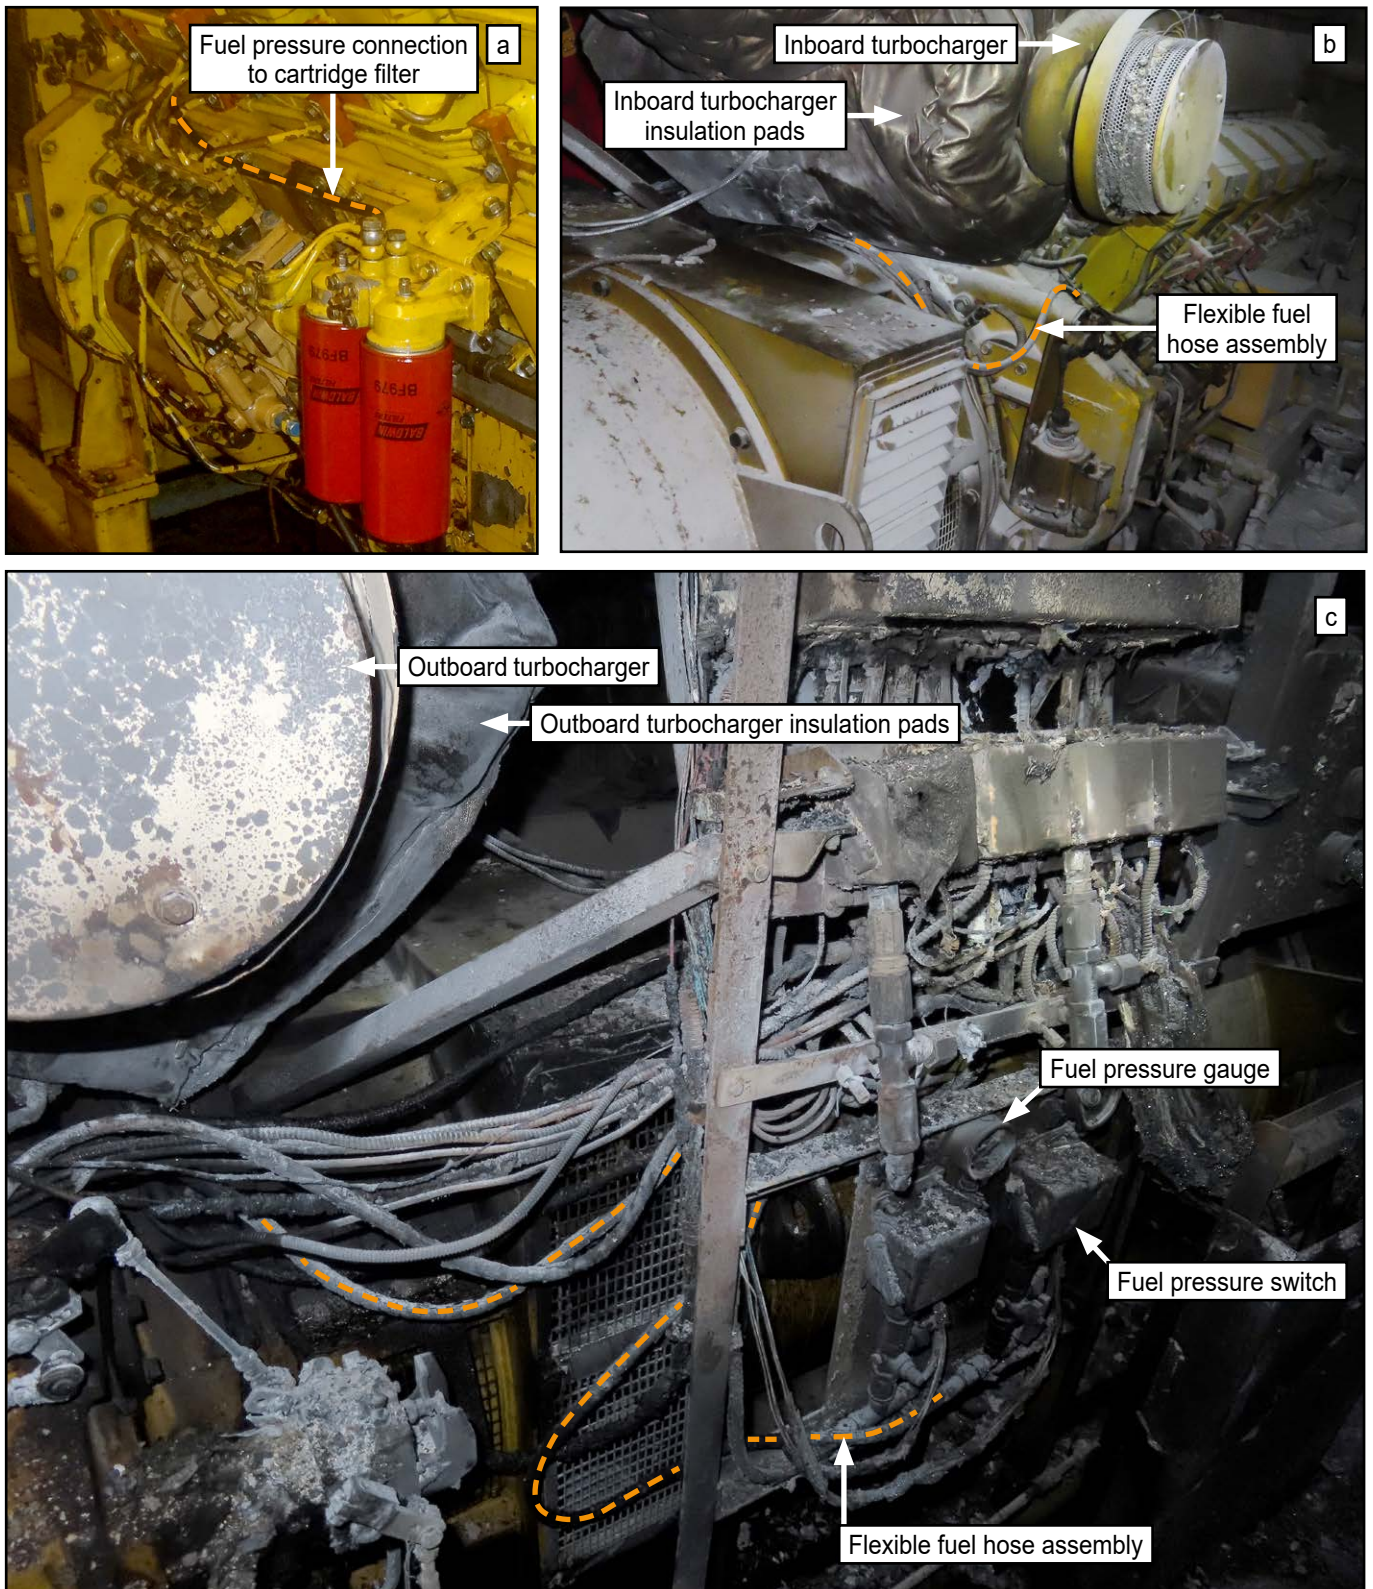
The MAIB investigation identified that the fire started below the outboard turbocharger of AE2 when a small-bore flexible fuel hose failed. Exhaust gas had leaked from the outlet of the turbocharger and caused the fuel hose to overheat and fail allowing MGO to spray onto a high temperature surface, where it ignited and a significant fire developed.

The flexible fuel hose that failed in the accident was connected to the outlet from the inboard set of AE2 cartridge filters (**Figure 3a**); the hose was routed aft along the engine and passed over the top of the flywheel cover under the turbochargers (**Figures 3b** and **3c**). It then connected to a pressure sensor on an instrument panel mounted outboard of the AE2 alternator. Both this hose and the matching hose on AE1 were 3.4m in length. No isolation valve was installed at the connection to the cartridge filters.

The thermal insulation that covered the auxiliary engine turbochargers had also been modified by the installation of bespoke insulation pads over the existing insulated box structure. The flexible fuel hose from the AE2 inboard fuel cartridge filters was routed under these insulation pads.

**Figure 3:** Small-bore flexible fuel hose assembly on AE2, as indicated by dashed orange line

In this case, the flexible hose assemblies were not needed to accommodate relative movement between fixed piping and machinery parts over their entire length between the cartridge filters and the instrument panel. Furthermore, the routing of the hoses under the turbochargers covered by the insulation pads exposed them to the risk of contact with high temperatures and also made them difficult to inspect.

- The risks associated with a modification on safety critical equipment should be considered before and during the work being completed. In this case, the positioning of the fuel pressure gauges and pressure switches required the pressure signal to be transferred from one side of the engine to the other. The relocation of the pressure switch closer to the cartridge filters would have removed the need for a long hose; if this was not possible, a rigid metal pipe secured with clamps and routed at an appropriate distance from the engine's exhaust might have been a safer option.

- Flexible hoses are recognised as having a higher risk of failure than a properly fitted metal pipe. An isolation valve fitted at the point of supply allows a flexible hose to be safely isolated in the event of leakage.
