## Simultaneous Operations

- 1.1. This Safety Alert is issued by The Bahamas Maritime Authority to share lessons to be learned from the death of a subcontractor, working at height on a pipe laying vessel. It is based on the findings of a preliminary investigation into a very serious marine casualty.
- 1.2. Many of the lessons to be learned from this casualty are for crew, contractors and subcontractors involved in simultaneous operations, particularly in the offshore sector. However, it is important for companies, operators and managers, regardless of the scope of operation, to understand the risks associated with shipboard teams working simultaneously while assessing their safety in isolation.

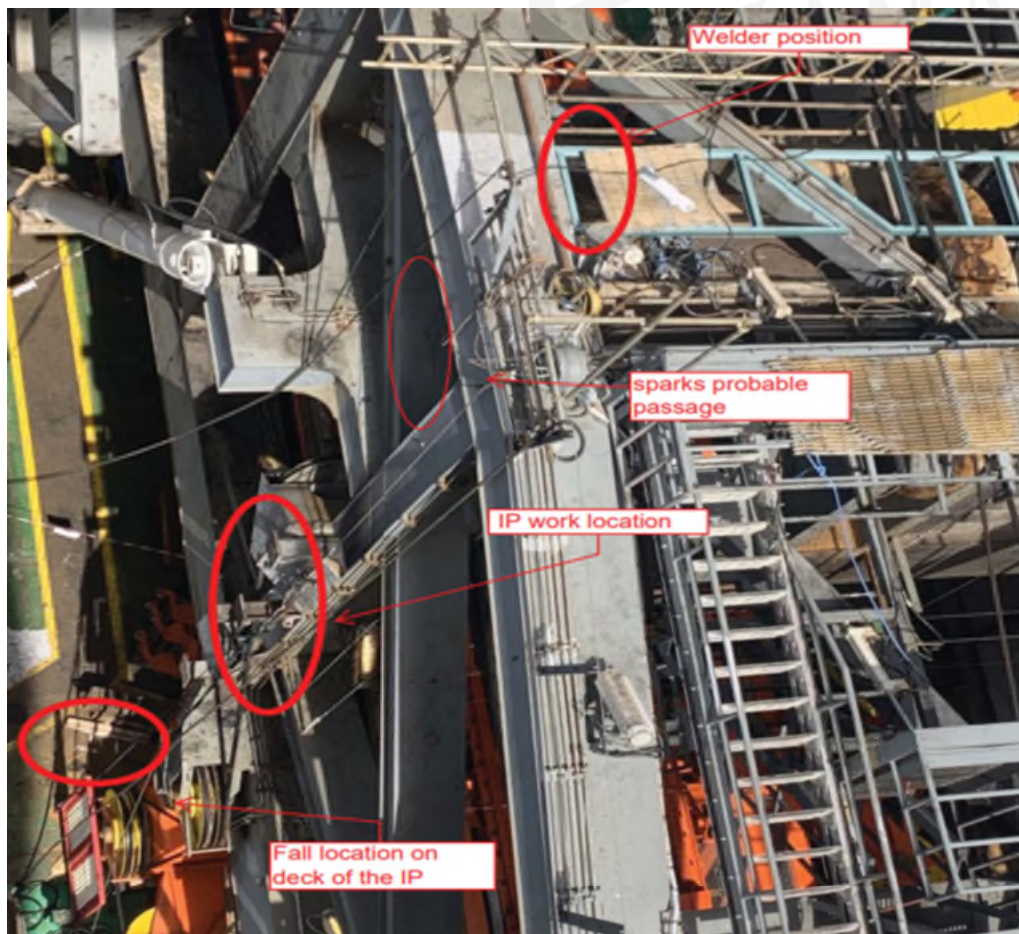
- 2.5. Shortly afterwards, sparks from the hot work ignited the paint thinner. The rope access technician pushed the paint thinner container away but the ignited material splashed onto the safety harness, causing it to melt and fail. The rope access technician fell approximately five meters to the deck and died from his injuries.

Scene of casualty

- 4.1. While conducting simultaneous operations, effective supervision means maintaining oversight of the entire operation to enable identification of areas which overlap and the associated potential risks.

- 4.2. During simultaneous operations, job safety analyses (JSA), permits to work (PtW) and risk assessments lose their effectiveness if each team completes their own in isolation. It is important to think of ship and crew safety holistically, not as isolated departments.

- 4.3. Work planning meetings should include (at minimum) a supervisor or representative of each independent team to ensure all teams have a unified understanding of ongoing operations and how it relates to their work. This contributes to an overarching understanding of risk, rather than just a team specific focus.

- 4.4. Stop work authority is a safety policy that authorizes employees to put a stop to unsafe work, even when they normally don't have that level of authority. It is only effective when considered more than a written policy and actually utilized. All shipboard personnel and subcontractors alike, should be aware of this, while managers should emphasize there are no repercussions to crew who choose to exercise their stop work authority. Operations should not be dependent upon the intervention of senior staff or supervisors to determine that work is safe to carry on, this practice is detrimental to onboard safety culture. Stop work authority can be used to reassess risks and reset a scenario, potentially saving a life.
