**REPORT: M/V “WAKASHIO”**  
**IMO: NO. IMO 9337119**  
**R-029-2021-DIAM**  
**Casualty Date: JULY 25, 2020**

**SAFETY INVESTIGATION REPORT**  
**OF**  
**THE GROUNDING**  
**OF**  
**MV "WAKASHIO" IMO: 9337119**  
**VERY SERIOUS MARINE ACCIDENT**  
**INCIDENT OCURRED**  
**ON JULY 25, 2020**  
**AT 1925 ON THE SOUTHEAST COAST**  
**OF BLUE BAY IN FRONT OF POINTE D'ESNY ON**  
**THE ISLAND OF MAURITIUS**

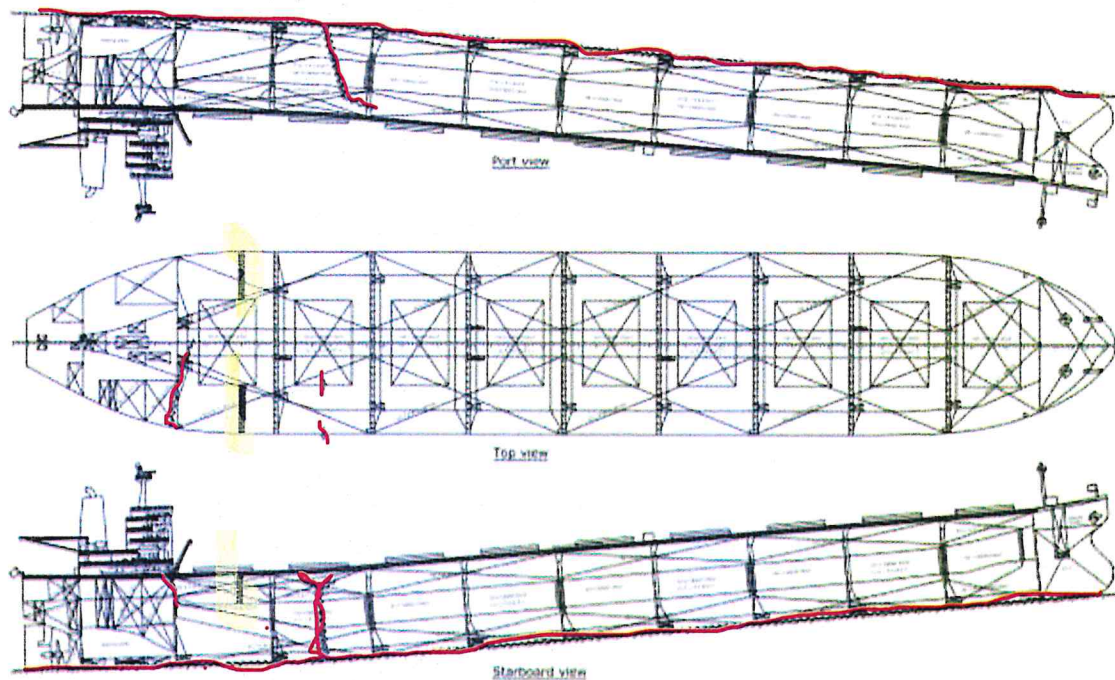
*Figure 1 Overview of the damages on the Wakashio.*

On the overview drawing of the damages on the Wakashio on August 9<sup>th</sup>, 2020, the various cracks and deflections were presented to the best accuracy possible with the means at hand. The crack propagation under water was based on experience and observations on the casualty.

The cracks are presented above in red, and the buckling is presented in yellow. Note that based on the observations on board it seems that the vessel was almost broken in two pieces, attached by the deck only.

Since there was a large crack on the side shell on both sides at frame 83 and since this was also the location of the highest deflection, it was believed that this was where the vessel would be break eventually. This is also reflected by the motions of the bow section, which was floating and heaving on the swells. In the aft section there is little to no motion was sensed. As a result, both sides of the cracks were continuously moving and propagating.

However since there was also a crack forming just forward of the accommodation, the vessel could have also broken at this location after which it is uncertain whether the stern section was remained upright in the prevailing swells.

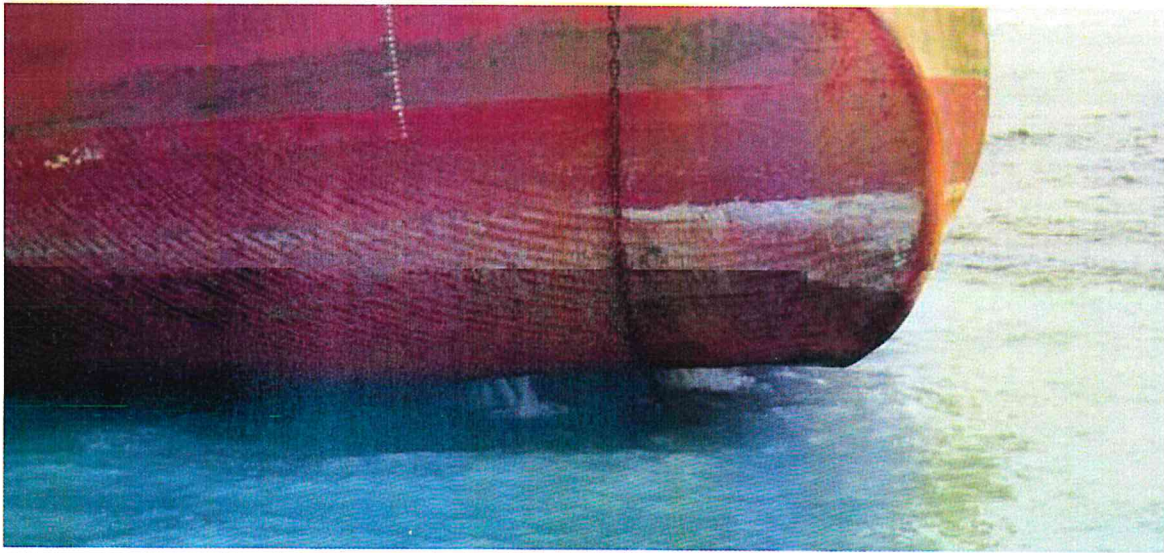
With the bow of the vessel protruding above the waterline, the damage on the bottom shell plating is made clear by the amount of water flowing out. Also, from the interrupted curvature of the bulbous bow, it can be deduced that the bottom plating is compressed.

*Figure 2, Protruding bow section with water flowing out.*

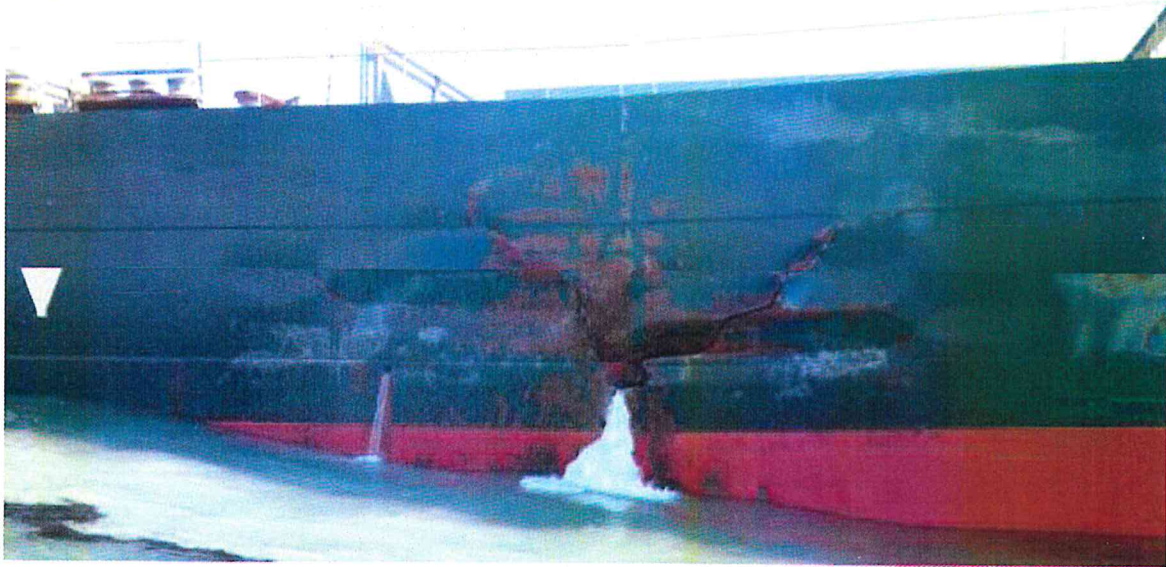
On the SB side shell, a crack was propagating from Frame 83 up to 21.9m from the base. On main deck, this area is clearly the point at which the vessel is leaned, the forward section had an aft trim of approx. 5 deg. And the aft section had an aft trim of approx. 2 deg. This would bring the total deflection to about 3.2m at Frame 83. As can be seen on the picture was the crack showed in two directions towards main deck.

*Figure 3, SB crack at Frame 83*

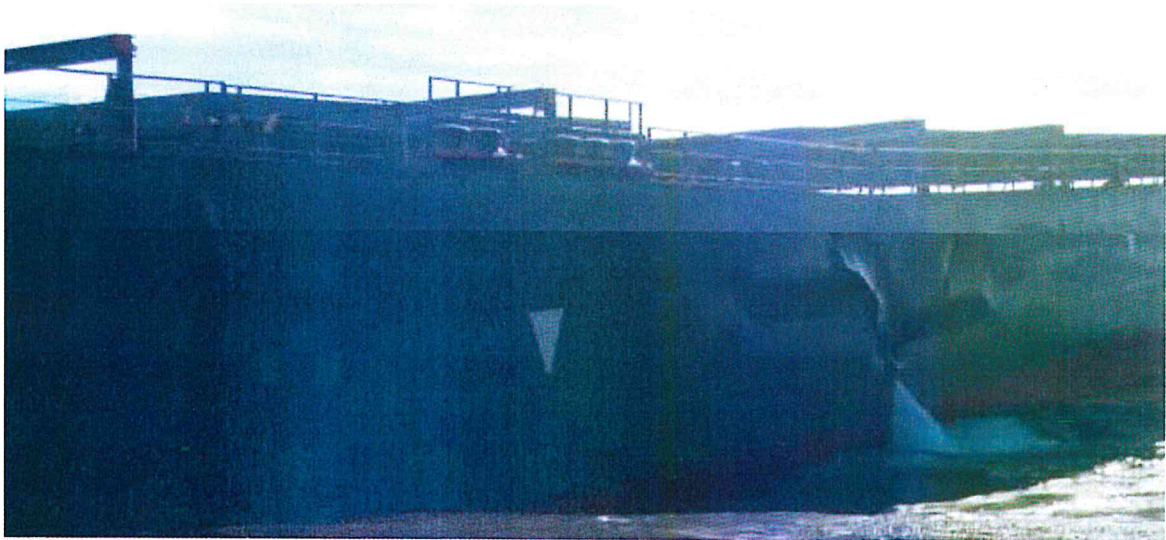
*Figure 4, SB crack at Frame 83, view from aft*

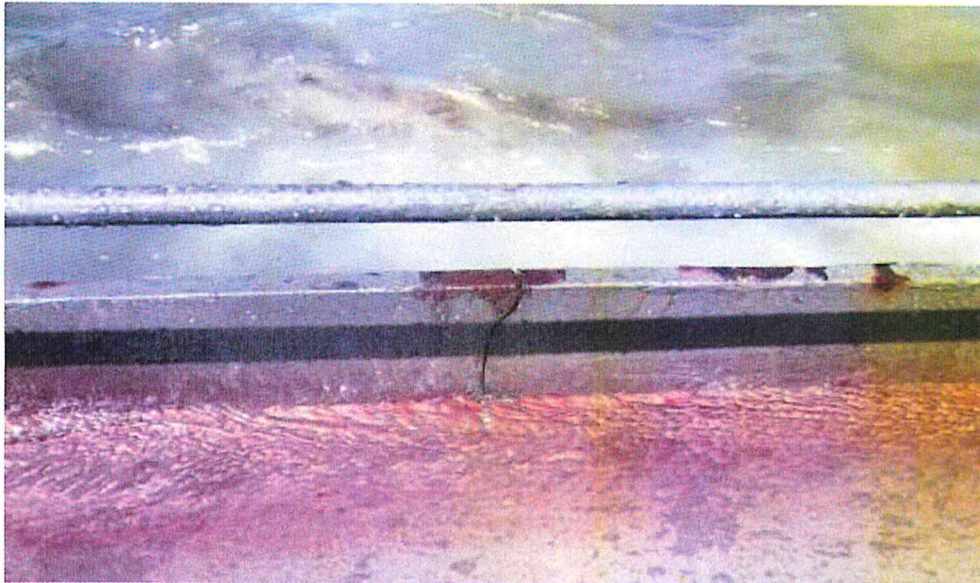
On the morning of 9<sup>th</sup> August 2020, the side shell was also cracking on main deck.

*Figure 5, Side shell crack at main deck Fr.83*

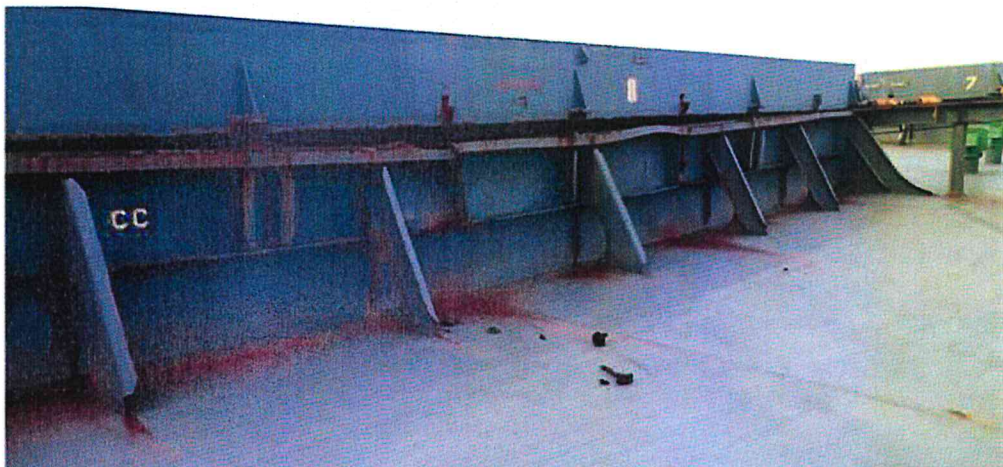
On the SB coaming, the lashing bracket has broken off and the hatch cover is approx. 20cm above the coaming in the center. Where the lashing bracket has broken off, the coaming is starting to shear. This effect is not present on PS.

*Figure 6, Coaming and hatch cover CH8 SB.*

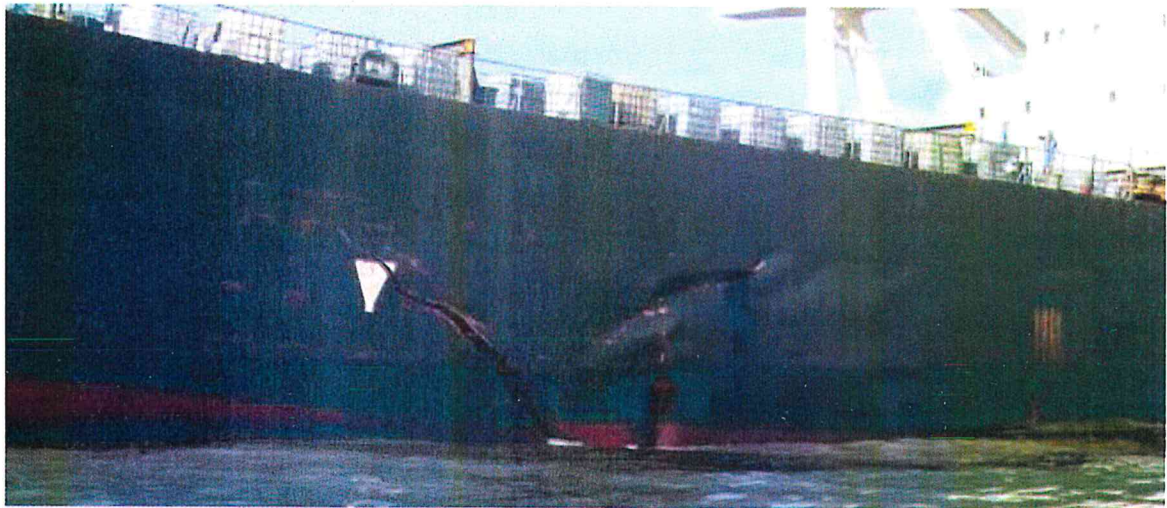
On the portside side shell a crack was started at frame 91 (WL) and was progressing upwards to 21.35m from the base and forwards to Frame 99. Similar to the starboard side, this area is where the vessel was showed a clear deflection. It was expected that this crack originates from around frame 83 on the baseline, similar to the starboard side.

*Figure 7, PS crack at Frame 91.*

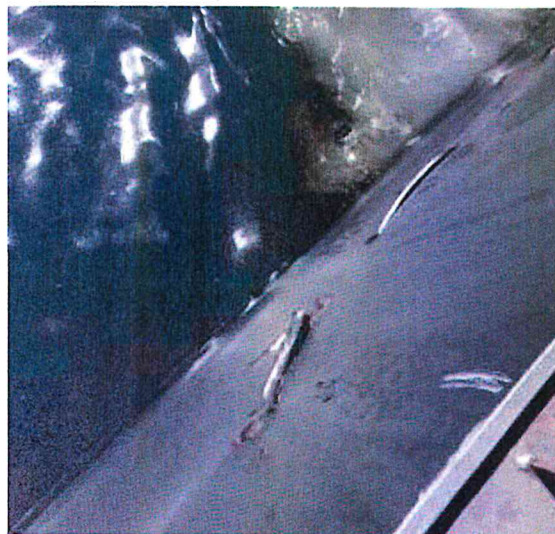
The buckling on the aft part of this crack had started to crack as from 9<sup>th</sup> August, a view from the deck is shown below.

*Figure 8, PS crack at Frame 91, view from deck*

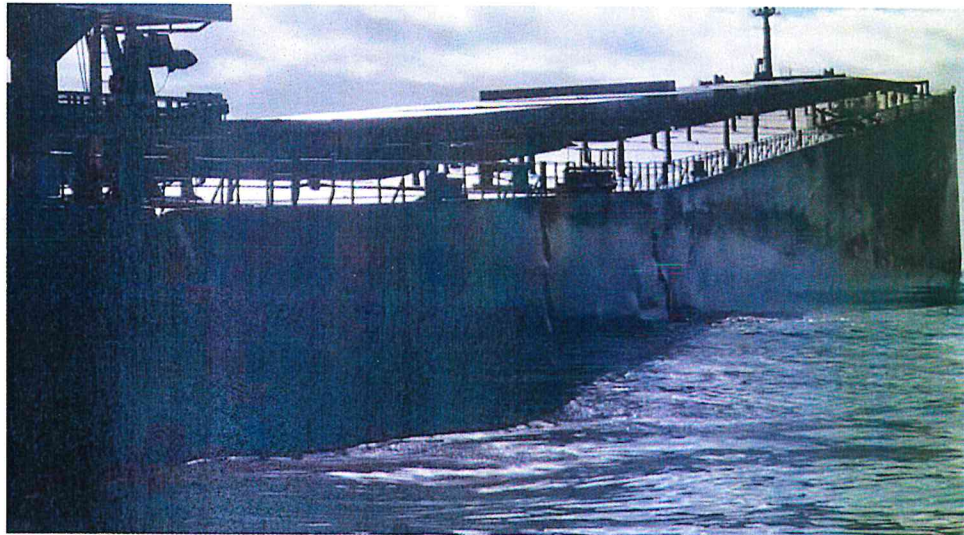
At approx. Frame 60, the side shell and deck were buckled, this had been observed for at the same time as the crack at CH8 was observed and does not seem to change. No cracks were visible in this area.

This buckling continues on main deck over the entire beam of the vessel, the PS side shell was not buckled visibly.

In the same picture below, the deflection of the vessel is also clearly visible.

*Figure 9, SB buckling at frame 60, view from aft.*

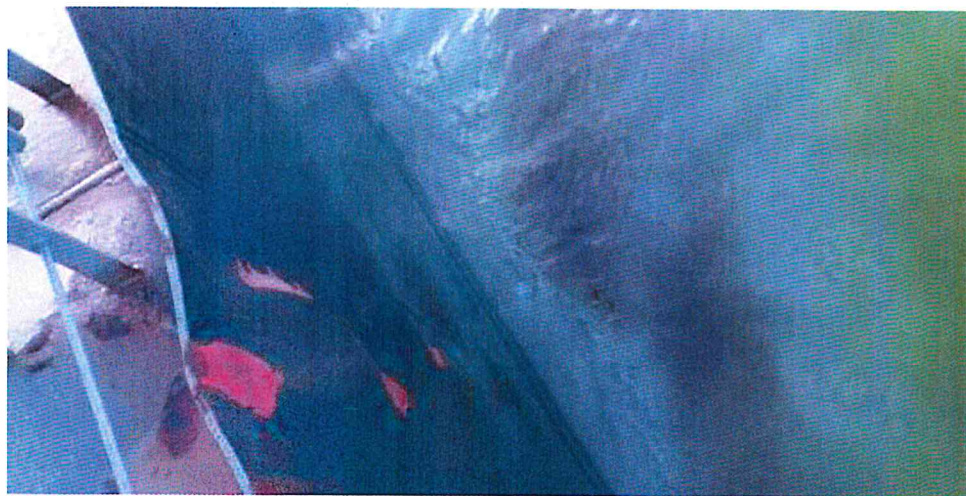
*Figure 10, SB buckling at frame 60, view from deck*

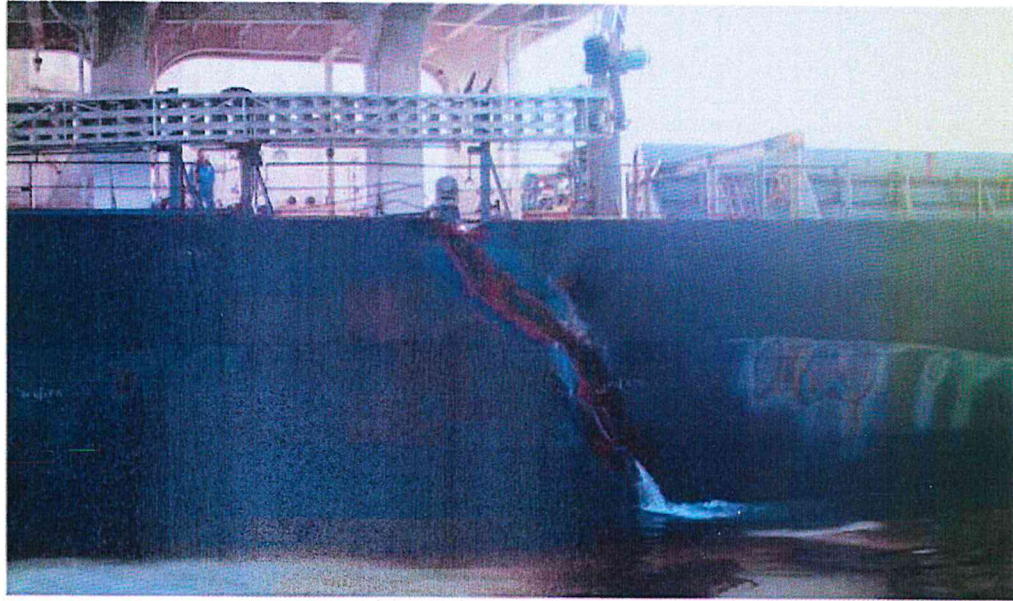
The crack at number 1 starboard fuel tank be started just forward of frame 42 and continues up to main deck at frame 40.

*Figure 11, SB crack at frame 42*

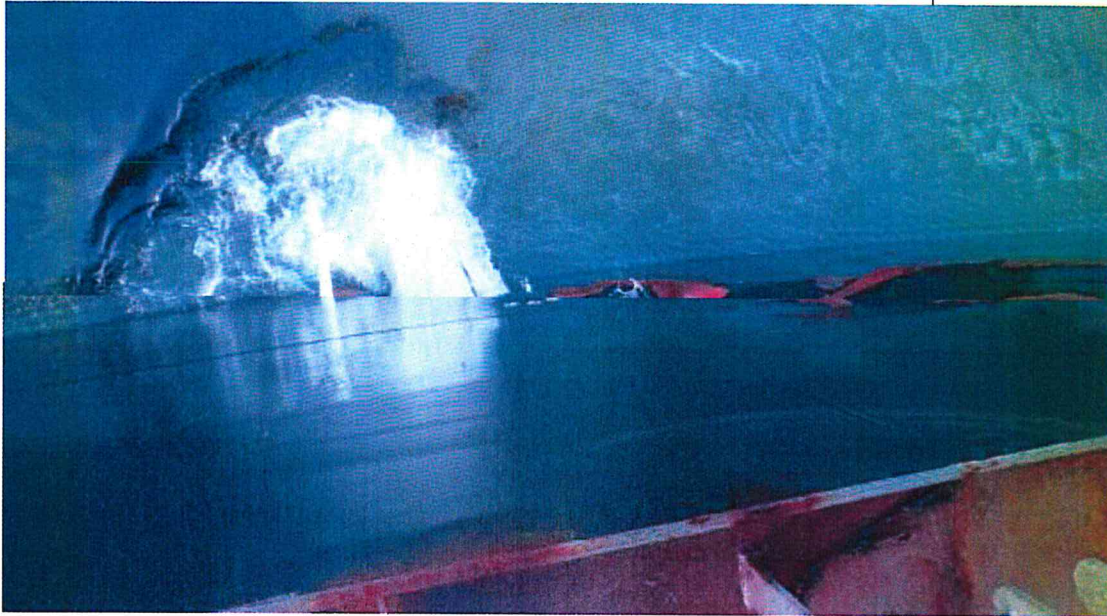
*Figure 12, SB crack at frame 42, view from main deck.*

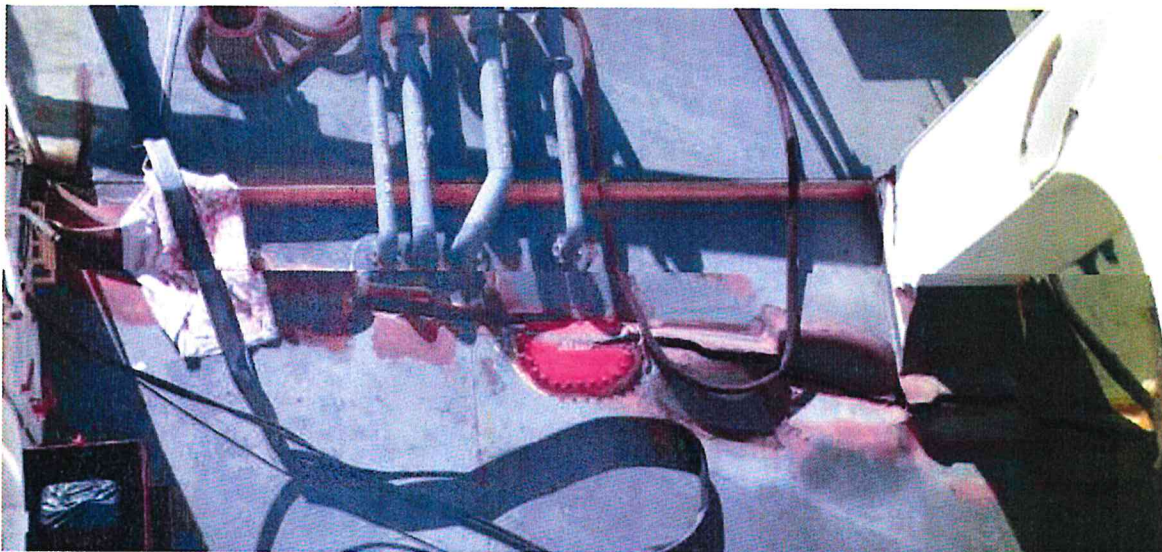
The crack at frame 40 continues onto main deck, where the deck is completely cracked up to about 50cm PS of the CL. The two sides of the crack were continuously moved lengthwise by about 2cm with the bow section moving in the swells and the stern section firmly grounded. The following pictures show this crack spreading to PS and forward (on the CL, the crack is at frame 46).

*Figure 13, SB crack at frame 40 on main deck*

Note in the above images, the support of the bridge wing cracking, as one this support is on the forward part of the crack, while the rest of the structure was on the aft.

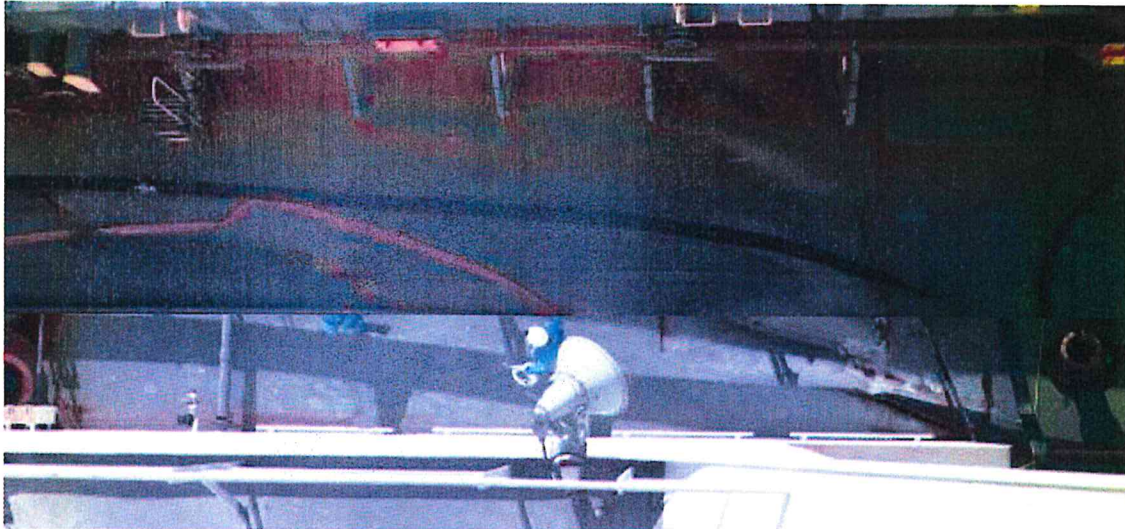
Crack spreading in this area was monitored for a few hours and continues with about 1-2cm per hour depending on the location of the crack. The crack spreading at the centerline was a bit less with about 2-5mm per hour, this can change as parts of the structure give way.

*Figure 14, SB crack at frame 42-46 on main deck.*

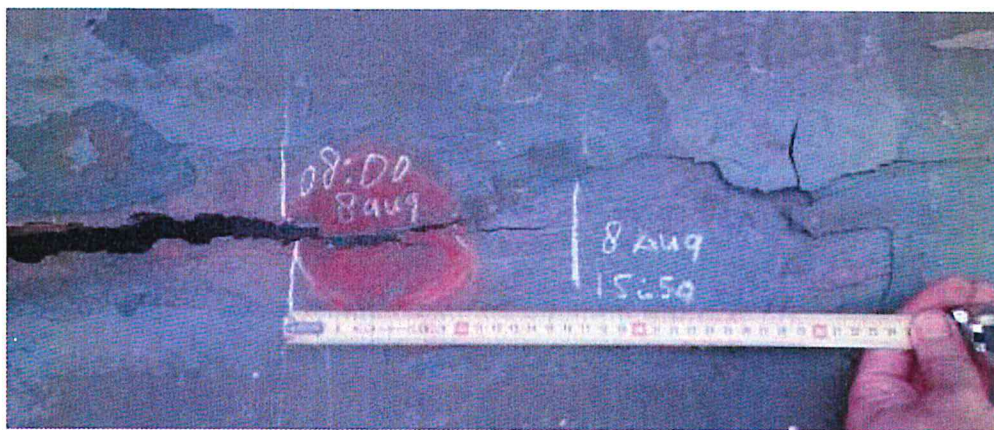
*Figure 15, SB crack spreading on main deck.*

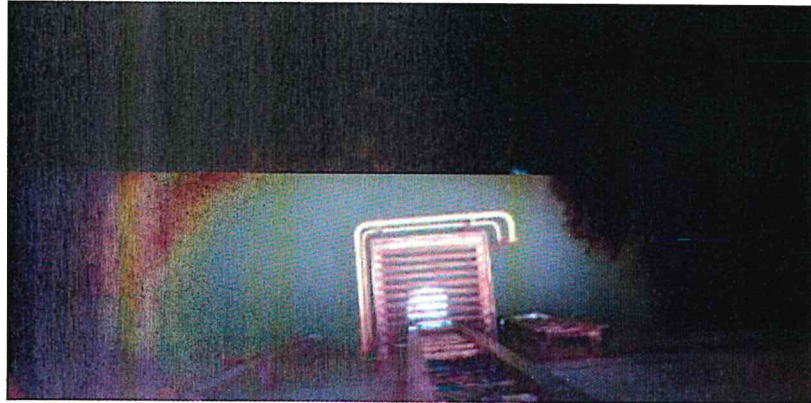
As the crack on SB frame 40-46 was propagated through both FOT1(S) and CH9, it caused these two compartments to be common, the picture below from CH9 shows an oil sheen on the water inside CH9. The oil is blown away from the access hatch due to the air being pushed in and out of the hold by the swells was continued into the hold.

*Figure 16, Oil in CH 9.*

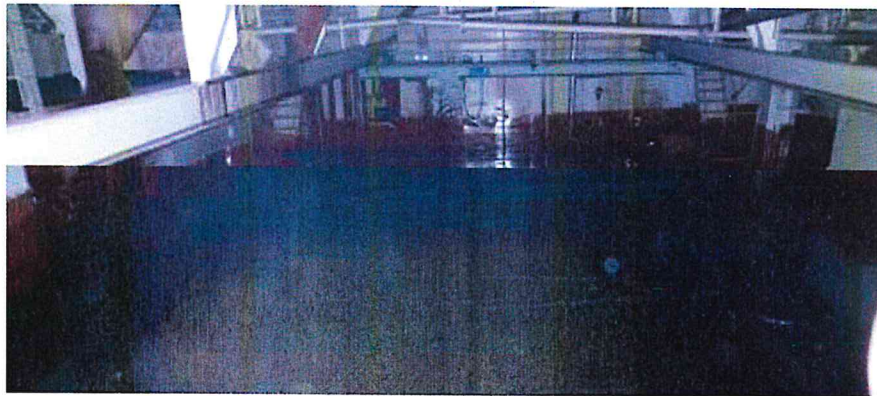
The engine room is tidal with a layer of oil of about 2cm on top of the water level. The increased oil level can be caused by rolling and pitching or due to an increased previous water level in the ER. It is unknown whether the engine room is common with any other tank.

*Figure 17, Engine room from funnel access staircase looking fwd.*

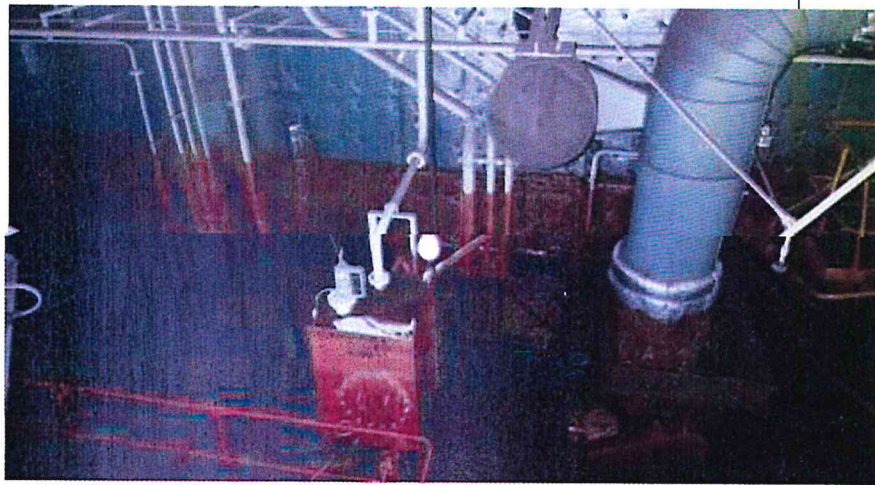
*Figure 26, Engine room from funnel access staircase looking aft.*

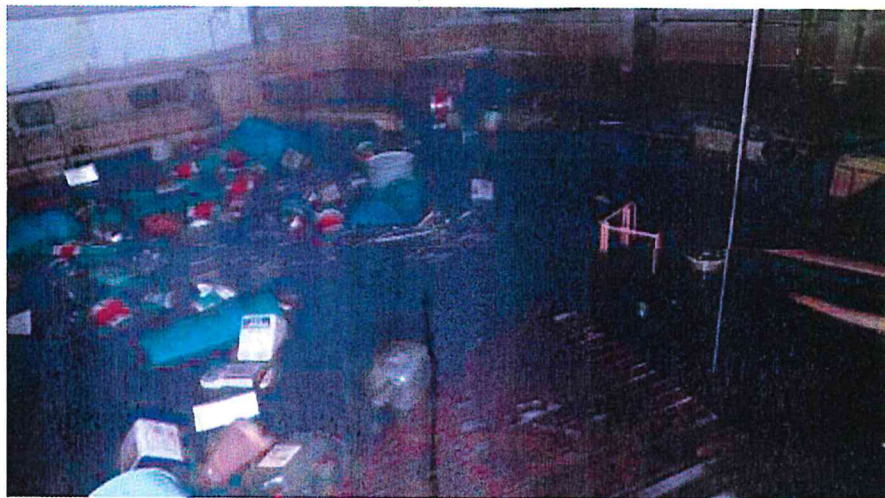
The steering gear room is also tidal with a similar layer of oil floating on the water, there is also some debris floating around in this space.

*Figure 28, Steering gear room from main deck access staircase looking aft.*

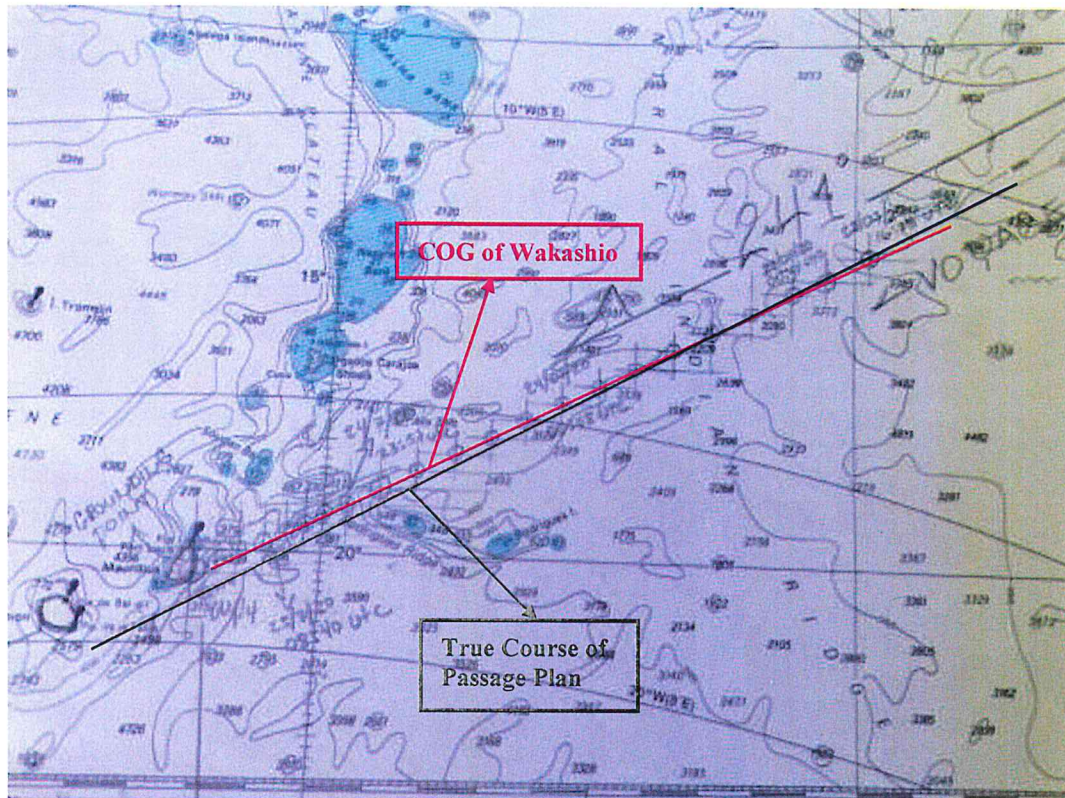
**Extract from the Navigational Chart No. 4071 (Admiralty)**

*Figure No.1 Nautical Chart plotted the True Course and Course over ground.*

- Line of True Course according to Voyage Plan
- Line of COG of MV Wakashio

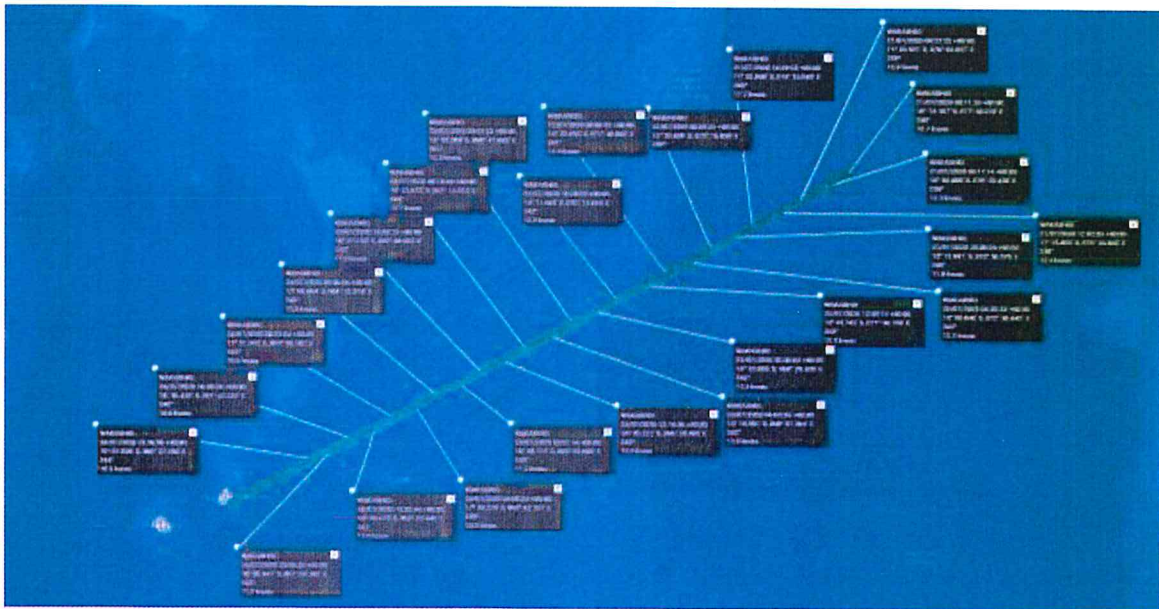
*Figure No. 2 AIS positions during the Indian ocean navigation.*

We can see in the figure the positions of the Wakashio taken by the AIS during the navigation through the Indian Ocean when it was heading towards Mauritius. In each box are the date, time, position, course and speed of the ship.

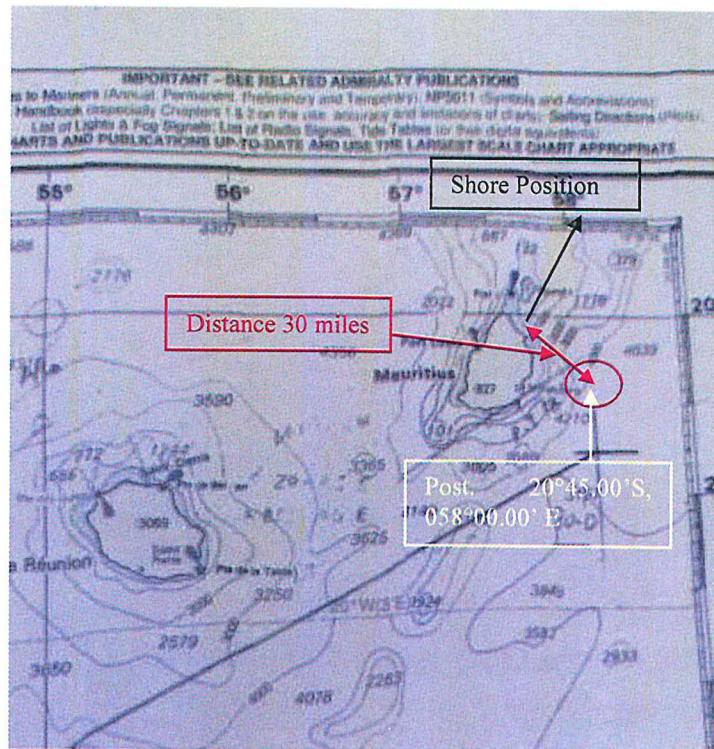
**Extract from Navigational Chart No.4700 (Admiralty)**

In the chart it can be observed that the distance between the Way Point of the Voyage Plan and the southern coast of Mauritius was 30 miles difference, which was well away from the coast, according to the Captain's orders the ship would pass within 5 miles of the South coast of Mauritius Island.

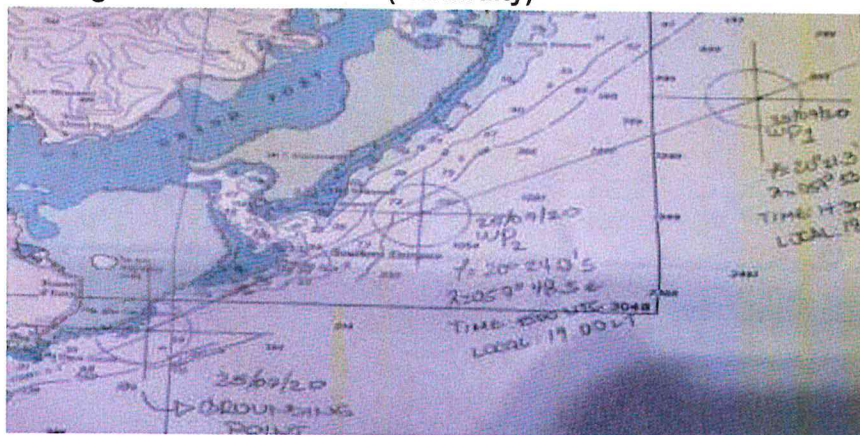
**Extract from Navigational Chart No.711 (Admiralty)**

*Figure No.3 Position of Grounding*

During the July 25 navigation, the OOW was aware that it had to pass 5 miles from the south of the island, if it can be observed in figure No. XX we see that if the ship had passed 5 miles the depth would be 200 meters, which would have followed their course.

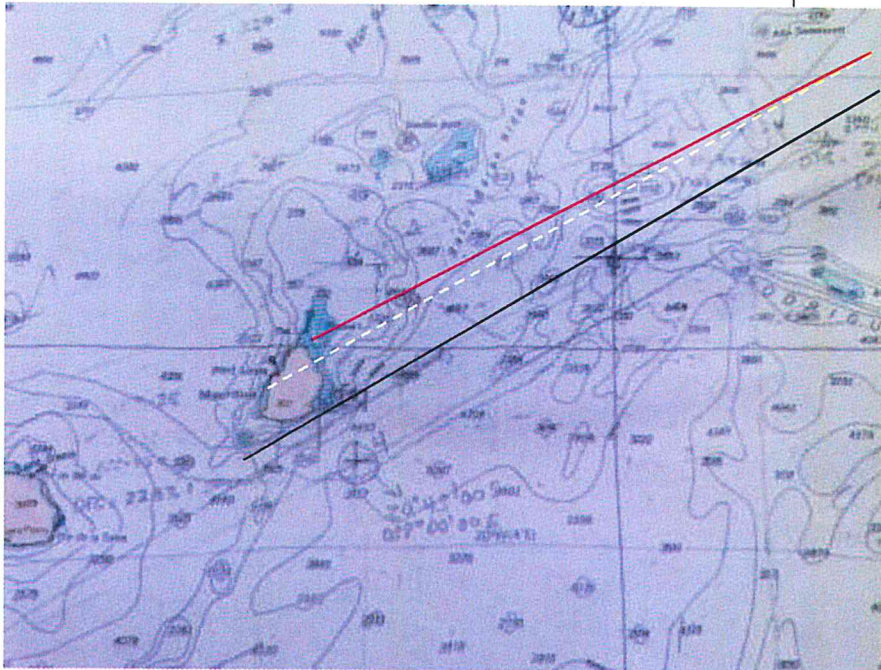
**Extract from Navigational Chart No. 4702 (Admiralty)**

Figure No.4 approaching to Mauritius Island and Way Point No. 23 of Passage Plan

During the navigation from July 23 at 0001, the change of course began to be noticed, however, there was a route traced to pass 5 miles south of the coast of Mauritius, it is not known exactly whom of the officers drew it, however the Captain's orders were followed.
