MIR-23-14

Collision between US Coast Guard Cutter *Winslow Griesser* and Center-console Boat *Desakata*

Near Dorado, Puerto Rico

August 8, 2022

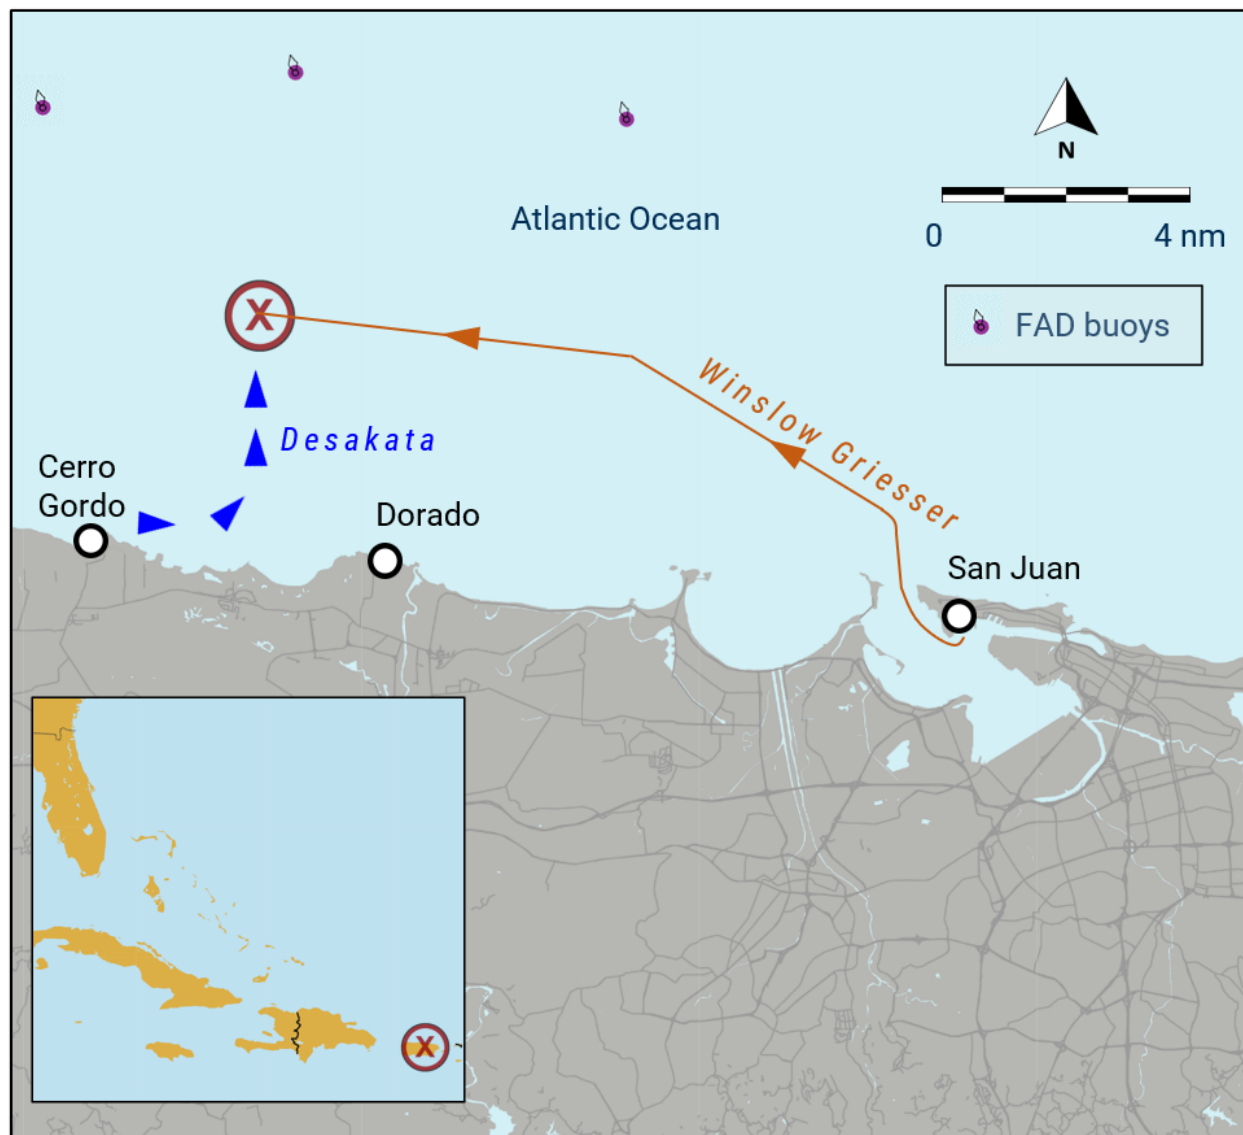
After departing Cerro Gordo, following the coast, then turning north, the *Desakata* slowly proceeded north while trolling for fish with four lines in the water. The owner operated the *Desakata* from the center console as the boat headed toward a FAD buoy, making about 5 knots with the seas on the starboard beam. The coastal weather forecast issued at 1106 called for 15- to 20-knot easterly winds and 4- to 6-foot seas with occasional 8-foot seas. Figure 3 shows the vessels' tracks.

Figure 3. Area where the *Winslow Griesser* and *Desakata* collided, as indicated by a red X. The *Desakata*'s trackline is approximate. (Background source: Google Maps)

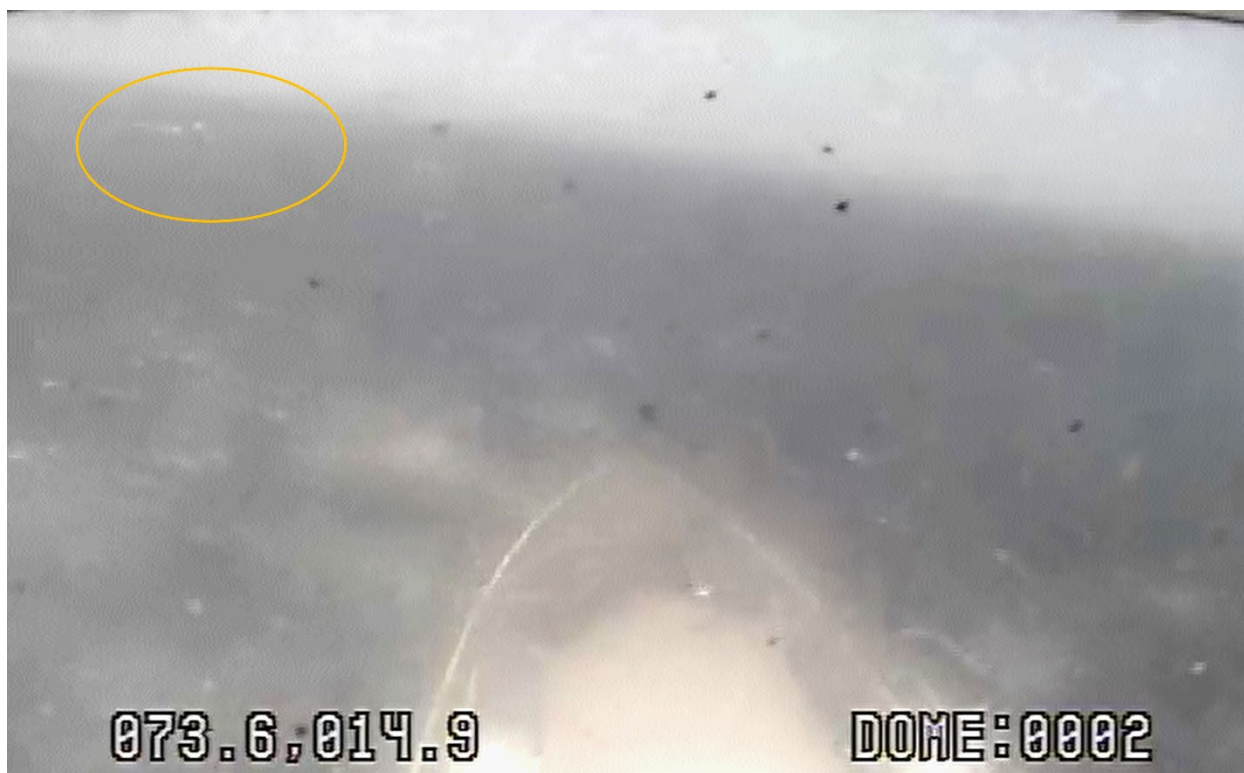
The *Winslow Griesser* was outfitted with at least 16 closed-circuit television (CCTV) cameras. A forward-looking camera high on the *Winslow Griesser's* mast above the bridge first captured the *Desakata* about 19 seconds before the collision, crossing from port to starboard at a near right angle roughly 10° off the bow (see Figure 4). The camera footage, which was not clear because of a salt-crusted lens, appeared to show the *Desakata* disappearing and reappearing in the waves a few times. Camera footage also showed the *Winslow Griesser* yawing to port and starboard in following seas.

Figure 4. The *Desakata* as recorded from the *Winslow Griesser's* salt-encrusted mast camera at 1416:53, 19 seconds before the collision. (Source: Coast Guard)

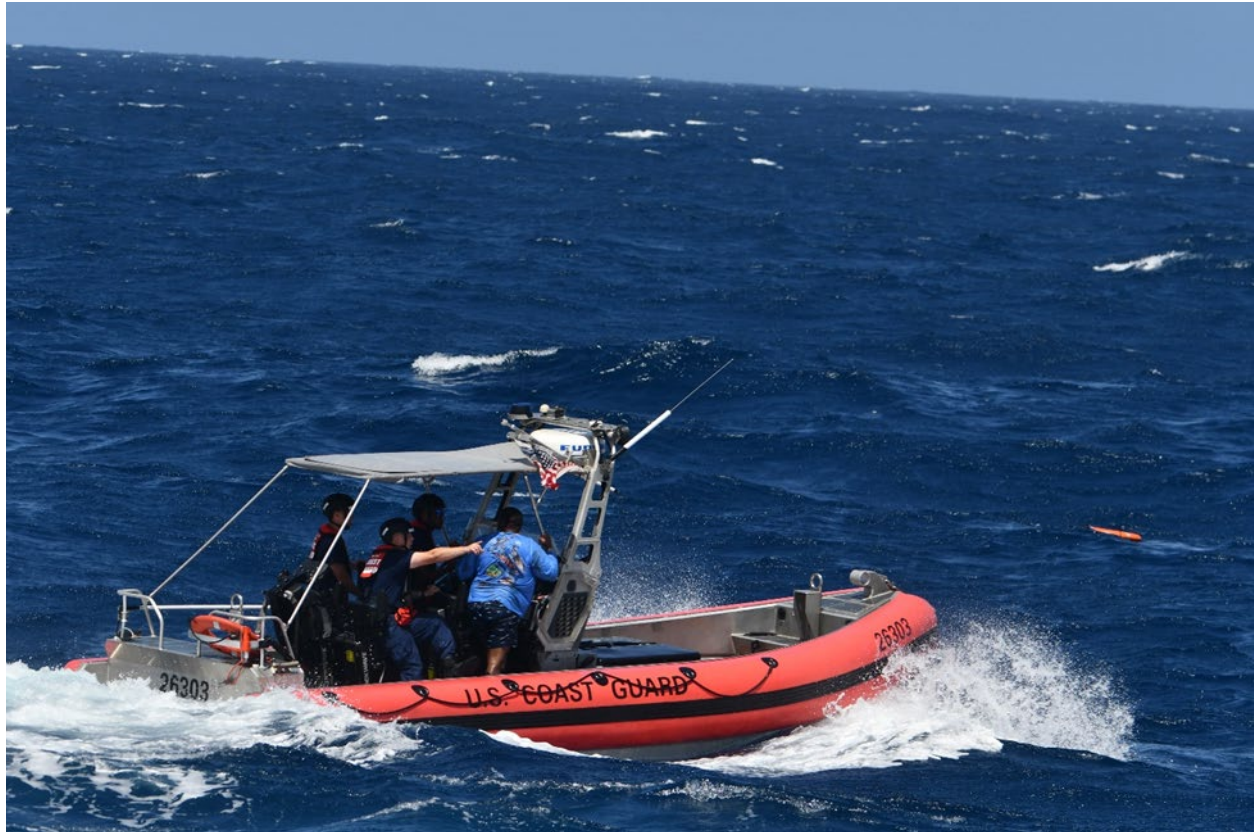
The *Winslow Griesser* crew logged the on-scene weather at 1500 as scattered clouds, 16-knot winds from 073°, visibility 9 miles, 85°F air temperature, and 80°F water temperature. There were 2-foot seas and 4-foot swells (combined seas of 6 feet) (see Figure 9).

Figure 9. The seas immediately following the collision, with *Winslow Griesser's* small boat in view. (Source: Coast Guard)
