**The Bahamas**  
Maritime Authority

# Marine Safety Investigation Report

into a mooring fatality onboard Aruba Pearl  
on 26 October 2022

Date of Issue: 21 September 2023  
Bahamas Maritime Authority  
120 Old Broad Street  
LONDON  
EC2N 1AR  
United Kingdom

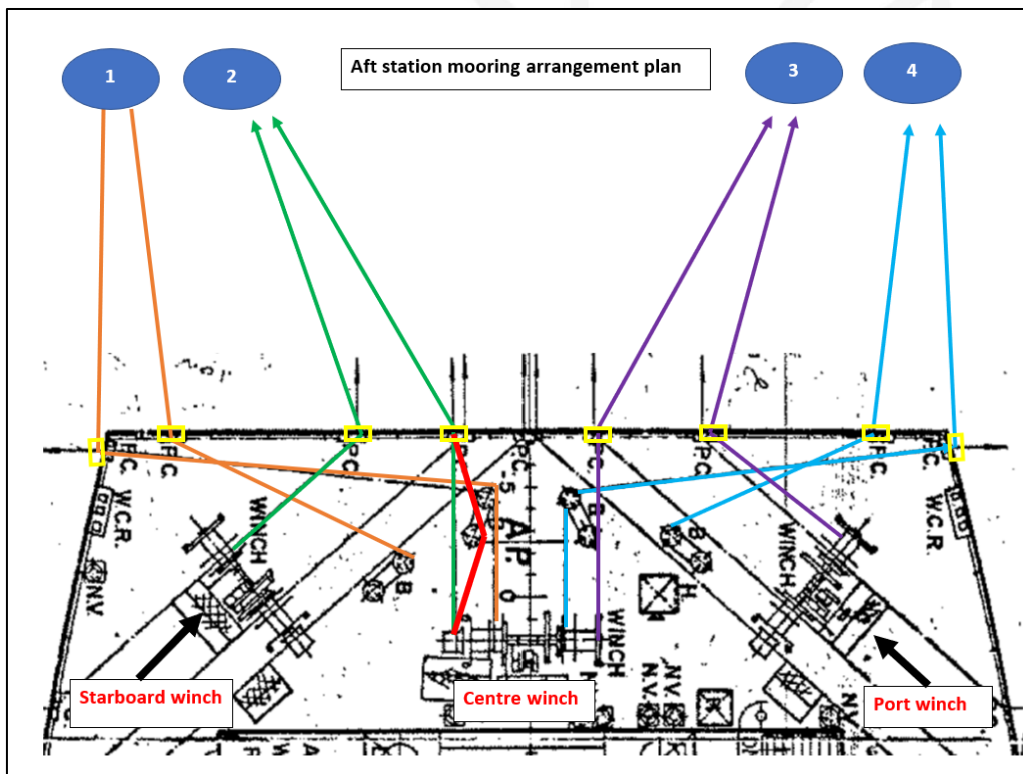
Figure 2. Mooring arrangement plan - aft (depicting incorrect lay of line in red)

The mooring line that was being guided onto the winch drum had been placed on the wrong side of the bitt in preparation for applying the stopper. Once tension was applied and increased it sprung free and struck the AB who was standing in close proximity to the bitt.

Never tension mooring lines with an upward lead around bitts so that it is retained by the flange - the likelihood of it slipping up and off is incredibly high.

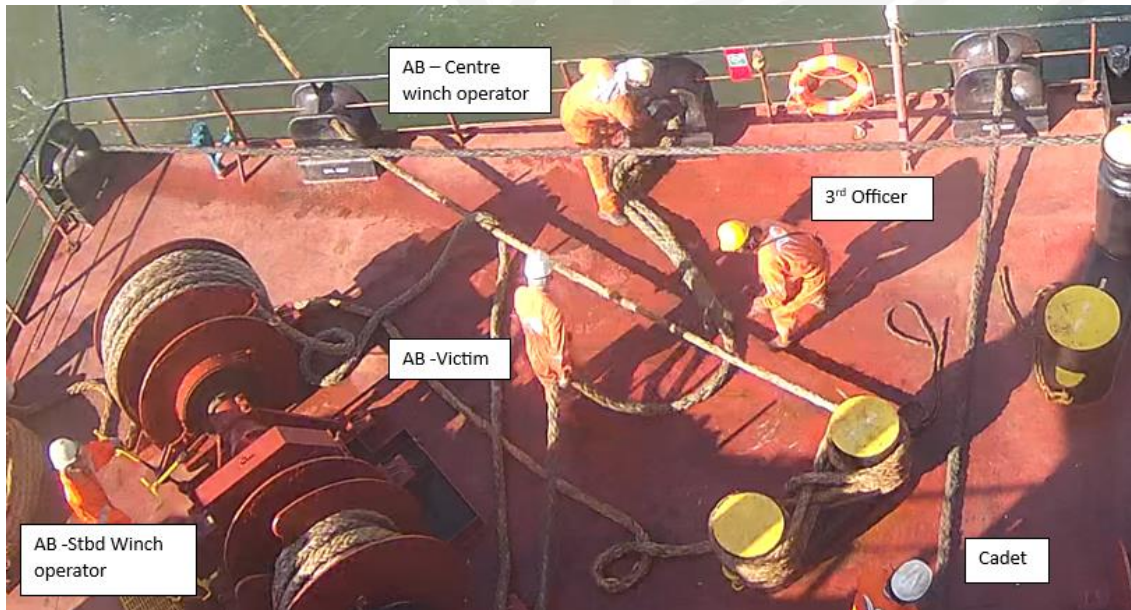
**Figure 3. Mooring deck – crew positions during untangling of line**

Whilst mooring was underway, the master accompanied by the berthing pilot observed that two of the lines aft which were due to be sent out were not in sequence and had become tangled. The master halted operations aft until such time that the lines were corrected. The third officer who was new to the role, but experienced onboard was instructed by the master to correct the setup and untangle the lines prior to hauling up on the winch (Figure 3).

Conscious of time and the imminent crew change, the third officer, departed from his role as mooring party leader and set about physically helping the crew untangle, pay out and secure the lines.

Whilst the lines were being untangled, the third officer moved the third line clear from where work was taking place and positioned it over a bitt before continuing to assist the others in correcting the lines.

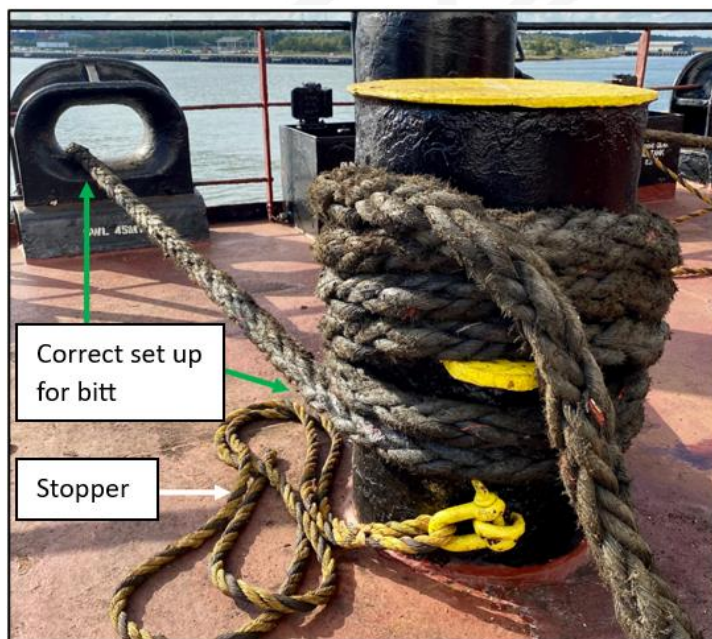
Figure 4. Stoppers -Aft (image courtesy of United States Coast Guard)

In overlapping, bypassing and running lines out at acute angles to the winch carries a greater risk, including securing of lines to only one end of a double bitt bollard. In order to achieve this, stoppers were required to take the strain whilst the line was transferred to the bitt (Figure 4).

Stopping off a line entails risk. High loads in the lines must be avoided since the stoppers have less strength than the mooring line. Furthermore stoppers need to be applied leading away from the winch in the direction of the buoy. The AB attempted to fasten the stopper in the direction of the winch and not leading away as would be required, distracted from the task at hand.

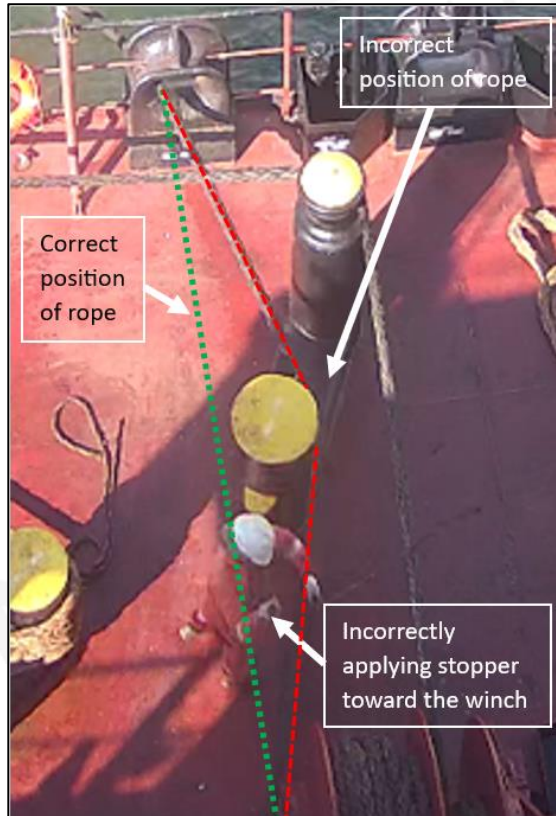
**Figure 5. Stopping off the line**

The properties of man-made fibre ropes such as polypropylene mean that they can extend up to one third their original length when tension is applied. Once the maximum permissible tension is applied the rope will recoil back to its static position once freed from its fouled position with the force equivalent to over 250 Newtons (1 Newton = 1 kg • m/s<sup>2</sup>- /Newtons 2<sup>nd</sup> Law) (figure 5).

Although the AB had carried out mooring on MBM arrangements several times before, his decision to place the mooring line on the opposite side of the bitt, and tie off the stopper leading towards the winch and not the chock (Figure 5), was most likely due to distraction.
