Marine Investigation Report MIR-23-22

Engine Room Fire Aboard Passenger Vessel *Spirit of Norfolk*

Elizabeth River
Norfolk, Virginia
June 7, 2022

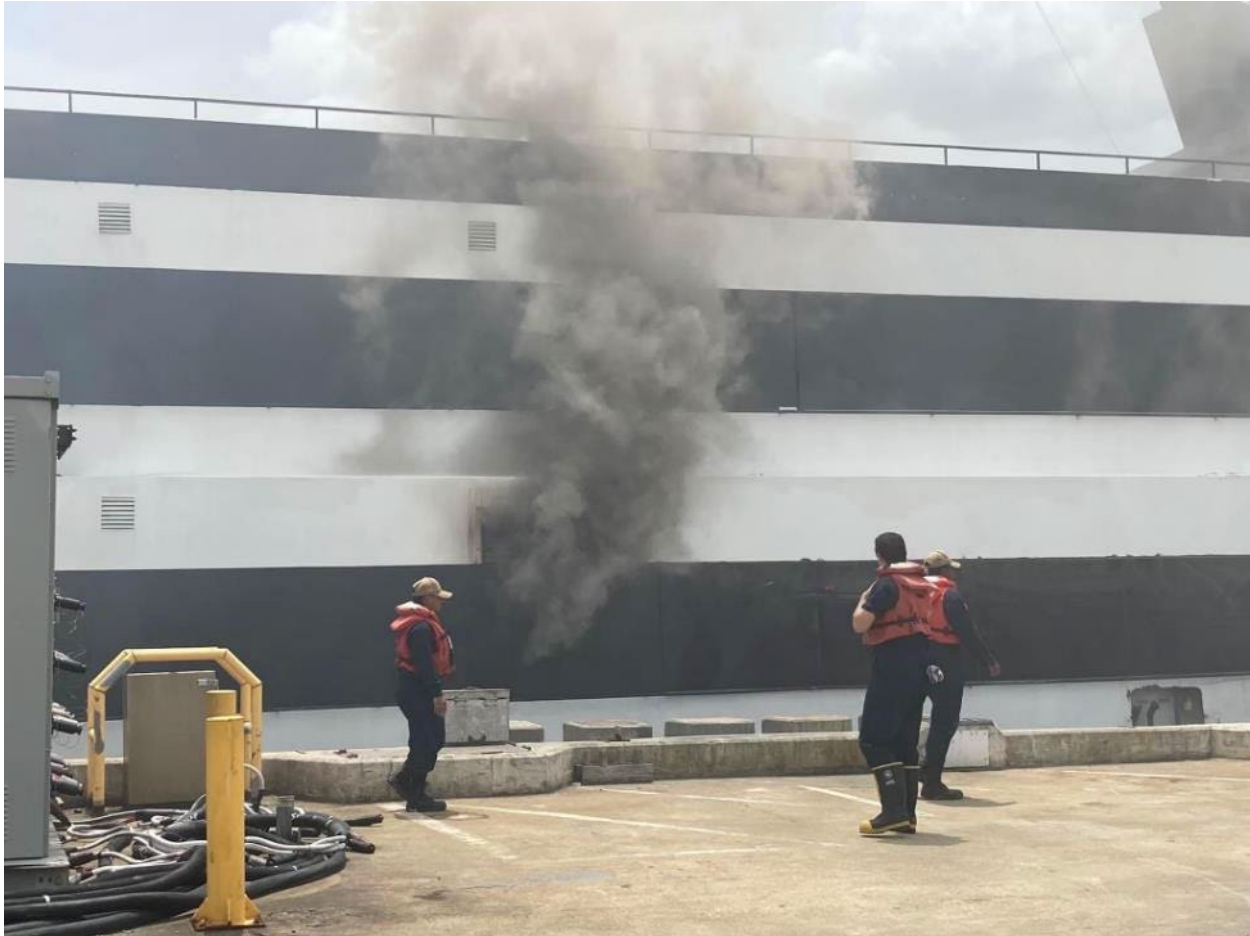
During the casualty, air continued to enter the engine room, and fire and smoke continued to exit the engine room from both the port and starboard exterior exhaust hull ventilation openings after the captain secured the air supply fan (see Figure 8).

Figure 8. Smoke from the engine room starboard exhaust ventilation opening. (Source: Coast Guard)

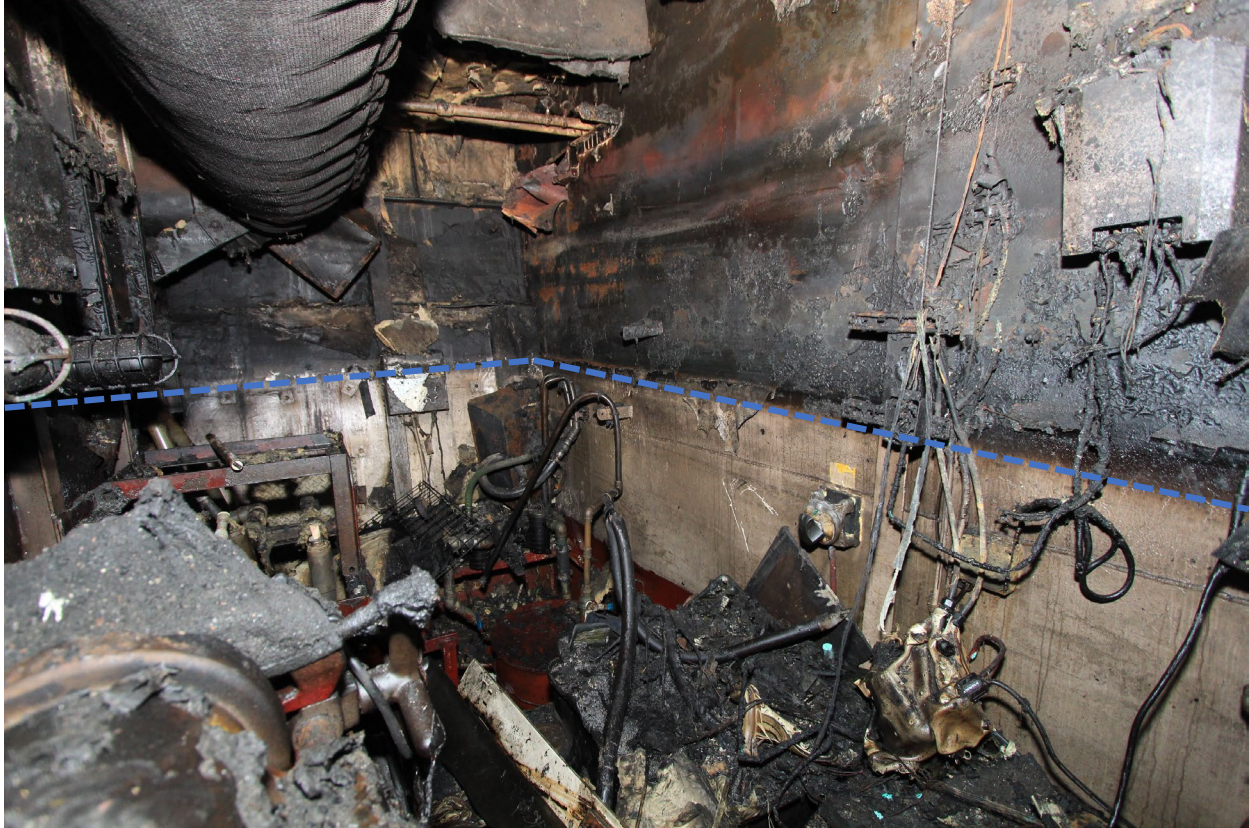
Fire damage was observed throughout the engine room compartment, with the most severe damage concentrated at ceiling height where structural members were deformed and, in some instances, fractured due to thermal expansion. The overhead thermal damage was mostly uniform throughout the engine room. The thermal damage to the engine room exhibited a gradient of thermal damage from the overhead toward the deck, with the most severe damage overhead. The gradient of thermal damage also exhibited a sharp line of demarcation below which the thermal damage abruptly stopped (see Figure 9).

Figure 9. Portside engine room bulkhead exhibiting demarcation line (*dashed blue*) between thermally damaged and undamaged area.

The NTSB assessed the damage in the engine room and identified a line of demarcation, consistent with a water line resulting from the firefighting efforts introducing water into the engine room. Any thermal damage found below the line of demarcation would indicate damage that occurred early in the event. The area outboard of the port main engine exhibited fire damage below the overall line of demarcation extending down to the deck, indicating this damage occurred before firefighting efforts began. The NTSB also observed similar low-lying fire damage on the bulkhead forward of the port main engine—near where the throttle controller for both main engines was located. A photograph taken on June 22, 2022, showed metal shelves attached to the hull outboard of the port main engine. Fire completely consumed these shelves from the overhead down to the deck; thus, this area had also been on fire before the firefighting response.

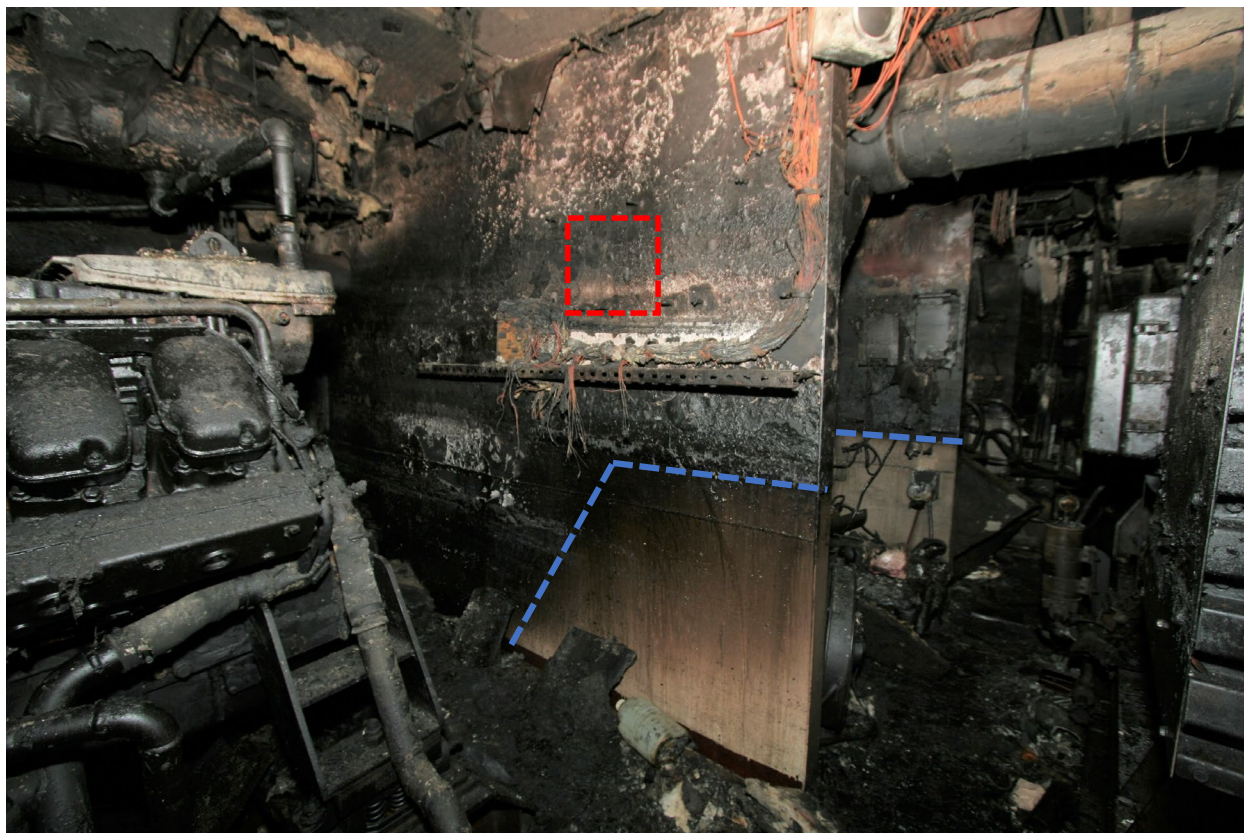
The electronic throttle controller, mounted to the bulkhead forward of the port main engine, was destroyed (see Figure 10). (The port engine's drop to 0 rpm and the throttle controller alarm was the new-hire captain's first indication there was a problem in the engine room.)

Figure 10. Bulkhead forward of port main engine with low-lying damage towards the outboard side. Demarcation line (*dashed blue*) and original location of electronic throttle controller (*red*) shown.

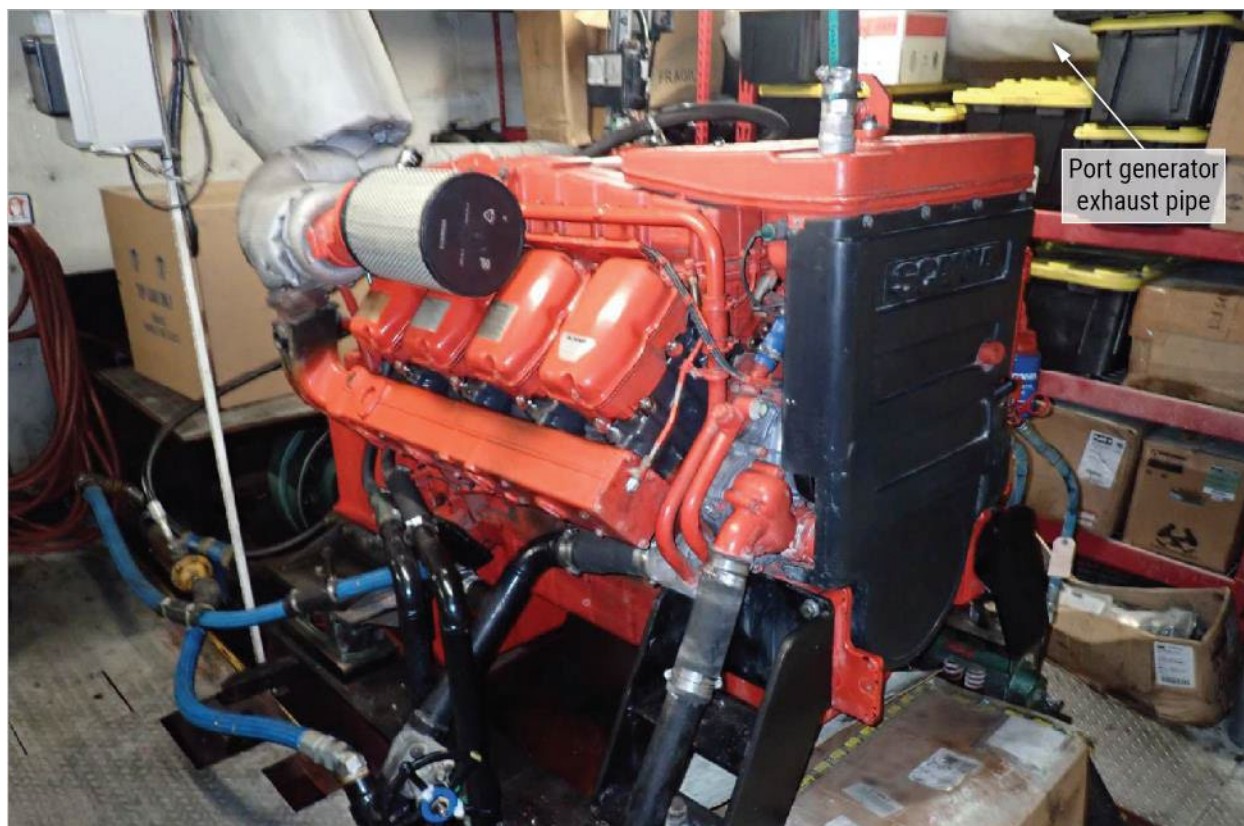
The hull outboard of the port main engine had metal storage shelves. A photograph from a marine survey on June 2, 2022, showed numerous cardboard boxes and plastic totes (see Figure 11). The captain told investigators that they've "always" had shelves there and "always" kept spare items on those shelves, including plumbing parts, filters, air filters, HVAC pumps, and a starter for one of the generators. The photo from the marine survey also showed that the insulated exhaust pipe from the port generator was routed through the top shelf of the storage rack and next to the materials on the shelf.

Figure 11. Photo from survey on June 2, 2022, showing port main engine (*foreground*) and storage shelf. The white port generator exhaust pipe is visible behind some of the boxes on the shelves. (Source: Knox Marine Surveyors & Consultants)

Because the damage assessment indicated the fire likely started outboard of the port main engine, the NTSB focused on the shelves attached to the port hull in this area. The photograph from the June 2022 marine survey showed the presence of combustible items, including cardboard boxes and plastic tubs, stored on the shelves. The captain told investigators that they “always” kept spare items on those shelves, including plumbing parts, filters, air filters, HVAC pumps, and a starter for one of the generators, so it is likely those items were still present at the time of the fire. Further, the insulated exhaust pipe from the port generator was routed through the top shelf of the storage rack and next to the materials on the shelf.

Although the survey photograph showed the pipe was insulated, the fire damage precluded an assessment of the pre-fire condition of the insulation. The insulation may have shifted or been damaged, and any gaps, discontinuities, or other conditions could have allowed heat transfer from the exhaust to the adjacent combustible materials, which could have then ignited. Therefore, the NTSB concludes that although a definitive ignition source cannot be determined, the most likely cause of the fire was the ignition of combustible materials stored near the exhaust pipe of the operating port generator.

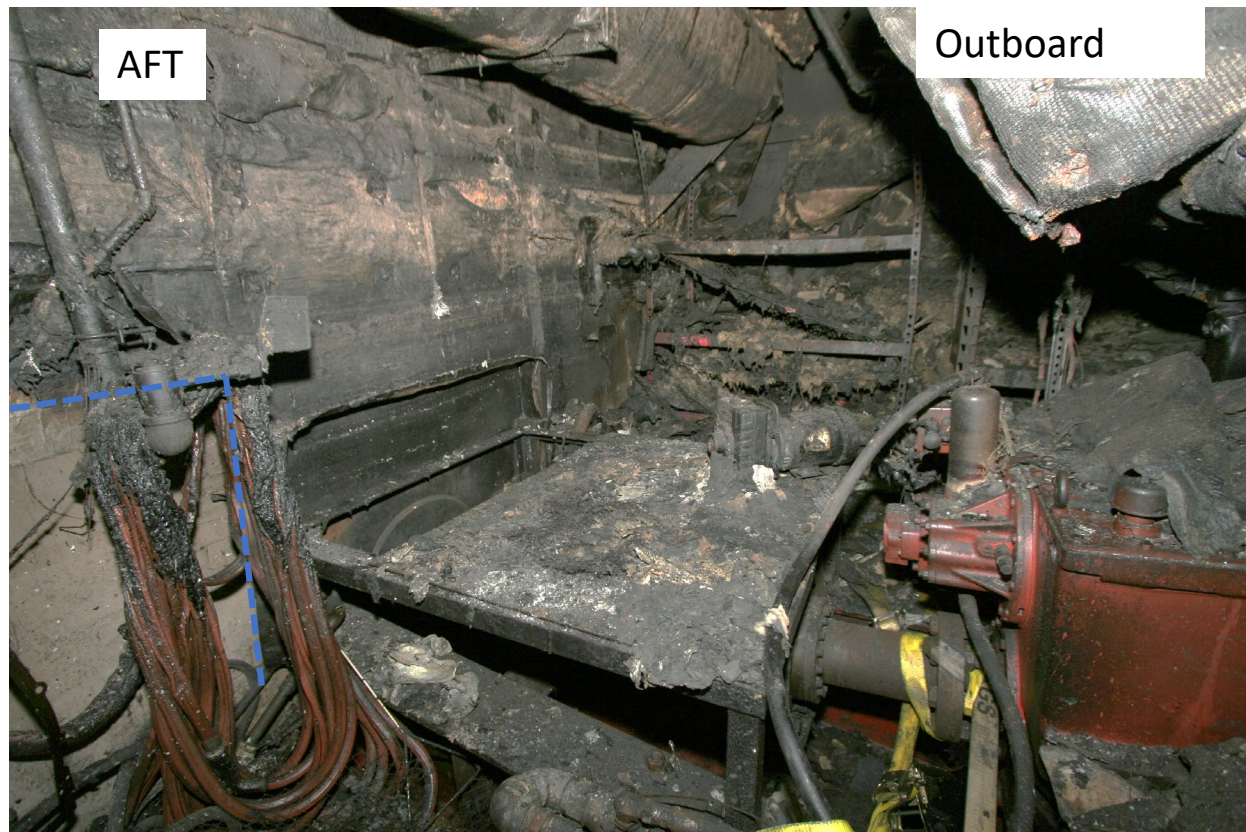
The area outboard of the port main engine exhibited fire damage from the overhead level down to the deck; the shelf contents in the area were completely consumed by the fire (see Figure 12).

Figure 12. Fire damage on the bulkhead aft and outboard of port main engine. The metal frames of the storage shelves are visible against the bulkhead.

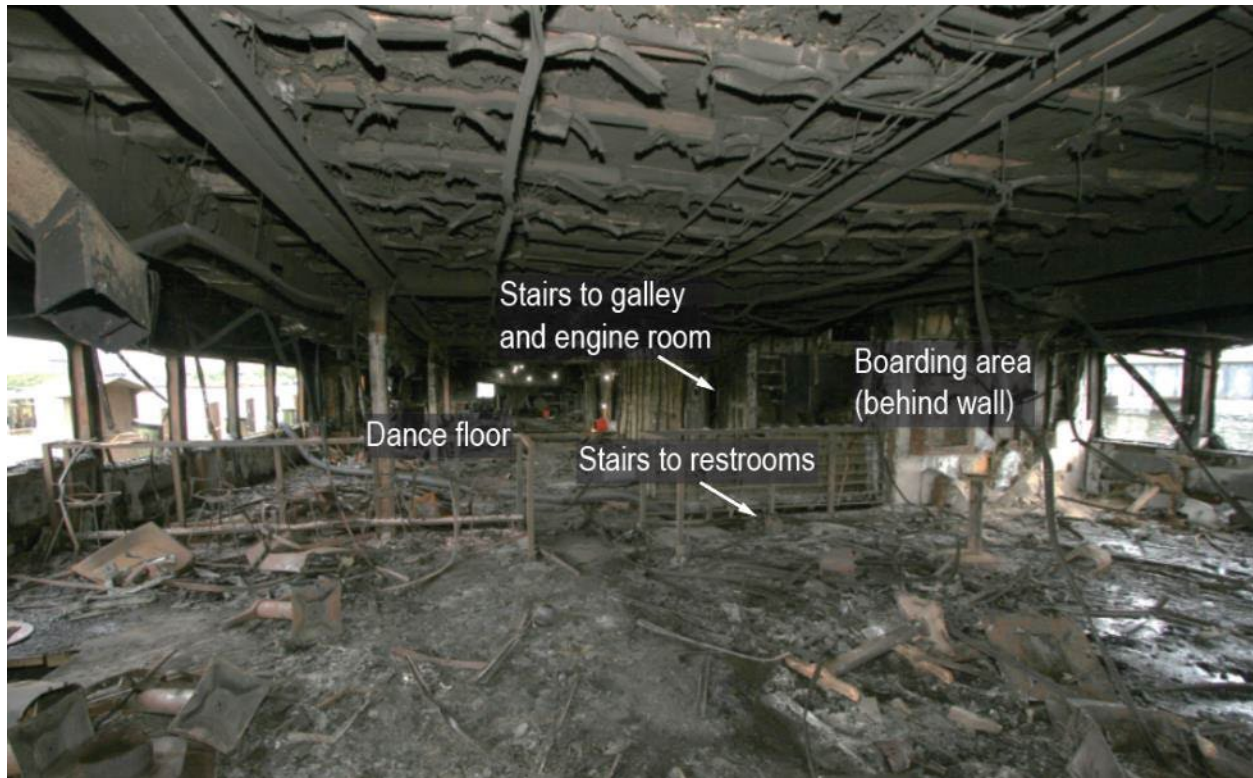
The interior of the main and second decks, and interior stairwells were completely consumed by the fire (see Figure 14, Figure 15). Exterior areas on the stern of the main deck were not fire damaged but did exhibit some sooting. The pilothouse was completely consumed by fire. Below deck, the engine room and galley sustained extensive fire damage.

Figure 14. Main deck interior looking aft.

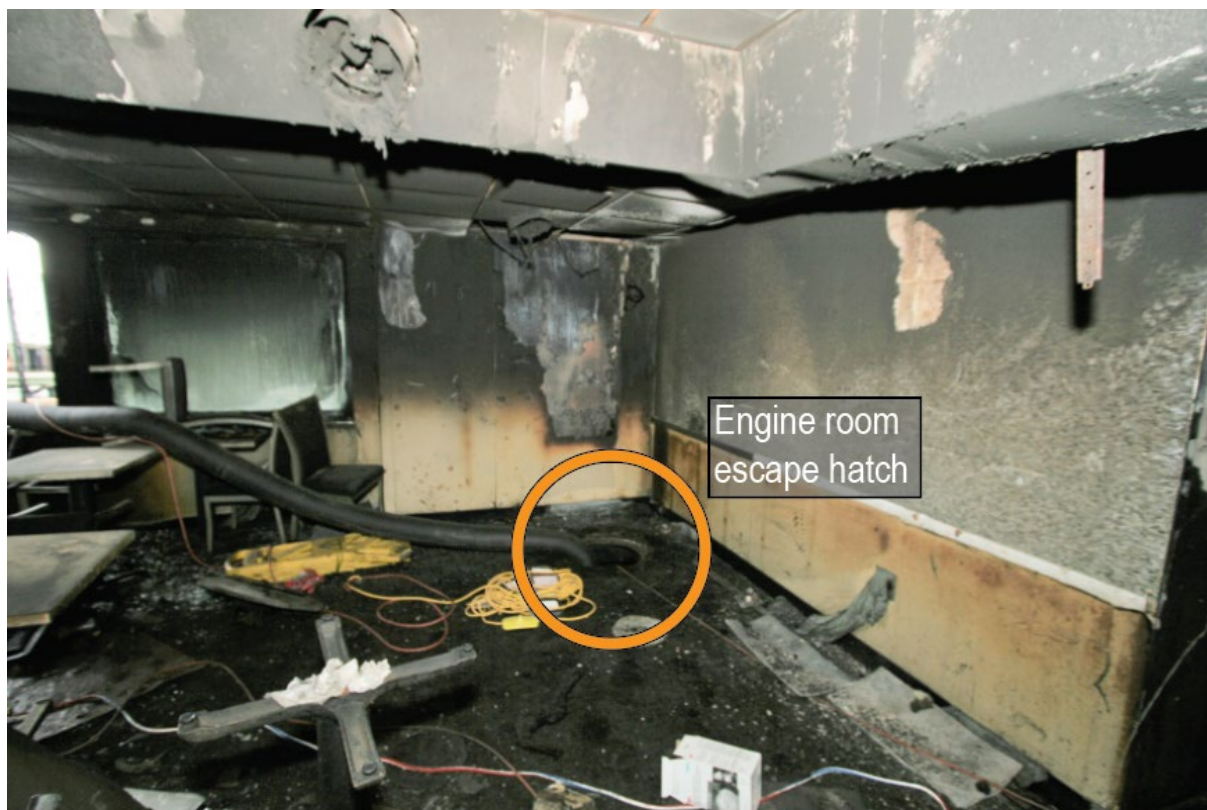
Figure 15. Photo of the engine room escape hatch on the main deck after the fire.
