NATIONAL TRANSPORTATION SAFETY BOARD

2022

# SAFER SEAS Digest

Lessons Learned from  
Marine Investigations

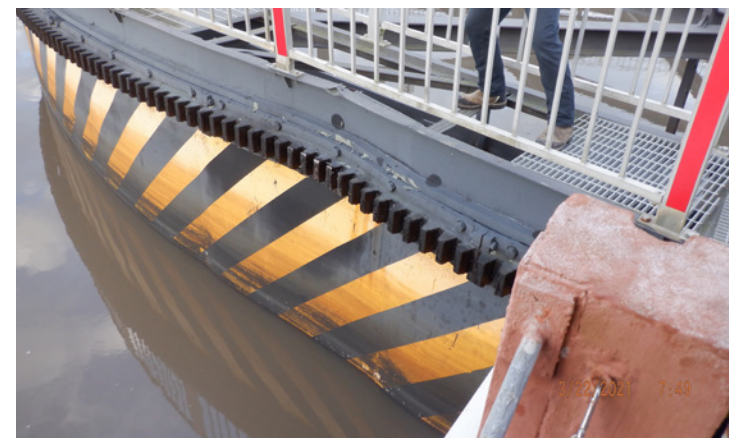
**THE PROBABLE CAUSE** of the contact of the *Ava Claire* tow with the Leland Bowman Lock gate was the towing vessel captain's decision to assume the helm watch and attempt a predawn transit into the lock immediately after awakening while he was likely impaired by sleep inertia.

**Figure 38.** Below: Damaged steel plating and rack on gate.

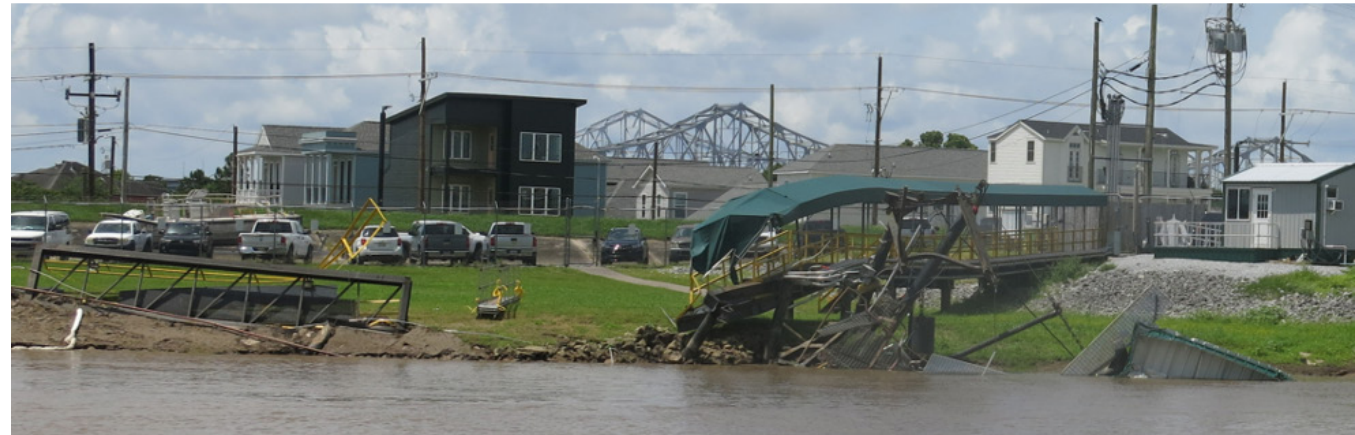
**Figure 45.** Postcasualty damage to office barge moorings, catwalks, and gangways.

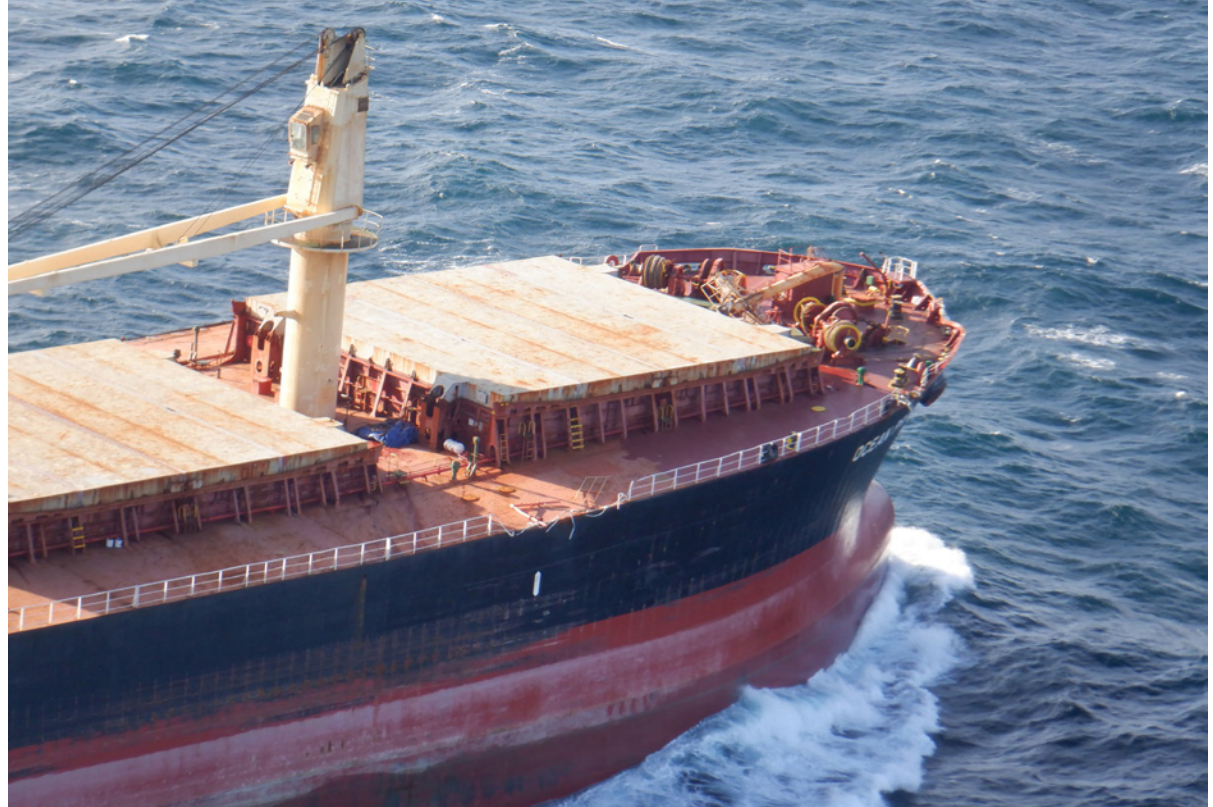
**Figure 54.** Knocked down mast and damaged bulwark, anchor windlass, and handrails on the *Ocean Princess* following the casualty. SOURCE: BUREAU OF SAFETY AND ENVIRONMENTAL ENFORCEMENT

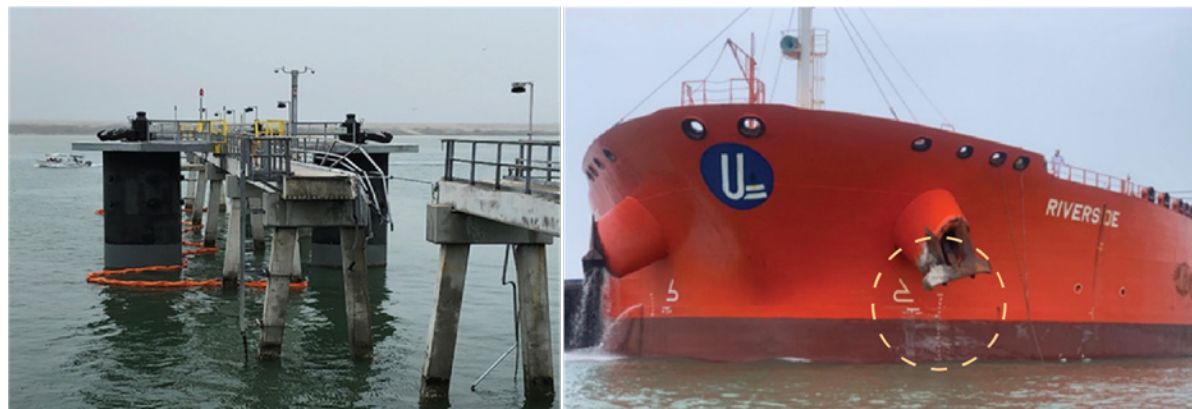
**Figure 58.** Damage to the no. 4 Moda dock catwalk (left) and the *Riverside* (right, circled). SOURCE: COAST GUARD

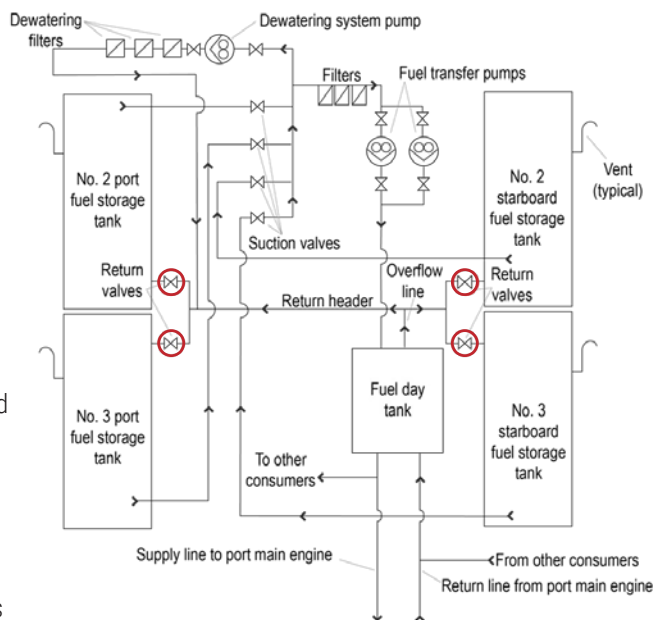
**Figure 84.** Fuel piping diagram for the *Mary Lynn*. Fuel return valves, circled in red, were inadvertently left closed when a fuel transfer pump was started and the no. 3 starboard suction valve was opened.

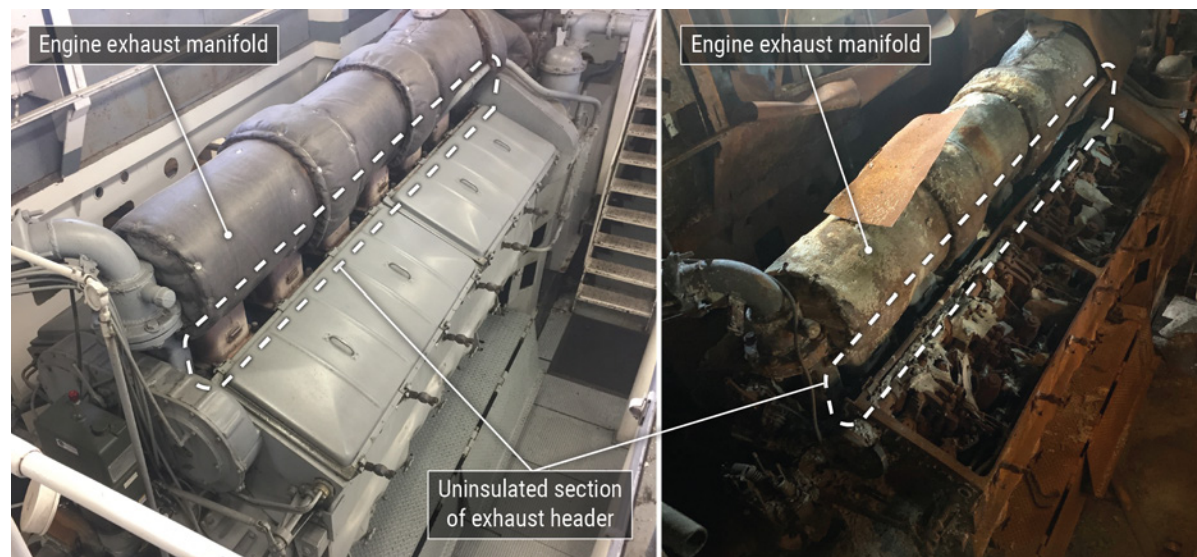
**THE PROBABLE CAUSE** of the engine room fire aboard the towing vessel *Miss Dorothy* was the ignition of spraying diesel fuel from a main engine's fuel system onto an uninsulated section of the engine's exhaust system. Contributing to the severity of the fire and damage to the vessel was the inability to effectively secure ventilation to the space and fuel to the affected engine.

**Figure 91.** Starboard main engine before (left) and after (right) the fire, with the uninsulated section of exhaust header indicated. BACKGROUND SOURCE: WESTERN RIVERS BOAT MANAGEMENT INC.

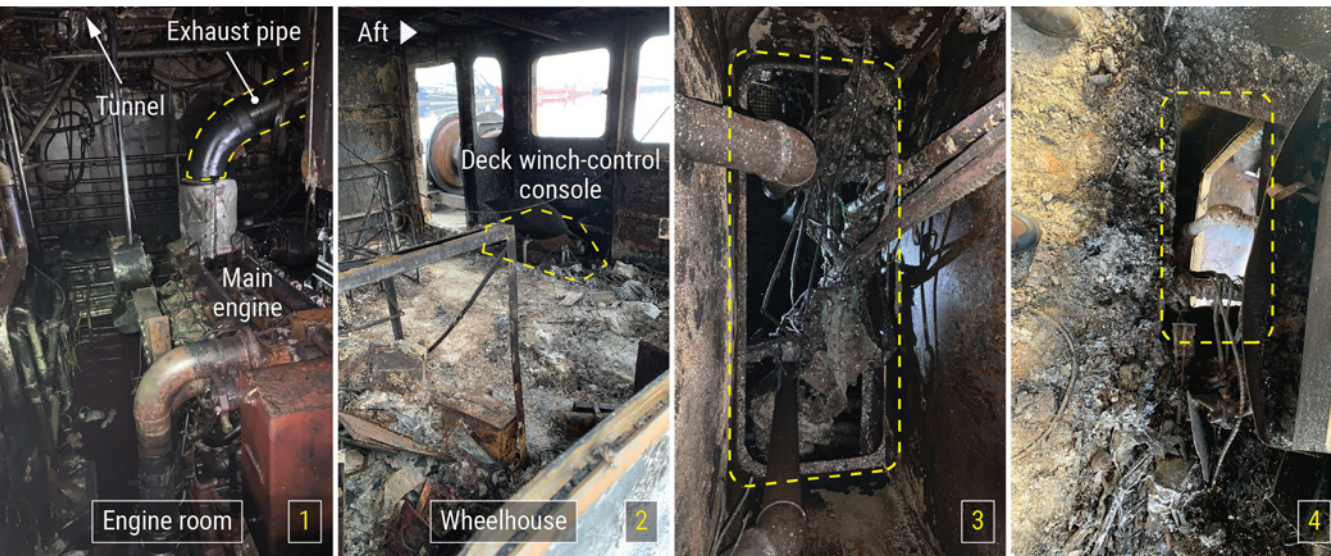
**Figure 94.** Left to right: Post-fire damage of (1) the engine room, where the crew removed the lagging from the exhaust pipe, as indicated by the dashed line; and (2) the wheelhouse, where the captain observed black smoke emanating from under the deck winch-control console. Damaged pipe/hose tunnel, as identified by dashed rectangles, looking up from the engine room (3), and down onto the deck winch-control console location (4).

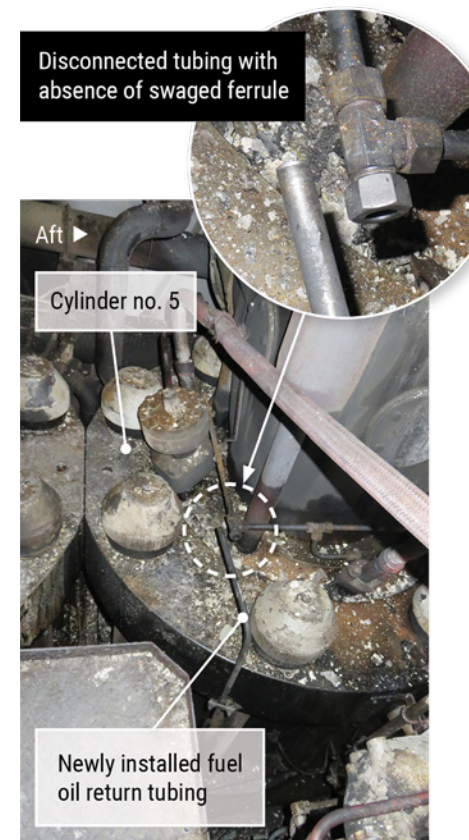
**Figure 98.** Cylinder no. 5 and the disconnected, newly installed fuel oil return tubing (inset).

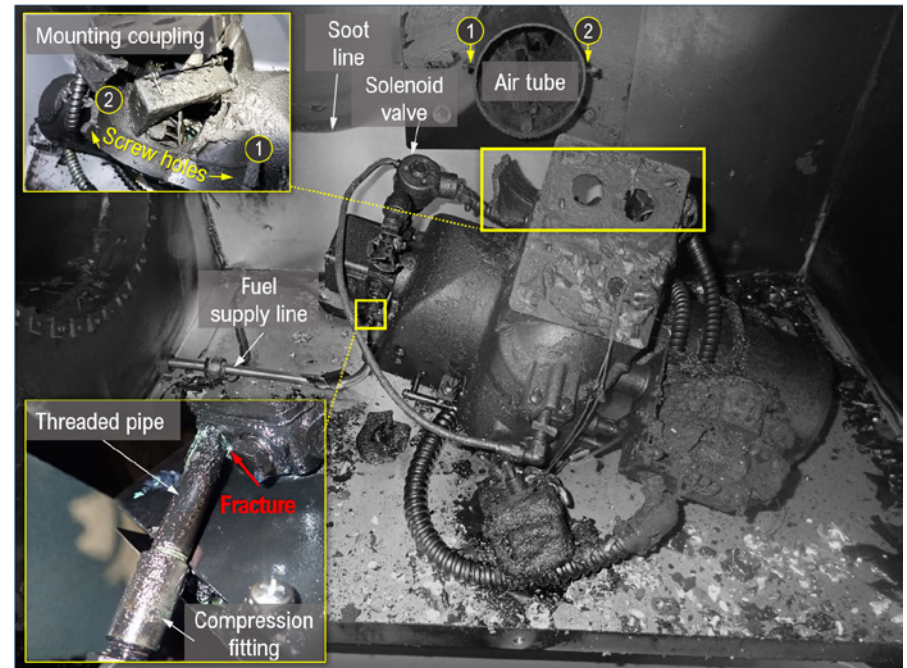
**Figure 105.** The fire-damaged burner detached from the air tube, lying on the bottom of the enclosure. Photo shows the fractured mounting coupling (top inset, interior view) and the fracture point where the fuel supply pipe threaded into the burner assembly (bottom inset). SOURCE: COAST GUARD

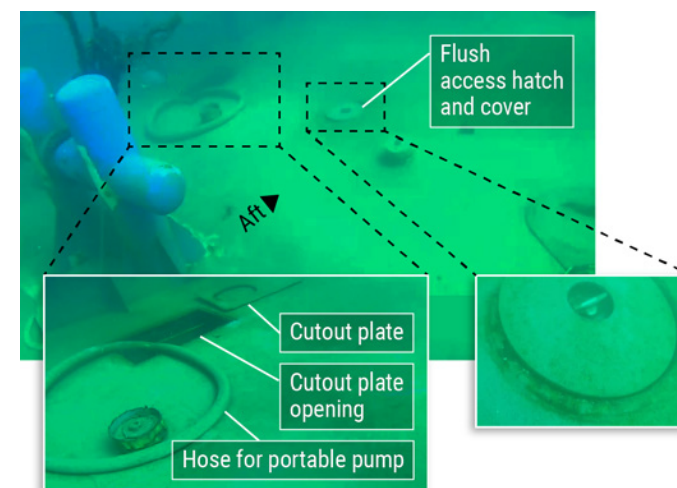
**Figure 111.** Starboard-side cutout plate with missing quick-acting flush access hatch cover (left close-up) and unseated center quick-acting flush access hatch cover to flanking rudder compartment (right close-up).

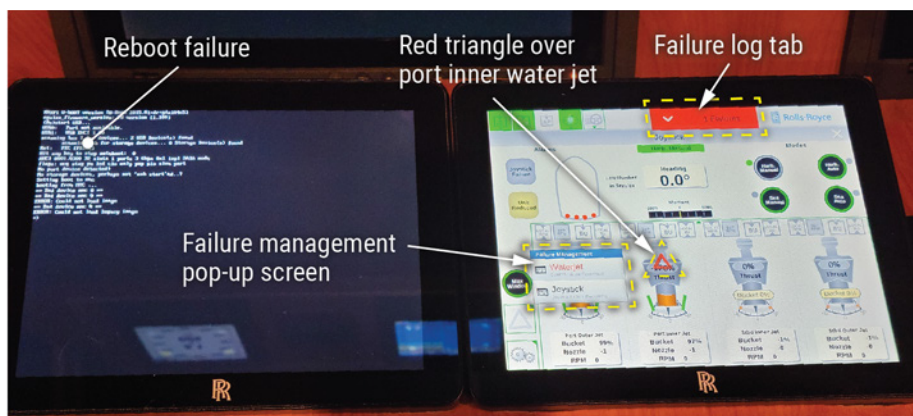
**Figure 121.** *Commodore's* main control station during postcasualty examination. Above: main A display screen's reboot failure (left) and the red failure log tab, red triangle over the port inner water jet icon, and the failure management pop-up screen on the main B display screen (right). Below: main control station's hand controls and water jet display screens.

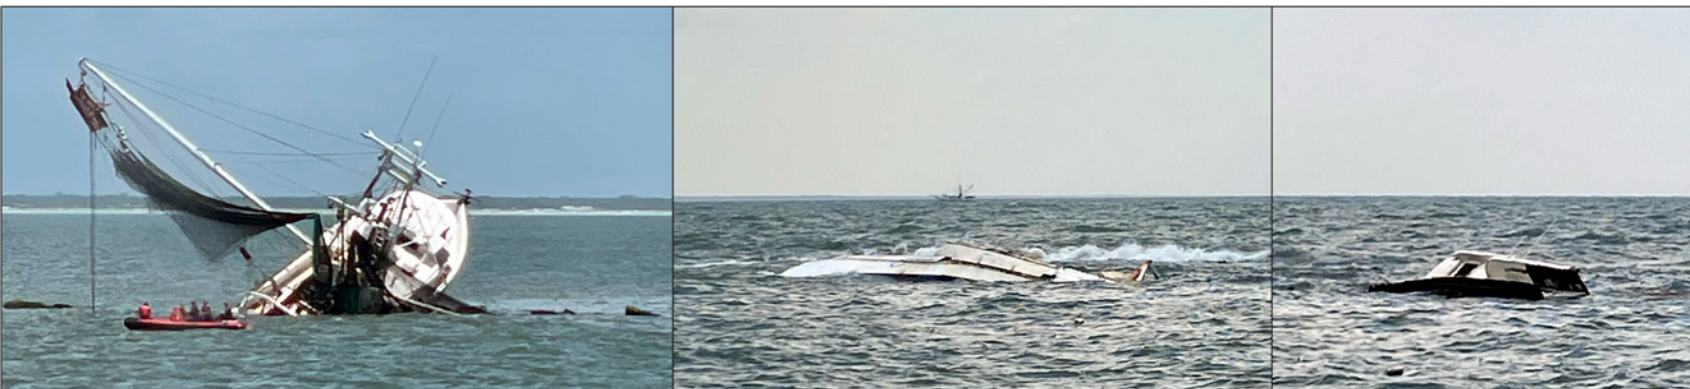
**Figure 129.** Left to right: *Sage Catherine Lane* following the grounding on the jetty, and after being broken apart on the jetty 3 days later.

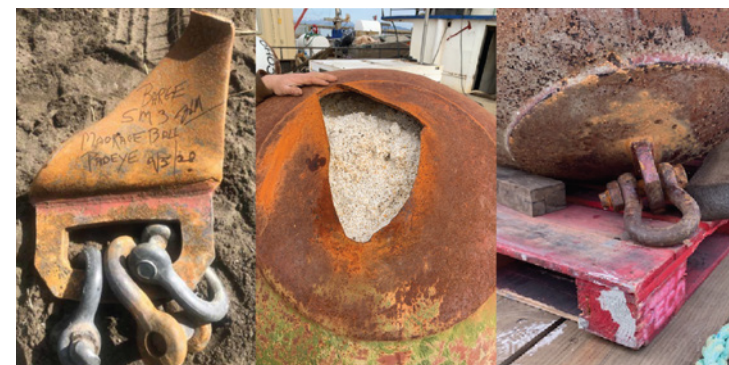
**Figure 134.** Left to right: *SM-3* mooring buoy: failed weld (with three shackles) that separated from buoy; damaged top with padeye missing; and undamaged bottom padeye. SOURCES ALASKA MARINE SURVEYORS AND NORTHLINE SEAFOODS
