Bundesstelle für Seeunfalluntersuchung
Federal Bureau of Maritime Casualty Investigation

Investigation Report 300/21

**Fire in the engine compartment with subsequent
foundering of the fishing vessel FREYJA
in Schleswig-Holstein's Wadden Sea
during the night of 17 to 18 September 2021**

15 March 2023

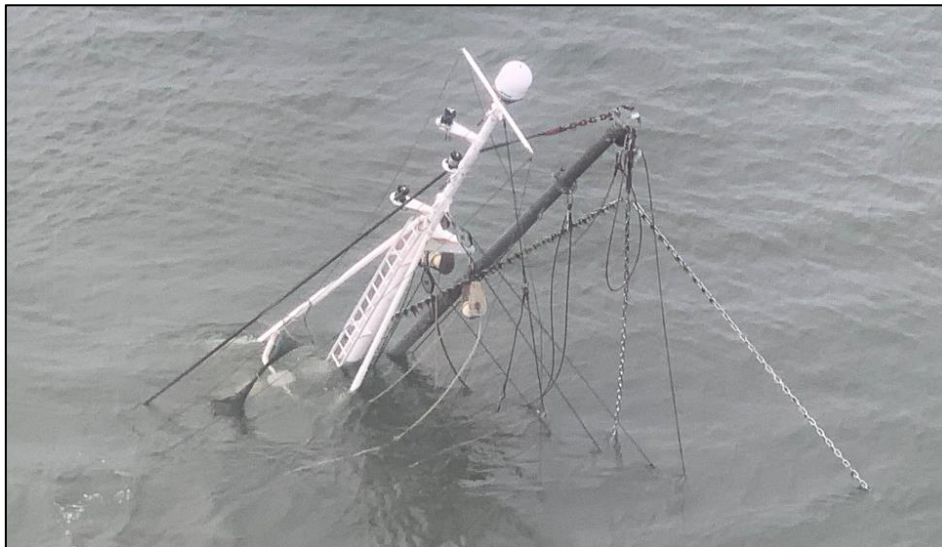
Figure 3: Mast head of the foundered fishing vessel FREYJA protruding from the water⁷

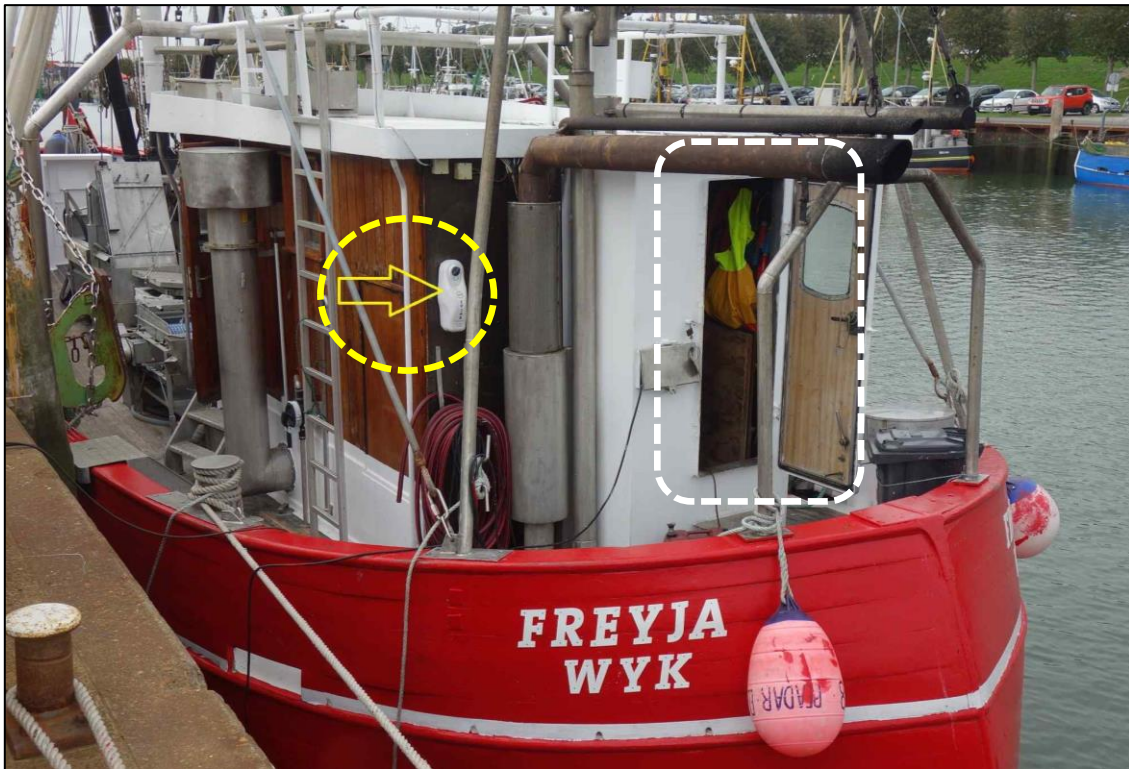
The FREYJA had a continuous bilge from the engine compartment to the foredeck. Access to the engine compartment was only possible via the aft entrance to the deckhouse (see white outline in **Figure 4**).

Figure 4: Access to the engine compartment in the aft section of the FREYJA's deckhouse and installation position of the EPIRB¹²

The engine compartment was not lined with steel plating or other fireproof material. As is generally the case with fishing vessels like the FREYJA, the cabling for the auxiliary diesel engine and starting system was laid within the engine compartment bilge. Regular inspection, maintenance or replacement of these cables was not carried out due to their poor accessibility. The cabling and its plastic insulation was not shielded from the chemical influences of the oil and water mixture naturally present in the bilge by a specially protected cable duct.

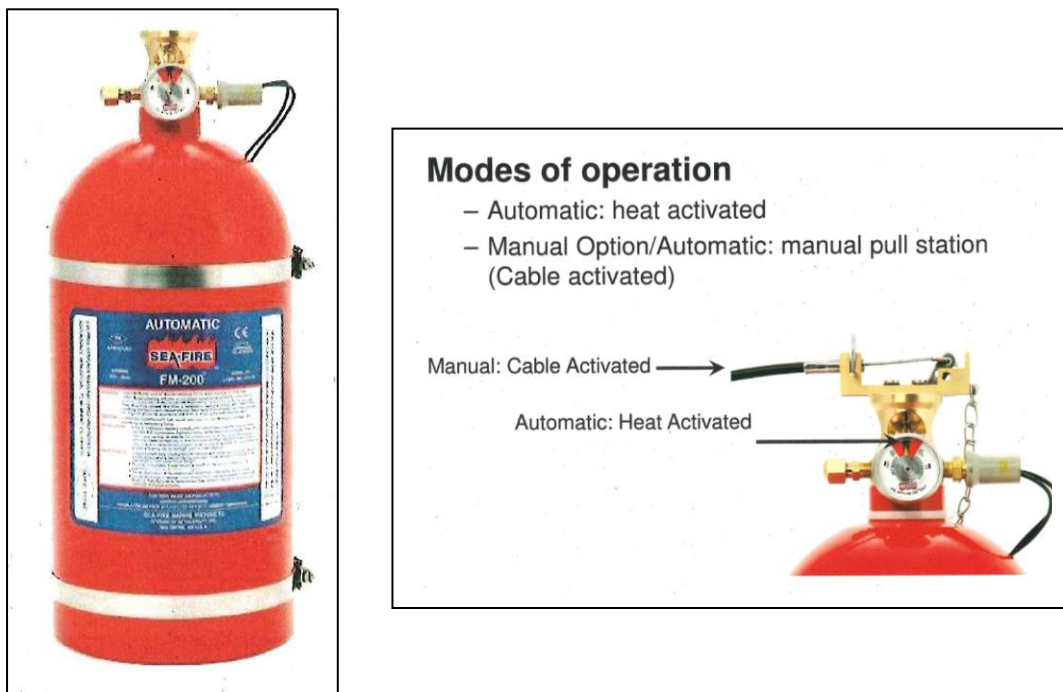
Figure 5: FM 200 fire extinguishing system¹⁵

Both the skipper of the fishing vessel and the deckhand stated in their interviews after the accident that the skipper had operated the manual release device of the extinguishing system immediately after discovering the fire. However, the manufacturer has not included a display indicating that activation of the system was actually successful at the operator's position in question. Moreover, there was no noise or anything else to indicate to the skipper that his operation of the release lever actually caused the fire extinguishing system to activate. According to the manufacturer's agent in Germany, the noise of the flowing gas is so loud that the skipper of the fishing vessel would definitely have heard it, however.

Although the design of the firefighting system alternatively provides for automatic (thermal) activation, it is possible that this trigger mechanism was also defective or that the system was positioned such that it did not come into contact with hot gases (in time).²³

²³ The manufacturer's agent told the BSU that a defect in the automatic triggering mechanism was reportedly 'hardly' possible. Instead, he believes that an unfavourable positioning in the room may have been responsible for the system not being activated automatically (i.e. thermally).

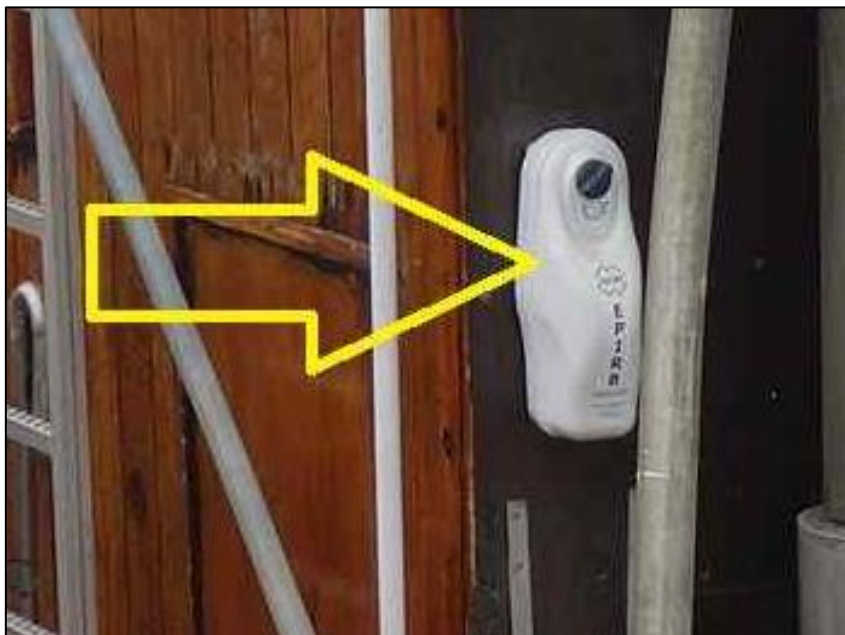
Figure 7: Close-up of the fishing vessel FREYJA's EPIRB

With regard to the expiry dates of the EPIRB's internal device battery and hydrostatic release unit, the aforementioned inspection certificate from the engineering company contains the entries '12.28' and '03.21'.

According to information given by MRCC Bremen, no distress signal was received from the EPIRB after the FREYJA accident. Since the fire on the fishing vessel started in the engine compartment and then spread from the stern across the vessel and the entire wheelhouse fell victim to the flames, it is reasonable to assume that the EPIRB, which was in plastic housing, duly mounted on the wheelhouse and not removed from its holder by the skipper before abandoning the fishing vessel, burnt. Accordingly, it was inevitably unable to automatically detach from its holder, float up and transmit a distress signal when the fishing vessel foundered.

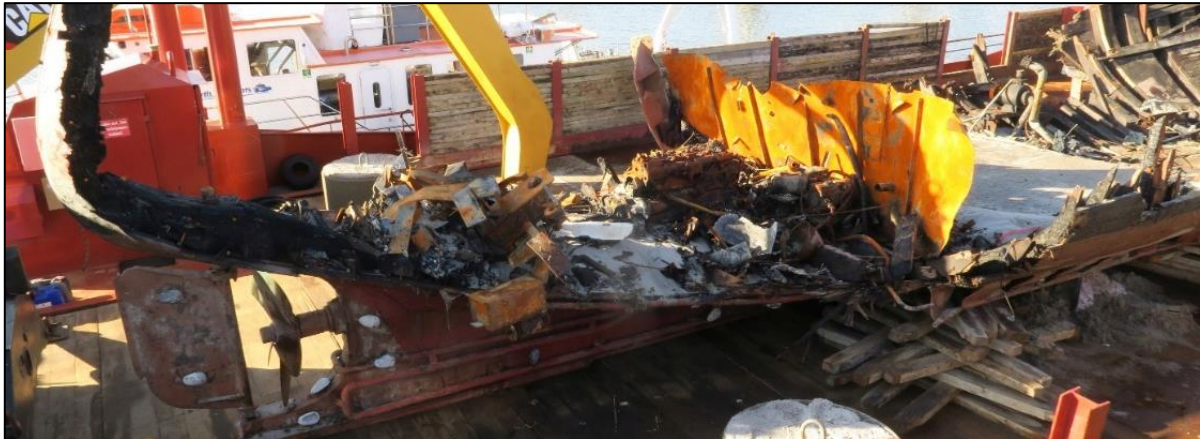
- the entire underside (or bottom of the hull), including – unless burnt – the stern and bow of the FREYJA had been stored on the CATJAN (**Figure 9**);

Figure 9: Burnt out wreck of the fishing vessel FREYJA on the deck of the CATJAN (in this case, the vessel's aft section with propeller and remnants of the engine compartment)

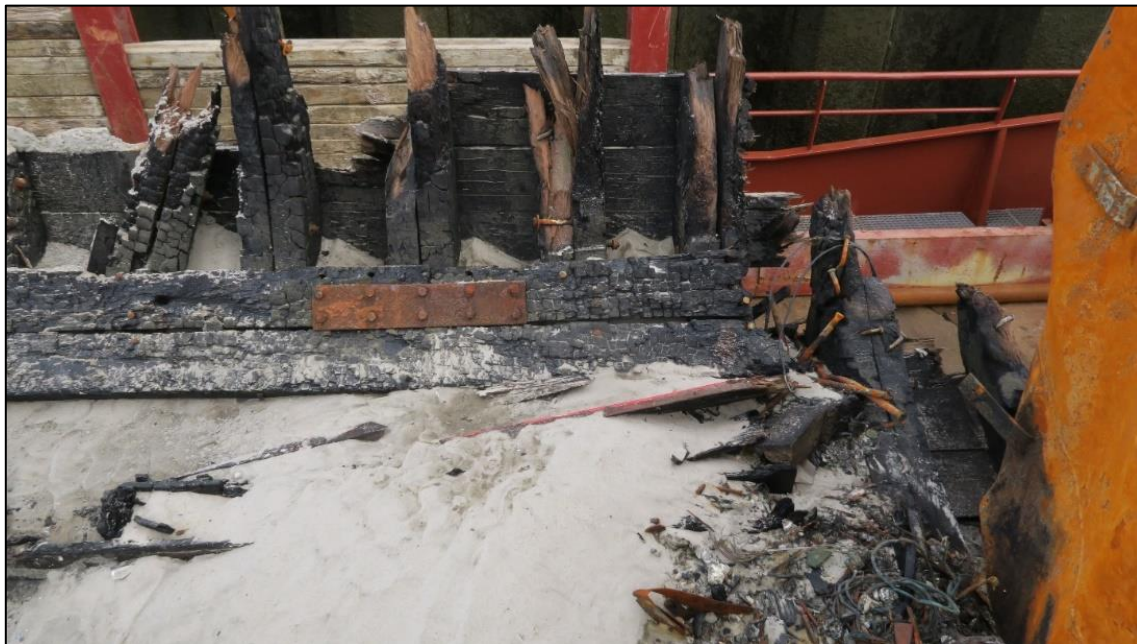
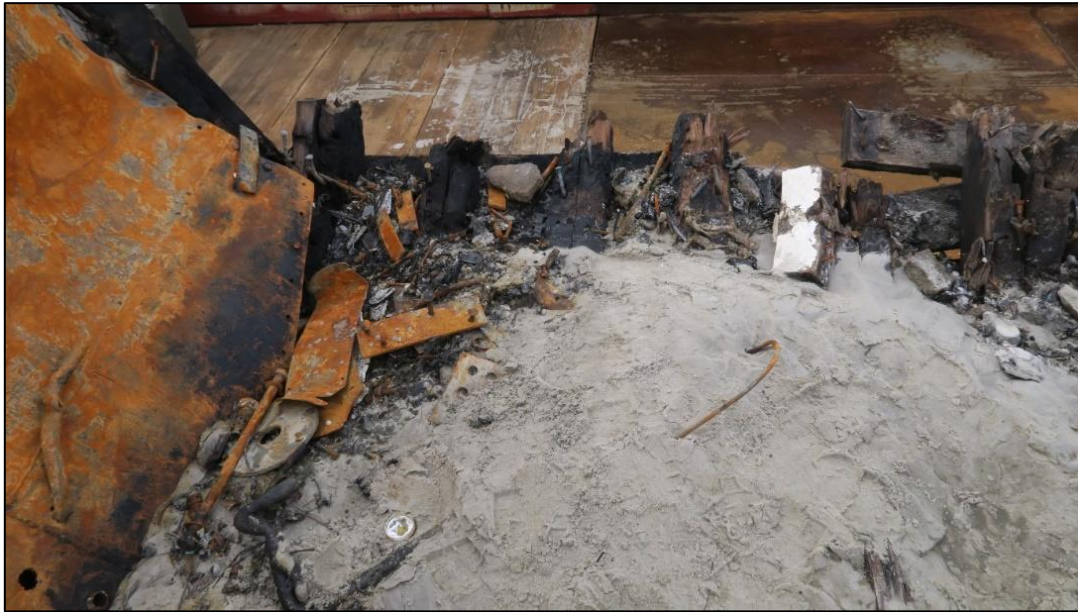
- the port and starboard sides of the hull exhibited differing degrees of destruction in that the remaining sides had a different height above the keel (**Figure 10 f.**). Although this observation is consistent with the impressions of the diver, it should be noted that the degree of destruction of the wreck is naturally also related to the salvage of the vessel and as such cannot be attributed solely to the course of the fire. Accordingly, it was not possible to reliably reconstruct the development and thus origin of the fire;

Figure 10: Frames in the area of the fish hold on the starboard side

Figure 11: Frames in the area of the fish hold on the port side

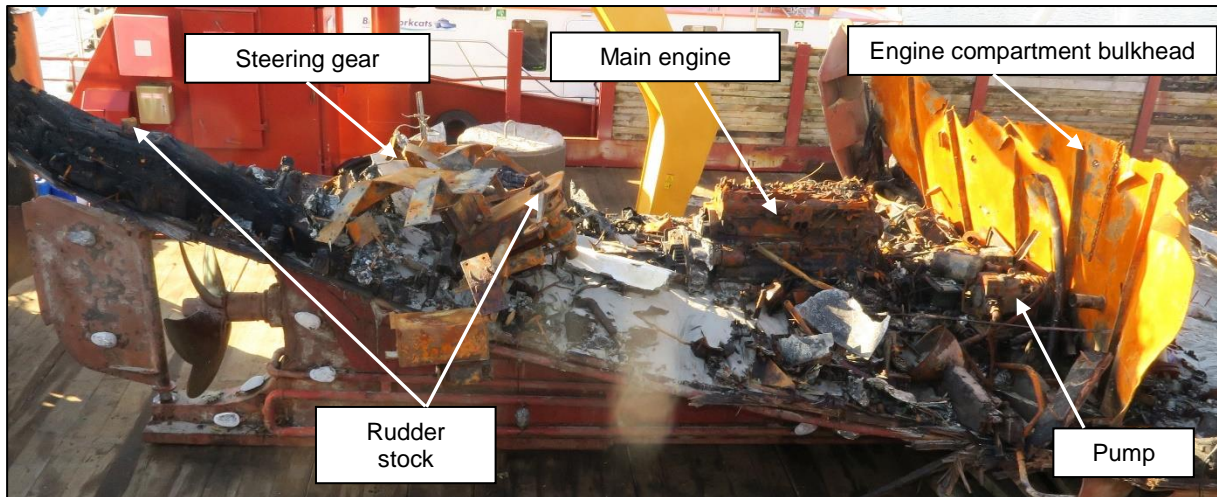
- the engine compartment was also destroyed. As regards the auxiliary systems, only one pump was left on the engine compartment bulkhead on the starboard side (**Figure 12 f.**);

Figure 12: Engine compartment

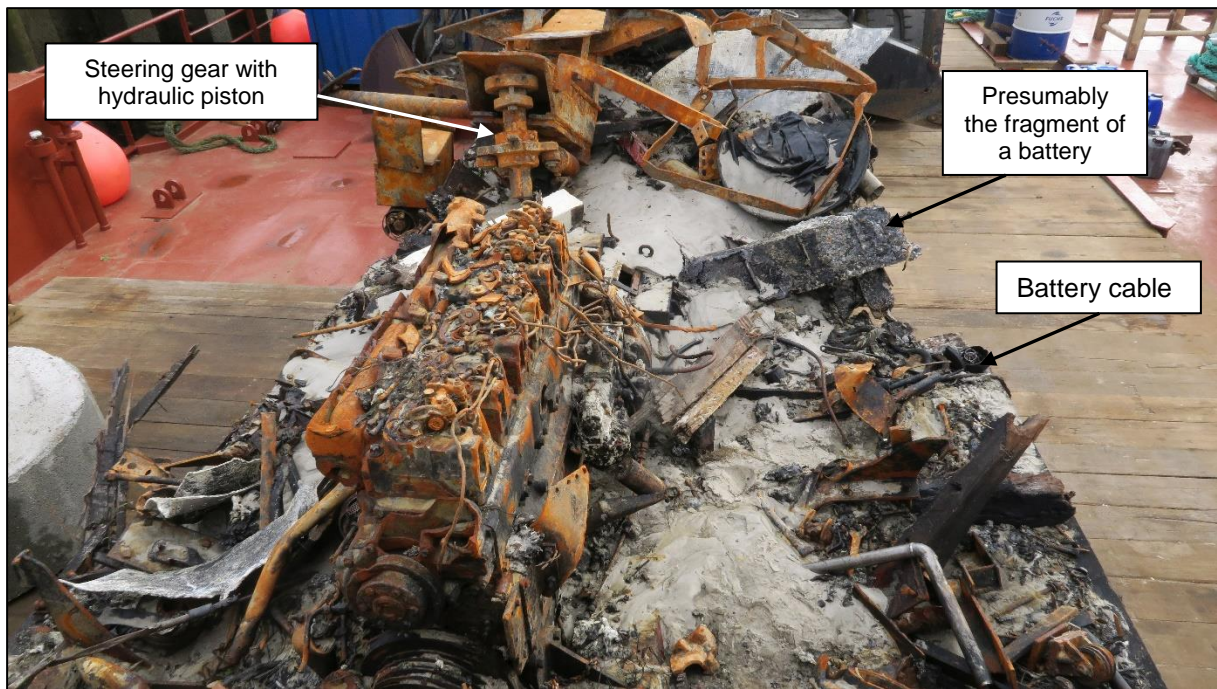
- only fragments of the batteries, also located on the port side, were left (**Figure 13**);

Figure 13: View of the main engine toward the stern

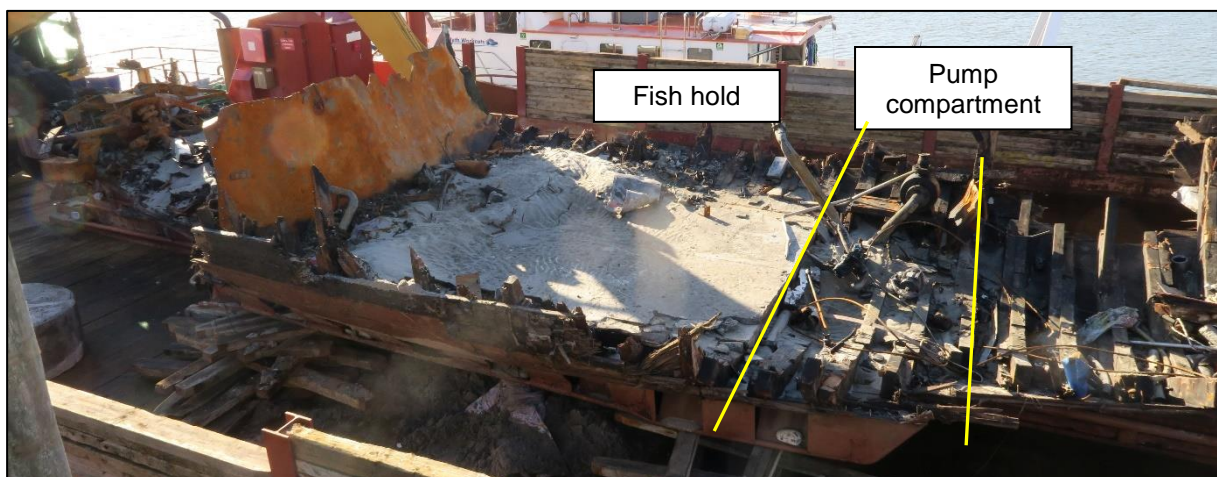
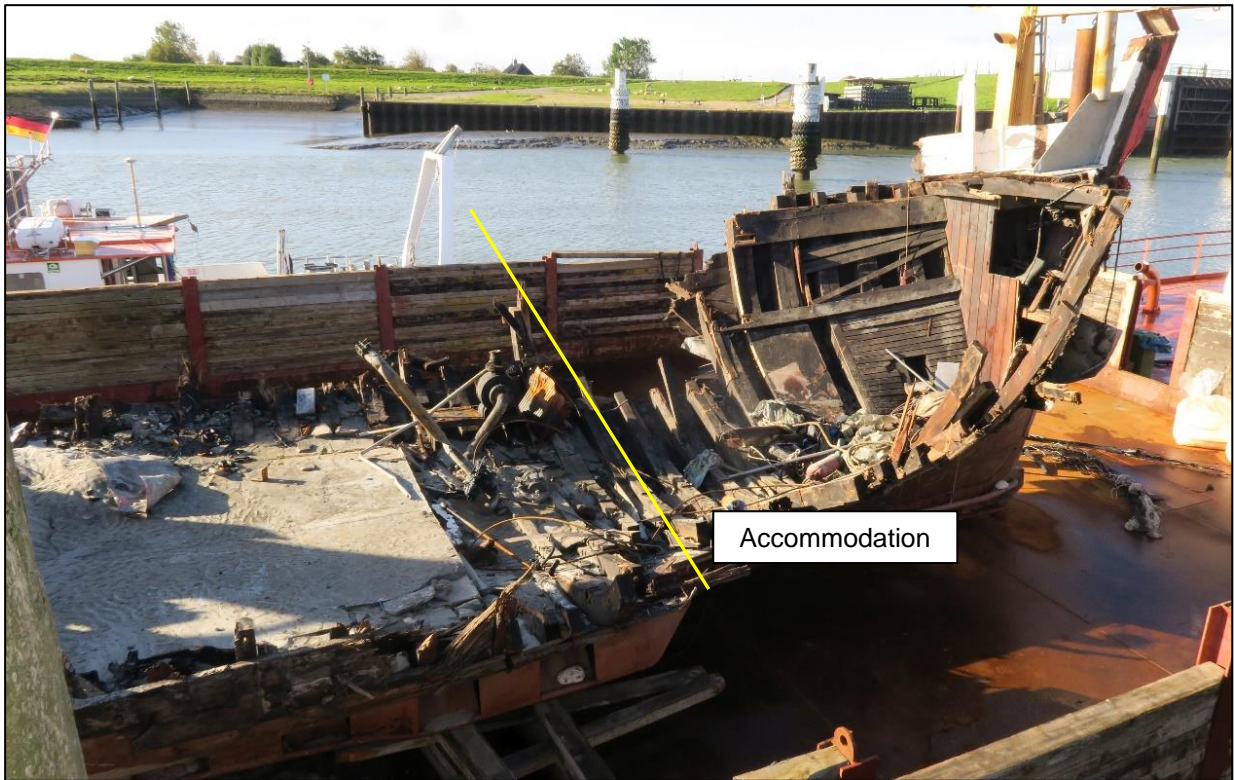
- the fire damage decreased toward the bow. No fire damage was visible in the remaining hull after the crew's accommodation. All in all, the debris gave the impression that the fire load on the port side of the engine compartment was greater than on the starboard side;
- it was striking that plastic and rubber parts on the floor of the engine compartment that could ignite or melt had not burnt or melted. The door to the engine compartment that was open may have allowed the heat to dissipate at the beginning. The heat was subsequently probably able to escape through the burnt deck above the engine compartment.

Figure 14: Fish hold and pump compartment

Figure 15: Fish hold, pump compartment and accommodation
