Report on the investigation of  
the grounding of the general cargo vessel

***BBC Marmara***

in the Little Minch, off the west coast of Scotland

REPORT NO 8/2023

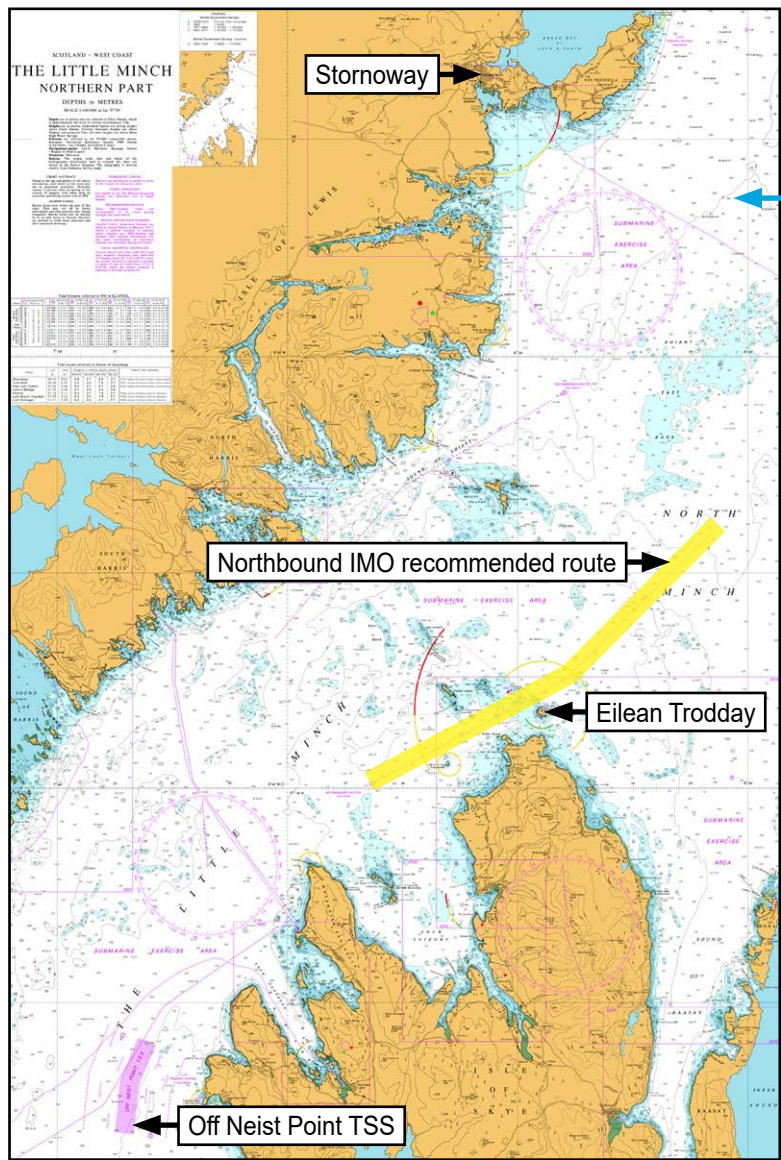
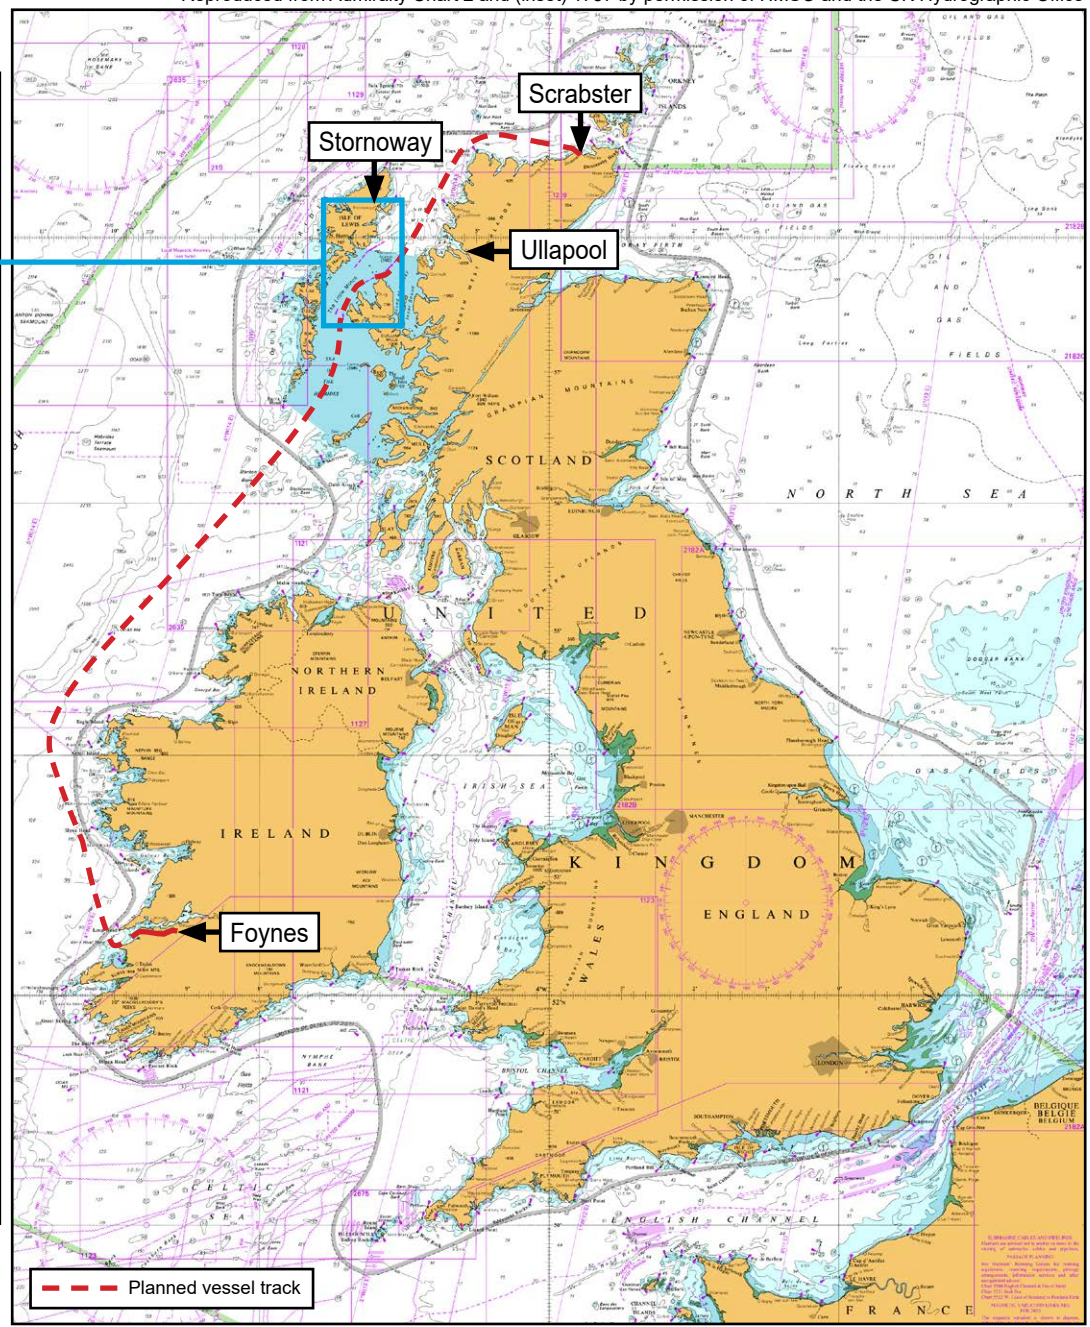
Figure 1: Overview of BBC Marmara's planned track and points of interest

At 1645 on 23 July 2021, the cargo vessel *BBC Marmara* departed from Foynes, on the west coast of the Republic of Ireland, with 1407 metric tonnes of reinforced concrete beams on board. The ship's passage through the Little Minch and North Minch to its destination port of Scrabster, on the north coast of Scotland, was planned to conform with the mandatory and recommended International Maritime Organization (IMO) ships' routeing (**Figure 1**).

The approved MyRA voyage plan and the one in use at the time of the grounding (**Figure 12**) are summarised in **Table 1** and show the courses and XTDs from waypoints 26, before the Off Neist Point TSS, along the northbound IMO recommended route to waypoint 32, beyond Eilean Trodday (**Figure 1**).

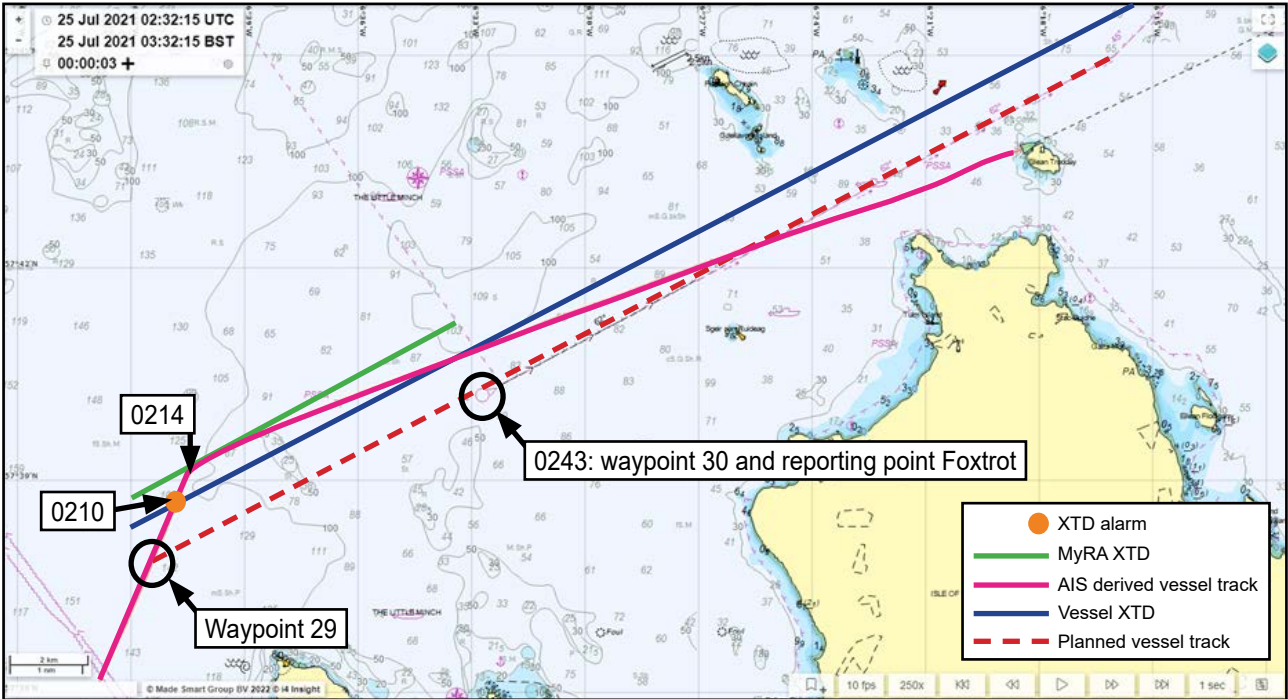
**Figure 2: BBC Marmara's AIS track, passage planning details and XTD alarm position**

At 0210, *BBC Marmara* overshot a planned alteration of course. At 0214, the Electronic Chart Display and Information System (ECDIS) alarm sounded to indicate that the vessel had exceeded the maximum planned cross-track distance (XTD) (**Figure 2**). The alarm sounded 15 times until an incremental alteration of course to 070° was made, which placed the vessel on a convergent course with the IMO recommended route and planned track of 062° passing north of the island of Eilean Trodday (**Figure 2**).

- The XTD alarm sounded when *BBC Marmara* was just over 1000m from the planned track to port, after missing the alternation of course to 062° at waypoint 29. The MyRA voyage plan showed an XTD of 2000m for this leg (**Figure 2**).
- No XTD alarm was heard as the vessel passed more than 710m to starboard of the planned track, which was the XTD value set in the MyRA voyage plan between waypoints 30 and 31 (**Figure 3**).
- No XTD alarm was heard before *BBC Marmara* ran aground. This is consistent with the 1000m XTD value set in the ship's voyage plan, which encroached onto the land mass of Eilean Trodday (**Figure 12**).

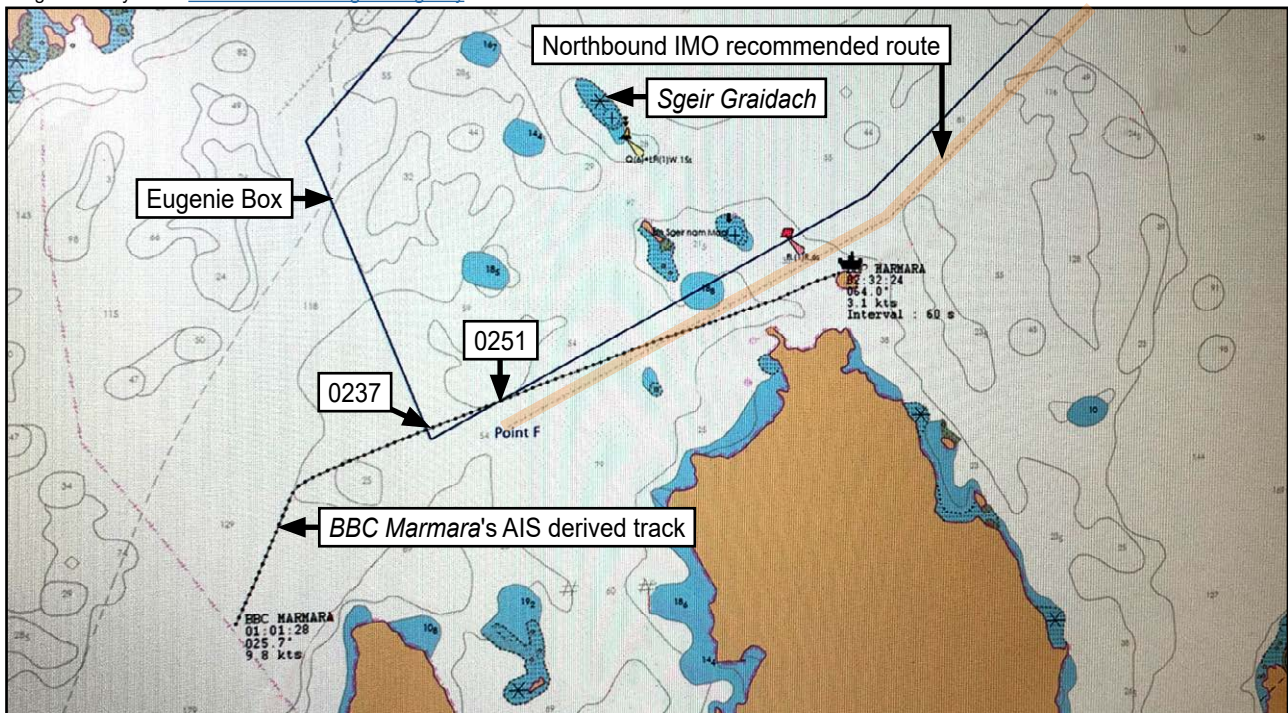
**Figure 4:** C-Scope image showing the Eugenie Box and *BBC Marmara*'s AIS track

At 0237, *BBC Marmara* triggered an alarm on the C-Scope<sup>7</sup> system as it entered an area known as the Eugenie Box<sup>8</sup> (**Figure 4**), which the SMOO acknowledged but took no action on because the vessel was observed to be on a convergent course with the recommended route. At approximately 0243, at the same time as *BBC Marmara* was passing reporting point Foxtrot (**Figure 2**), the SMC received a phone call from Aberdeen MRCC about the ongoing incident. At 0251, the SMOO observed *BBC Marmara* leaving the Eugenie Box. At 0254, having offered assistance to the SMC, the SMOO called Aberdeen MRCC.

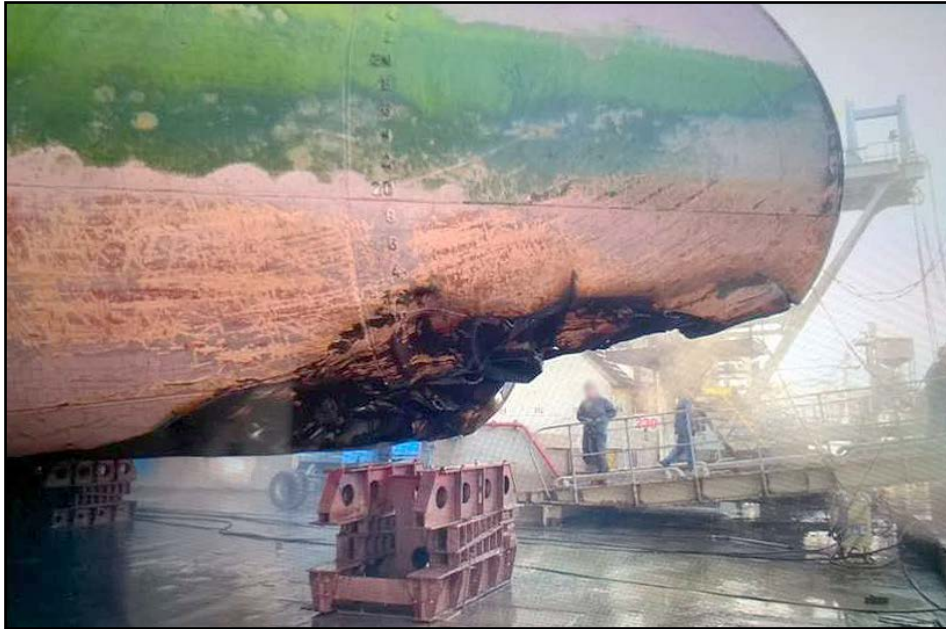
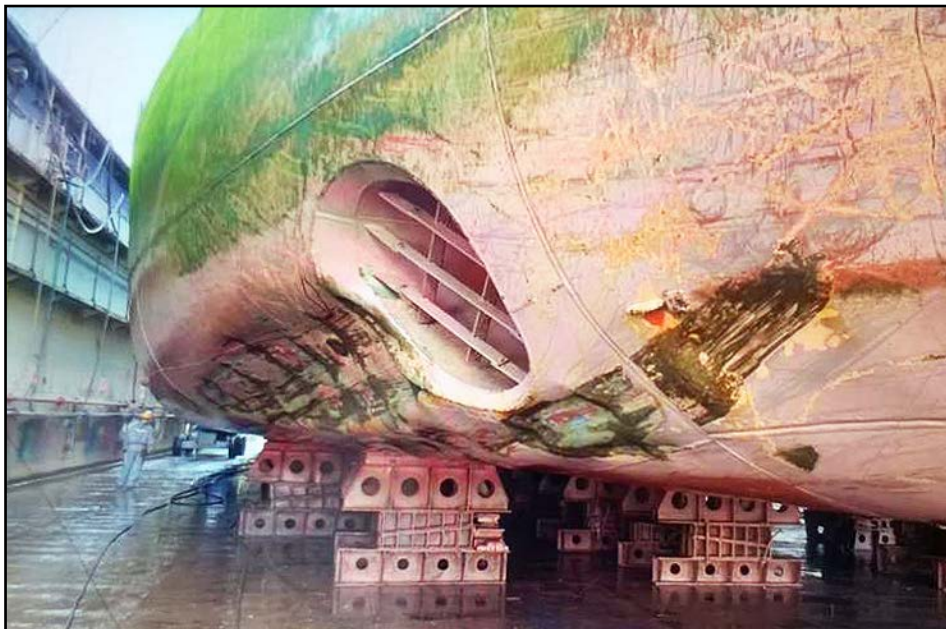
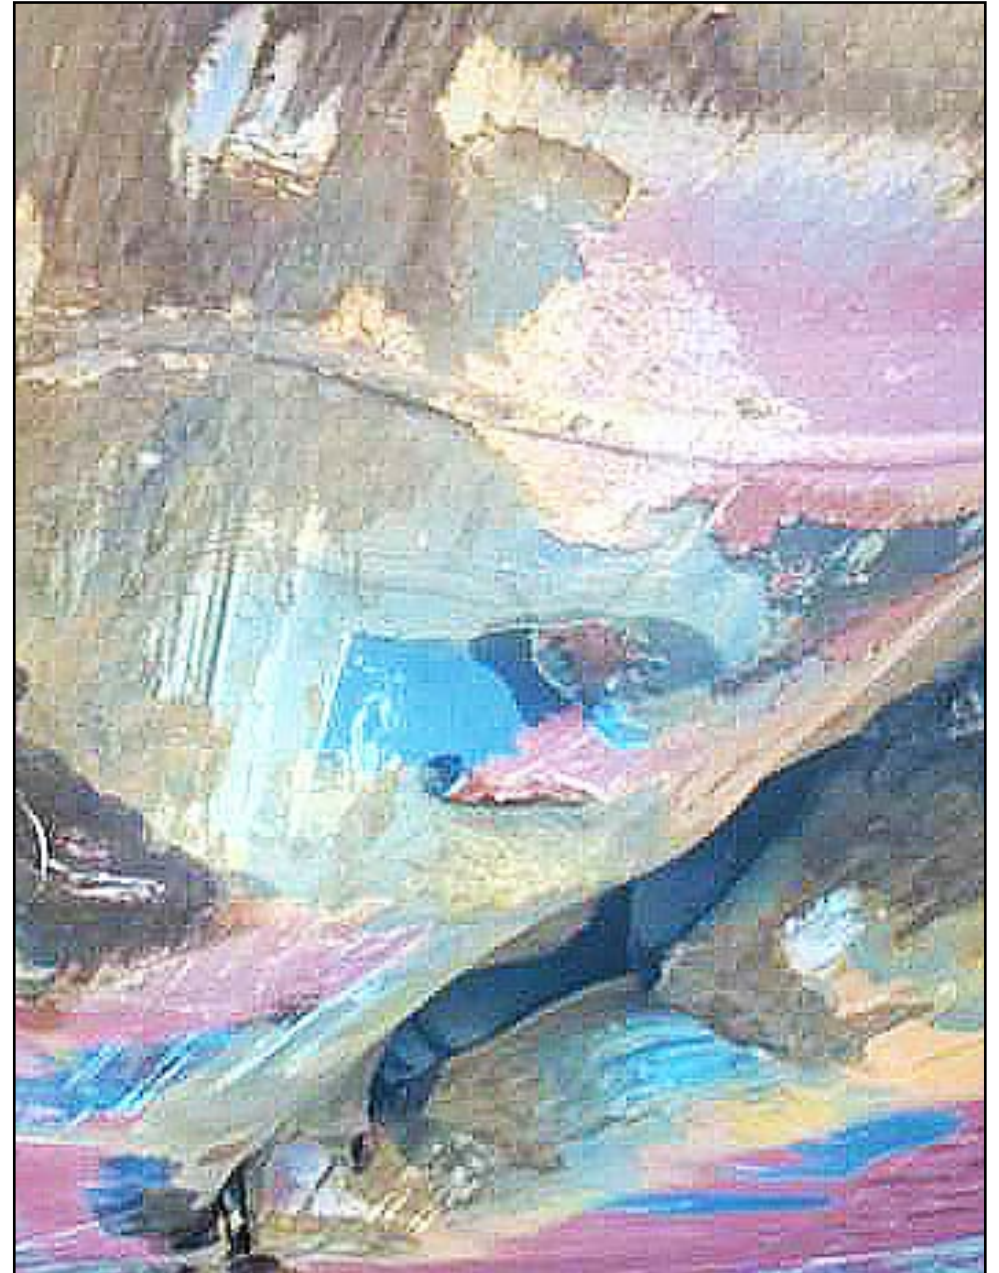
**Figure 5:** The extent of the hull damage

The resulting dive survey identified that *BBC Marmara* had suffered significant hull plating damage (**Figure 5**), including penetration of the forepeak tanks and bow thruster space. Following a classification society survey the vessel was permitted to continue to Scrabster to discharge its cargo before heading to Gdynia, Poland, for repairs.

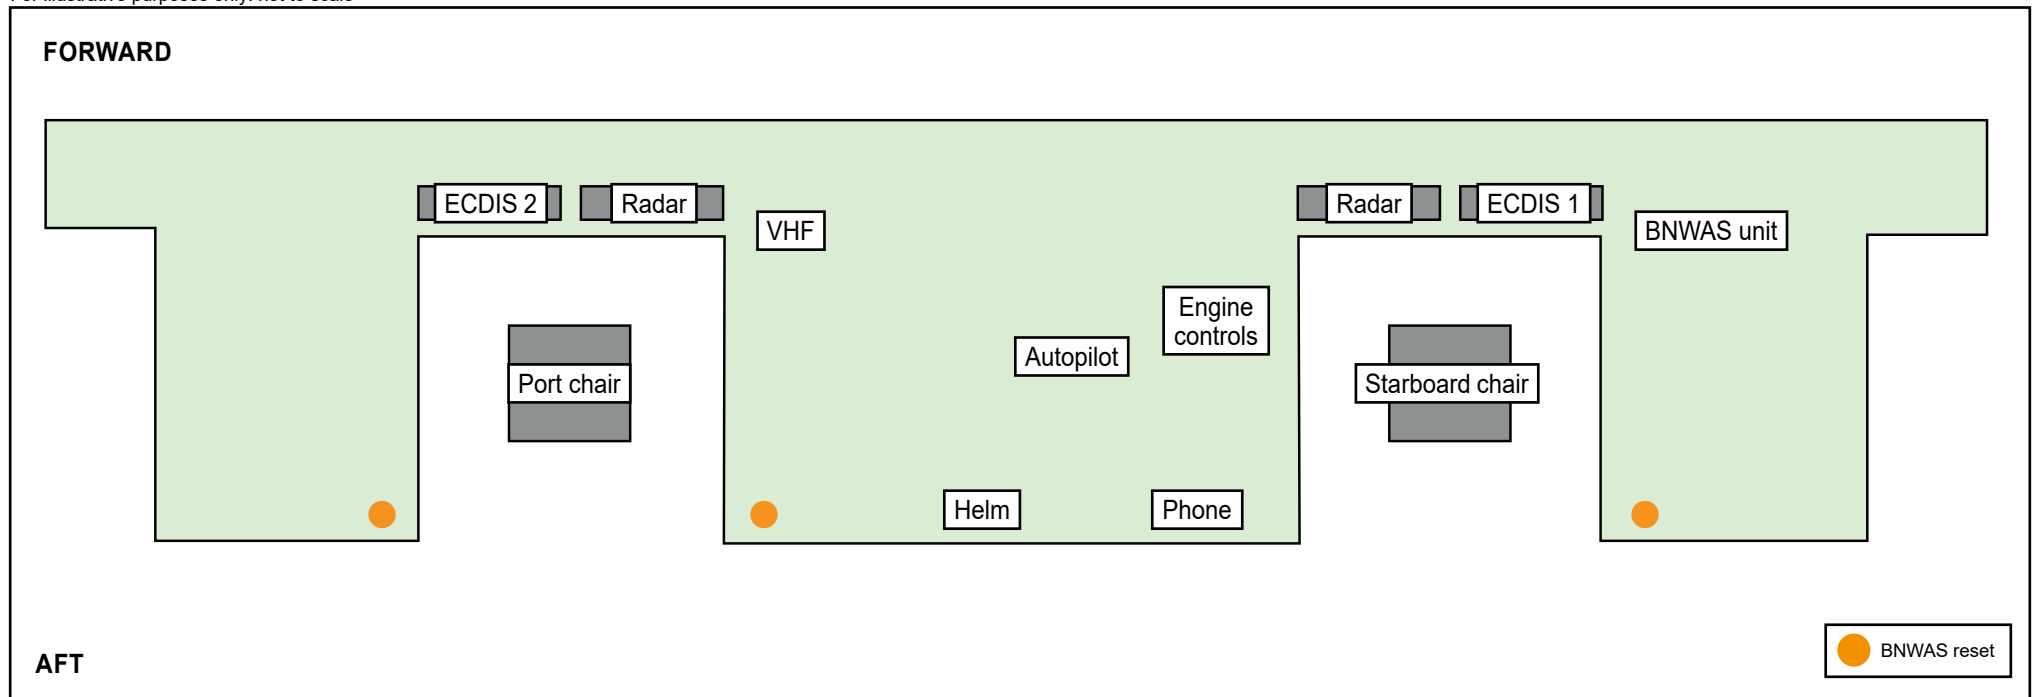
Figure 6: BBC Marmara's bridge layout and navigation equipment

The primary ECDIS terminal was used for planning and monitoring and was located on the main bridge console directly in front of the starboard chair (**Figure 6**). The back-up ECDIS terminal was in front of the port chair. A radar display was positioned next to each of the ECDIS terminals, but the two systems were not integrated.

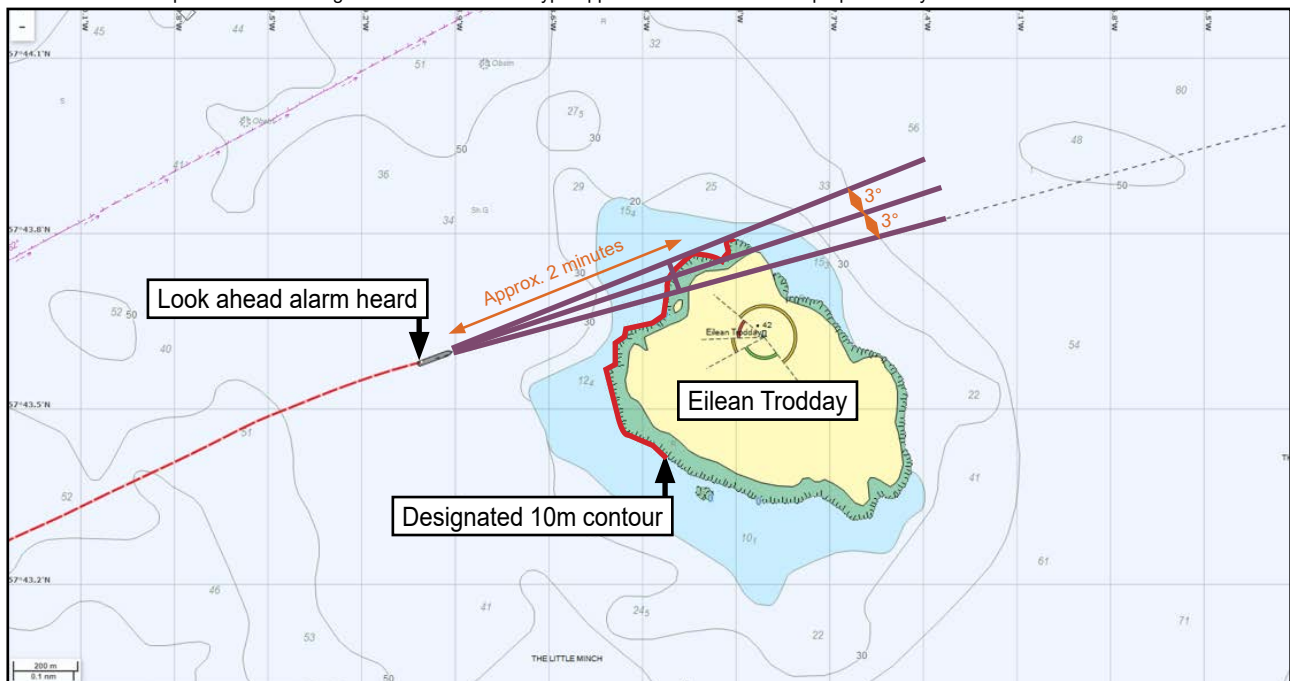
**Figure 11:** Location where the look ahead alarm was heard on the VDR and the 10m contour around Eilean Trodday

Based on the survey data available and the extreme topographical nature of the coastline, the United Kingdom Hydrographic Office set the 10m contour around Eilean Trodday at the boundary of the drying area displayed on the ENC (**Figure 11**).

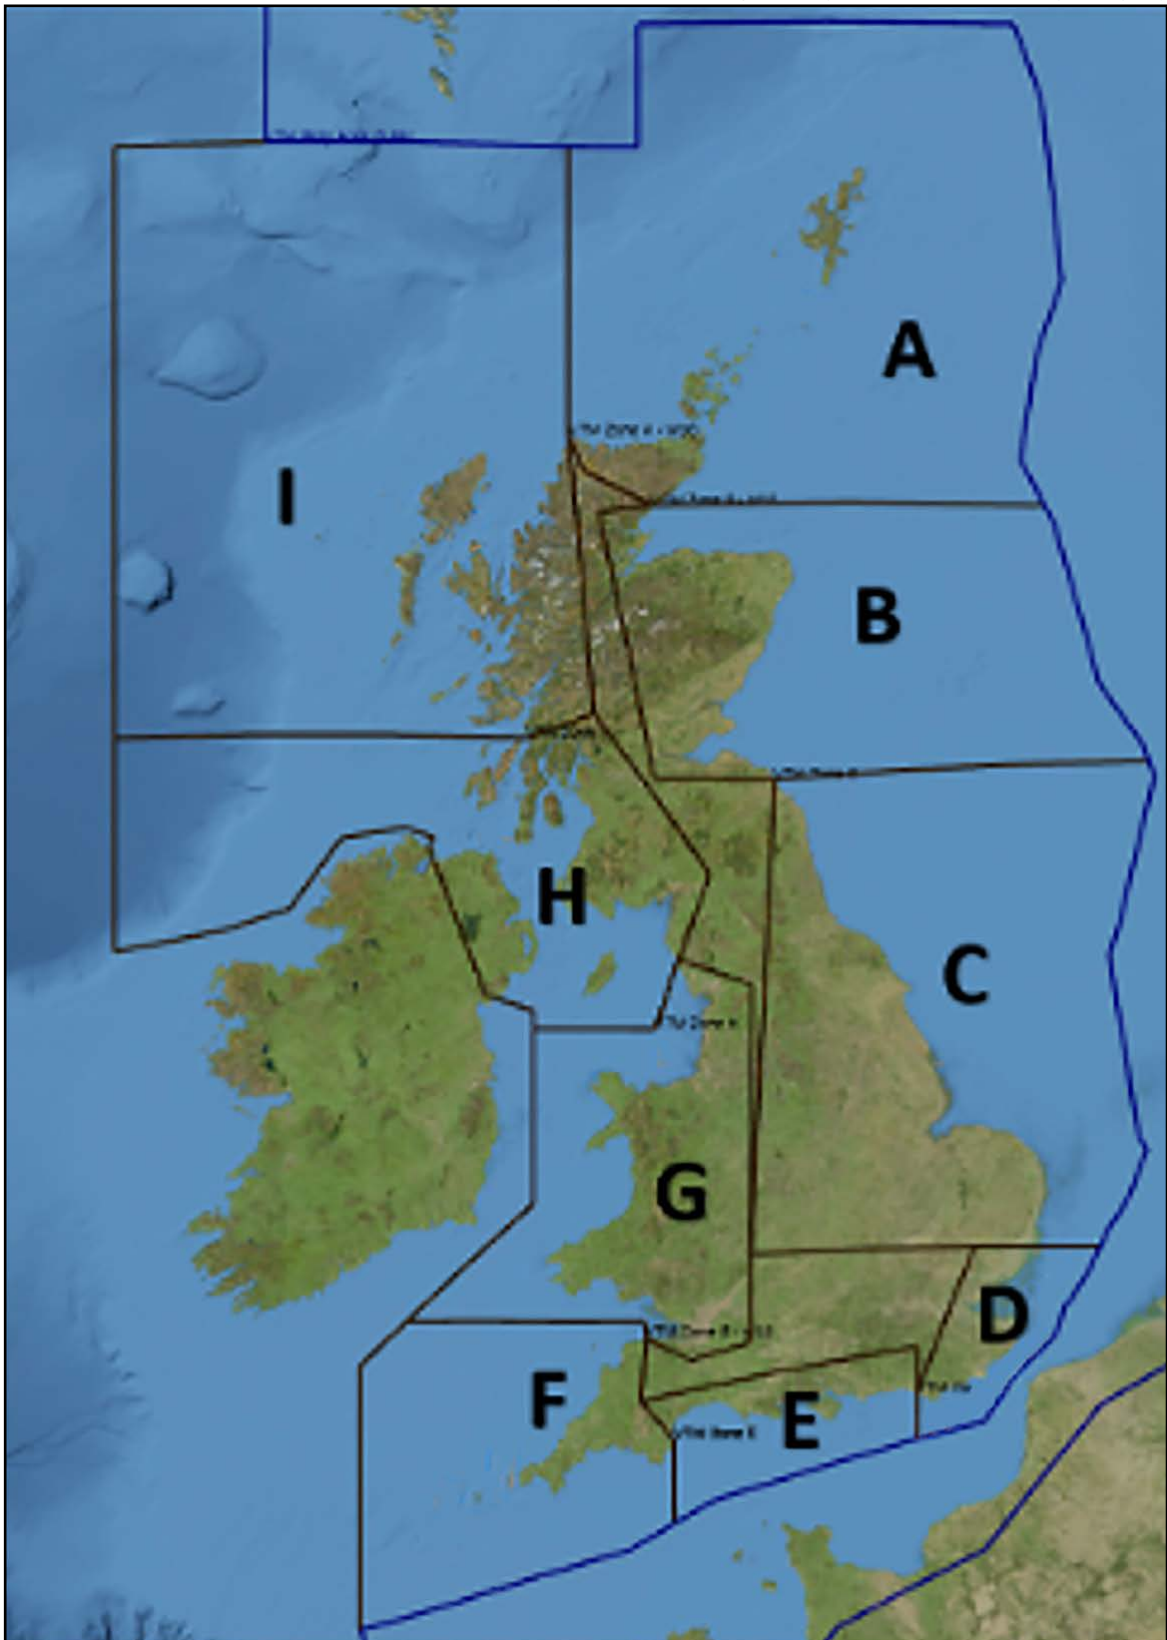
**Figure 14:** HM Coastguard VTM areas

VTM Area I (**Figure 14**) contained the Minches voluntary reporting scheme and included the Off Neist Point TSS and the IMO recommended routes for south and northbound vessels. The area was monitored by Stornoway MRCC as part of the UK national coastguard operations network.
