Report on the investigation of the falling of  
a lifeboat into the sea during  
a launching exercise on board the  
polar research vessel

***RRS Sir David Attenborough***

on Loch Buie, Isle of Mull, Scotland

on 4 March 2021

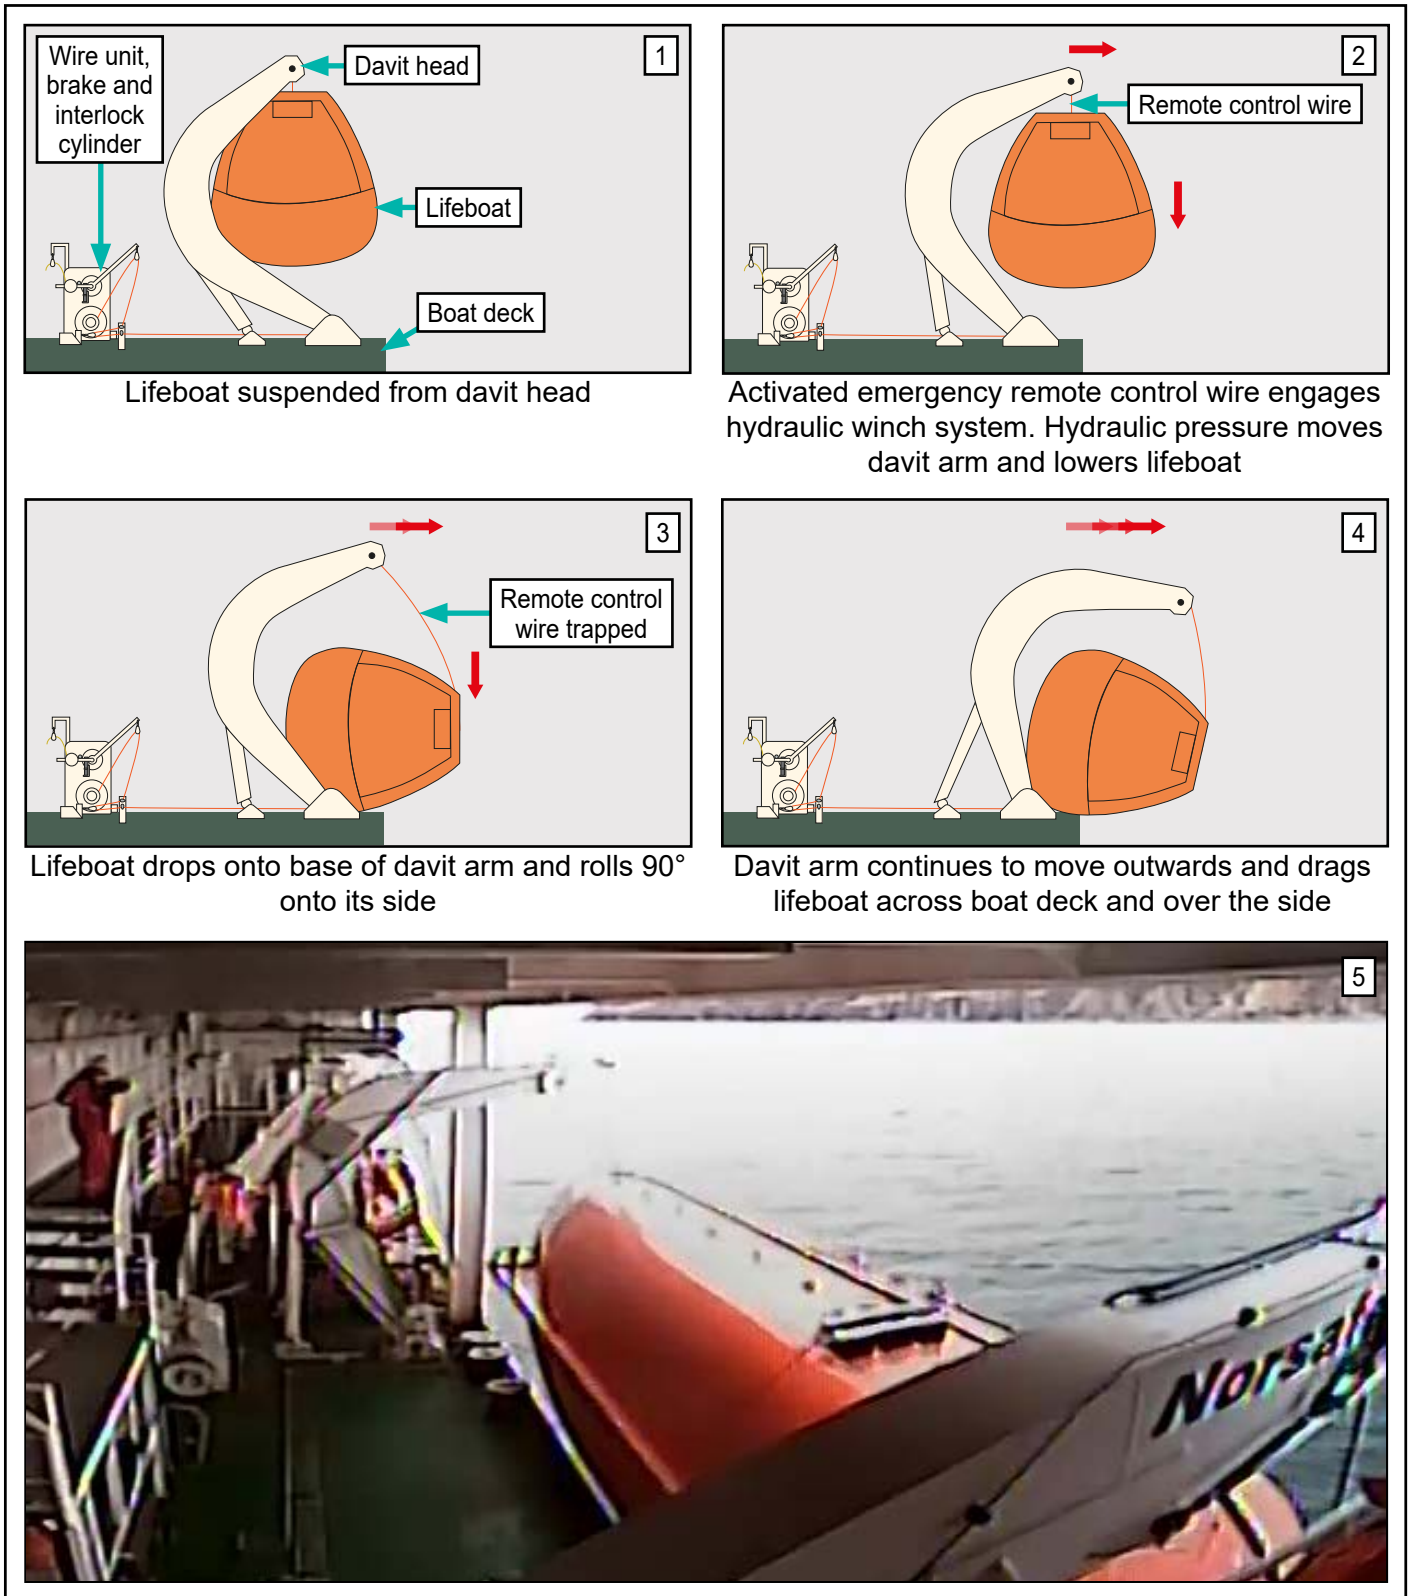
**Figure 3:** Sequence of lifeboat being dragged overboard

The lifeboat dropped from the davit head, landed on the base of the davit arms and rolled 90° onto its side on the deck. The SG1 let go of the remote control wire and was thrown towards the helmsman's seat. On the boat deck, the bosun's mate activated the hydraulic system pump's emergency stop but the davit arms continued to move outwards. The lifeboat was dragged across the deck and momentarily balanced on the deck edge before being pulled over the side (**Figure 3**). The forward hook released the falls suspension ring followed by the suspension ring being released from the aft hook. The lifeboat, with its bow pointing downwards, fell towards the sea. The aft falls suspension ring ripped the aft hatch off as the lifeboat dropped bow first into the water. The 3/O and the bosun inside the lifeboat remained in their seats but the SG1 fell to the bow. The lifeboat became completely submerged and water started to flood through the aft hatch opening before the lifeboat righted itself and came to rest, floating on an even keel.

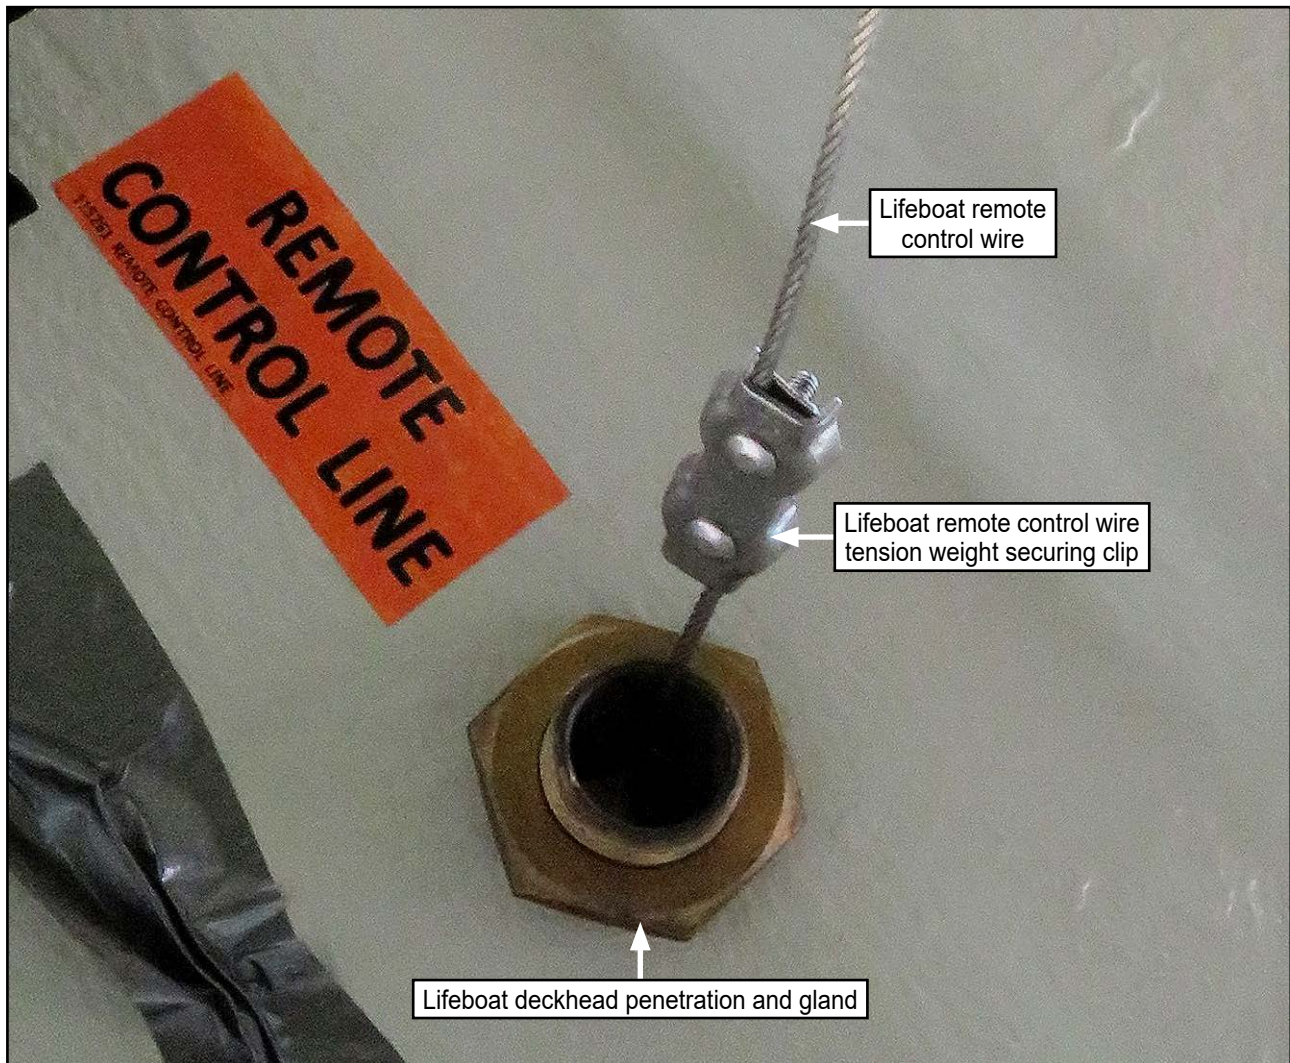
**Figure 7:** Lifeboat remote control wire tension weight securing clip

During the commissioning process for the lifeboat it was found that the remote control wire tension weight securing clip (**Figure 7**) was too big to pass through the deck gland fitted to the lifeboat canopy deckhead. To overcome this the VLSE service engineer enlarged the deckhead aperture and fitted a larger gland. In February 2020, the load testing of the davits and winches was signed off as completed, having been witnessed by an LR surveyor, Cammell Laird staff and VLSE service engineers. In July 2020, following basin trials of the lifeboats, BAS staff signed a document to accept that all lifesaving equipment and lifeboats had been installed and commissioned and were functional.

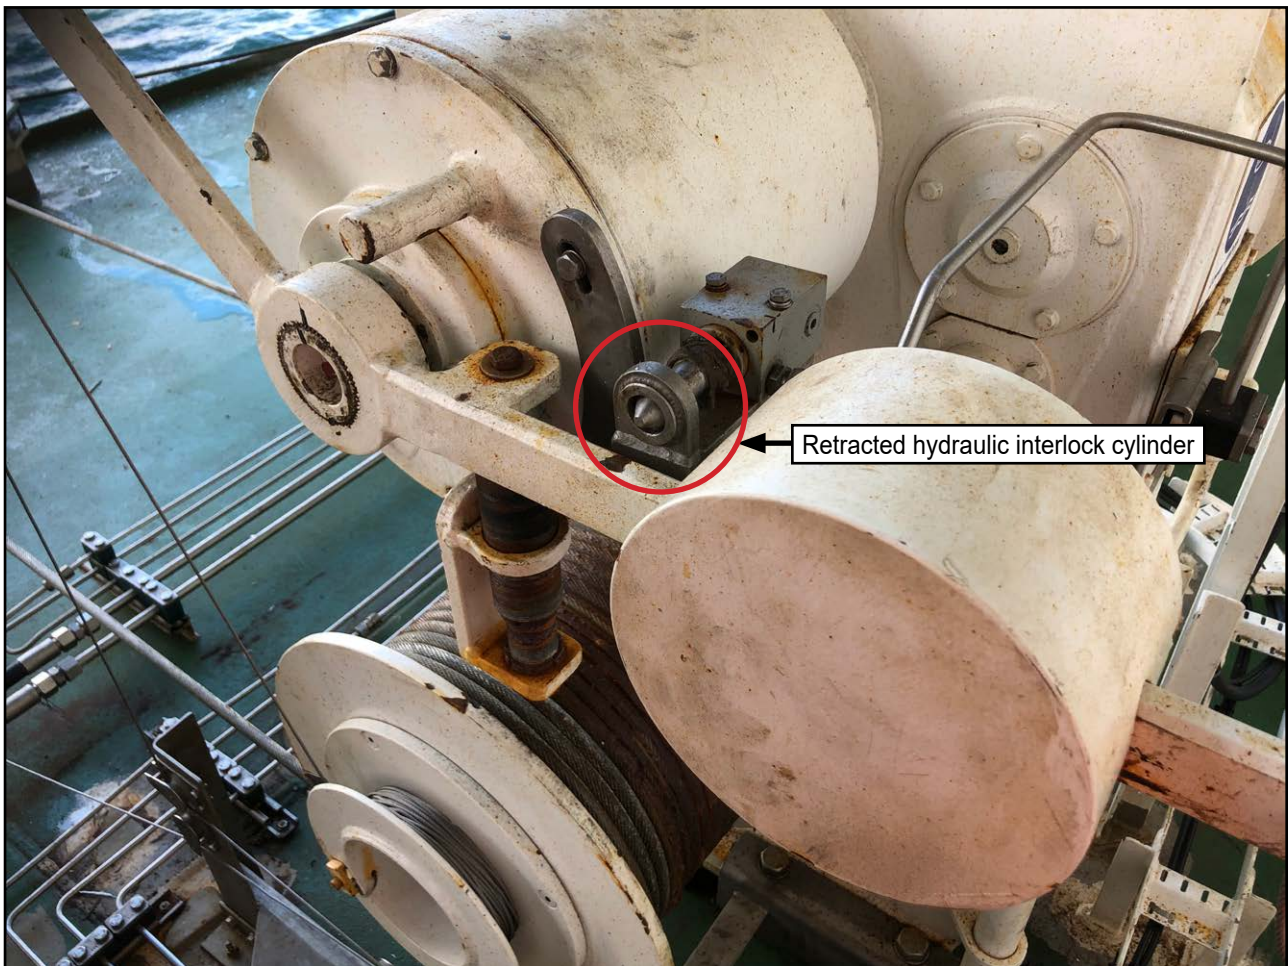
**Figure 8:** Retracted hydraulic interlock cylinder

The hydraulic system was powered up and a series of simulated davit lifeboat launch sequences were carried out. It was found that hydraulic pressure was applied to the interlock cylinder at the correct point in the sequence, retracting the interlock cylinder rod and releasing the winch brake operating arm. When the hydraulic pressure was released the interlock cylinder rod did not return to the extended position over the winch brake operating arm (**Figure 8**). This sequence was repeated several more times with similar results.

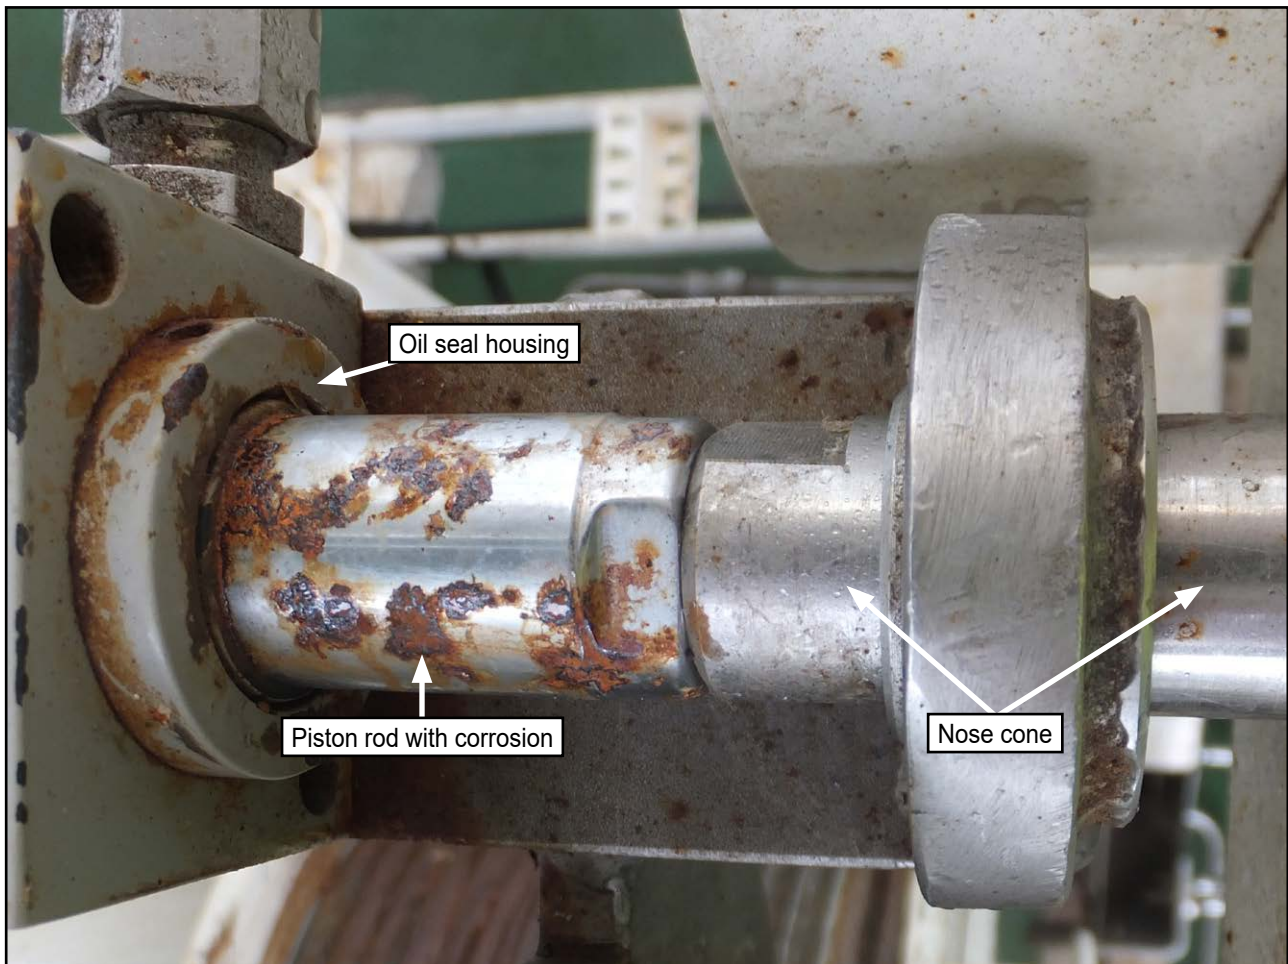
**Figure 9:** Corrosion on hydraulic interlock cylinder piston rod

The winch brake arm hydraulic interlock cylinder was removed from the davit system and sent to a specialist hydraulic engineering company for examination and testing. The initial test showed that the interlock cylinder piston rod did not return to its extended position when the hydraulic pressure was released. The examination determined that the internal components of the interlock cylinder, including the return spring, were in good working order with no defects. The oil seals exhibited no signs of wear. The interlock cylinder piston rod had corroded around its circumference, leading to pitting and a rough finish to the surface area (**Figure 9**); it was demonstrated that this degradation prevented the rod from moving linearly over the surface of the hydraulic oil seal and so held the rod in the retracted position. It was also noted that the sintered bronze filter in the vent port for the interlock cylinder rod return spring space had been painted over.

The interlock cylinder piston rod was cleaned to remove the corrosion and to give the surface a more consistent finish before being retested several times. In each test the interlock cylinder rod returned to its fully extended position when the hydraulic pressure was released.

It is likely that corrosion caused the interlock cylinder piston rod to seize in the retracted position after the initial unmanned lifeboat launches. The interlock cylinder piston rod was vulnerable to the effects of the marine environment because it had not been designed to operate in a salt-laden atmosphere. The piston rod was manufactured from chrome steel to produce a uniform hardened finish that would resist wear and maintain unrestricted movement of the rod through its cylinder. RRS *Sir David Attenborough* was built and outfitted outside and the davit equipment had been installed during the vessel's build, 16 months before the accident, and the interlock cylinder had not been maintained in accordance with VLSE instructions since its installation. The interlock cylinder's piston rod had corroded due to its prolonged exposure to the elements and the surface finish had degraded sufficiently over time to cause it to seize in its housing. As a result, the interlock cylinder's spring could not overcome the resistance of the corrosion and return the piston rod to its extended position once the hydraulic pressure had been released.

The lack of maintenance and inspection of the interlock cylinder meant that the corrosion went unnoticed and so the interlock cylinder was not replaced in accordance with the instructions in the manufacturer's manual.

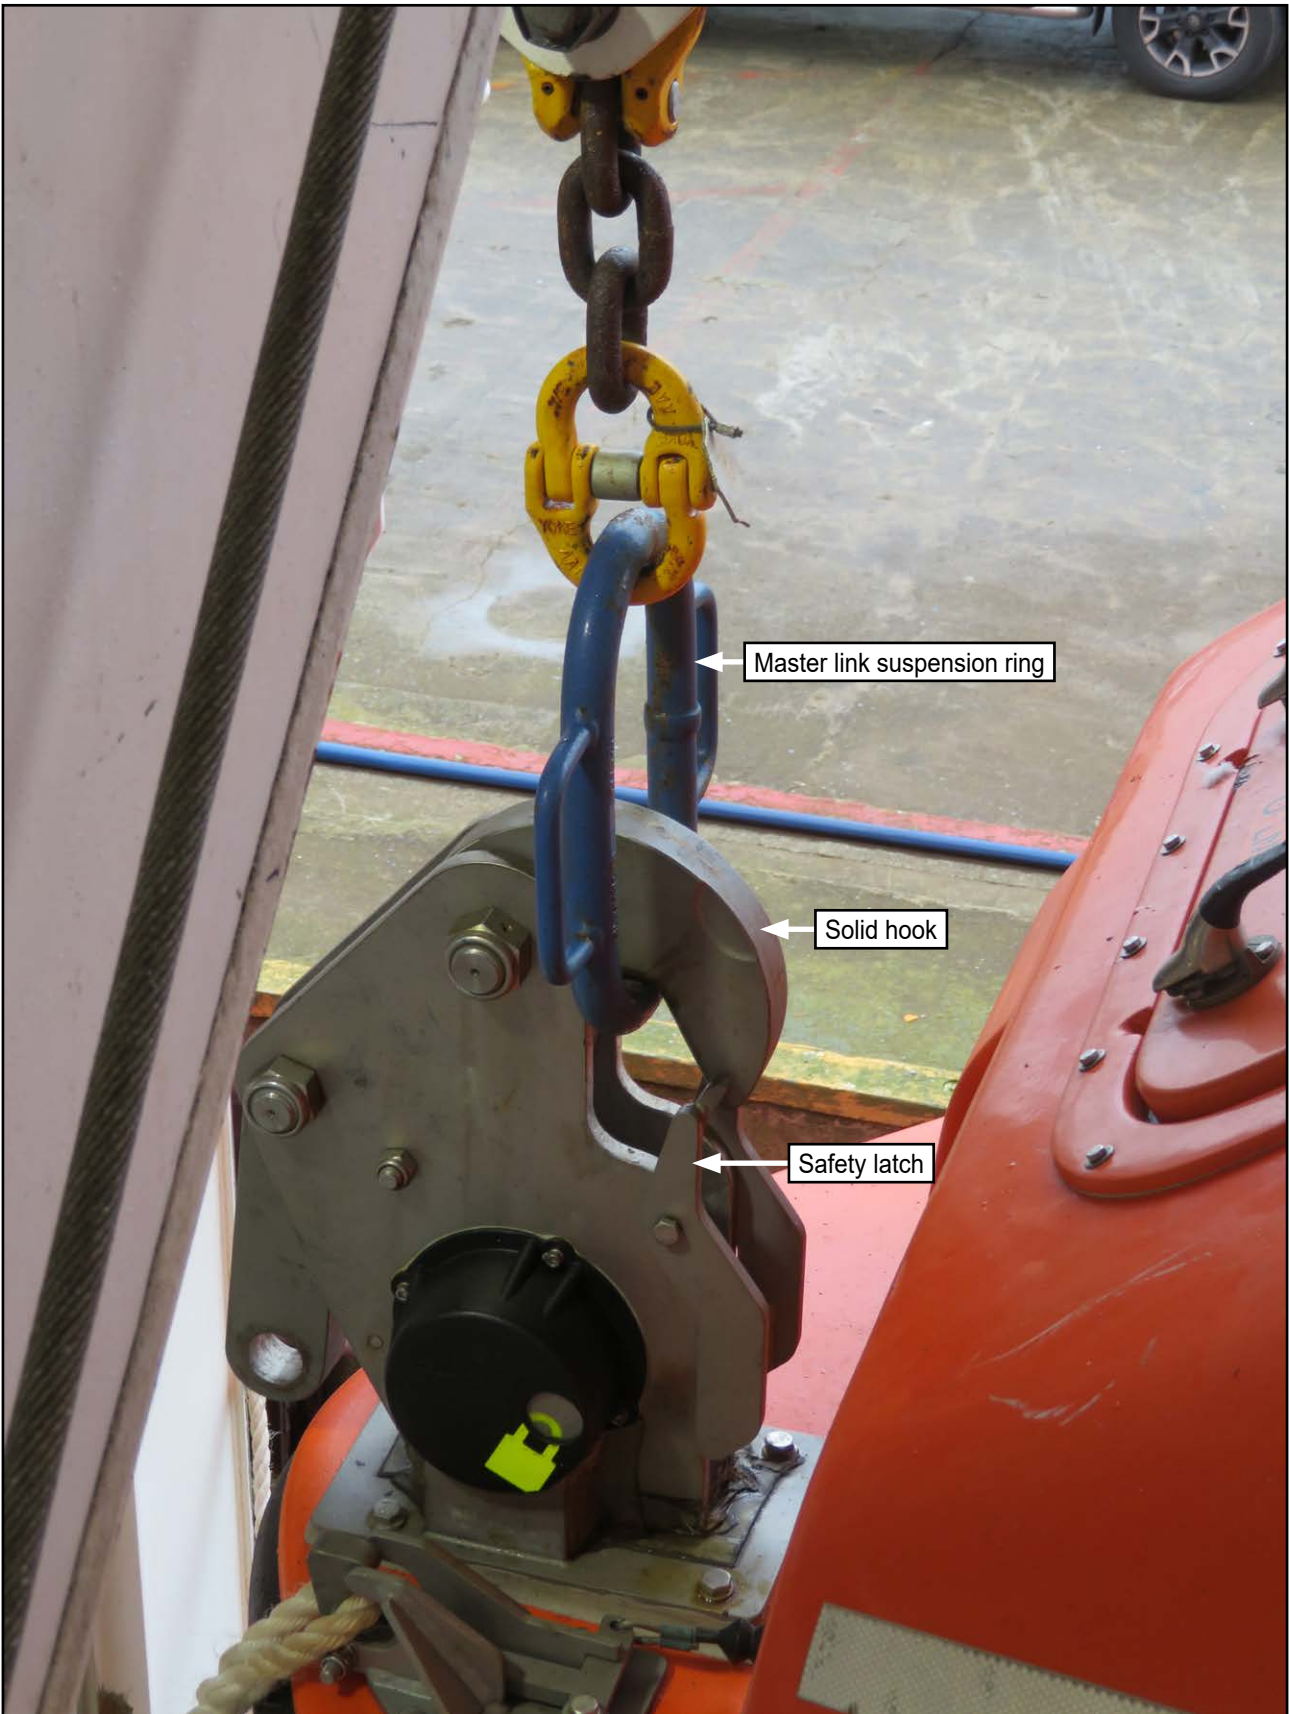
**Figure 10:** Lifeboat hook and master link suspension ring

The safety latches of both lifeboat hooks sustained damage when the master link suspension rings<sup>9</sup> on the davit falls (**Figure 10**) disengaged from the hooks as the lifeboat rolled onto its side and fell to the water. The damaged safety latches were replaced after the accident and the lifeboat hooks were load tested.

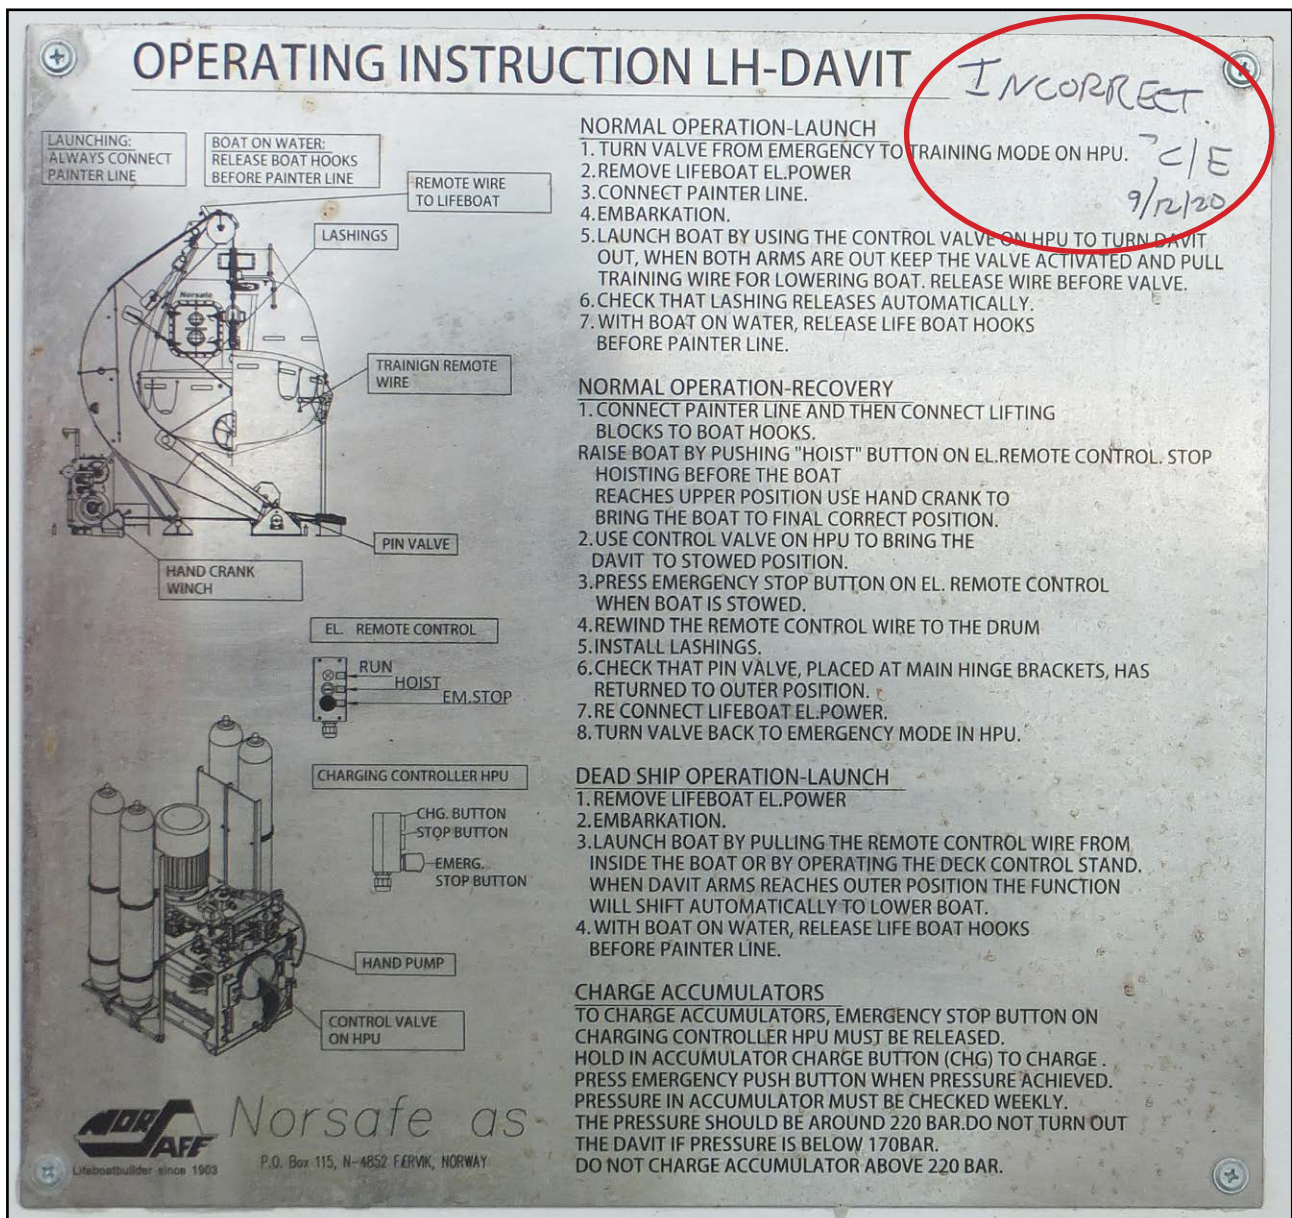
**Figure 11:** Instruction plates fitted adjacent to lifeboat davits, showing the handwritten statement

The description for the training mode procedure deviated from that stated in the Norsafe operation and maintenance manual and included a note that, *This process needs to be confirmed once onboard* [sic]. General information about the davit highlighted the function of the interlock cylinder and the winch brake operating arm. There was no reference to the safety checks that were to be conducted after the davit operation.
