November 16, 2023

MIR-23-25

# Engine Room Fire aboard Tank Vessel *Endo Breeze*

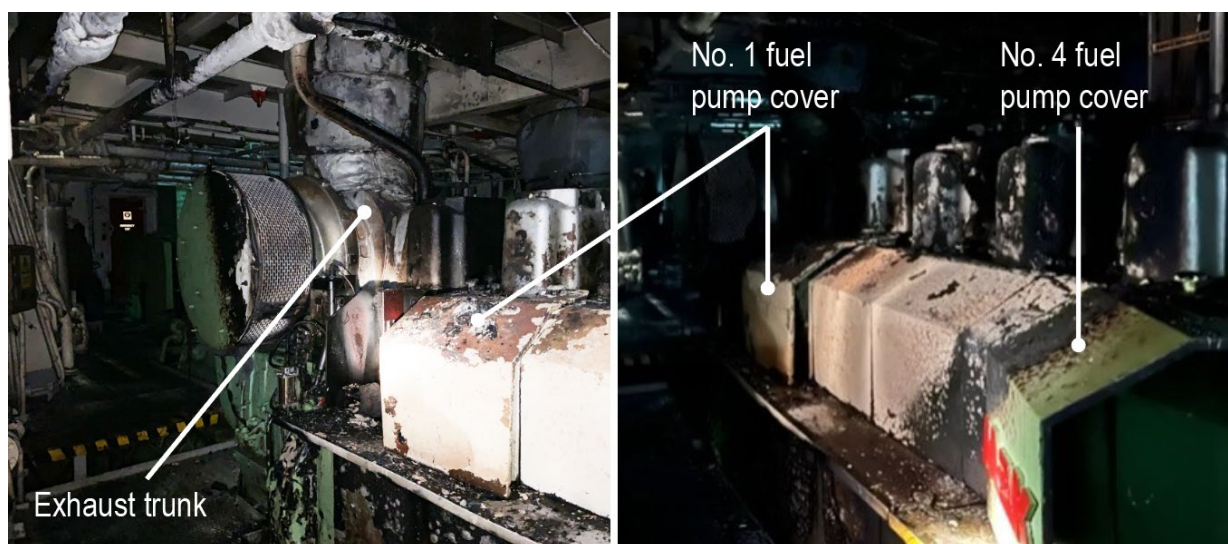
About that time, the second engineer and the fourth engineer, who were conducting a round of the engine room, smelled fuel oil and saw a haze in the air near the starboard main diesel engine. The second engineer approached the starboard engine and noticed fuel oil on the deck near the outboard side of the starboard engine. He opened the no. 4 cylinder fuel injector pump cover of the starboard main engine and determined that the fuel mist was coming from the aft end of the engine, near the no. 1 cylinder. When he opened the no.1 cylinder fuel injector pump cover, high-pressure fuel oil sprayed from the no. 1 fuel injection pump banjo tube into the air near the turbo charger and exhaust manifold.<sup>2</sup>

**Figure 3.** (Left) Location of the turbo charger relative to the no. 1 fuel pump cover. (Right) Location of fire on the starboard engine with fuel pump covers nos. 1 and 4 left partly opened. (Source: US Coast Guard)

To reduce the fuel spray, the second engineer placed a shop rag over the banjo tube, then he and the fourth engineer quickly proceeded to the engine control room to notify the chief engineer of the situation. Both fuel pump covers were left partially open.

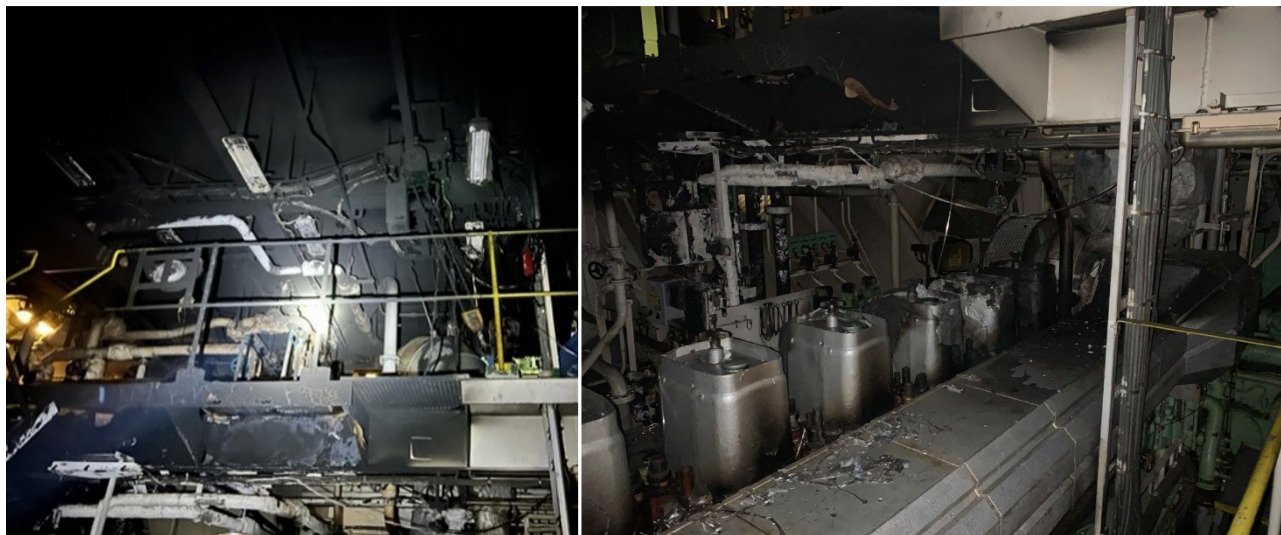
Most of the fire damage was located on the lower engine room platform near the top end of the starboard main propulsion engine. The fire damage was concentrated between cylinder nos. 1, 2, and 3 on the outboard side with no. 1 experiencing the most severe damage. Motor controllers and associated wiring located directly outboard of the starboard engine were also damaged. There was also damage to the main lube oil pumps, main lube oil auto filters, and separator pumps.

**Figure 4.** (Left) Smoke and fire damage to the upper engine room postcasualty. (Right) Fire origin and damage to the starboard engine and upper engine room postcasualty.

The fire damage continued upward and through the grating above the starboard engine to the lighting fixtures and fire/smoke/flame detection system sensors in the overhead, and up through the engine room exhaust trunk casing. Damage to the vessel was estimated at \$1.2 million.

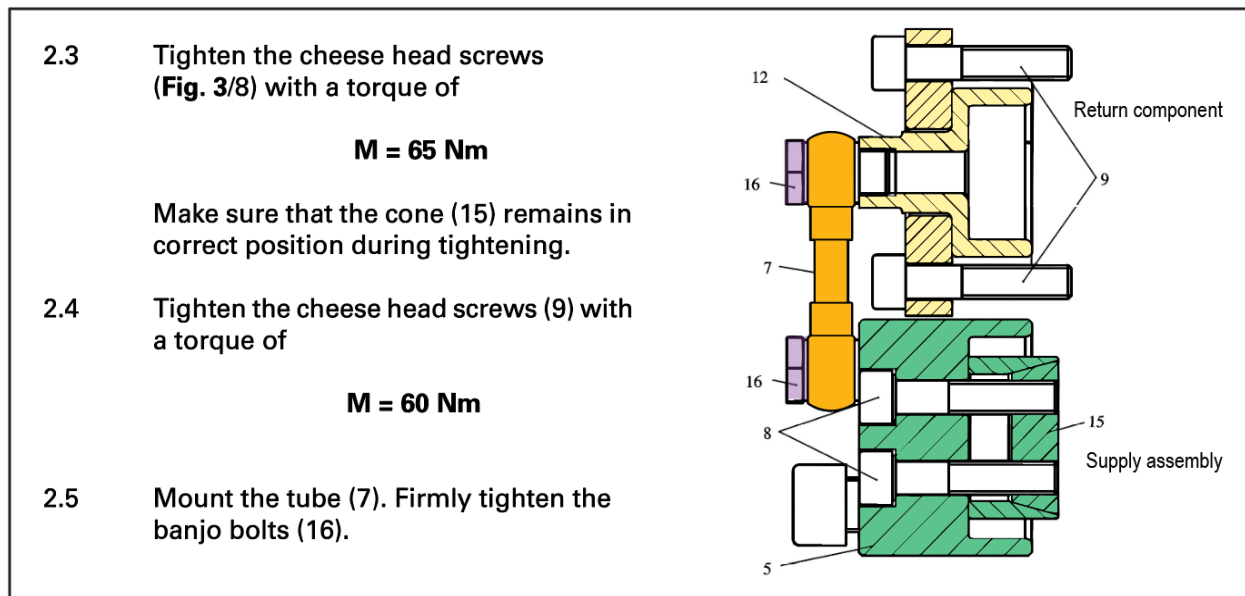
The reassembly procedure identified the correct placement of the sealing flange and lid to the no. 1 cylinder fuel injector pump for the fuel supply and return piping. The procedure also listed the proper torque values for the fasteners during reassembly. Step 2.3 specified, "make sure that the cone (15) remains in correct position during the tightening."

**Figure 6.** No. 1 fuel oil injector pump reassembly procedure and diagram of piping components. The banjo tube (orange) connects the fuel pump supply line assembly (green) to the return component (yellow). (Background source: MAK)

To determine the cause of the banjo tube leak, investigators examined the engine's no. 1 cylinder fuel injector pump and discovered a slight offset (misalignment) on the affected banjo tube assembly. The second engineer had replaced the no. 1 fuel injection pump earlier that day. He told investigators that he followed the manufacturer's manual reassembly procedure, which required components to be tightened in a specific order to maintain alignment. However, if he tightened the banjo tube bolts before properly tightening the sealing flange and/or lid assembly to their specified torques, the pump sealing flange and/or lid assembly may not have been evenly aligned when the

banjo tube was installed. Because investigators found an offset on the banjo tube assembly, it is likely that the engineer did not correctly follow the manufacturer's reassembly procedure for the fuel injector pump.

Due to the high risk of fire associated with pressurized fuel, when working with diesel engine components, it's critical to carefully follow manufacturer assembly procedures and review manufacturer manuals and guidance on a regular basis to ensure familiarity with correct maintenance procedures.

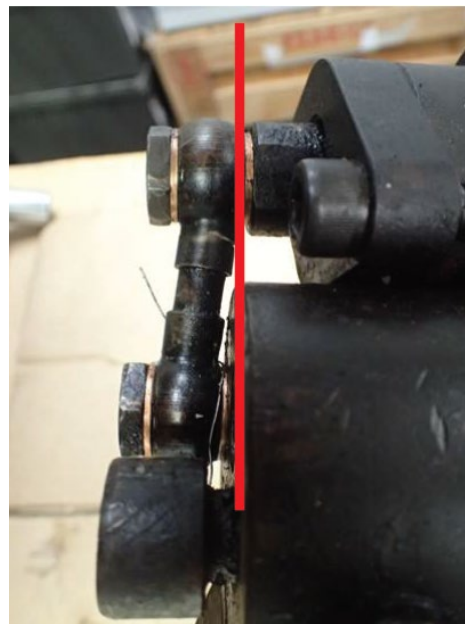
Investigators conducted a postcasualty examination of the no.1 fuel injector pump and associated fuel piping and banjo tube where the second engineer first observed the oil leak. When investigators compared the port and starboard engines' no. 1 fuel pumps, they found a slight offset (resulting in misalignment to the fuel injector pump body) of the starboard main engine's banjo tube. They also found a fracture near the top portion of the inboard side of the banjo tube mounting surface to the sealing flange.

The banjo tube was cleaned and inspected under stereomicroscope. Observed was that the tube was bent to accommodate the offset of the tubes. Machine mark line[s] were noted longitudinal to fracture. On both ends cracks are on the stressed side of where the tube was mounted.

**Figure 4.** Banjo tube connected to the sealing flange and lid of no. 1 cylinder fuel injector pump assembly showing misalignment. (Source: QC Metallurgical, Inc.)

The banjo tube was sent for third-party metallurgical testing. Metallurgical testing did not find any material or dimensional issues with the banjo tube bolts or other involved parts. However, testing found that the tube had bent to accommodate the offset, and fractures on both ends of the tube itself—where it connected to the sealing flange and lid—were discovered. Therefore, stresses associated with the offset likely caused the banjo tube to bend and fracture, causing the oil leak.

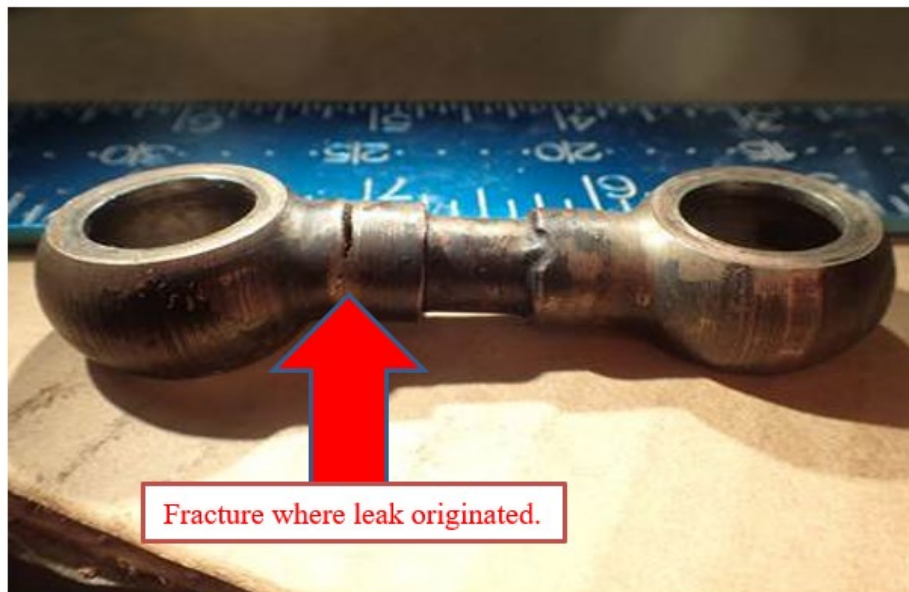
**Figure 8.** The fractured banjo tube. (Source: QC Metallurgical, Inc.)
