SAFETY INVESTIGATION REPORT

REPORT NO.: 15/2023

MV PORT GDYNIA **Fatal fall of a stevedore,** **during cargo operations** **in the port of Bata, Equatorial Guinea** **07 October 2022**

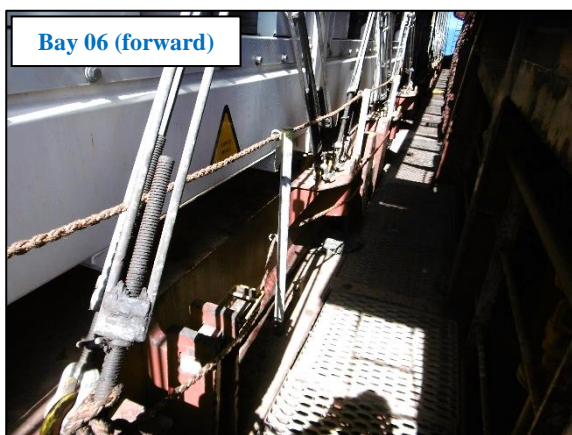
The vessel was also equipped with portable stanchions, serving as a physical barrier between the cross-bay's walkway and the cargo hold opening (**Figures 2 and 3**). These stanchions were one metre high, with ropes passing horizontally through welded eyes at the top and mid-way to the deck. They were normally fitted when the cargo hatch covers were removed.

Figure 2: Stanchions and rope fitted on the forward side of bay 06

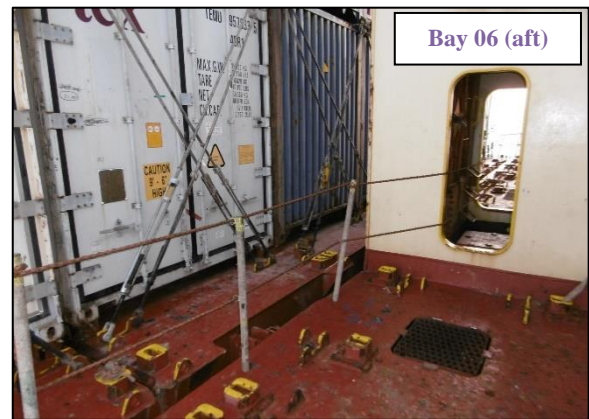
Figure 3: Stanchions and rope fitted on the aft side of bay 06 and passing through crane no. 1's platform

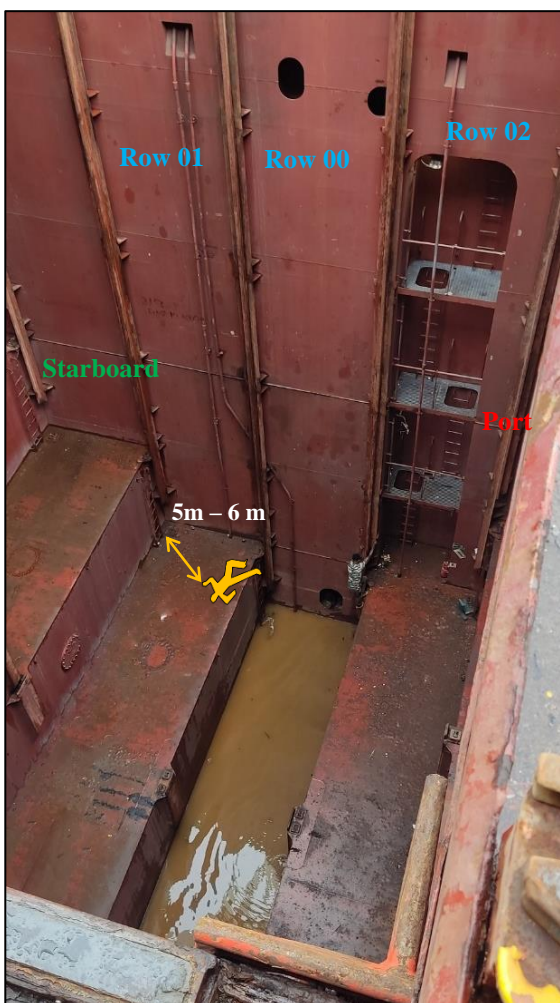
The chief officer proceeded on site, while the vessel's medical officer (second officer) was called to assist. Eventually, it was confirmed that a stevedore had fallen into the cargo hold and landed on the tank top of bay 06, row 01 (Figure 4).

Figure 4: The location where the stevedore was found

The fatally injured stevedore, who was wearing an orange coverall, and a pair of safety boots, was found about 5.5 m from the nearest vertical ladder. His legs were hanging over the bottom of row 01's edge, into the row 00's space.

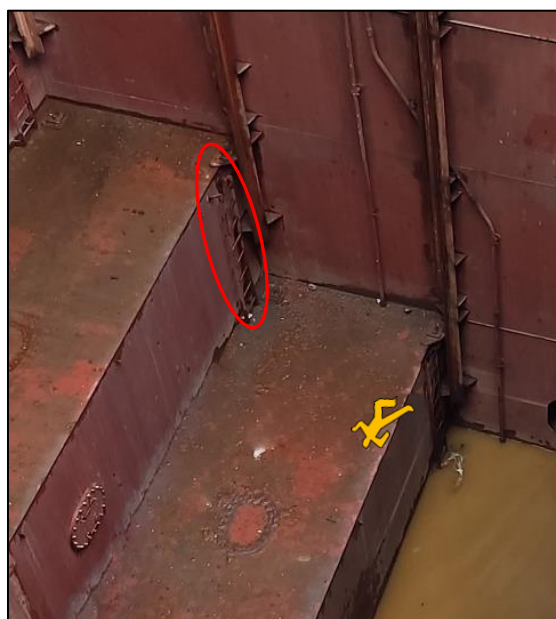
As mentioned elsewhere in this safety investigation report, the fatally injured stevedore was found about 5.5.m from the nearest vertical ladder. Since his final position was deemed too far off from the ladder, it was considered highly unlikely that he had slipped while ascending / descending that ladder (**Figure 5**).

Figure 5: Position of the body and the nearest vertical ladder

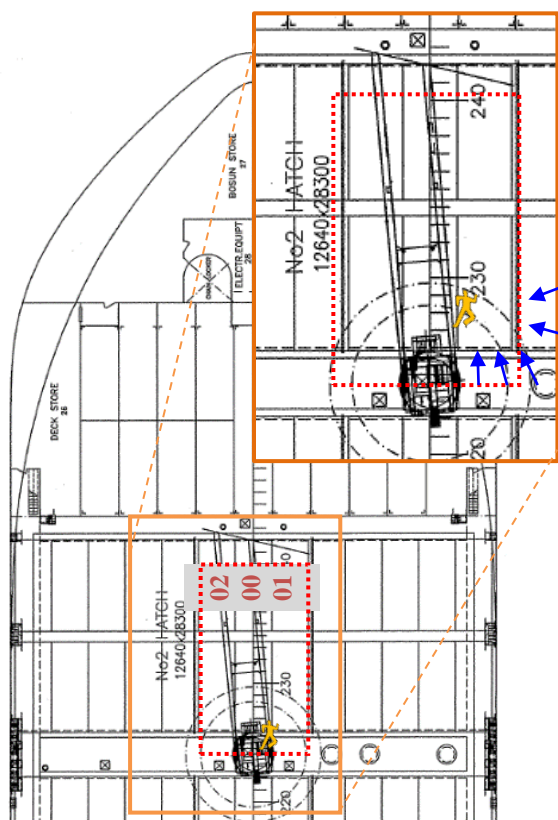
The centre hatch of bay 06 had been opened and placed on the port side hatch cover of the same bay. The removal of the centre hatch provided access to rows 01, 00 and 02 of the cargo hold for loading. It was not excluded that before the stevedore fell into the cargo hold, he was either standing on the starboard side hatch cover, or on the cross bay between bay 06 and bay 10, near the vessel's crane structure (**Figure 6**).

Figure 6: GA plan extract showing the open access to the cargo hold's centre relative to the fatally injured stevedore's location. Inset – arrows showing possible locations from where the stevedore could have fallen

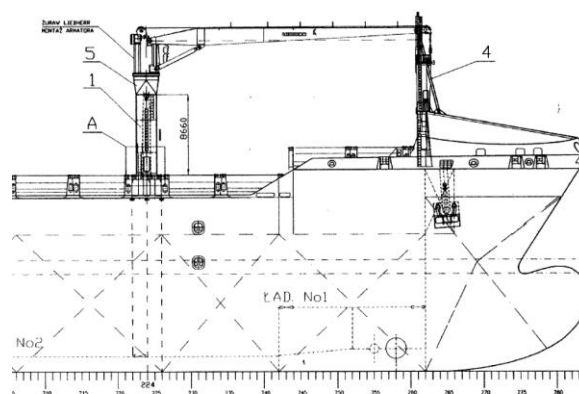
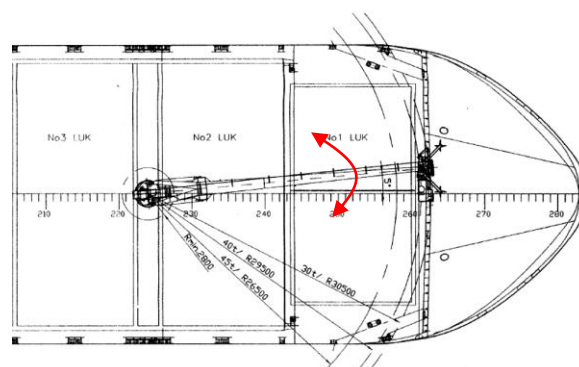
Figure 7: Deck crane details over cargo hold no. 1

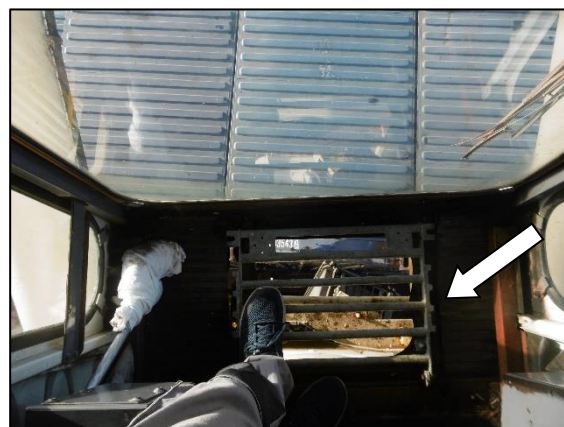
The access hatch faced forward (Figure 8) and provided access to, *inter alia*, the floodlights fitted to the crane. The hinges were fitted away from the front windowpane and therefore, the access hatch panel had to be pulled open towards the driver seat. Being an access panel, it was naturally wide enough for a person to go through. Then, the stevedore did not appear to have a large physique and would have managed to pass through.

Photos confirmed that there were no material defects which could have caused an accidental opening of the hatch. Therefore, it would have been a voluntary action by the stevedore if indeed, he slipped out of the cabin through the maintenance access hatch. The safety investigation, however, could neither confirm this nor determine why the

Figure 8: Maintenance access hatch inside the deck crane's cabin
