SAFETY INVESTIGATION REPORT

REPORT NO.: 14/2023

September 2023

MT VS SALOME **Fatal overboard fall of a crew member** **while disembarking at** **Teesport anchorage** **on 26 September 2022**

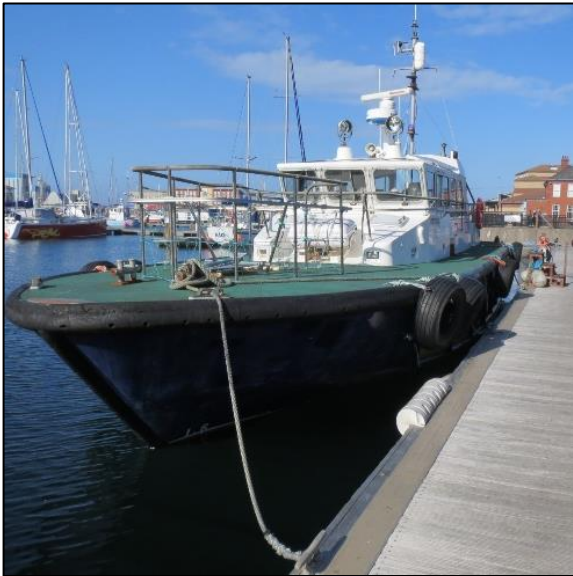
The service boat *Portunus* (**Figure 2**), an ex-pilot boat operated by Cook Marine Ltd., was tasked to pick up the disembarking personnel at 1145. By 1310, it departed from the base station in Hartlepool. *Portunus* was manned by a skipper and a deckhand.

Figure 2: Service boat *Portunus*

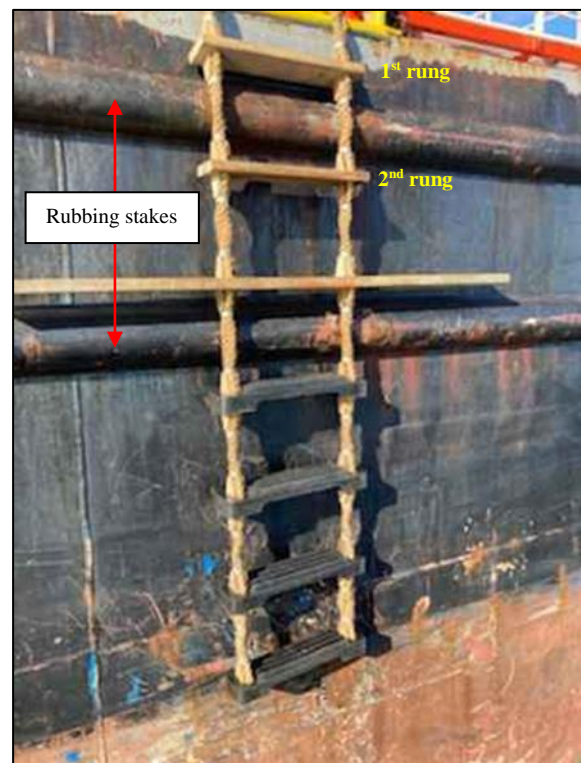
By about 1356, the main engine was prepared. The disembarking master took a VHF radio from one of the ABs and asked the bridge to go 'dead slow' on the main engine and the wheel 'hard to port'. A short while later, after a lee had been achieved, the disembarking master stepped on to the first rung of the pilot ladder. A reconstruction of the positioning of the pilot ladder is shown in **Figure 3**.

Figure 3: The pilot ladder

The master was in the process of placing his left foot on the second rung, when his foot slipped, and his shoe came off. He lost his balance and fell backwards into the water between the vessel and the service boat that had yet to come alongside in a position to receive the disembarking personnel. The lifejacket inflated upon his entry in the water. On board the vessel, the manoverboard alarm was raised by the crew over the VHF radio. Crew members threw a lifebuoy with a line attached to it to the master, and encouraged him to hold on to the lifebuoy, which the master did. The main engine was also stopped.

The loss of the master's left shoe suggested that while descending the pilot ladder, his left foot did not make full contact with the depth of the second ladder rung, possibly triggering the loss of balance.

It also appeared that when he was descending on to the second rung, he lost his shoe and balance when he was in the process of transferring his weight from the right leg on to the left leg. The loss of balance was more than likely to have been caused by the heavy backpack that weighed just over 10 kg. This would have exacerbated his situation to recover his balance. Moreover, it also explained the eyewitness' accounts that when the master let go of his right hand (that was holding on to the right stanchion), he pivoted to the left, and fell backwards.

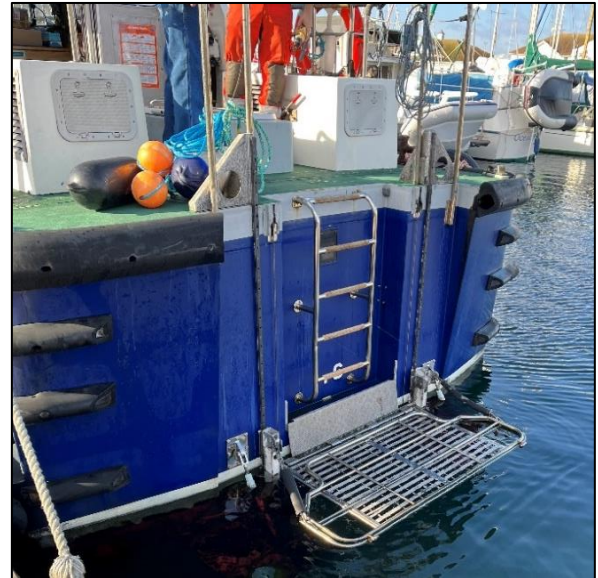
In the meantime, the third mate climbed down the pilot ladder to hold on to the master but had to climb back due to the sea and swell. The service boat attempted to snag the master to recover him on to the manoverboard cradle (**Figure 4**) but could not do so.

At about 1403, the service boat reported that the master had lost consciousness and was drifting under the stern of the vessel, out of sight of the crew and service boat. However, in a few minutes, the master floated clear of the vessel's stern and was caught by the service boat's boat hook and pulled towards the aft end of the service boat to recover him from the water, using the dedicated manoverboard cradle (**Figure 4**).

The master's backpack hampered his rescue as it kept getting snagged on the cradle. The skipper then climbed down on to the cradle to lift the master on it before being hoisted to

Figure 4: Manoverboard rescue cradle

14/2023_R2 consider keeping on board a manoverboard rescue pole.

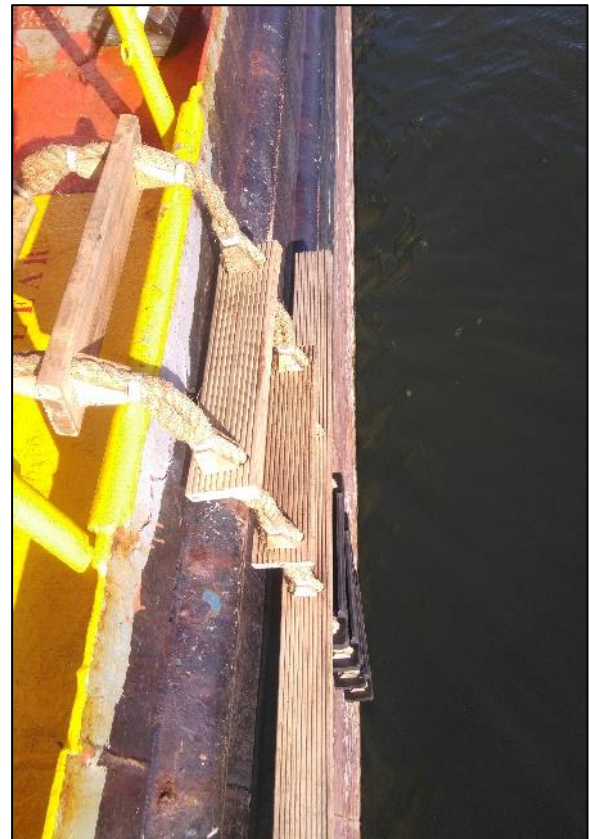
The safety investigation also considered an alternative scenario where, while descending the ladder, the master may have inadvertently stepped on to the rubbing strake (**Figures 3 and 5**) that had a round profile and protruded by about 8 cm from the hull. It was observed that although the pilot ladder steps rested firmly, the steps were held off the ship side because of the rubbing strakes, which may be also viewed as a trip hazard.

However, a closer inspection of the pilot ladder led to the exclusion of this scenario. It appeared to be an unlikely one because the distance between the rubbing strake and the first rung was too narrow for the master to accidentally insert his foot on the rubbing strake instead of the ladder rung (**Figure 3**). The crew members witnessing the accident recalled that it was the loss of the master's left shoe which had led him becoming unbalanced and, unable to regain it back, he fell backwards.

Figure 5: View of the pilot ladder from top

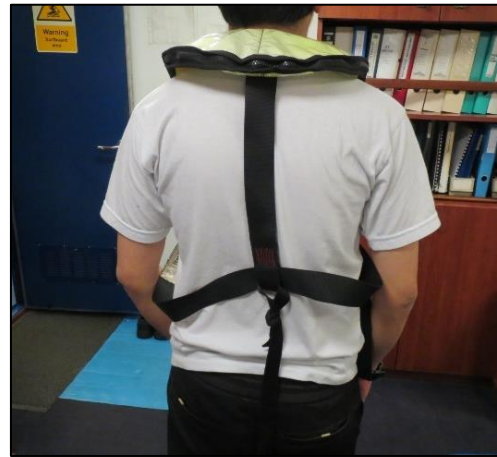
The lifejacket had been donned over the backpack, which resulted in two safety considerations. Due to the bulkiness of the backpack worn by the master, the crotch line could not be made fast (**Figures 6 and 7**)².

Figure 6: Back straps of the lifejacket

With no crotch strap made fast, when inflated, the lifejacket would just ride upwards and possibly obstruct the face, resulting in either breathing difficulties, or water inhalation.

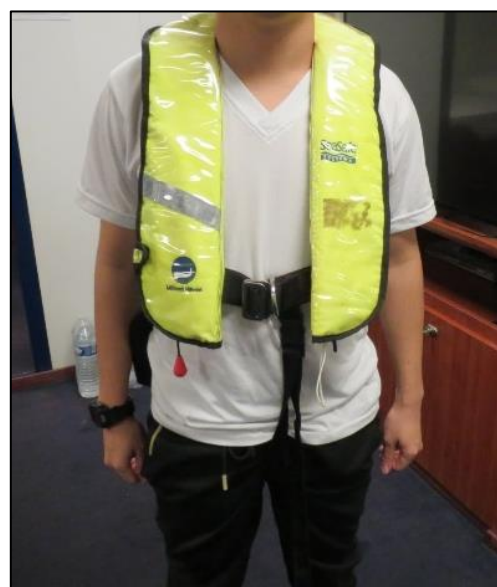
Figure 7: View from forward

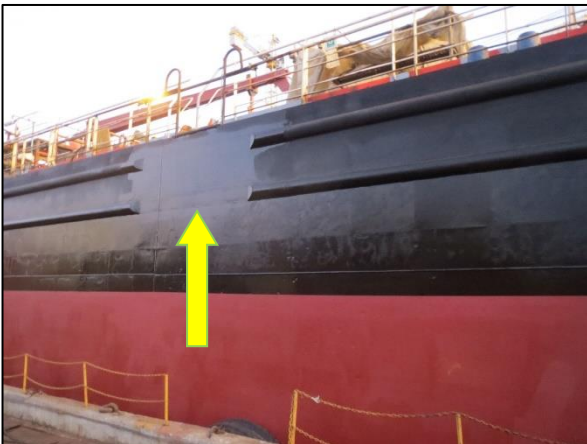
Figure 8: alterations to the vessel's shipsides, showing the removal of the rubbing strakes in way of the starboard side pilot station

- The pilot boarding position of the vessel has been reviewed and modified (**Figure 8**);
