SAFETY INVESTIGATION REPORT

REPORT NO.: 12/2023

July 2023

MT *SUNNY ISLES* **Fatal injuries to a crew member** **in the steering gear room,** **in position 21° 46' N 059° 58' E** **18 July 2022**

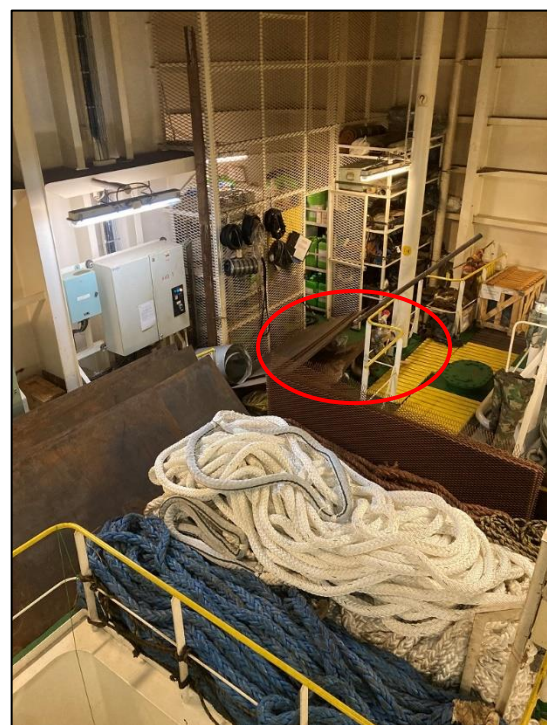
The fitter and MM 1 did not find the appropriate pipes for the task, and as they were leaving the steering gear room, MM 1 noticed a stack of spare steel plates resting against the guard rails at the starboard side of the steering gear. As he moved closer, he saw the second engineer trapped between the stack of plates and the guard rails (**Figures 3 and 4**)⁵.

Figure 3: Simulated photograph of the location at which the second engineer was found (red circle)

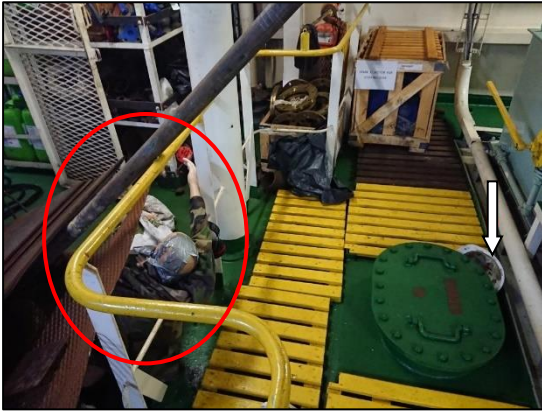
Figure 4: Simulation of how the second engineer was found (red circle); the second engineer's safety helmet can be seen near the manhole, to the left (white arrow)

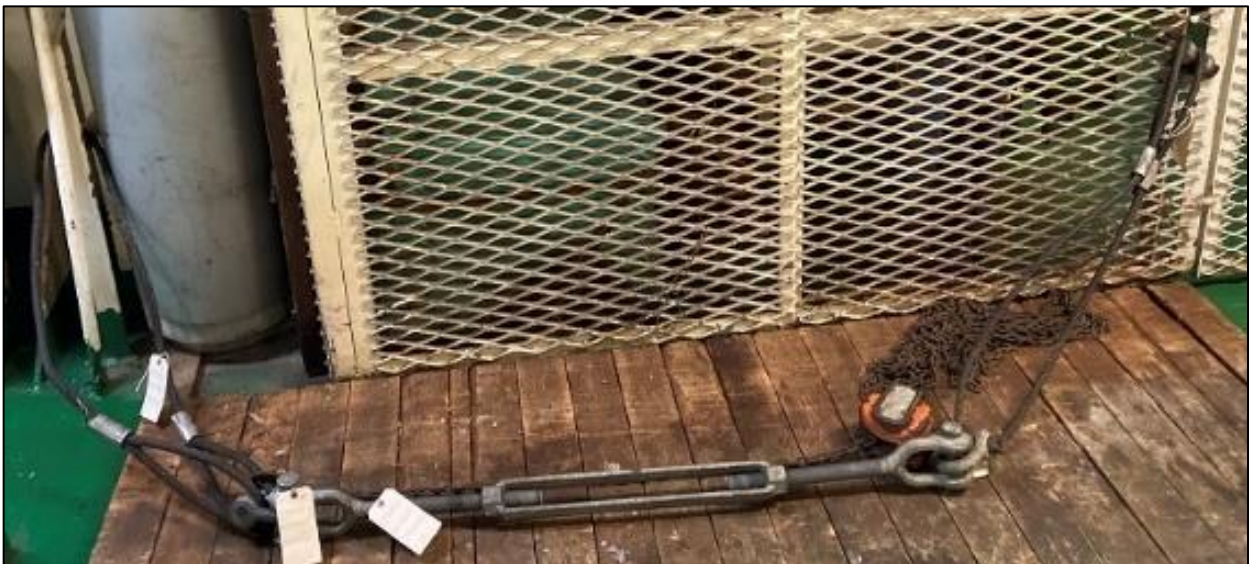
The arrangement (**Figures 5 and 6**) consisted of two wire slings, secured to the vessel's fittings, and connected by a turnbuckle across the face of the plates. A chain block was also connected to the wire slings, across the face of the steel plates.

Figure 5: Simulated photograph of the securing arrangement

It is likely that as the wire slings were pulled around the larger plates, there may have been some amount of slack in way of the smaller plates, if the securing arrangement consisted of only the turnbuckle and the wire slings. This may have led the crew members to consider the use of a chain block, whereby the slings could be held tight for further tightening of the turnbuckle. Additionally, once tightened, the chain of the hoist would tend to lay firmly against the stack of plates, thus appearing to serve as an additional means of securing.

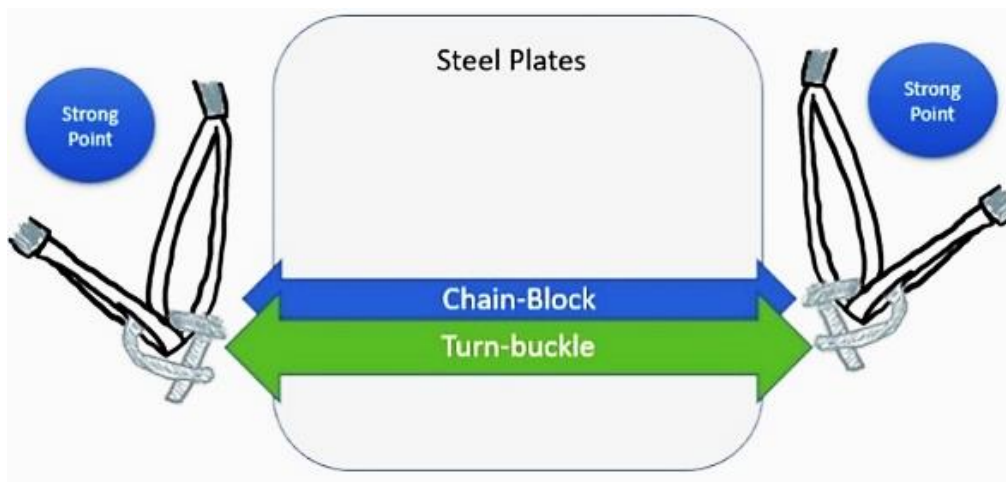
Figure 6: Sketch of the securing arrangement

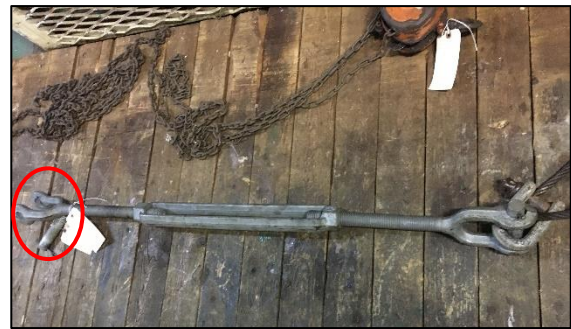
The crew members stated that, after the removal of all steel plates from the accident site, they found the turnbuckle and the hook at the running end of the chain block, released. They further found the pin at the released end of the turnbuckle not in place (**Figures 7 and 8**). The split pin⁷ (red arrow in **Figure 8**), which was designed to prevent the turnbuckle pin from slipping out, was found in the vicinity, intact but not in its place. No damages were observed on any part of the securing arrangement.

Figure 7: Photograph of the turnbuckle with the securing pin out of place at one end (red circle)

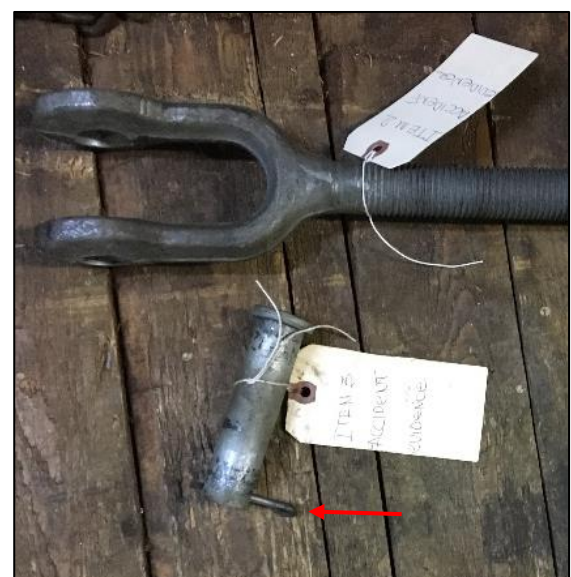
Figure 8: Close-up photograph of the turnbuckle with the securing pin (red arrow: split pin in place)

The crew members stated that they had found the split pin lying in the vicinity⁹, and its ends were found pressed together, thus suggesting that the split pin may have either been removed by the second engineer or slipped out at some point.

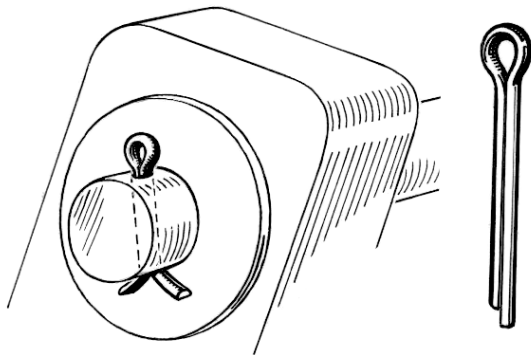
A split pin is used to prevent a bolt or securing pin from slipping out of its place. The pin is inserted into a pre-drilled hole in the bolt / securing pin and the ends of the pin are then twisted outwards to prevent the split pin itself from falling out (**Figure 9**).

Figure 9: Split pin (or cotter pin)

To remove the split pin, its (twisted) ends would have to be pressed and brought together again to allow it to be pulled out of the hole. If the ends of the split pin are not twisted outwards after inserting it in place, it may slip out in the event of any disturbance or vibration. The slipping out of a split pin would be even easier if its size is smaller than the one designed for the particular drilled hole.
