SAFETY INVESTIGATION REPORT

REPORT NO.: 17/2023

MV MILAGRO

Serious burn injuries to a crew member during maintenance work on a hydraulic pipe on deck, while drifting in position 37° 32' N 130° 20' E 26 September 2022

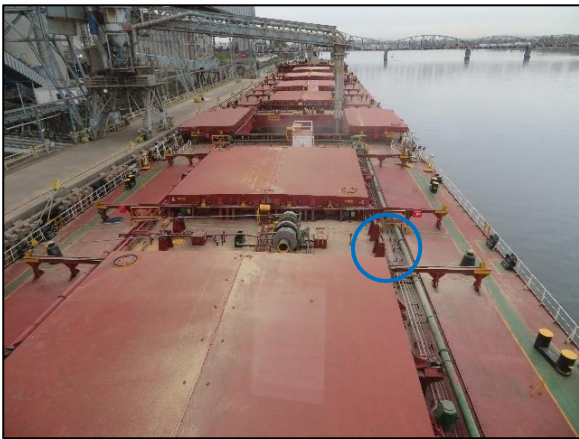
During the ballasting operations in the port of Donghae, Republic of Korea, the crew members noticed a stream of oil leaking from a 5 mm hole in a section of the hydraulic oil return pipeline for the water ballast tank valve remote operating system, on deck. This section was on the starboard side of the cross deck between cargo holds nos. 6 and 7 (**Figure 1**).

Figure 1: Location of the task (circled in blue)

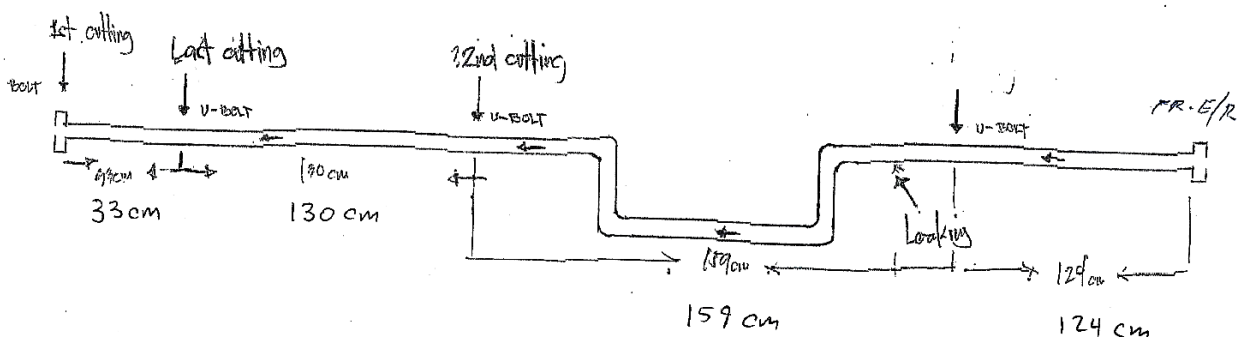
At about 0945, whilst the fitter was cutting the last U-bolt at the forward end of the pipe section (**Figure 3**), the pipe slipped down from the support on which it was resting.

Figure 3: Sketch of the hydraulic oil pipe section being worked on, indicating the location of the leak and the U-bolts, as well as the sequence followed by the fitter for cutting the bolts (provided by the crew members of *Milagro*)

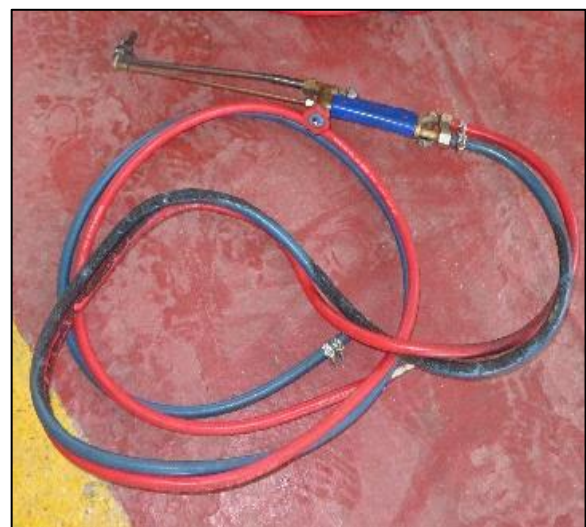
Crew members reported that none of the vessel's equipment / fittings were damaged. There were only signs of minor heat damages at around mid-length of the section of the oxy-acetylene hoses, which was closest to the torch (**Figure 4**).

Figure 4: Heat damages on the section of the oxy-acetylene hoses closest to the torch

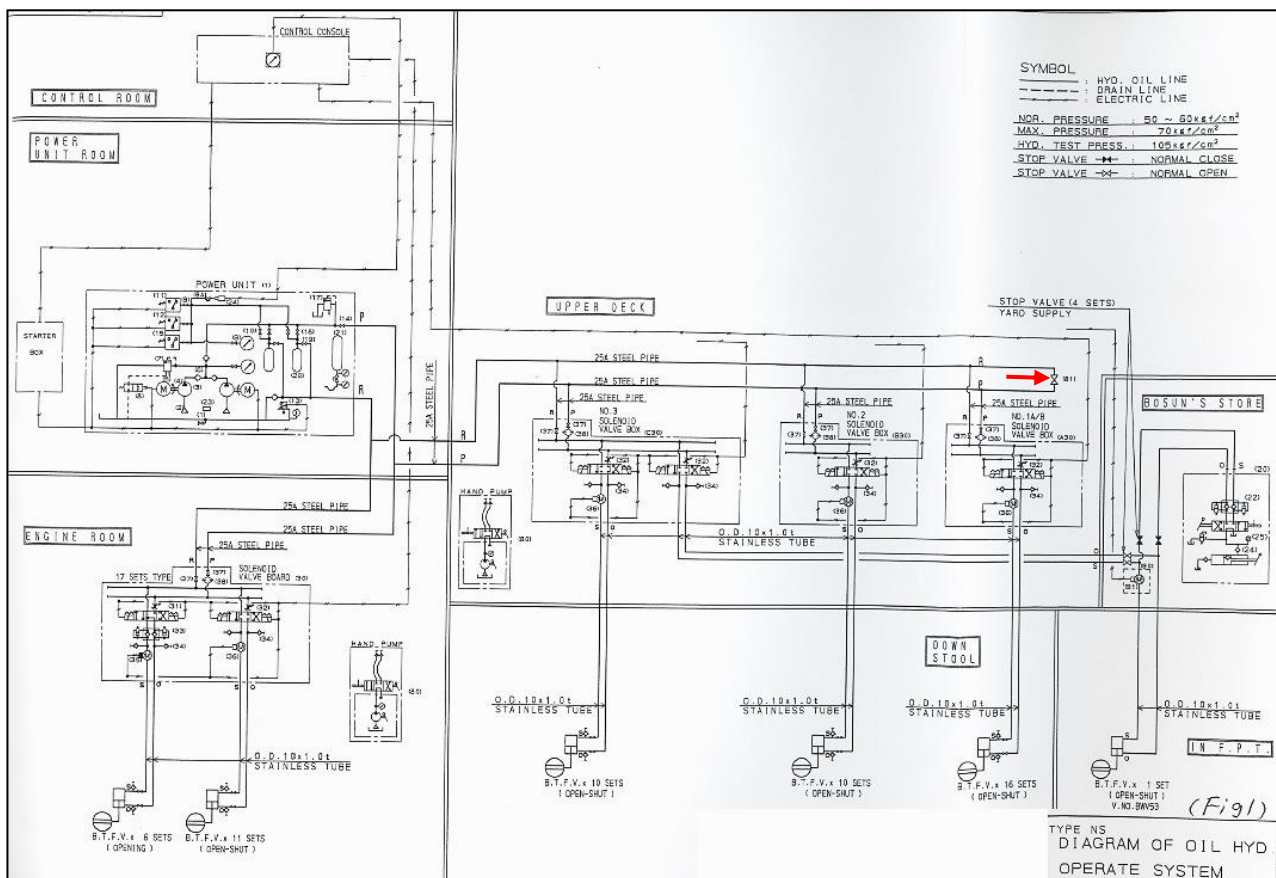
A cross-over valve (included in the schematic drawing – red arrow in **Figure 5**) connecting the delivery and return pipelines was not fitted on board, and the forward ends of the delivery and return pipelines were blanked off.

Figure 5: Diagram of the hydraulic oil pumping and piping arrangement for the water ballast tank valve remote operating system

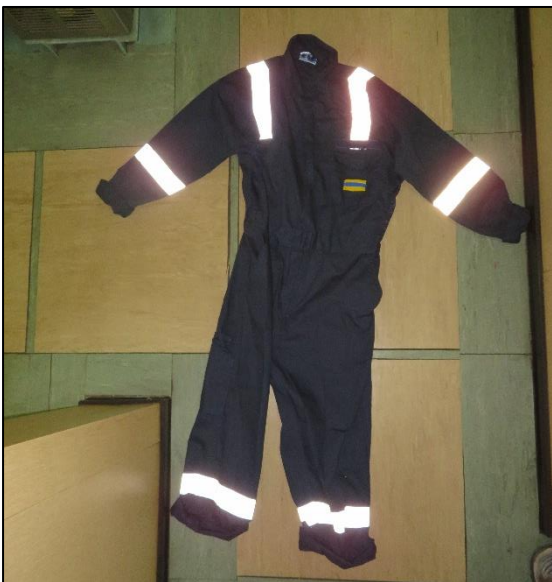
Figure 6: Coveralls similar to the one worn by the fitter for the task

The safety investigation observed that the coveralls did not bear any labels which would indicate whether they offered any degree of fire protection. However, considering that the seriously injured fitter was witnessed to have been covered in flames, it is highly likely that his coveralls did not offer any fire protection. Moreover, the spray of hydraulic oil would have contaminated his coveralls, causing it to ignite and allowing the fire to spread over it.

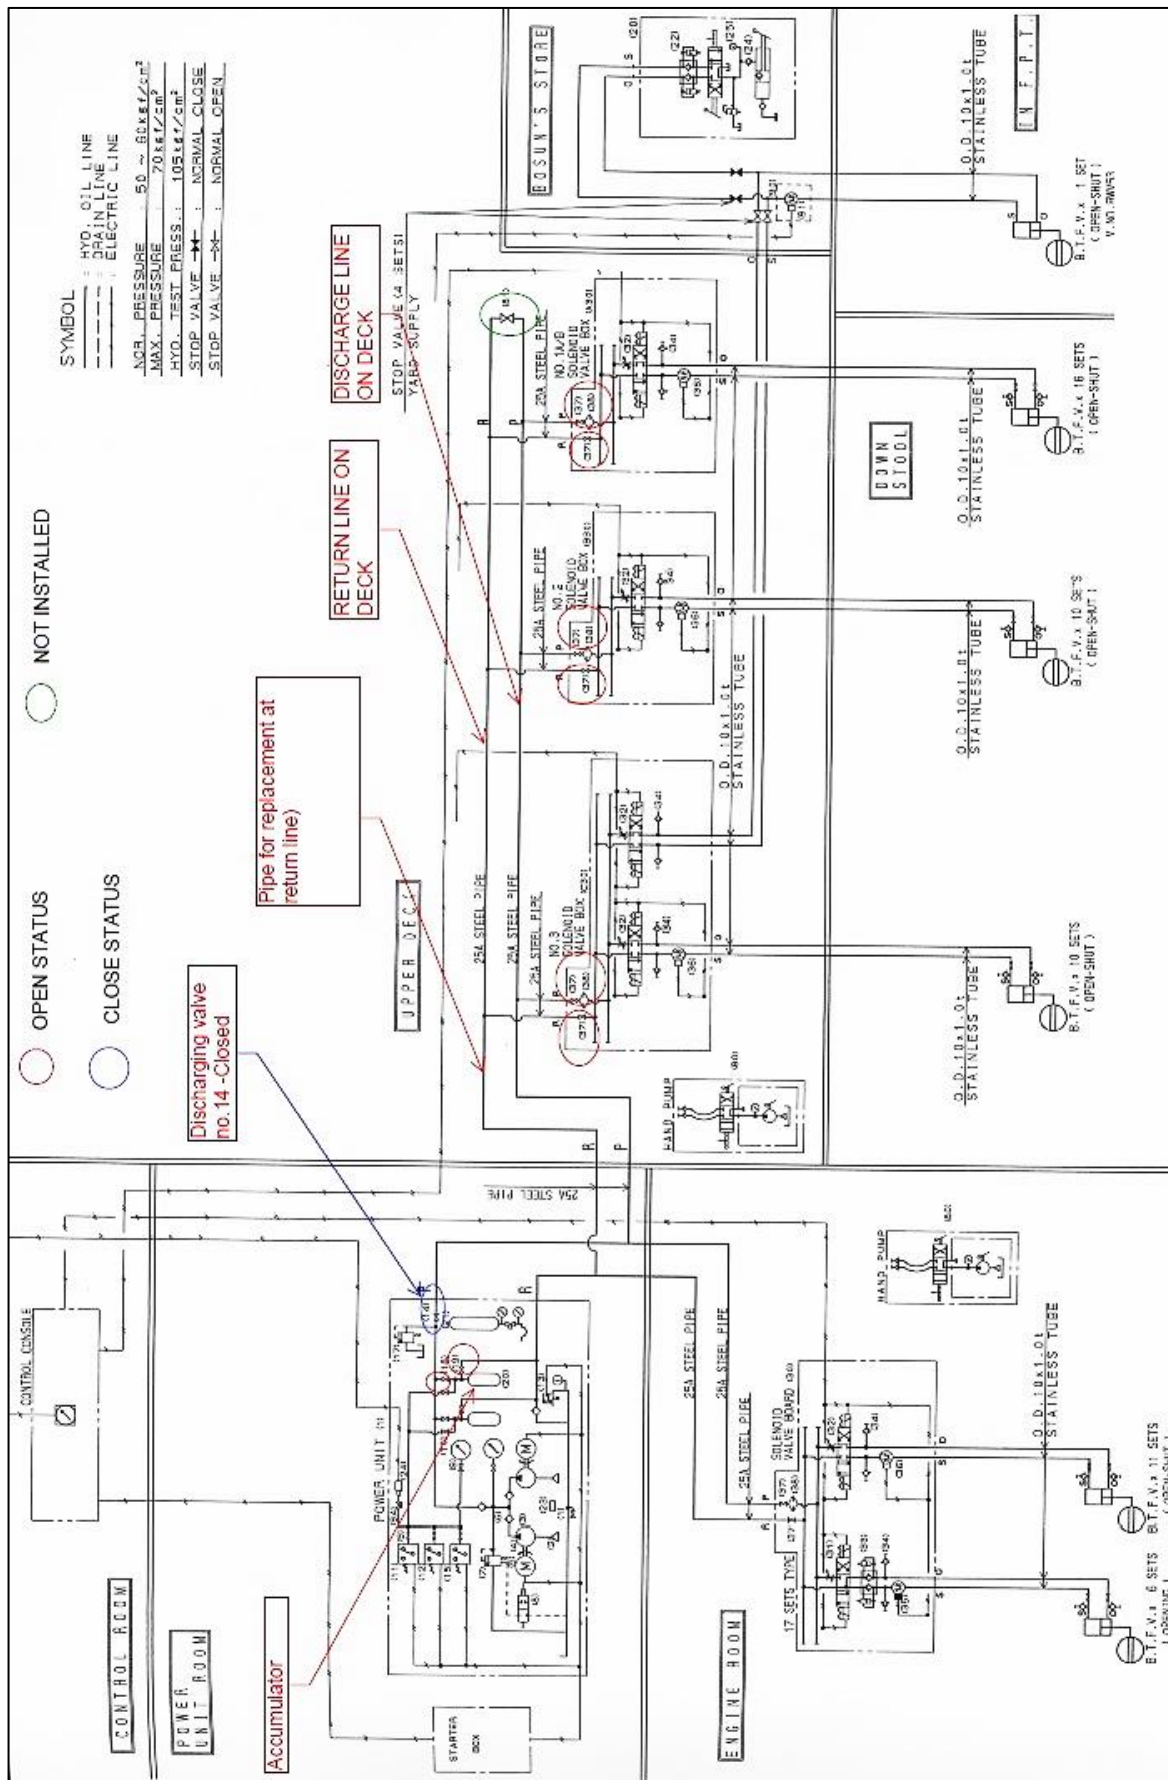
The third engineer informed the safety investigation that he had neither operated nor checked the isolation valves on deck. The safety investigation was later informed by the Company that, following the occurrence, the crew members inspected the status of the valves of the hydraulic oil system. In addition to the valve mentioned by the third engineer, they found that a valve in the engine-room, between one of the accumulators and the return pipeline, was

open (**Figure 11**). Consequently, the return pipeline may have still been pressurized by the accumulator. Furthermore, the (brief) spray of hydraulic oil onto the fitter after the pipe section slipped off the support, also suggested that the pipeline was pressurized.

If there was any residual pressure in the system, the pressure gauge on the accumulator should have indicated so. However, the crew members had neither checked the pressure gauges prior to the commencement of the task, nor had they monitored the gauges during the task.

Figure 11: Schematic drawing of the hydraulic oil pumping and piping arrangement for the water ballast tank valve remote operating system (markings and annotations by the Company)
