Tilting of Liftboat *L/B Robert*

On November 20, 2022, at 1256 local time, the liftboat *L/B Robert* was reported to be listing (tilting) alongside a stationary oil platform in the Gulf of Mexico near South Marsh Island Block 137, about 80 miles southeast of Lake Charles, Louisiana.¹ The crew had evacuated 2 days prior due to forecasted adverse weather in the area, leaving the vessel elevated out of the water and unattended. Following the casualty, vessel crewmembers, salvors, and personnel from the operating company assessed the damage and facilitated the tow of the vessel into port. No pollution or injuries were reported. Damage to the vessel and cargo was estimated at \$6.9 million.

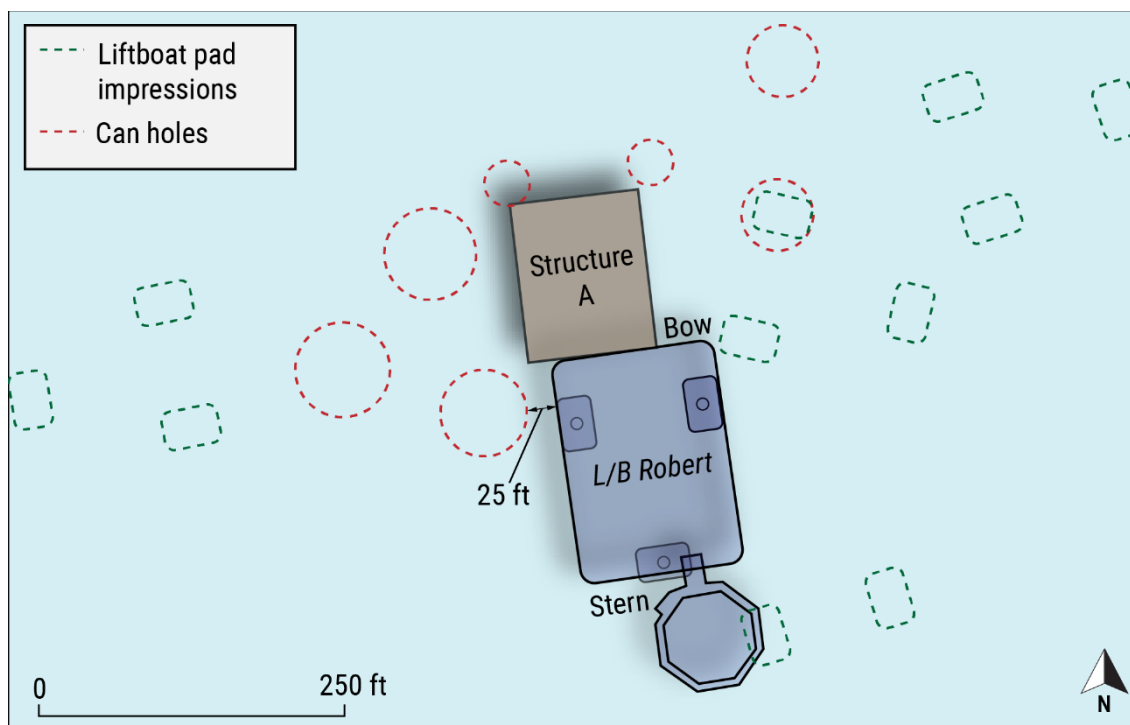
Figure 3. The *L/B Robert*, alongside the southern side of Structure A, and surrounding seafloor, including outlines of documented can holes and liftboat pad impressions from previous vessel jack-ups. (Data source: SEACOR Marine)

When the crew evacuated the *L/B Robert* on November 18, leaving it unattended, they left an air gap about 25 feet above the water's surface per guidance from shoreside management personnel to stay just at the maximum wave heights predicted by the weather forecasts, believing this would maintain the vessel's greatest resistance to overturning from the combined forces of wind and waves. The vessel was jacked up to an elevation of 267 feet, in a water depth of 217 feet, with the leg pads averaging about 25 feet of penetration into the seafloor. All these conditions were within the limits identified in the vessel's operations manual. The vessel had been elevated and operating for 6 weeks without incident, and the base map of the seafloor produced by a third-party survey company indicated no obstructions, debris, or can holes within 25 feet of the *L/B Robert's* three leg pads.

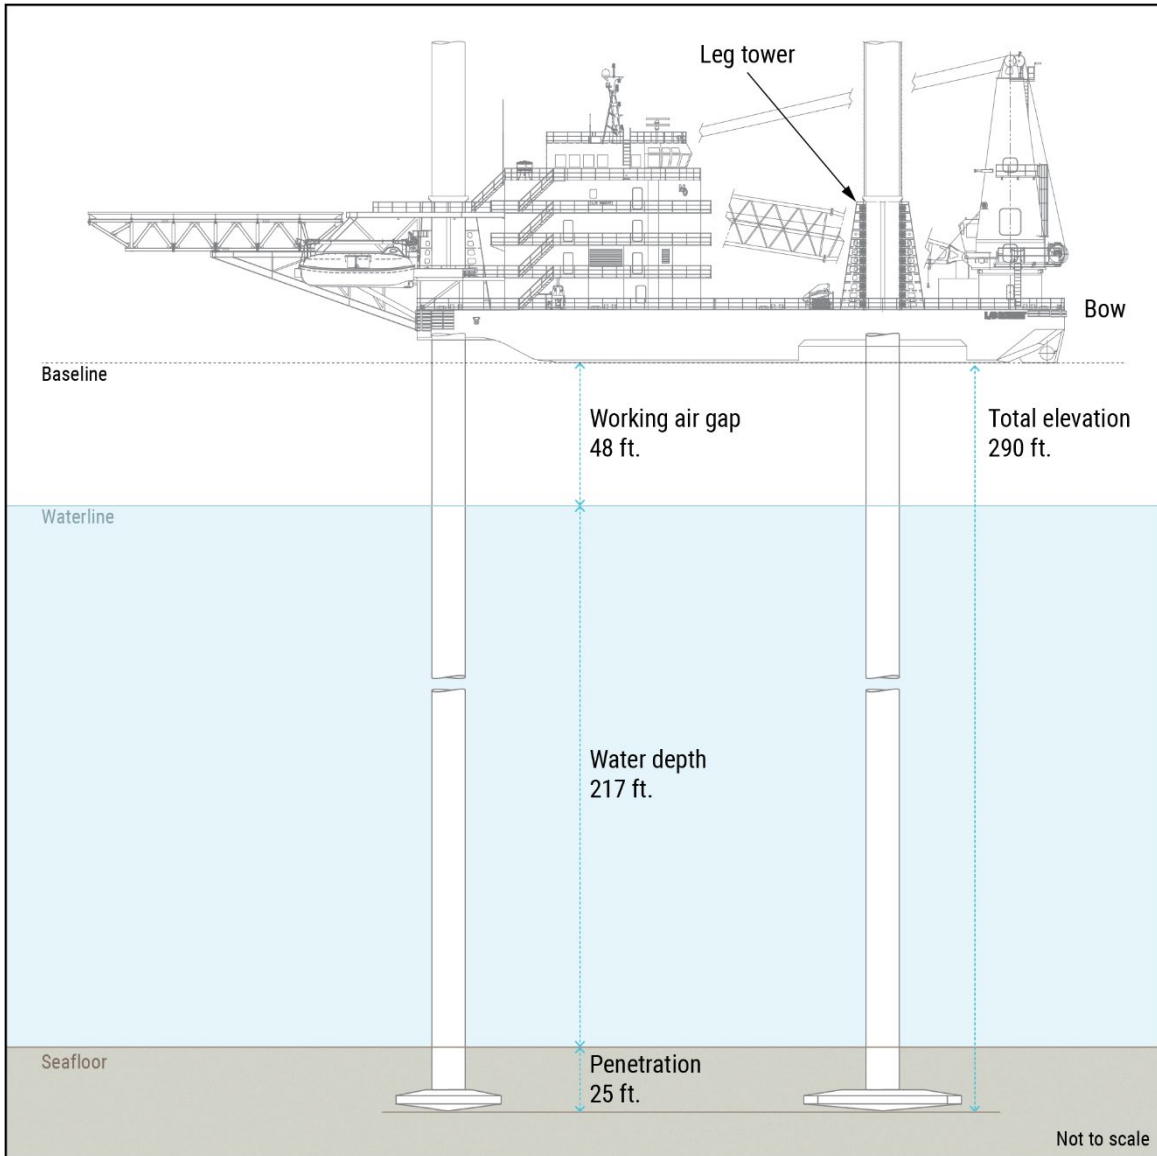
the vessel out of the water alongside Structure A in 217 feet of water. The three leg pads penetrated into the seafloor about 25 feet, leaving the vessel about 48 feet of working air gap. The crew measured this distance on board the vessel using a metered rope with a weight attached to the end.

Figure 4. *L/B Robert* approximate operating measurements at the casualty site after initially jacking up at Structure A in early October.

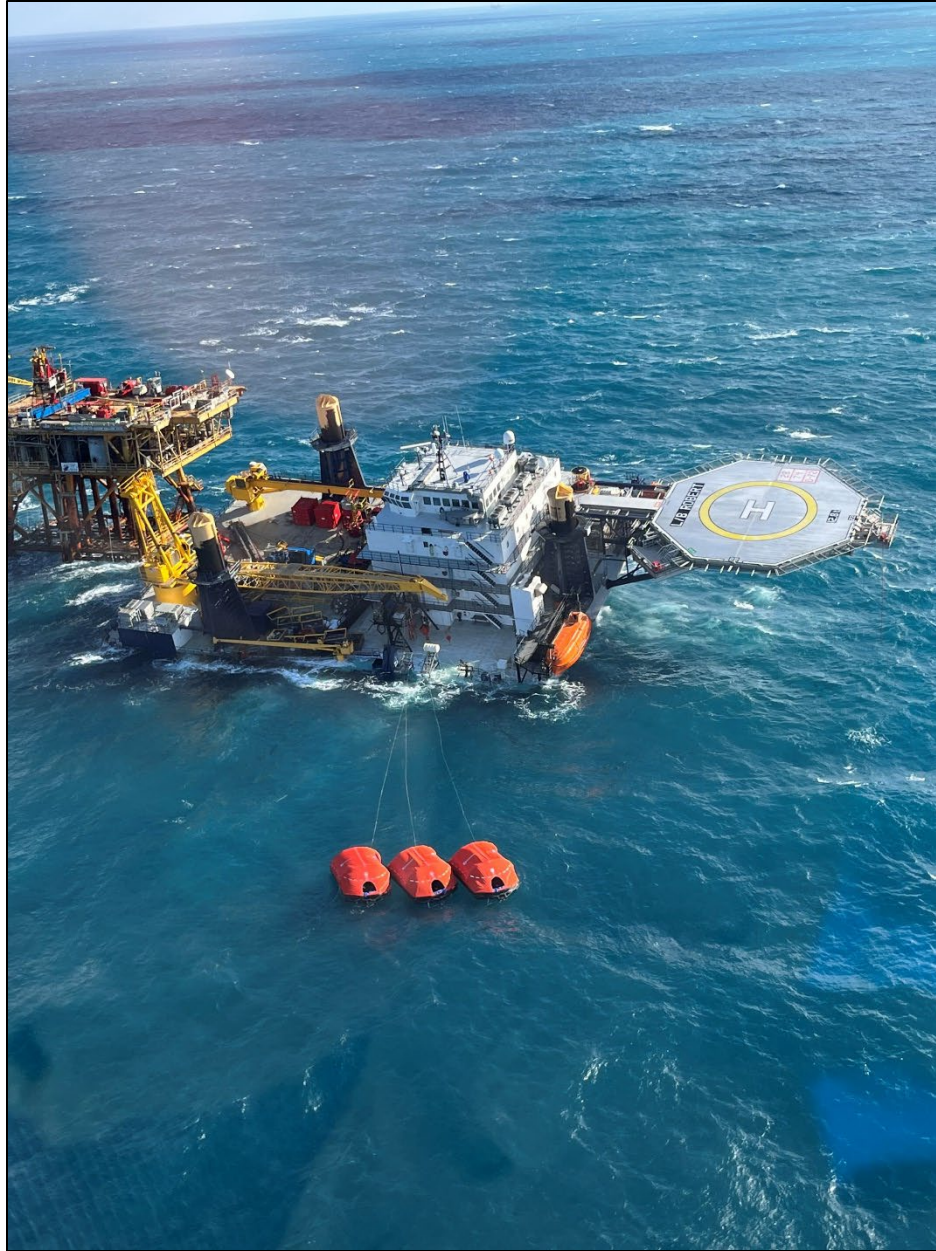
Two days later, about 0910 on November 20, recovered onboard CCTV that had remained operating after the crew evacuated captured video of the vessel slowly tipping to port (to the west). An hour and a half later, at 1040, the CCTV recorded the vessel leaning to port and deck cargo shifting in the same direction. Later, at 1256, a helicopter crew transporting personnel from another rig in the area flew over the *L/B Robert* and noticed the liftboat was listing (tilting) to port. The vessel remained supported by its legs, but the port deck edge was submerged and three of the vessel's liferafts had inflated and floated away from the vessel (they were still attached by their sea painters). The helicopter crew notified the US Coast Guard, and the Coast Guard contacted the operating company.

Figure 5. *L/B Robert* tilting to port as seen on November 21, 2022, at 0914. (Source: Coast Guard)

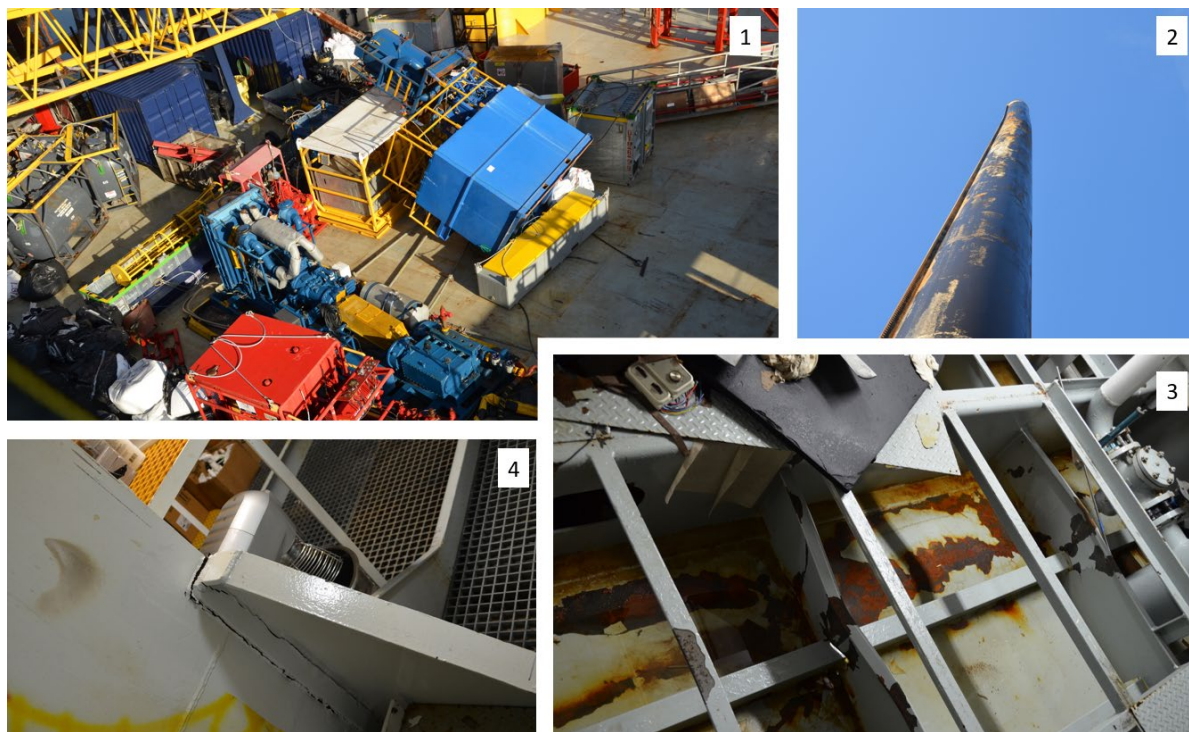
In addition to the cargo that shifted and was damaged, the *L/B Robert* sustained multiple stress fractures around the vessel on bulkheads and decking, including in port and starboard z-drive thruster rooms (one in the starboard thruster room created a hull breach). All three legs showed deflections and several cracks toward their upper sections where they were housed inside the jacking leg towers. The racks that facilitated jacking on all three legs were also damaged, consistent with the leg deflections. Total damage costs were estimated to be \$6.9 million.

Figure 6. Damage sustained during the *L/B Robert* casualty, including shifted deck cargo (1), leg deflections (2), starboard z-drive room damage (3), and port z-drive room damage (4). (Background source: SEACOR Marine)

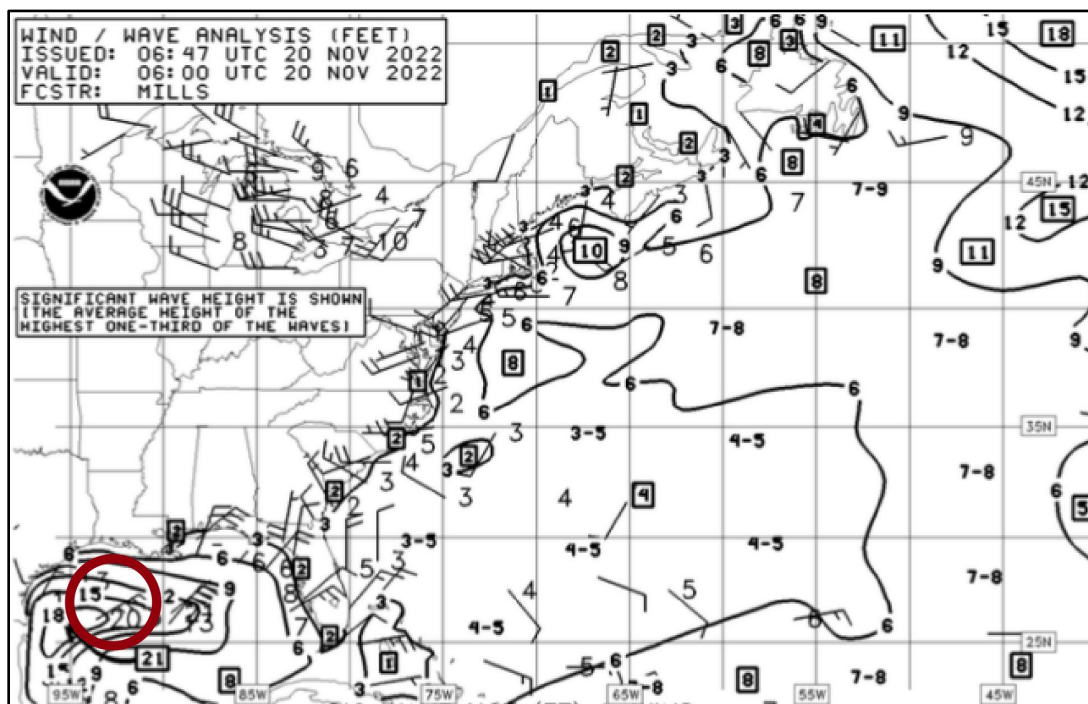
The closest weather stations with significant wave height information included Stations 42002 (about 157 miles southwest of the casualty site) and 42019 (about 173 miles west of the casualty site). Data from these stations indicated the casualty site may have experienced significant wave heights as high as 6.9 meters (22.6 feet) and 4.9 meters (16.1 feet) on November 19.⁶ The Ocean Prediction Center, which is responsible for National Oceanic and Atmospheric Administration forecasts for the northern Atlantic and Pacific Oceans, completed a wind and wave analysis of the casualty location and found significant wave heights between 12 and 15 feet on November 20 at midnight.

Figure 7. Ocean Prediction Center marine wind and wave analysis, valid until November 20 at midnight, with casualty location circled in red. (Background source: Ocean Prediction Center)
