Marine Safety Investigation Report

VERY SERIOUS MARINE CASUALTY | 05 February 2024

Beluga Reefer

Heavy Weather Casualty 30 June 2023

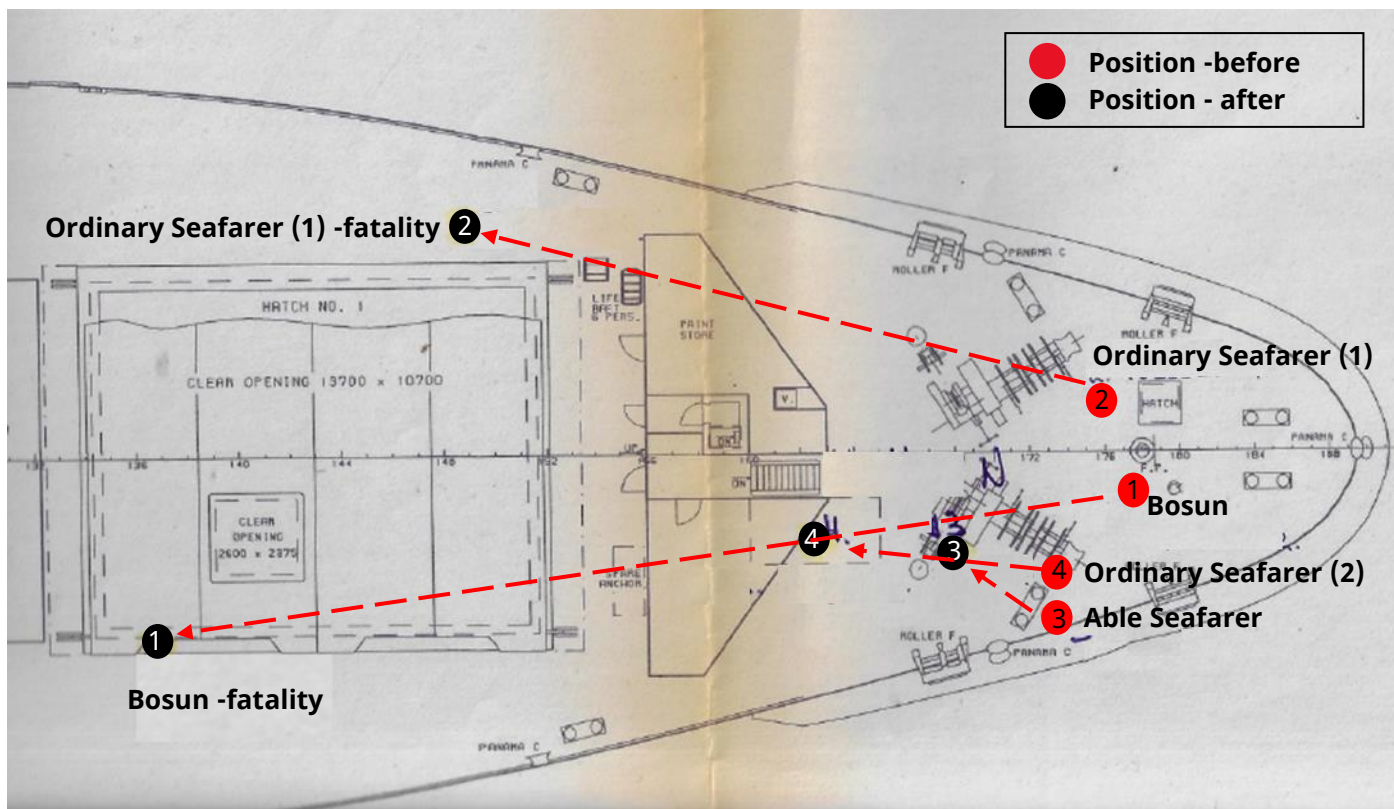
Four crew members were at the forward mooring station to secure mooring lines when the vessel was struck by a series of large waves, washing the four crew members off their feet, and propelling them into the ship's structure and deck machinery. Of the four crew members, two suffered fatal injuries, one sustained minor injuries and the other required emergency medical assistance ashore.

At around the same time the bosun and deck crew had woken, had lunch, and were preparing to return to work. At around 13:45 the bosun and members of his deck team made their way forward to make fast the lines and secure the deck machinery. Shortly afterwards the vessel was struck by a series of large waves, breaching the forecastle, washing the crew off their feet.

Before and after positions of crew when waves struck

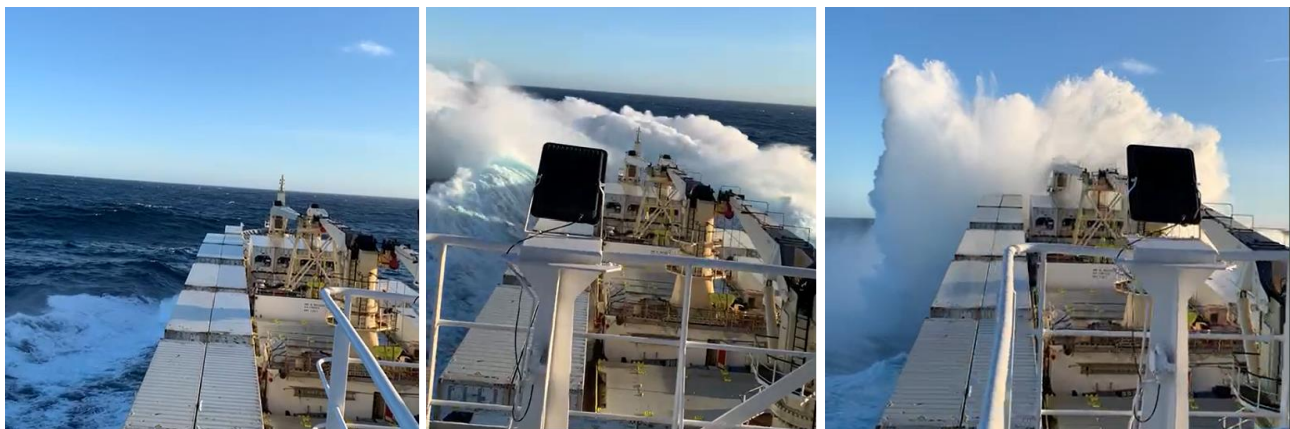
Prior to departure the weather forecast showed a deep low pressure frontal weather system in the Indian Ocean approaching the coast of South Africa. Wind strength of force five to six, occasionally gale-force eight from the southeast, veering to southwest had been forecasted, with a swell height of three to four metres from the southwest. The planned passage was into the wind and swell.

Conditions of weather as seen from the bridge one hour post-casualty
