January 24, 2024

MIR-24-02

Flooding and Sinking of the Towed Cargo Vessel *Carib Trader II*

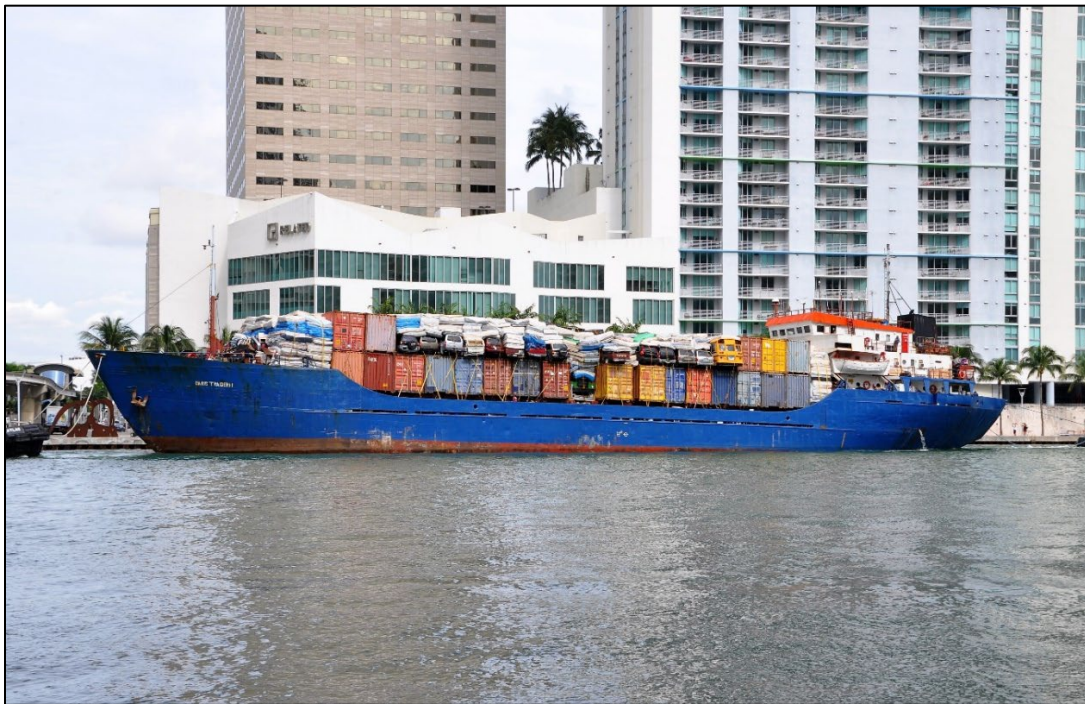
Figure 1. *Carib Trader II* pre-casualty. (Source: Gordon Dalzell, shipspotting.com)

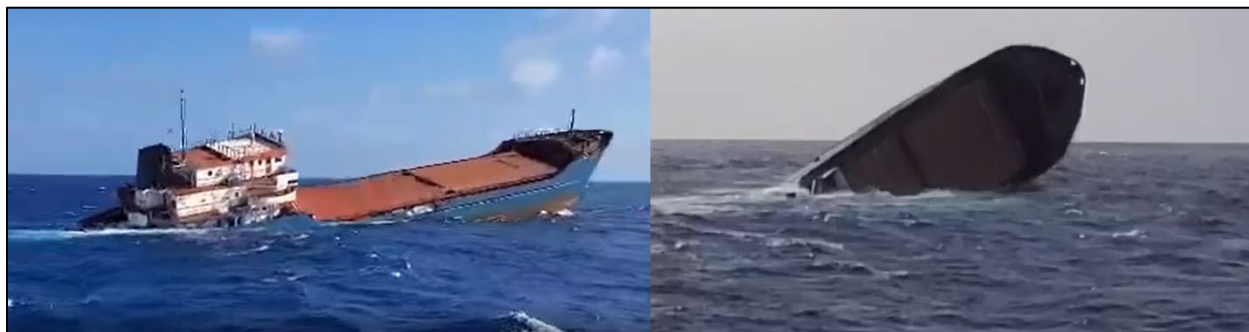
At 1100, the mate reported to the captain that the pump was not keeping up with the flooding. The captain told investigators that, by 1500, it became obvious that the *Carib Trader II* would sink. The *Carib Trader II* started listing to starboard and, about 1520, the mate departed the cargo vessel. The captain did not think the crew would be able to disconnect the tow before the *Carib Trader II* sank, so all of the tow wire was payed out to get the *Capt. Beau* as far away from the towed vessel as possible before the engineer cut the wire. The *Capt. Beau* remained nearby while the *Carib Trader II* continued to sink (see figure 3).

At 1620, the *Carib Trader II* sank stern first in a water depth of about 3,300 feet, taking the towing wire and bridle with it and leaving a small debris field. After the sinking, the *Capt. Beau* returned to Miami.

Figure 3. *Carib Trader II* during the casualty. (Source: *Capt. Beau* crew)
