## MARINE SAFETY INVESTIGATION REPORT

**Safety investigation into the engine-room fire on board the  
Maltese registered oil / chemical tanker**

***GRETA K***

MARINE SAFETY INVESTIGATION REPORT NO. 04/2024

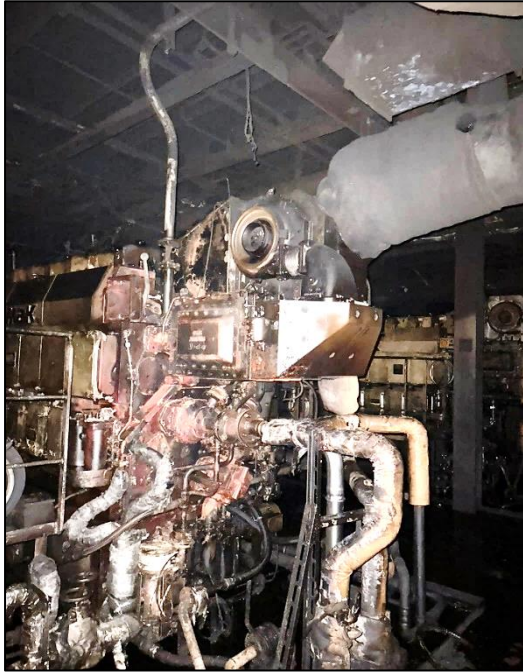
heat and / or smoke damage. **Figures 9 to 14** catalogue the extent of fire damage in the engine-room.

**Figure 9: Auxiliary engine (port side)**

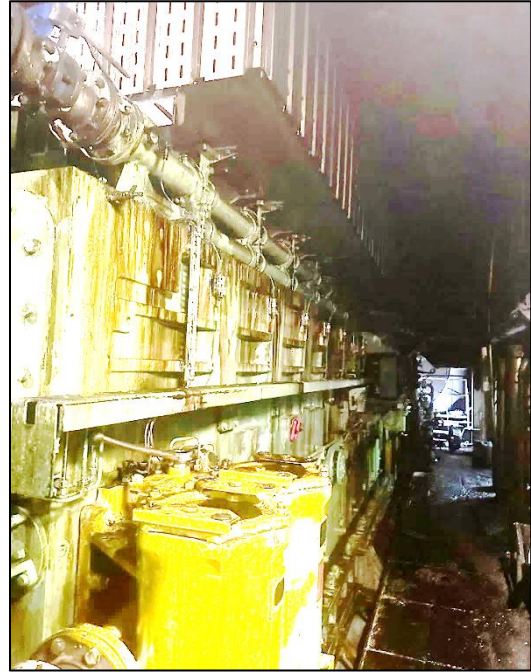
**Figure 10: Main engine view forward**

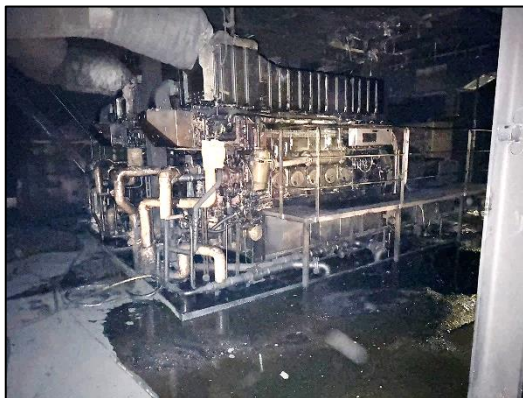
**Figure 11: Auxiliary engine (starboard side)**

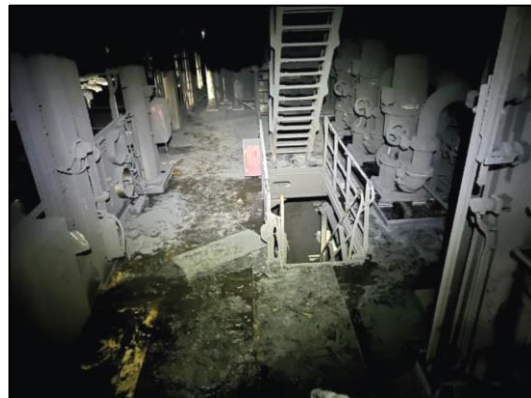
**Figure 12: Staircase to the lower platforms**

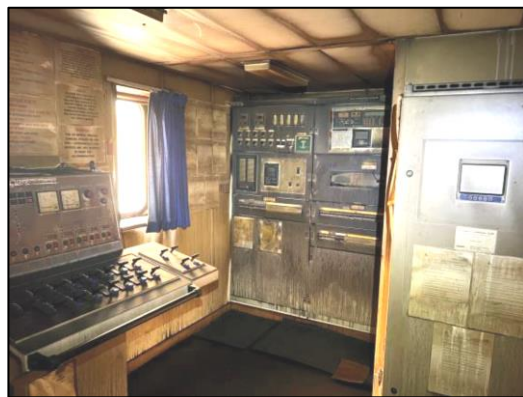
**Figure 13: Cargo control room**

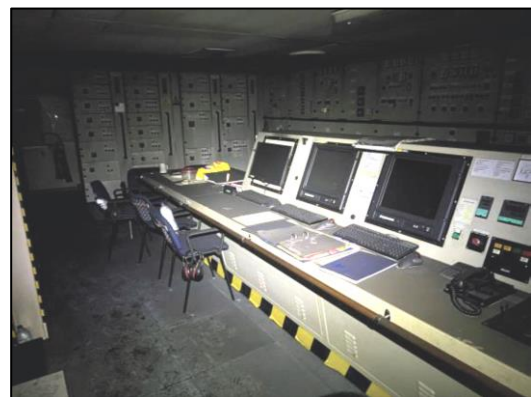
**Figure 14: ECR**

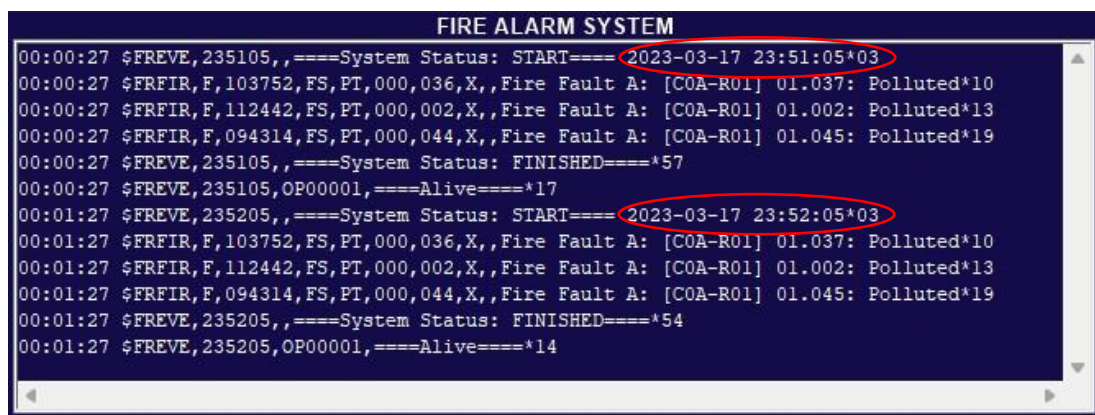
**Figure 16: Screenshot showing fire alarm system faults**

The safety investigation was of the view that the smoke detector located in the area (1.045) should have triggered the fire alarm first, but the VDR records indicated that it was faulty.

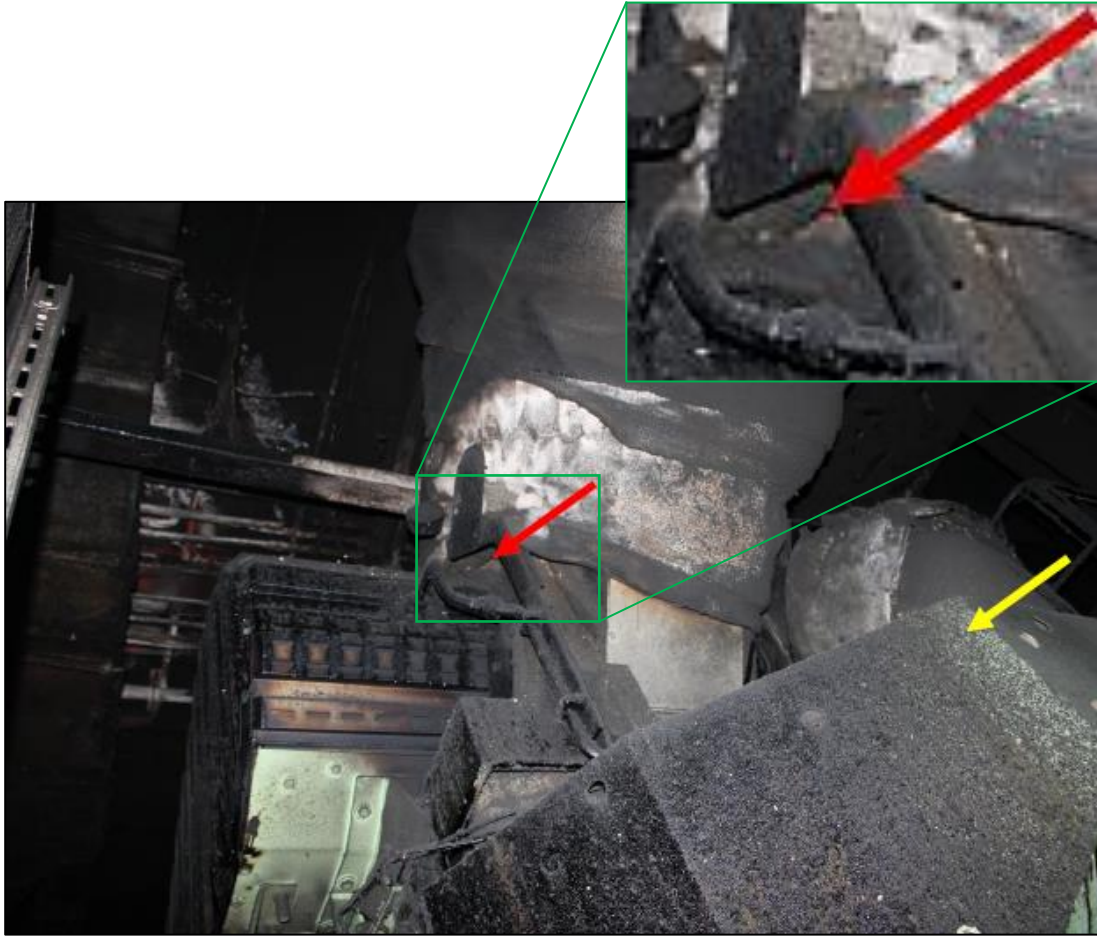
Fire experts on board suggested that the cause of the fire appeared to be related to the MDO pipe's flanged connection failure, which allowed MDO to spray onto the main engine's exhaust gas turbine. A small unshielded section, where the turbocharger connected to the exhaust manifold, ignited the MDO as it reached its auto-ignition temperature. This observation was based on the loose nut and bolt found on the MDO pipe's flange during the post fire survey and the direction of fuel spray seen on and around the main engine's turbocharger exhaust gas turbine.

**Figure 17** shows the main engine's turbocharger from below, on the aft portside of the main engine. The red arrow shows the location of the gap in the exhaust pipe's insulation and the yellow arrow shows the oil droplets residue on the engine's casing. The unaffected paint below the turbocharger casing indicated that the oil spray came from above and port side of the engine. Therefore, in the absence of any accident data, which indicates otherwise, the fire was considered likely to have been caused by fuel spraying on to a hot surface, that had a temperature which exceeded 220 °C.

**Figure 17: Main engine turbocharger on the aft portside with oil spray residues**

- .1 A gap in the main engine turbine's exhaust gas piping insulation provided the heat source to ignite the leaking oil spray;
- .2 The engine room's smoke and heat detectors did not detect the fire as they appeared to have been either isolated or faulty;
- .3 Failure of the hyper-mist fire extinguishing system was likely to have contributed to the spread of fire and further damage to the machinery and engine-room;
- .4 The damage to the automatic fire damper during the early stages of the fire may have likely contributed to prolonging the fire as it reduced the effectiveness of the CO<sub>2</sub> and kept the fire alive with an intake of air from the damaged ventilation.

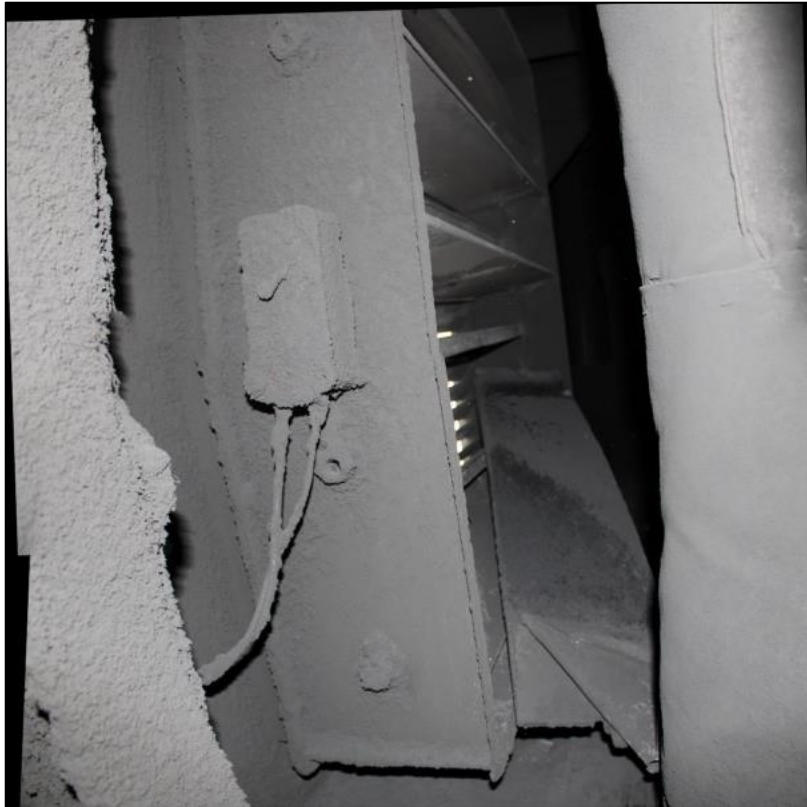
During the examination of the engine-room's ventilation dampers on the engine casing (in way of first crew deck – **Figure 18**), the lower damper was found to be fully closed; however, the upper damper was found in the partially opened position with the louvres bent inwards and deformed due to mechanical damage. The lowest louvre was also noted to be hanging on one pivot (**Figure 19**).

**Figure 18: Lowest louver covered in soot**

It was therefore concluded that the damage to the fire damper during the early stages of the fire, reduced the effectiveness of the CO<sub>2</sub>, had likely contributed to the prolonging of the fire, and kept it alive with the ingress of fresh air from the damaged ventilation damper.

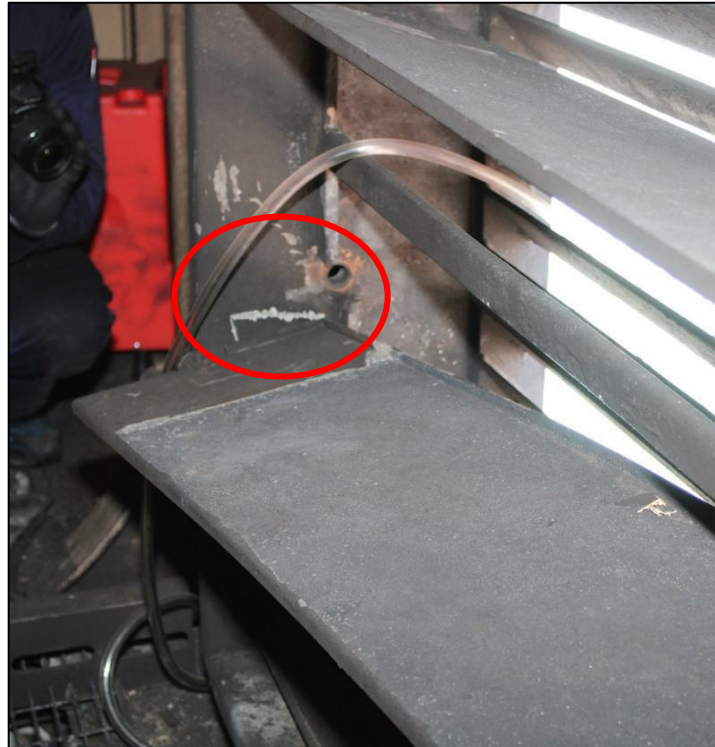
**Figure 19: Lower louver seen in a clean state**

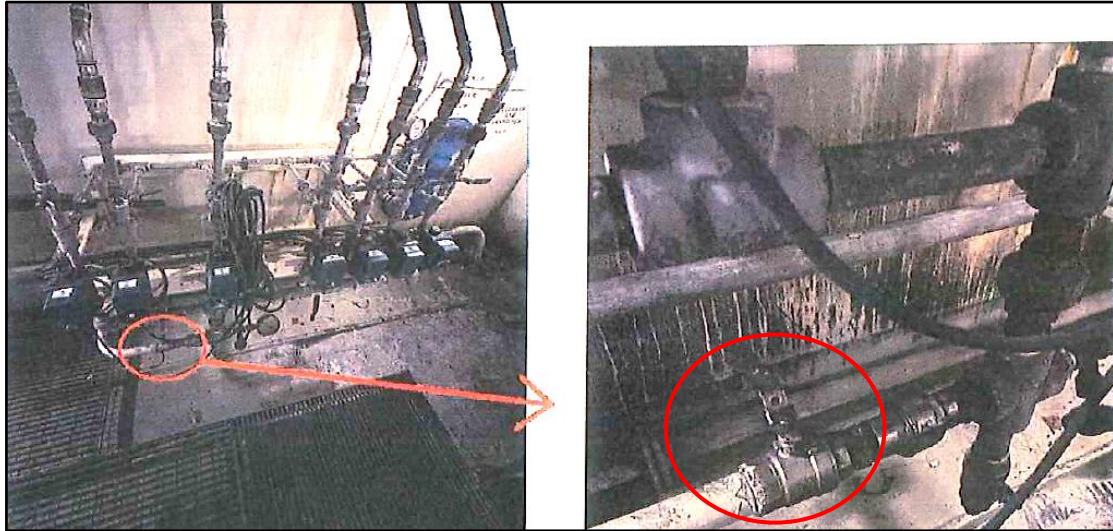
The inspection report also referred to a manual ball valve (arrow in **Figure 20**) as the ‘MAIN’ valve.

**Figure 20: Hyper-mist system piping arrangement in the steering gear compartment**

This valve was found in the ‘CLOSED’ position. Unless its position had been changed, this may have been the reason behind the hyper-mist system not activating. However, due to a gap of about eight months between the fire and post-fire inspection in the dry dock, the position of the ball valve may have been inadvertently changed and may not have been in its actual position prior to the start of fire on 21 March 2023.
