MARINE SAFETY INVESTIGATION REPORT

**Fall overboard and subsequent loss of life of a crew member,
while securing a pilot ladder combination arrangement of the
Maltese-registered oil / chemical tanker**

MARINER A,

MARINE SAFETY INVESTIGATION REPORT NO. 03/2024

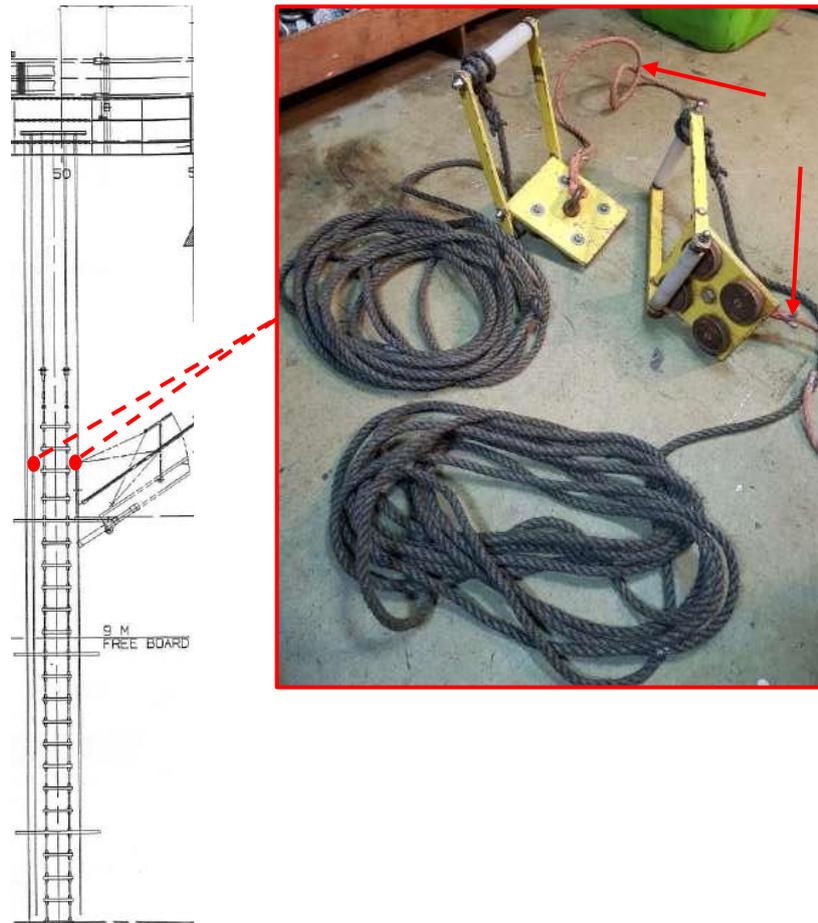
Figure 4: The pilot ladder rigging (red dots: the approximate location at which the magnets would be stuck by the crew members; inset: the magnets)

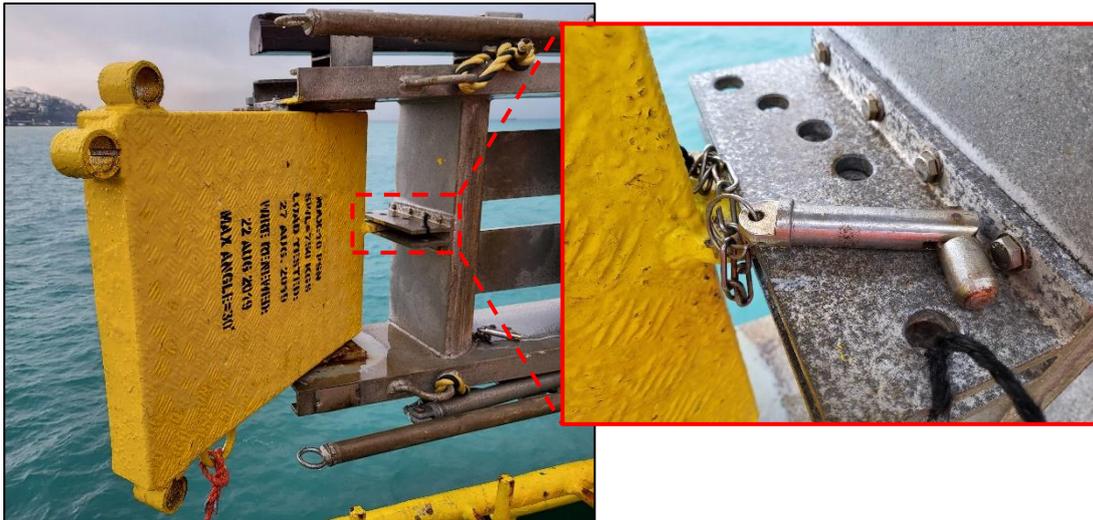
Figure 6: The adjustable lower platform of the accommodation ladder and its securing pin (inset)

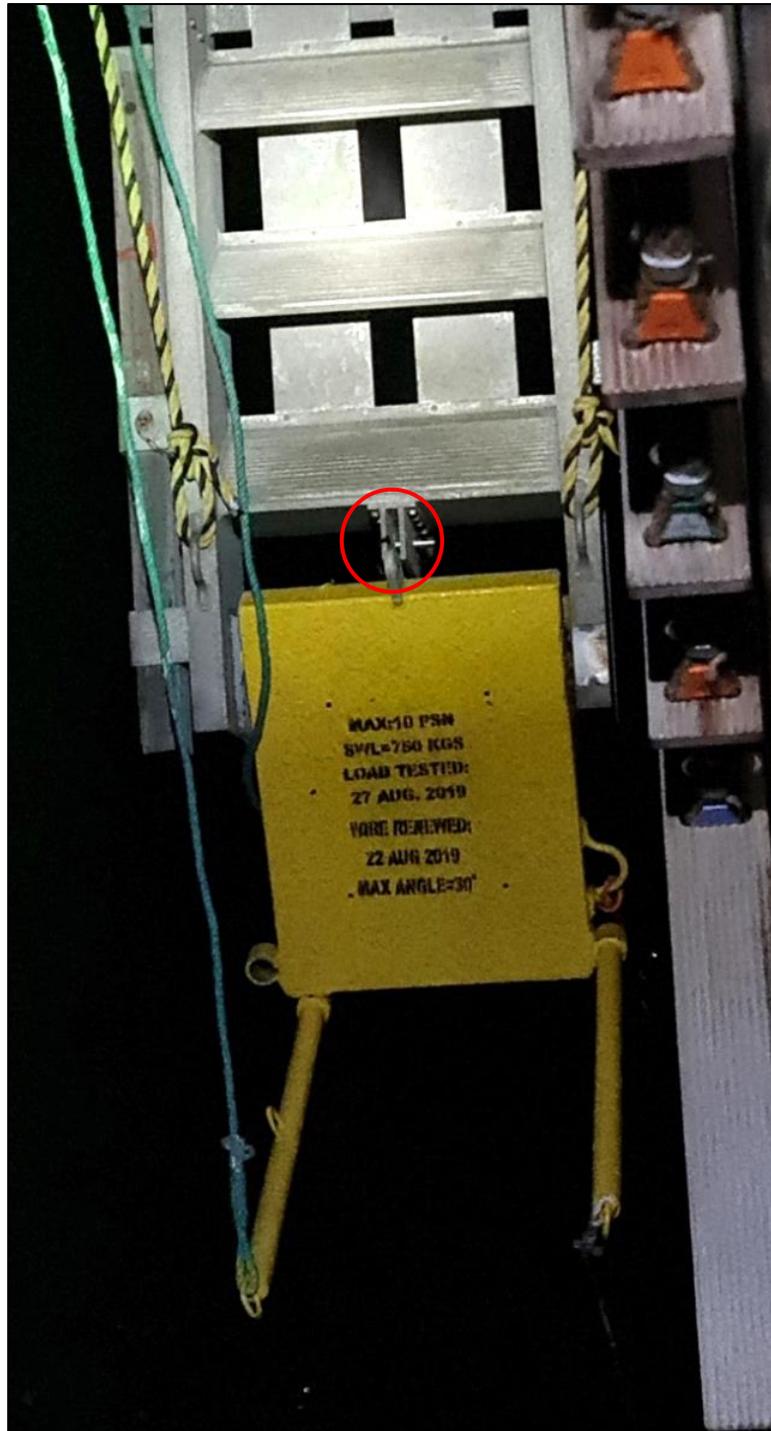
After the accommodation ladder was heaved in, while the vessel was at the anchorage, the crew members observed that the bottom platform was angled downwards

(Figure 7). While its securing pin was noticed to be in one of the slots, it was not securing the platform (red circle in Figure 7, and Figure 8). Damages were neither observed on any part the platform, nor the securing pin.

Figure 7: The accommodation ladder, as found immediately after the accident (red circle: position of the securing pin)

As the crew members found that the bottom platform was angled downwards and its securing pin, while being in one of the slots, was not securing the platform in position, it is highly likely that the bottom platform of the accommodation ladder suddenly slipped out of its intended position at one point. The loud metallic-like sound heard by the two OS, before the splash in the water, may have been that of the accommodation ladder's bottom platform striking the roller beneath it, after the platform slipped down from its position.

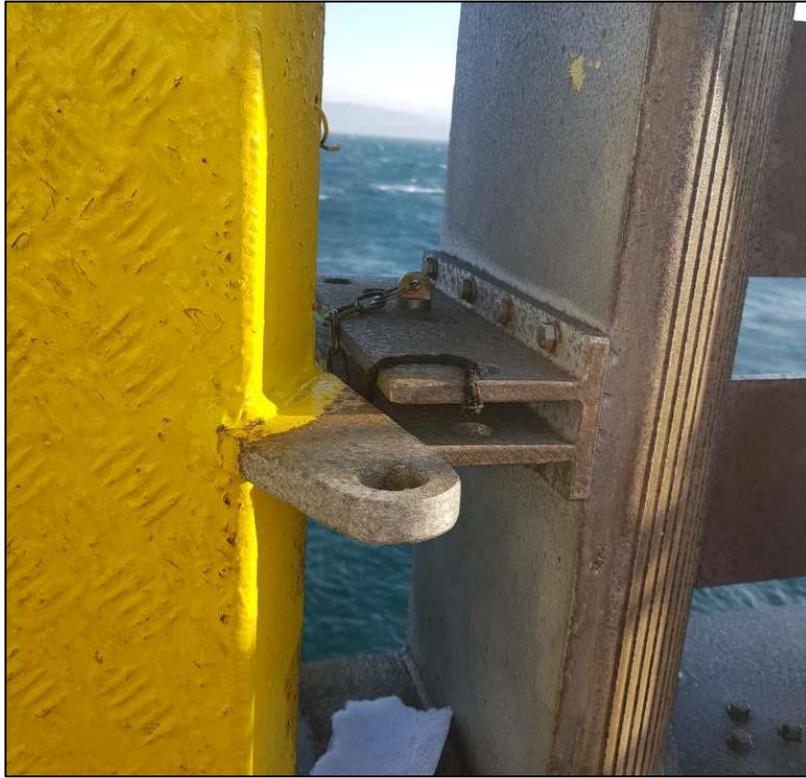
Figure 8: The position of the securing pin, as found after the accident (photograph taken by the crew members on 09 February)

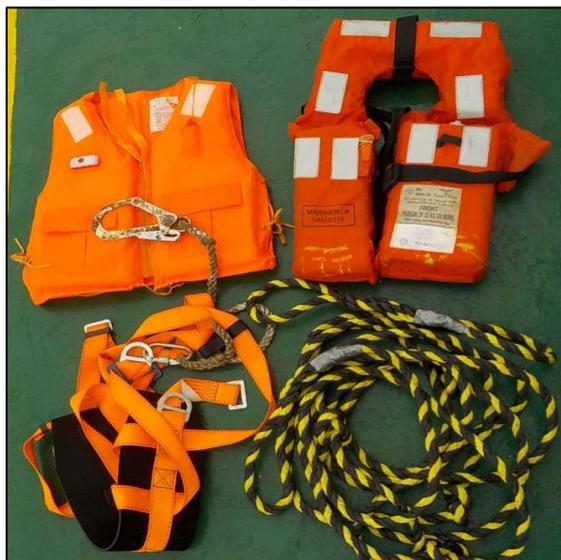
At the time of the occurrence, the bosun was wearing overalls, winter overalls, a winter jacket, a balaclava, helmet, leather gloves and safety shoes. The bosun was neither wearing a safety harness, nor a working life vest / life jacket (**Figure 9**).

Figure 9: A working life vest, life-jacket and safety harness available on board

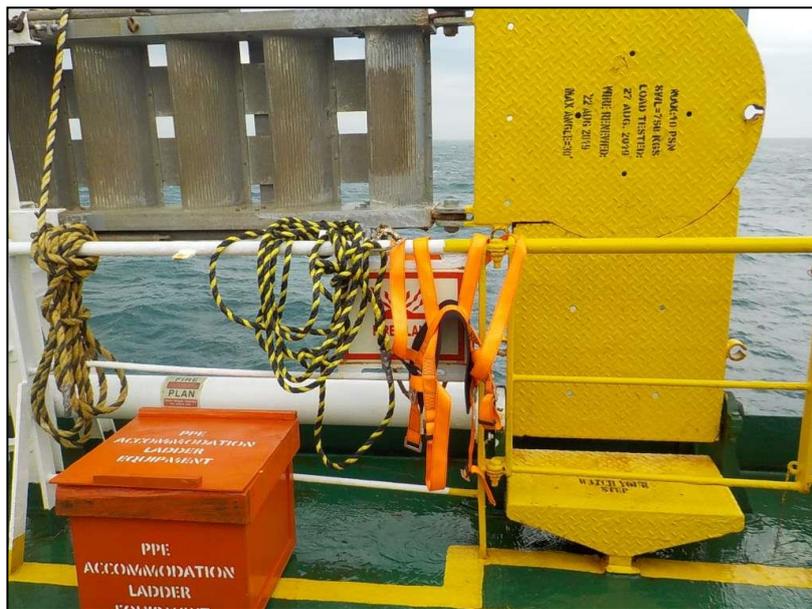
Figure 10: The PPE box, with the safety harness and safety line on the guard rails

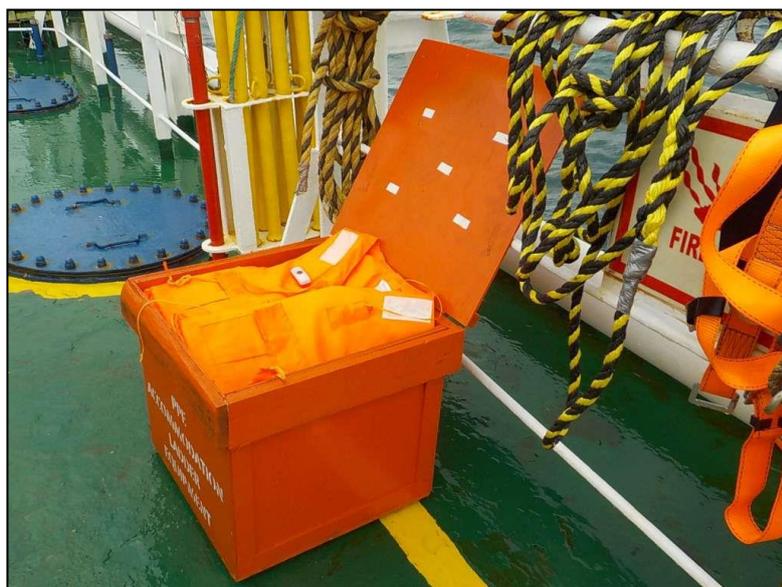
Figure 11: The working life vests inside the PPE box
