Marine Safety Investigation Unit

Transport Malta

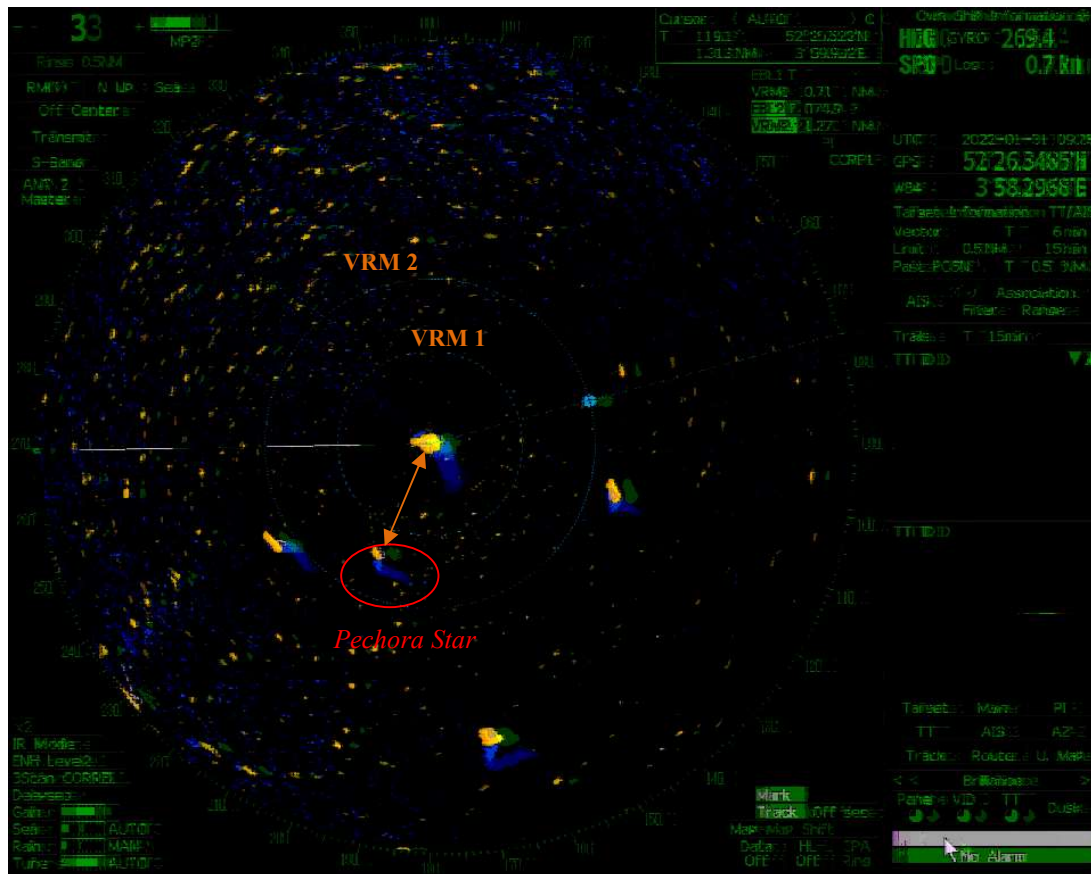
Figure 9: S-band RADAR screenshot at 1028 LT Vessel's STW 0.7 knots and SOG reaching 3.0 knots (SOG is not shown on this S-band RADAR screen)

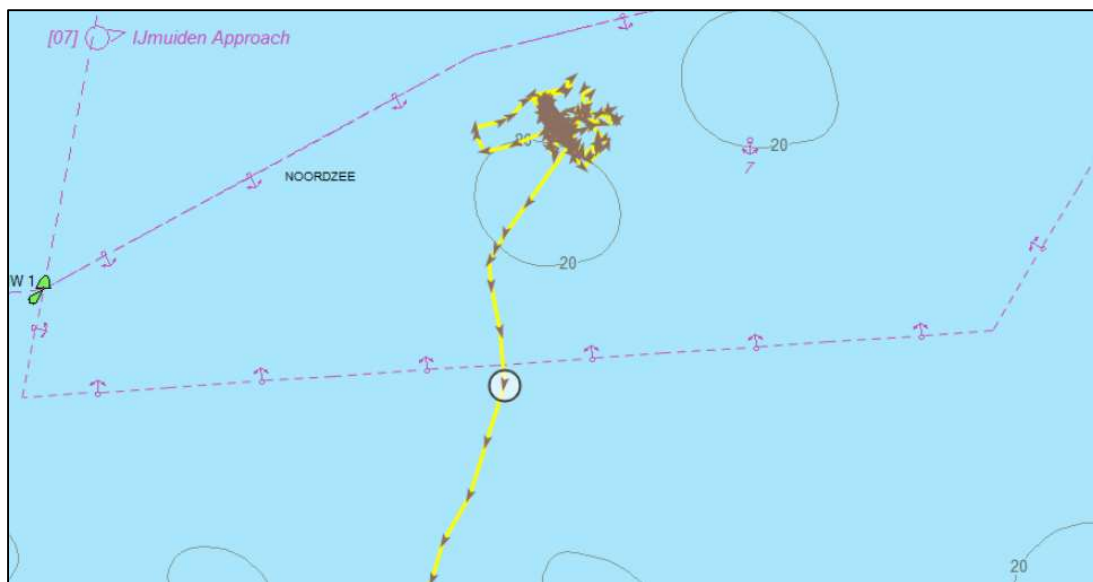
Figure 15: Julietta D's AIS track, circled position at 1050:40

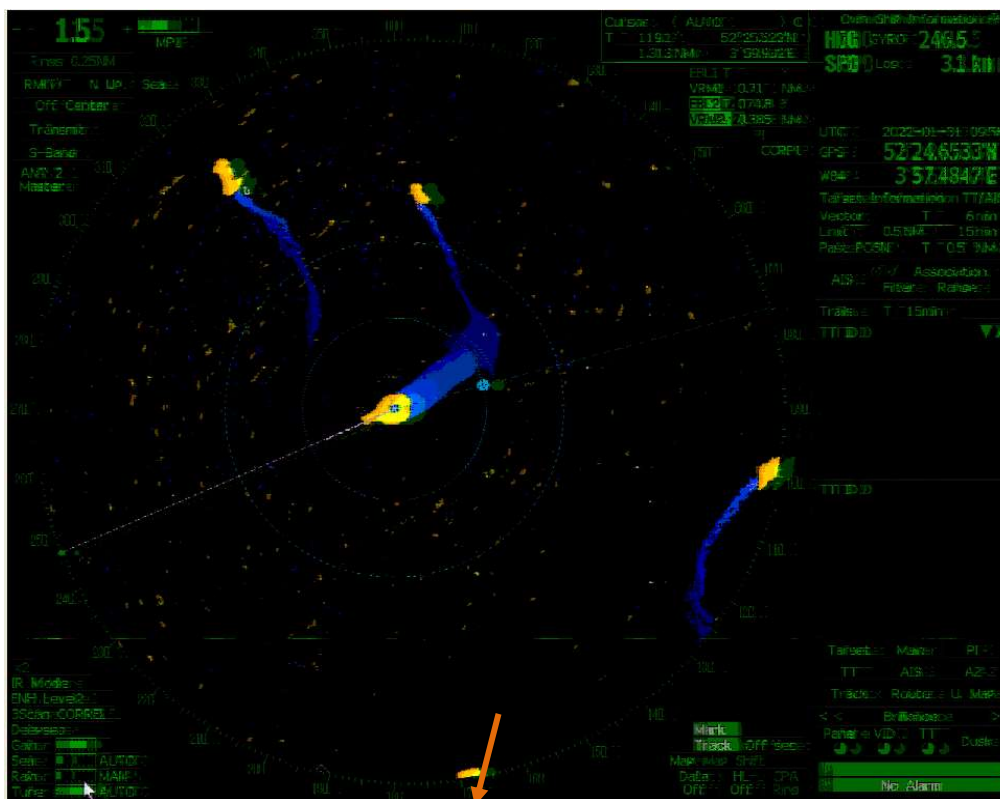
Figure 16: S-band RADAR screenshot at 1056 LT – Windfarm transition sections visible on the RADAR screen

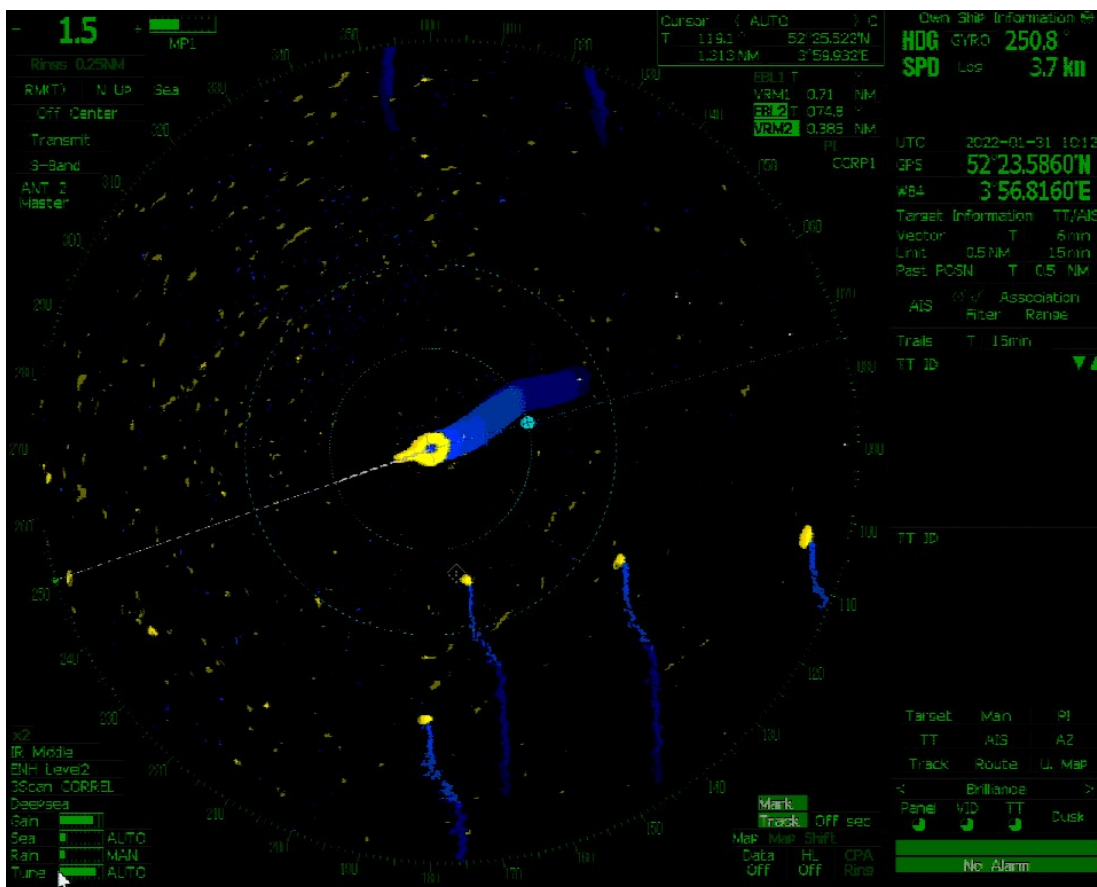
Figure 17: S-band RADAR screenshot at 1112 LT – more windfarm transition sections detected by the RADAR

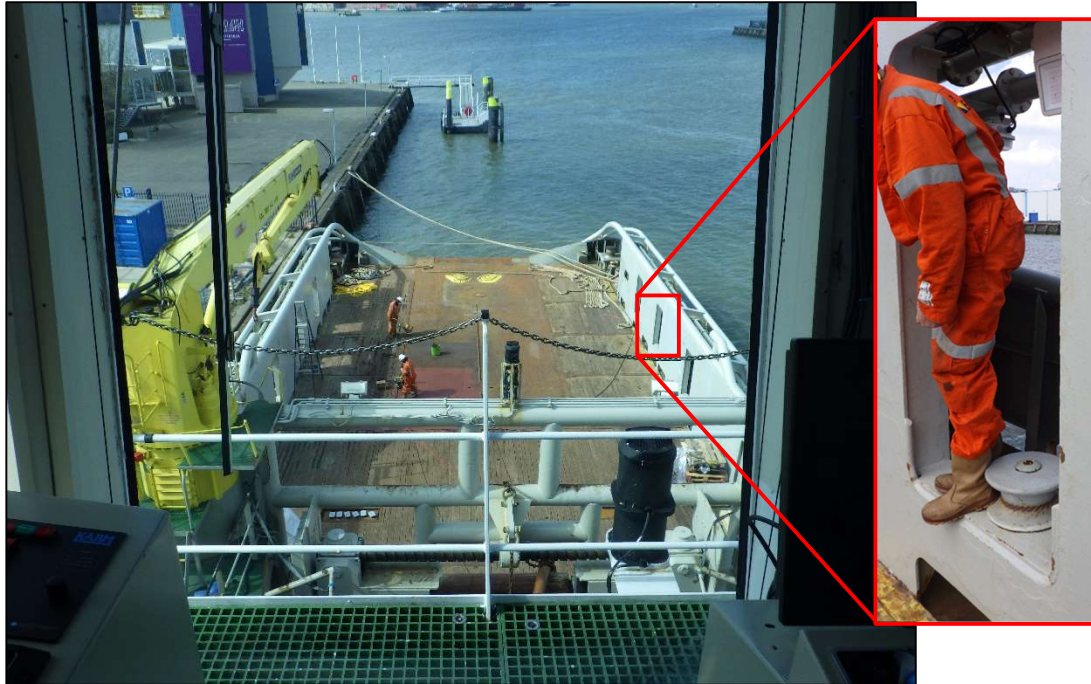
Figure 25: *Sovereign*'s low freeboard at the aft. Photo inset showing a simulated photograph of a crew member using the crash rail for shelter

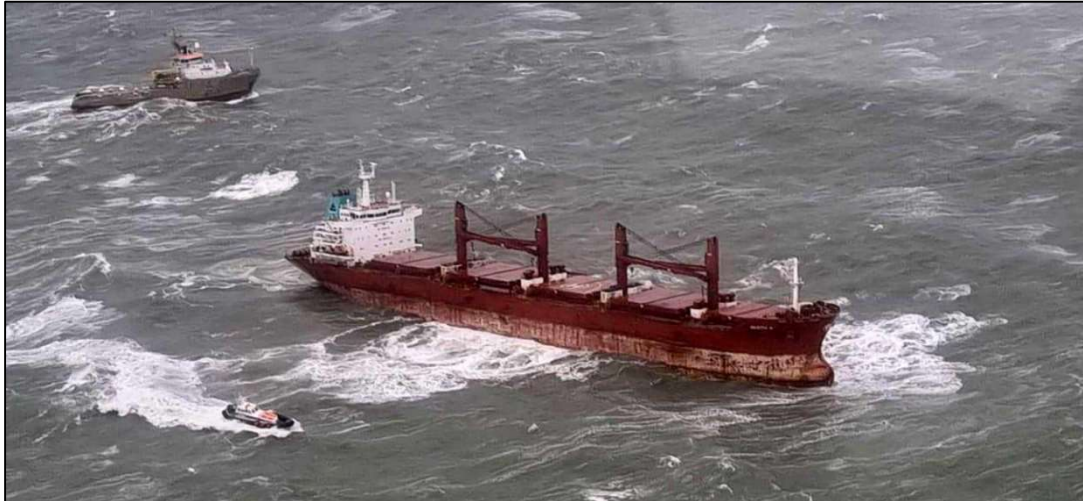
Figure 26: The bulk carrier *Julietta D* adrift with tug *Sovereign* at its stern and rescue boat *Koos van Messel* to its starboard side

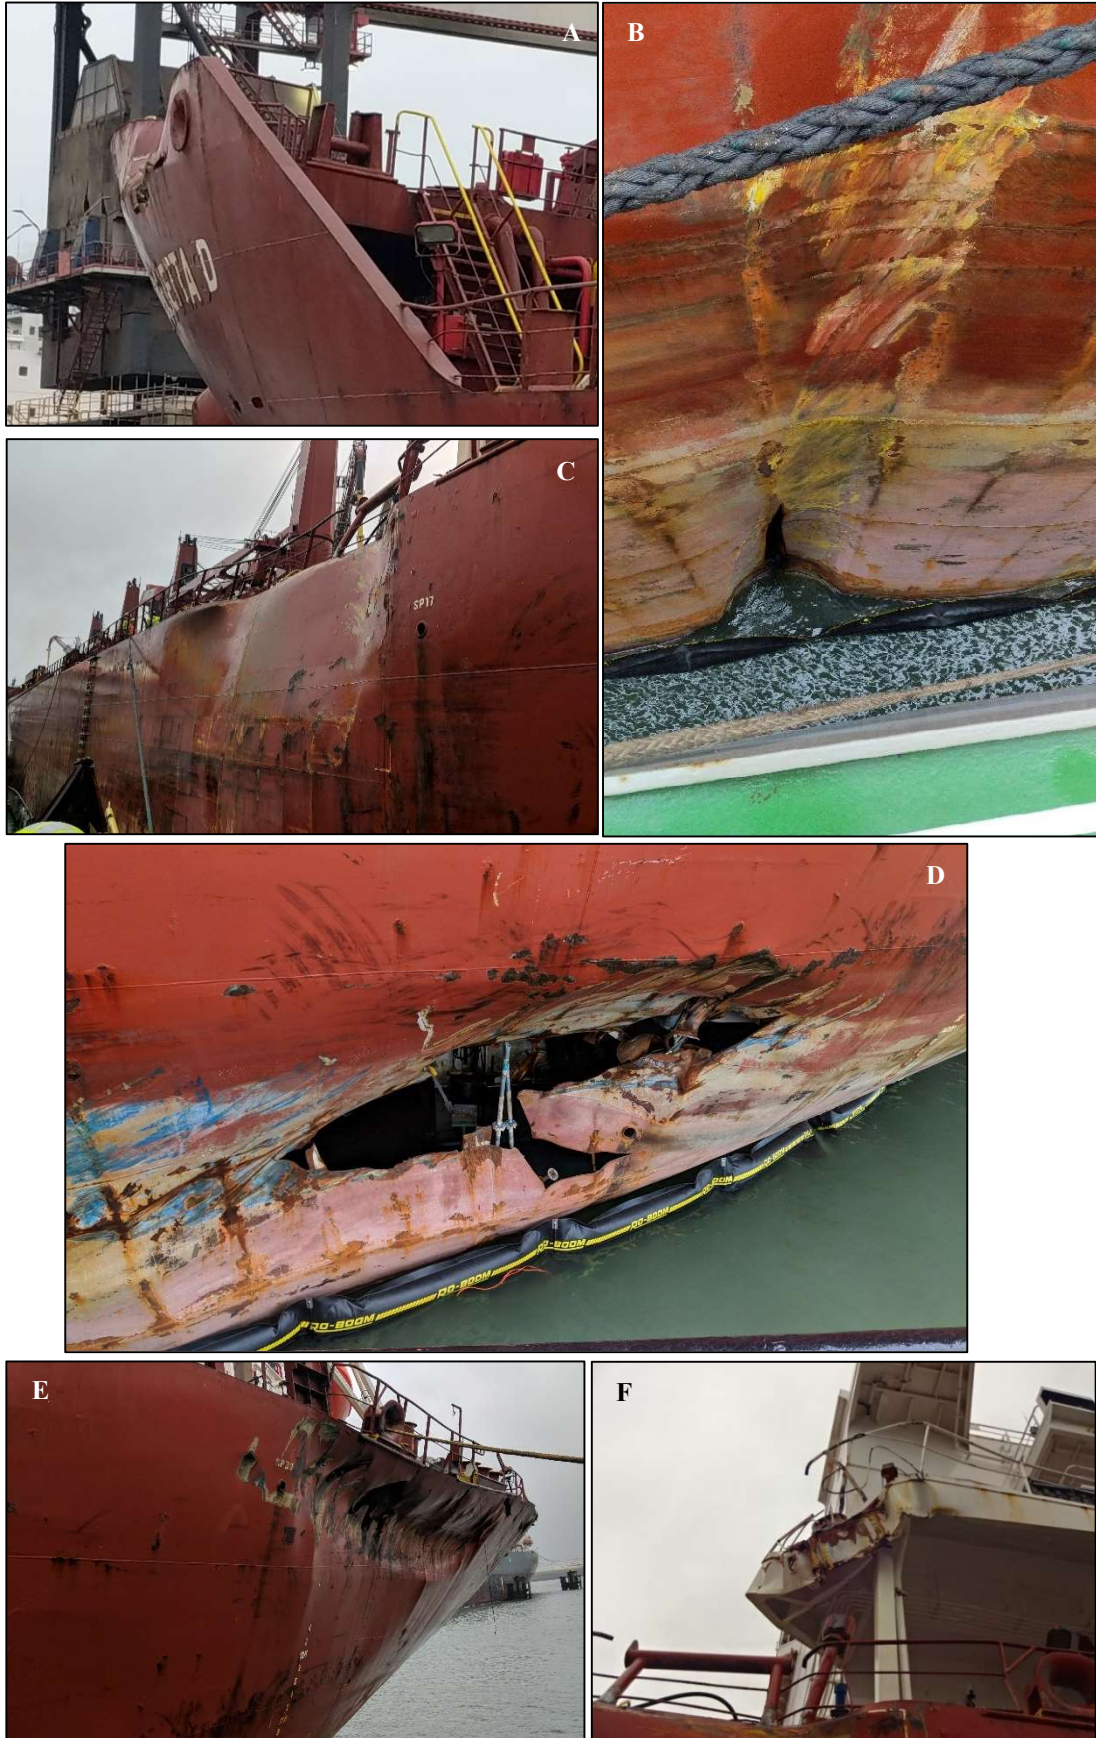
Figure 28: Some of the hull damages sustained by *Julietta D*

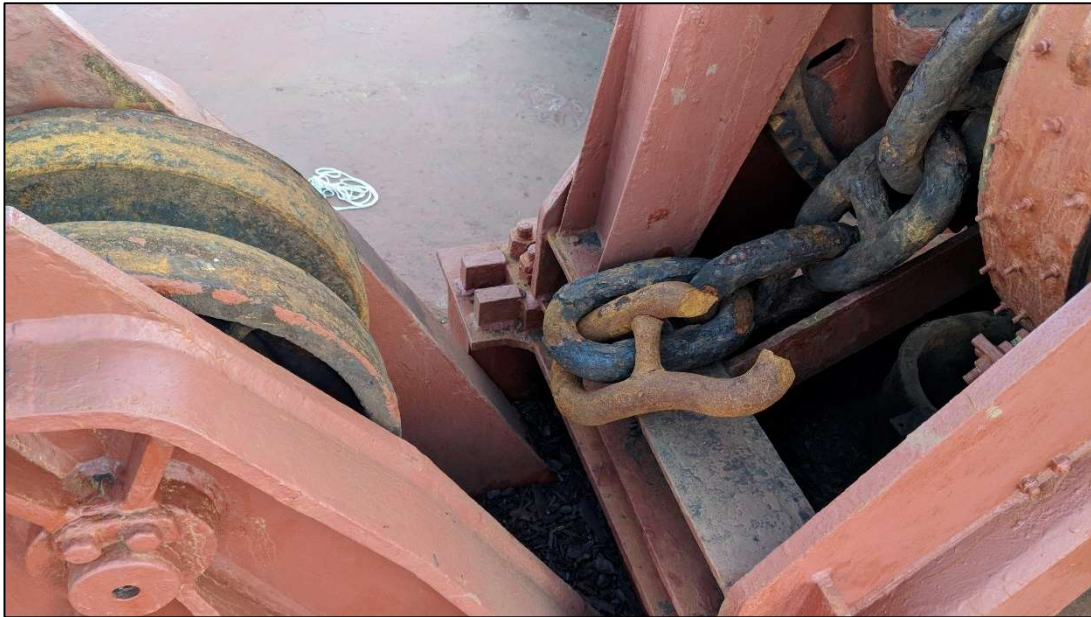
Figure 29: Port side anchor cable damaged joining shackle

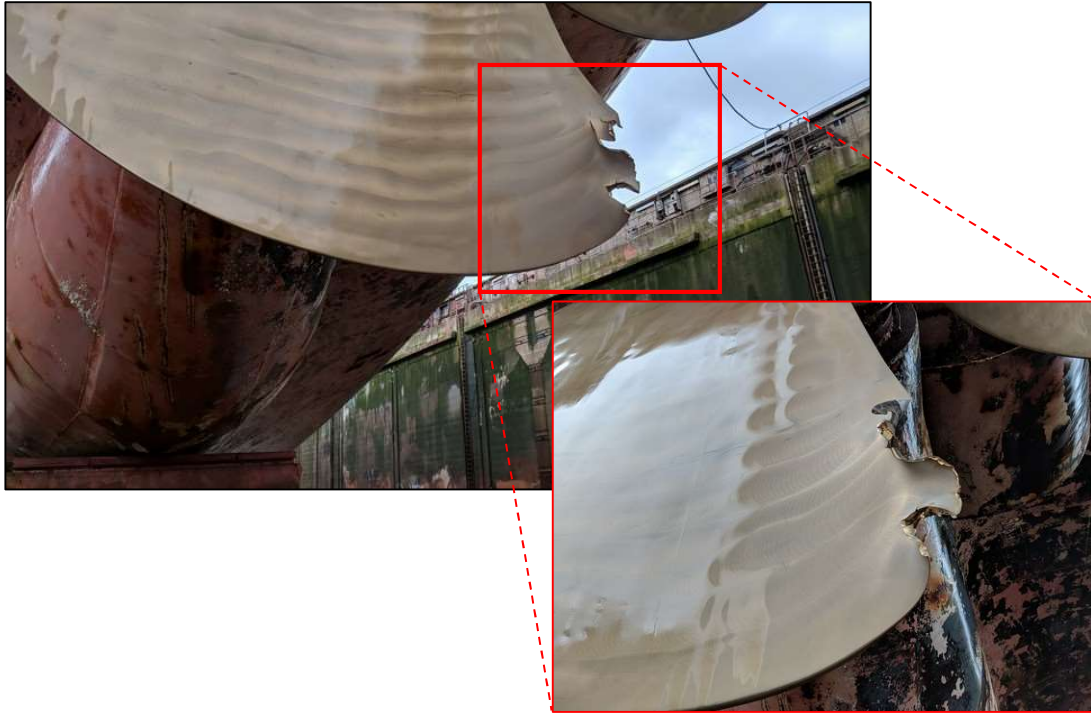
Figure 30: Damage incurred by one blade of the propeller

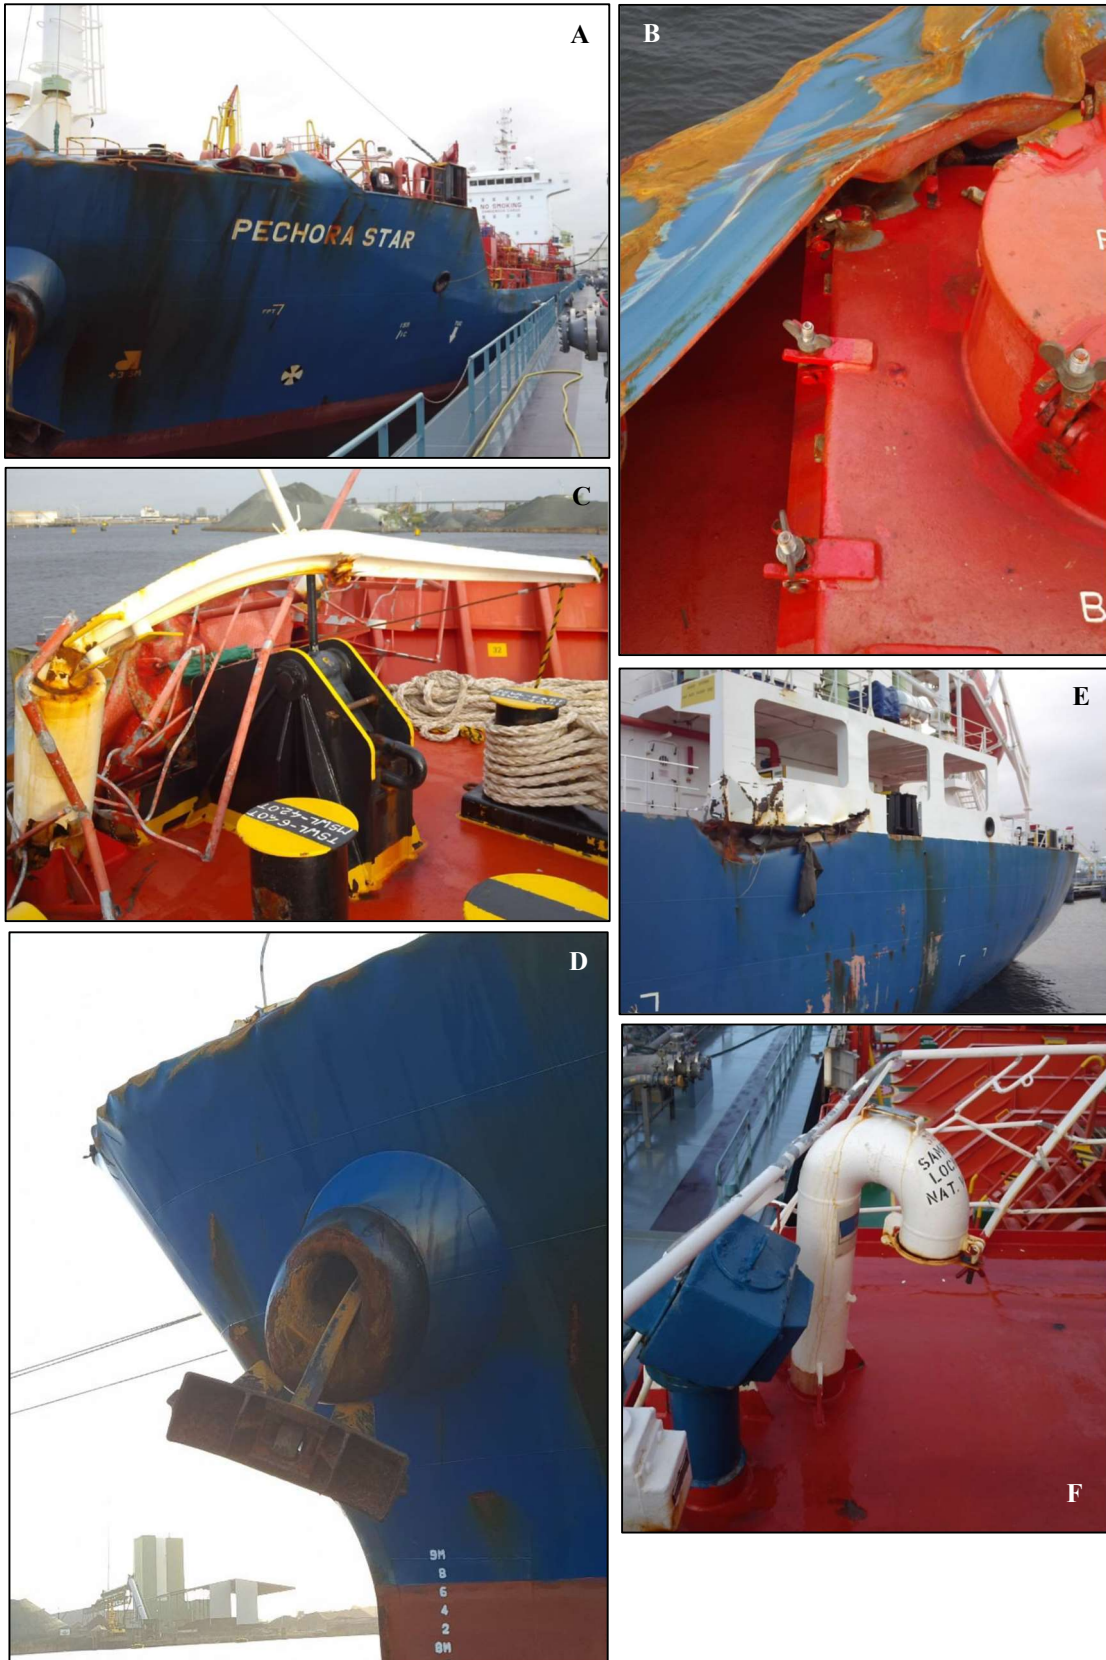
Figure 31: Some of the damages sustained by *Pechora Star*

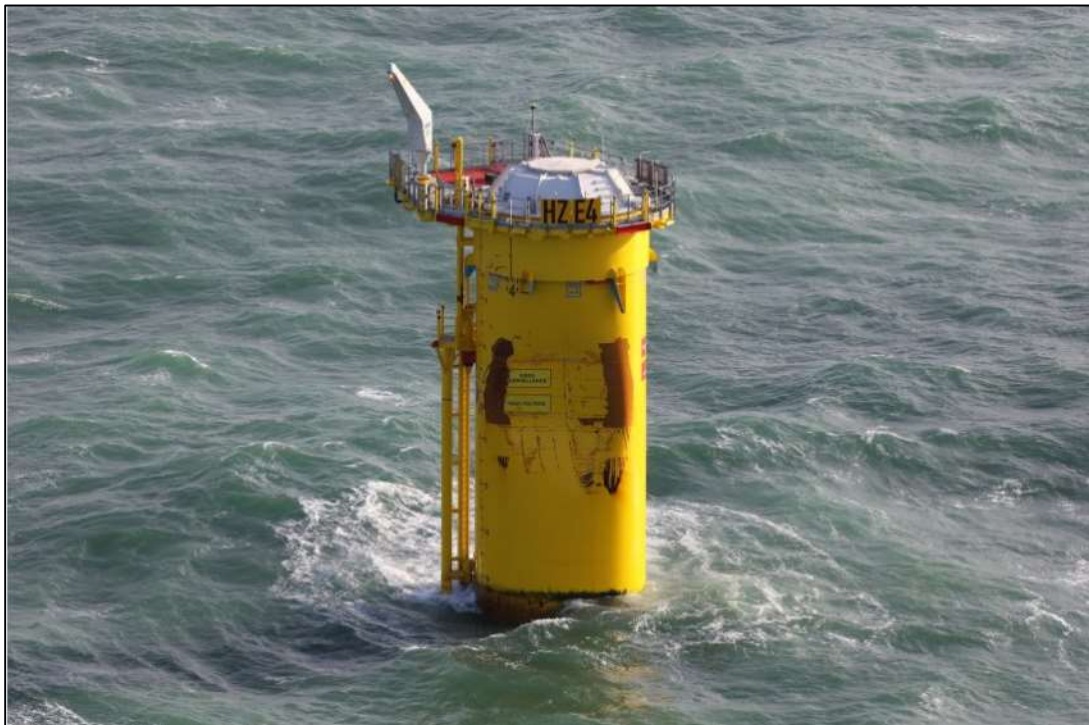
Figure 32: Aerial photograph showing some of the damages to the transition section of windfarm foundation HZ E4

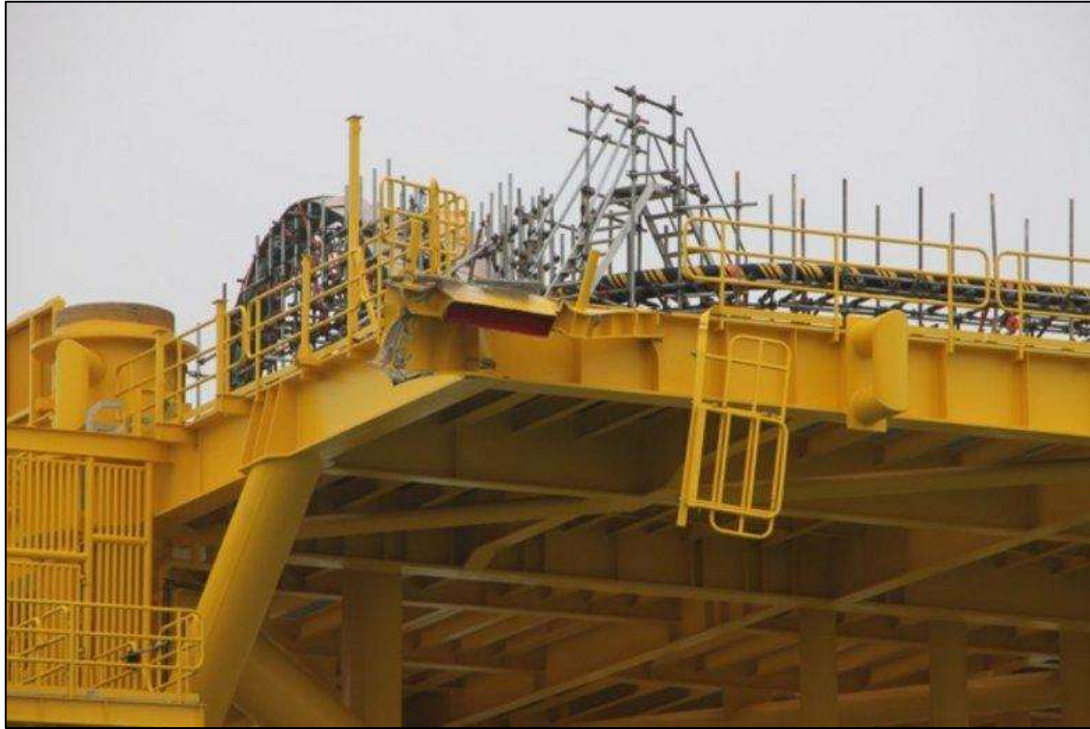
Figure 33: Part of the damages to *HZB*

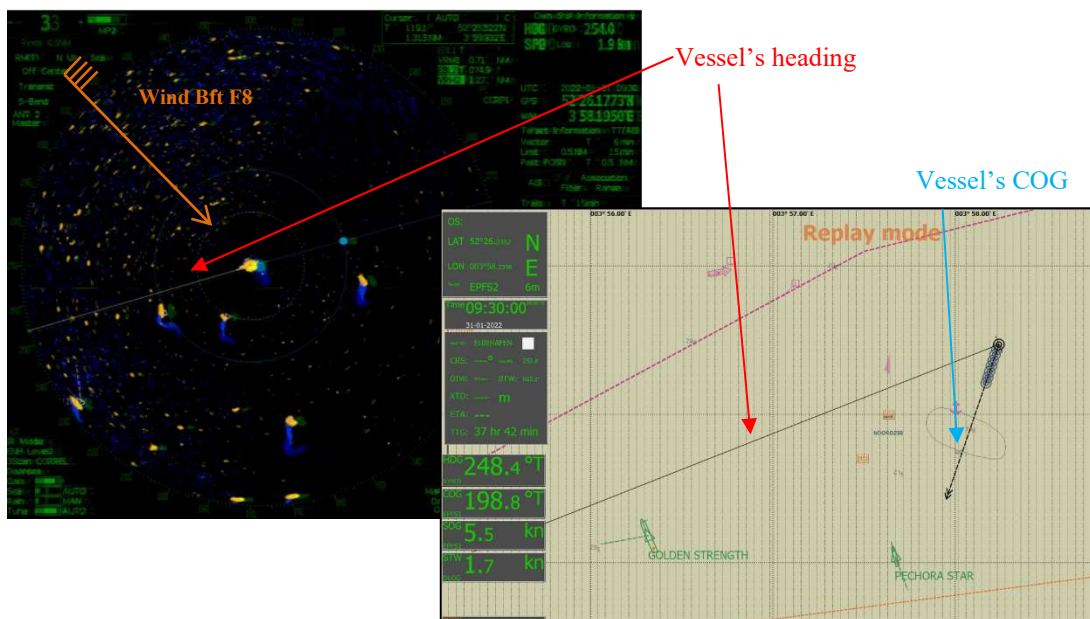
Figure 35: Screenshots from S-band RADAR and ECDIS in replay mode, at 1030, with wind direction superimposed on the RADAR screenshot

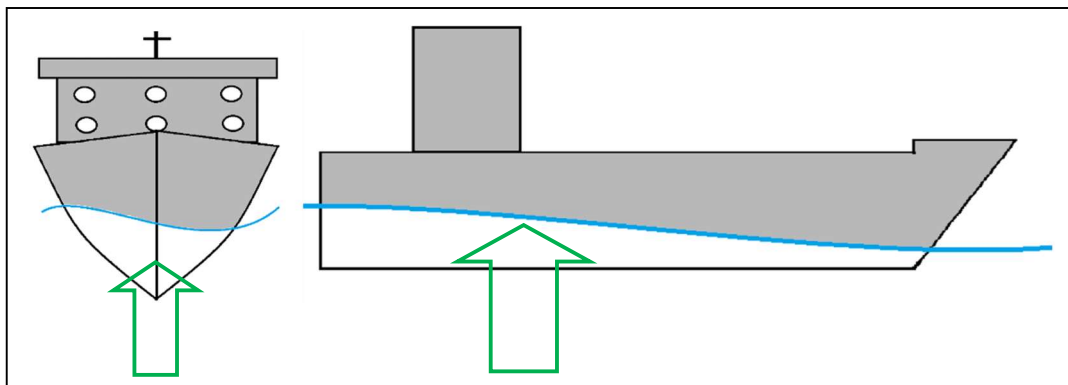
Figure 36: Frontal windage area (on the left) as compared to the lateral windage area (on the right)
