SAFETY INVESTIGATION REPORT

REPORT NO.: 01/2024

MV CAPE KORTIA **Fire in the engine-room,** **leading to the loss of all power** **at the port of Rodman, Panama** **30 January 2023**

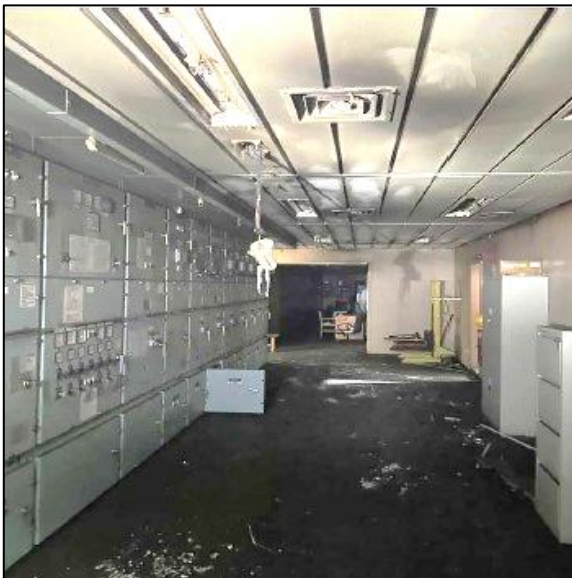
- the ECR and MVSB room were heavily contaminated with soot, CO₂ and acids (**Figure 7**);
- the 440 V and 6.6 kV power cables and other cables passing through the MVSB and transformer rooms, the open spaces on the first platform and the area in the vicinity of DG nos. 3

Figure 7: The MVSB room

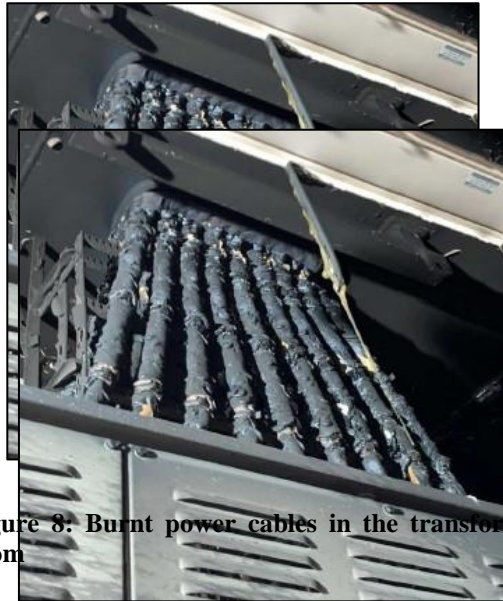
and 4, were completely burnt, along with their cable trays (Figures 8 and 9);

Figure 8: Burnt power cables in the transformer room

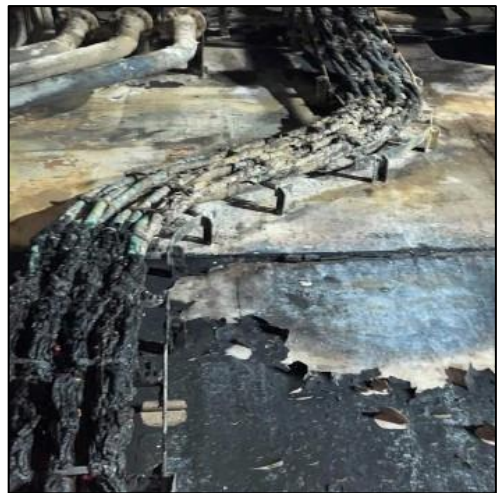
Figure 9: Burnt power cables outside the MVSB room

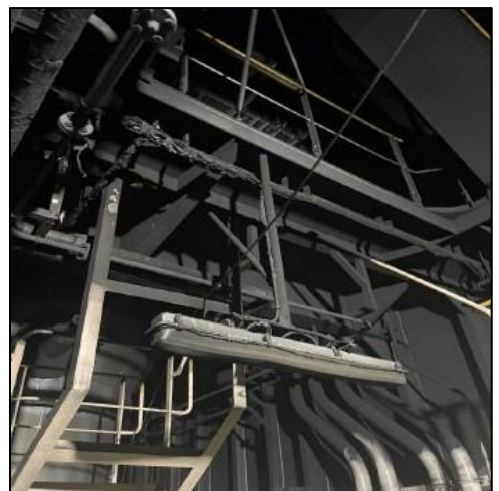
Figure 10: Burnt power cables and a lighting fixture outside the transformer room

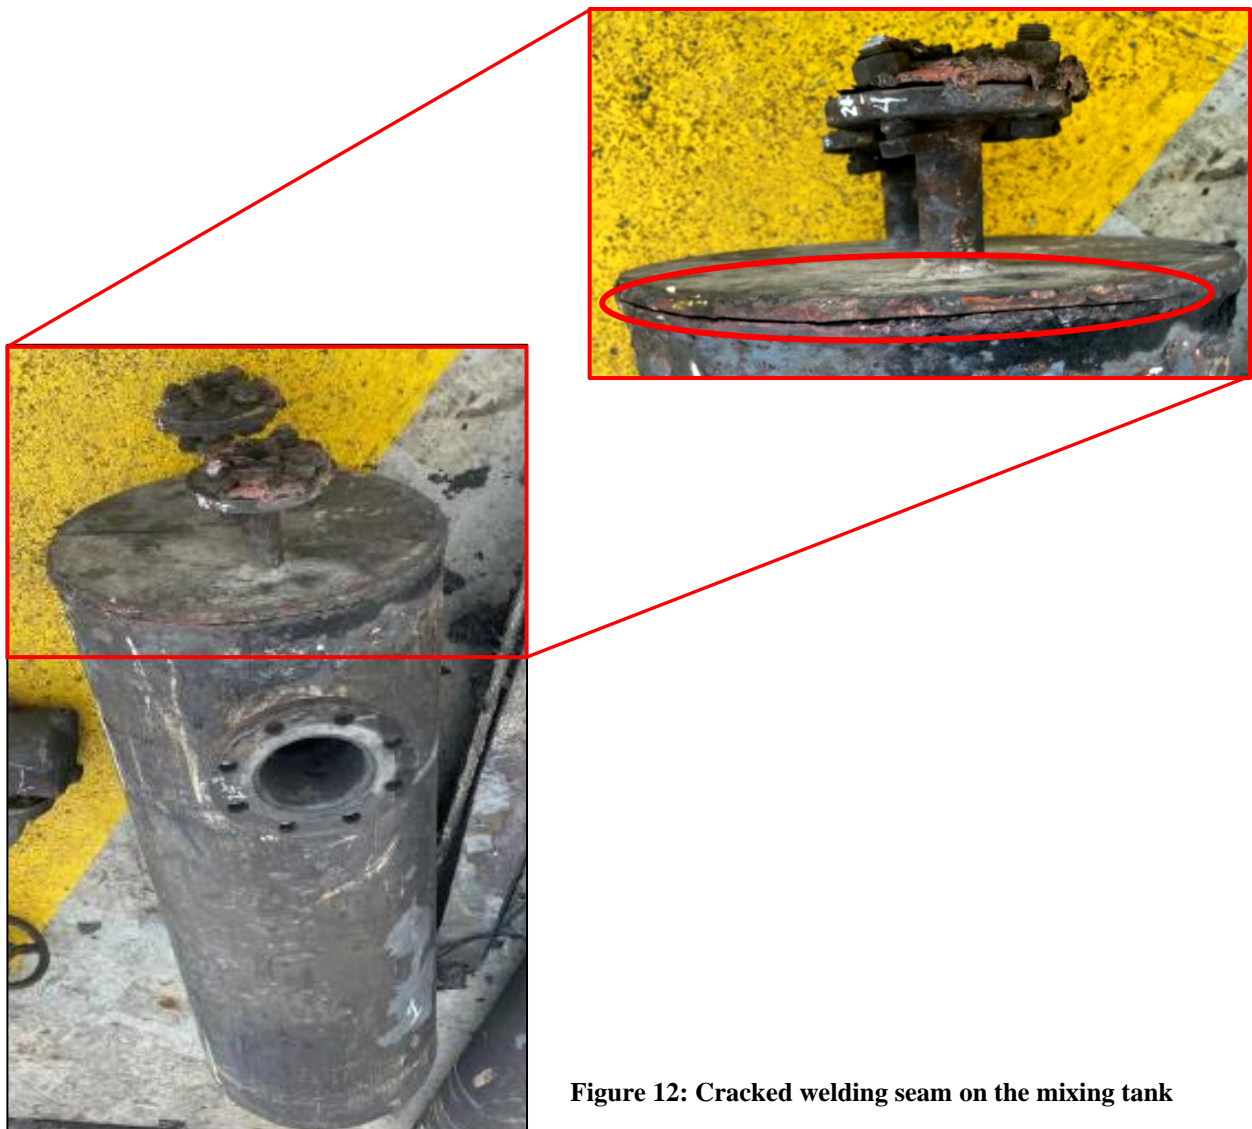
Several days after the fire, when it was safe for the crew members to access the machinery space accompanied by a chemist, damages were observed on the vessel's fuel oil system mixing tank, located high above platform no. 1. It was eventually determined that a failure of the weld seam on the mixing tank caused the leak (**Figure 12**).

Figure 12: Cracked welding seam on the mixing tank

The safety investigation did not have access to the damaged mixing tank. Moreover, the Company reported that no metallurgical tests were carried out to determine the technical cause of the weld failure. To this effect, the MSIU could only hypothesise the cause of the weld seam failure.

One of the factors, which the safety investigation considered as a potential problem was corrosion / pitting of the weld metal. Various studies have cautioned that the presence of microbes, additives and other chemicals may be a cause for concern with respect to corrosion, especially within those fuel systems (like this one) which store and / or process ultra-low sulphur fuel.

Humidity (and the presence of water due to condensation inside the tank¹⁰), especially in the vapour spaces, can be a matter of extreme concern due to the risk of corrosion. Not only it may lead to corrosion *per se*, but also allows for corrosive substances in the fuel to remain in contact with the material, for a longer period of time.

Yet again, since the weld failure was not analysed, the failure propagation could not be determined. Although the condition may have deteriorated over a period of time, it was not excluded that its failure was sudden, given that prior to the day of the accident, the crew members had not reported any unexplained spills inside the machinery spaces.

As soon as it was determined that the fuel oil system mixing tank had a weld failure, a circular letter was issued to the vessel's under the management of the Company.

The mixing tanks installed on board four sister vessels were thoroughly inspected. The lagging was removed, and welding seams were checked for cracks. Repairs were carried out, where necessary.
