## MARINE SAFETY INVESTIGATION REPORT

Safety investigation into the serious injury on board the  
Maltese registered ro-ro vehicle carrier

***TORTUGAS***

MARINE SAFETY INVESTIGATION REPORT NO. 02/2024

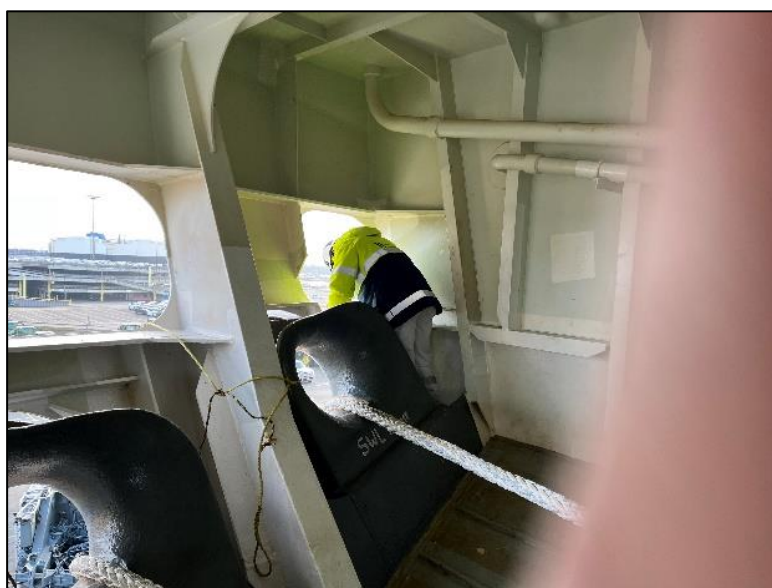
**Figure 4: Reconstruction of the position of the third officer when he was monitoring the forward spring, before it parted**

At the time of the occurrence, the third officer was standing aft of the forward spring line, which he was monitoring (**Figure 4**).

Just before the rope parted, the third officer had turned to face the mooring winch. It was at that time that the parted rope struck him on his right thigh. The other crew members at the forward mooring station recalled hearing the spring line stretch. However, they stated that the rope parted within seconds of them hearing the stretching sounds.

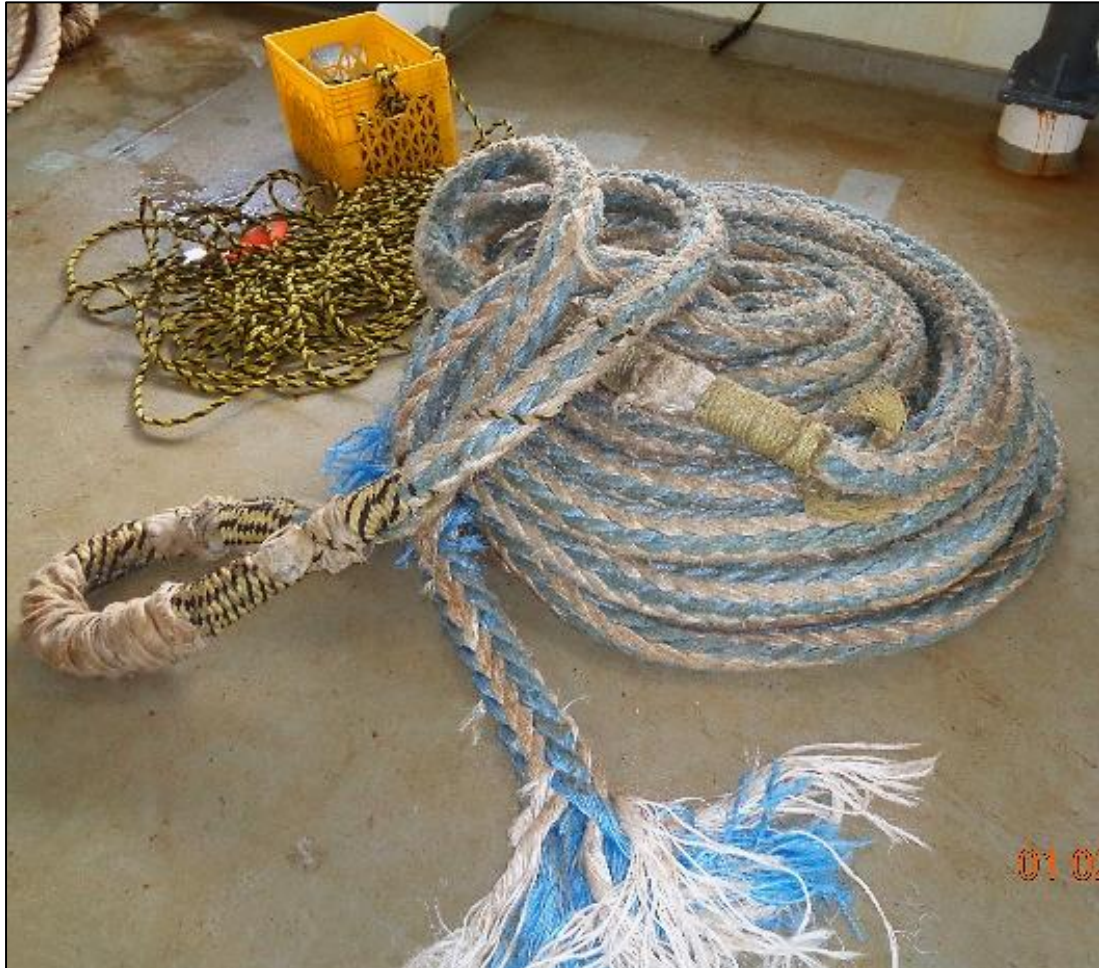
**Figure 6: The forward spring line that parted**

The mooring rope that parted (**Figure 6**) was a 12-strand, high performance polyester mooring rope. The mooring rope's certificate stated that it had a diameter of 56 mm, a length of 220 m, and a breaking load of 611 kN.

The mooring rope had parted about 63 m from its free end, and about a metre from the mooring winch *i.e.*, between the mooring winch and the pedestal fairlead around which it was passed (**Figure 7**).

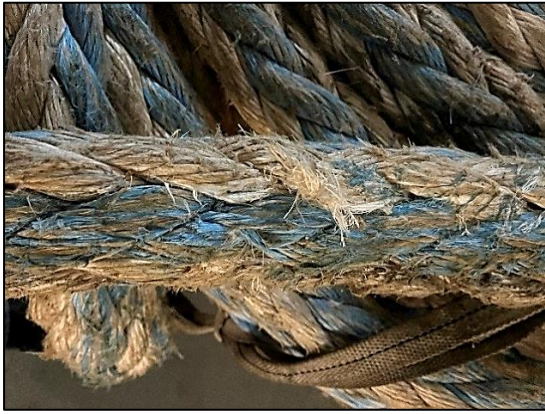
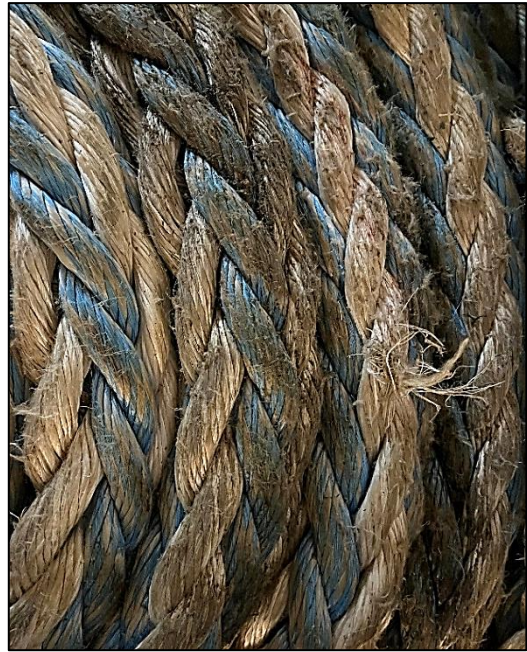
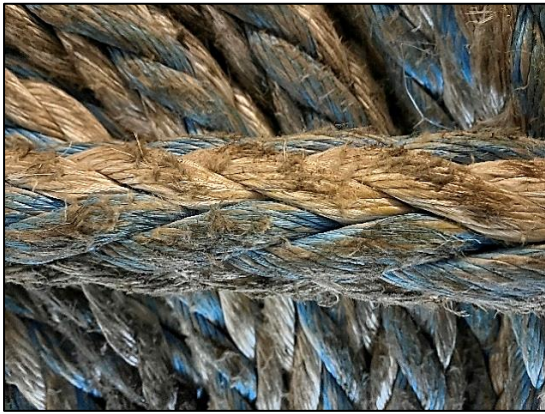
**Figures 8a to 8c: Other observed damages**

During the safety investigation's visit on board, however, several damages were observed along the length of the mooring rope (**Figures 8a to 8c**), other than the point of failure (**Figure 9**).

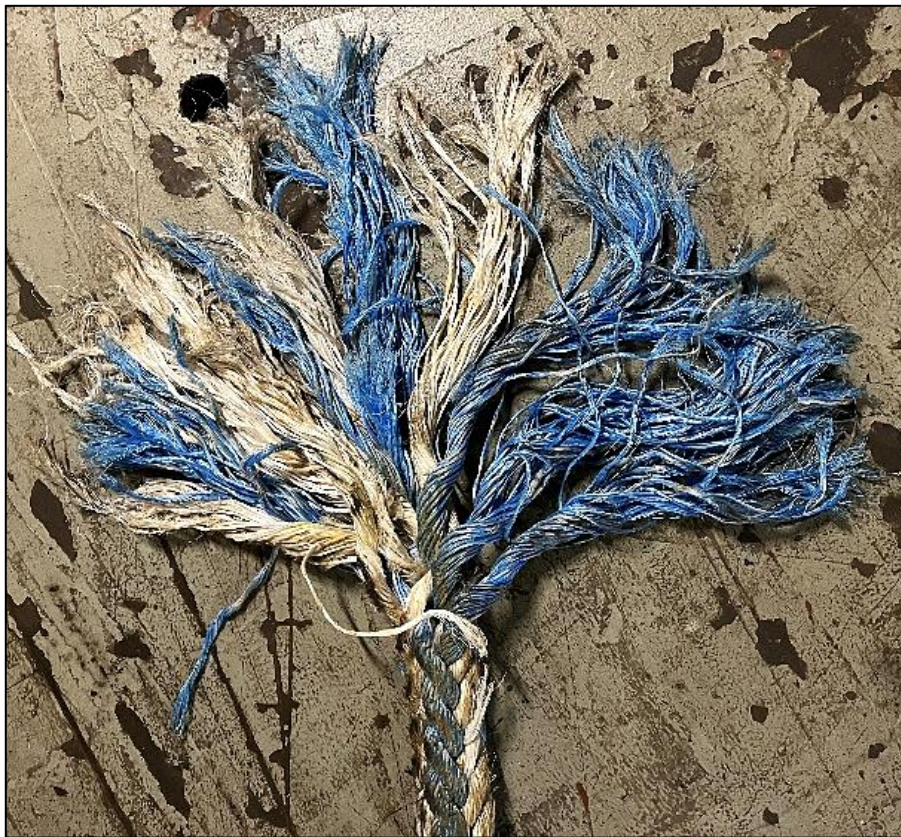
**Figure 9: The point of failure**

Based on the above, the safety investigation concluded that the mooring rope had failed due to tensile overload. The broken fibres and yarns had most probably lowered the rope's residual breaking load, thus making it susceptible to overload caused by dynamic loading conditions on the rope. The dynamic loading conditions would have been experienced due to, inter alia, the mooring equipment, effects of ship acceleration inertia, wind gusts, while the vessel was moored. Furthermore, similar past high load events may have caused creep damage, which would have significantly lowered the rope's maximum breaking stress prior to tensile failure.

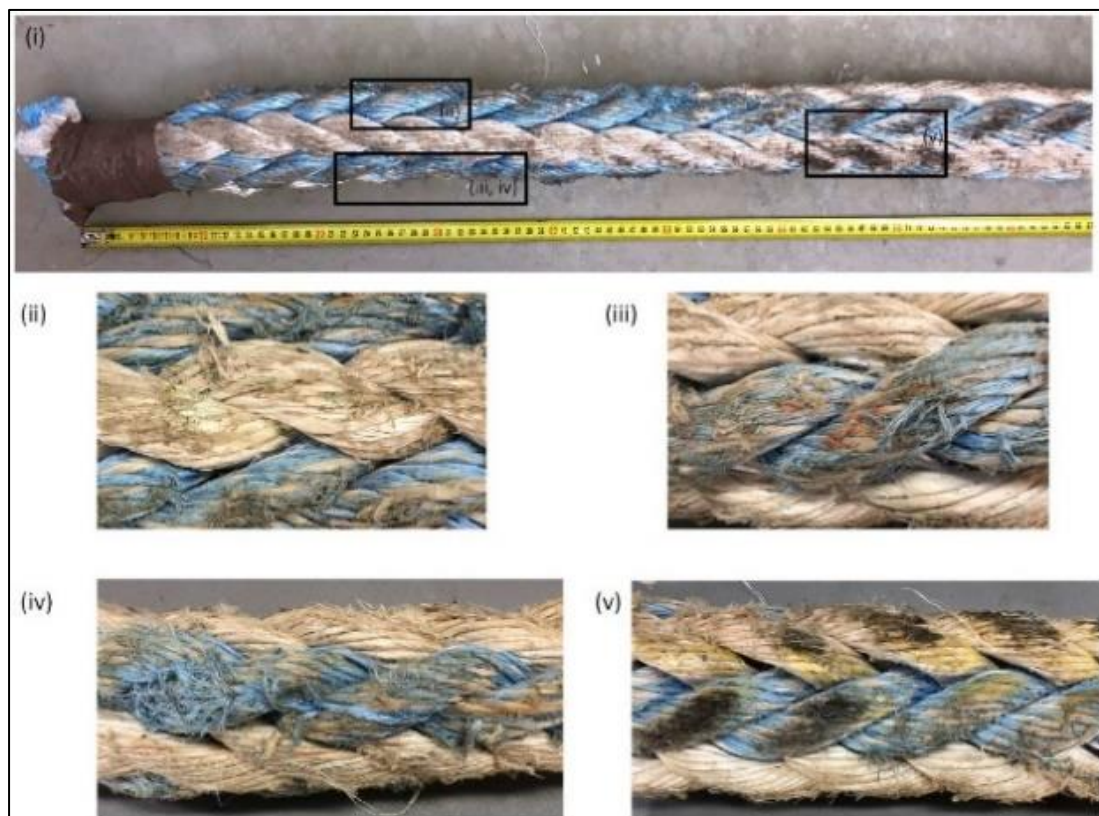
**Figure 11: Damages on the first segment of sample A**

Sample A was inspected in three segments. The visual inspection of the first segment (furthest away from the point of failure) showed signs of fraying and abrasion along the length of this section. A number of cut fibres were observed at a distance away from the point of failure (**Figure 11**).

Along the length of this sample, the damages were visible only on the surface and not on the inside / in between the strands. Powdered fibre (an indication of internal wear) was not observed. Additionally, several red, black, and yellow stains were observed.

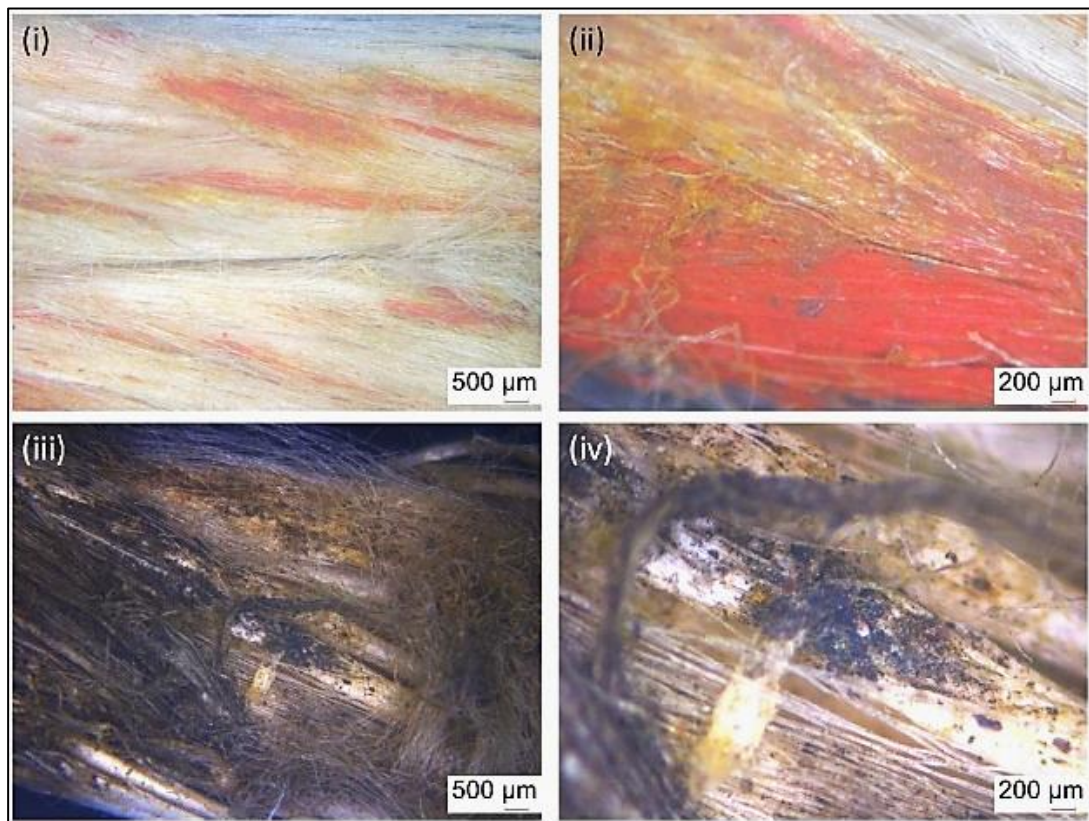
**Figures 12(i) to 12(iv): Stereomicrographs of the regions of staining on sample A**

The region of staining was studied using optical microscopy (**Figures 12(i) to 12(iv)**). The reddish traces seen in **Figures 12(i) and 12(ii)**, were attributed to the rope rubbing against the painted surfaces of mooring fittings. Localised red spots were also noticed and these, too, were observed to be due to paint transfer. There were no signs of adhesion of ferrous corrosion (traces of rust). The black stains appeared to be localised regions which were exposed to heat build-up, and dirt and grime, caused by friction, the rubbing of yarns on other yarns and against metallic surfaces.

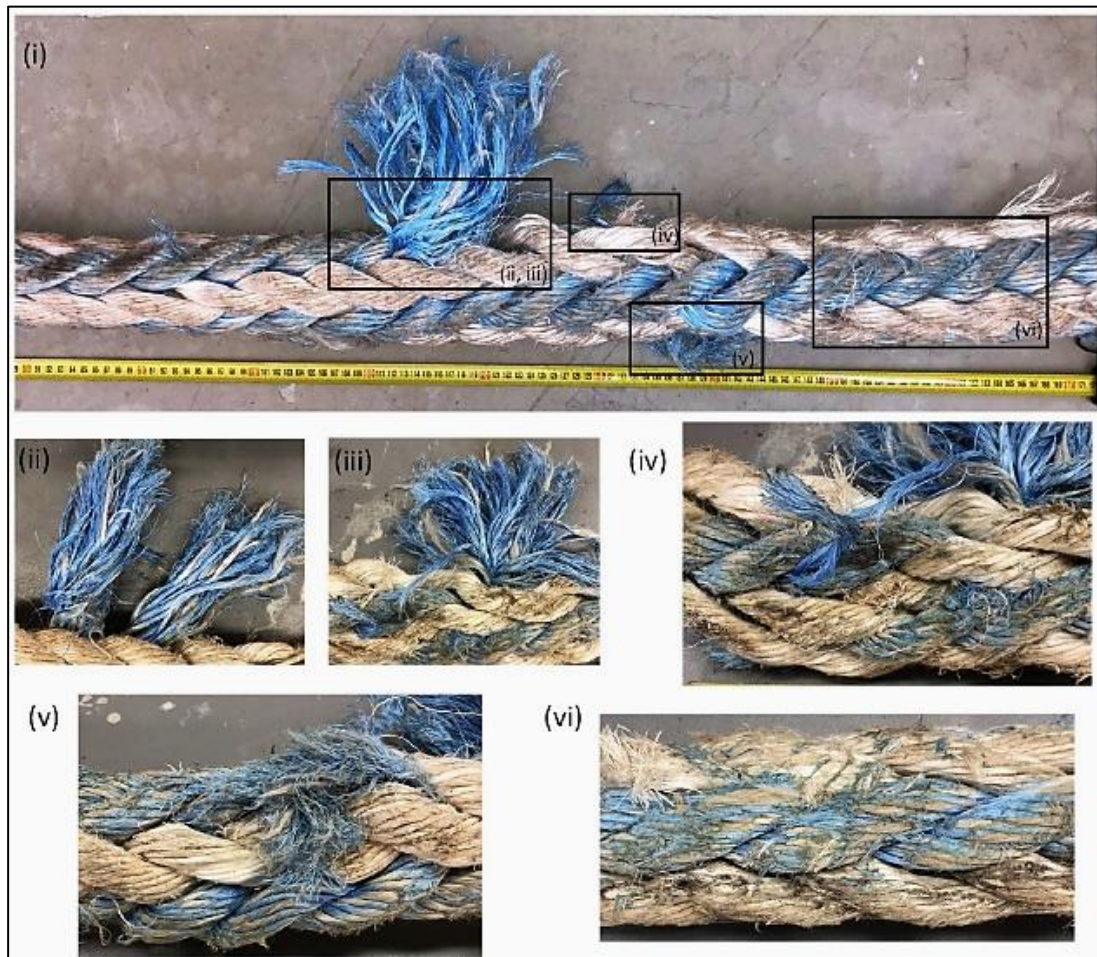
**Figures 13(i) to 13(vi): Damages on the second segment of sample A**

A higher degree of degradation was observed in the second (middle) segment *i.e.*, closer to the point of failure (**Figures 13(i) to 13(vi)**). The surface damage was more pronounced, but more importantly, large strand failure was prominent. The parted strands showed little to no degradation near the ends of the fibres (**Figure 13(ii), (iii) and 13(iv)**), indicating that these fibres had most likely failed during the same event.

Conversely, the morphology of the fibres seen in **Figure 13(v)** suggested that these may have parted during a previous mooring operation. The failed strands showed signs of abrasion and soiling, thus indicating continued use after this localised and relatively minor failure event. Such minor failure may have been caused by routine operation at loads closer to the breaking load of the rope, coupled with accumulated fatigue damage. The failed ends of these fibres would have been located in the interior region of the rope and would, therefore, rarely experience any wear against metallic surfaces.

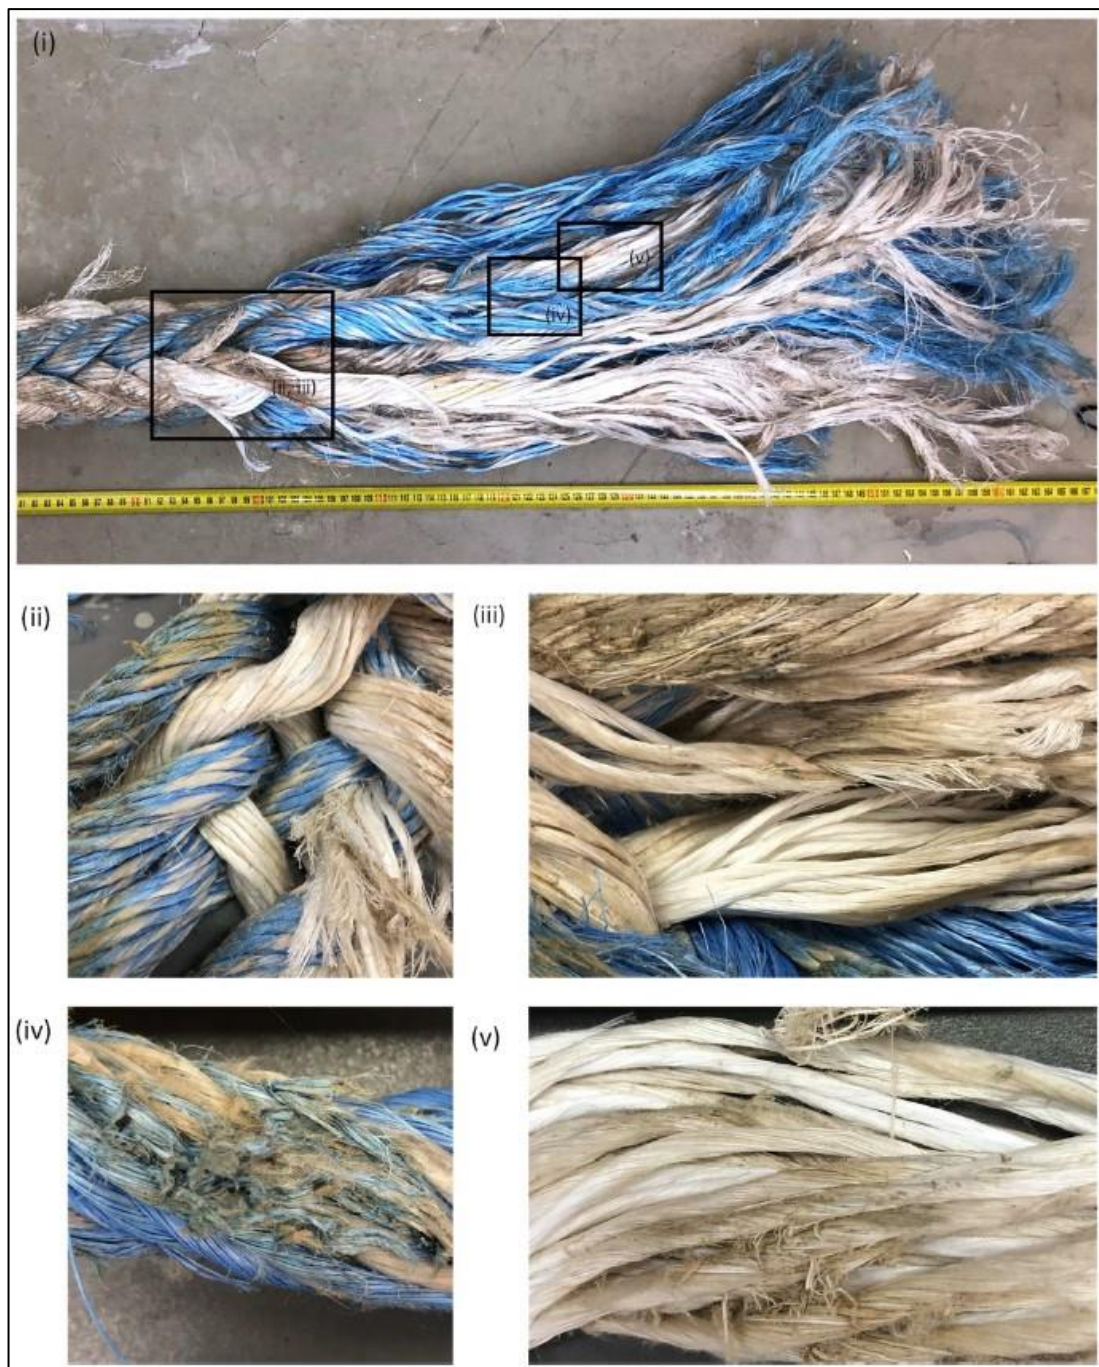
**Figure 14: Damages on the third segment (point of failure) of sample A**

On the parted end of the rope sample (third segment), too, abrasion was not observed on the inside surfaces (**Figure 14**). The exposed interior surfaces of the strands did not show major signs of twisting which would have allowed rubbing of internal surfaces. Thus, wear damage was mostly limited to the periphery of the strands, depending on the twist of the specific strand. There were minor exceptions, such as fibres which were visibly more deteriorated than the surrounding parted strands, which again suggested failure predating the final catastrophic event.

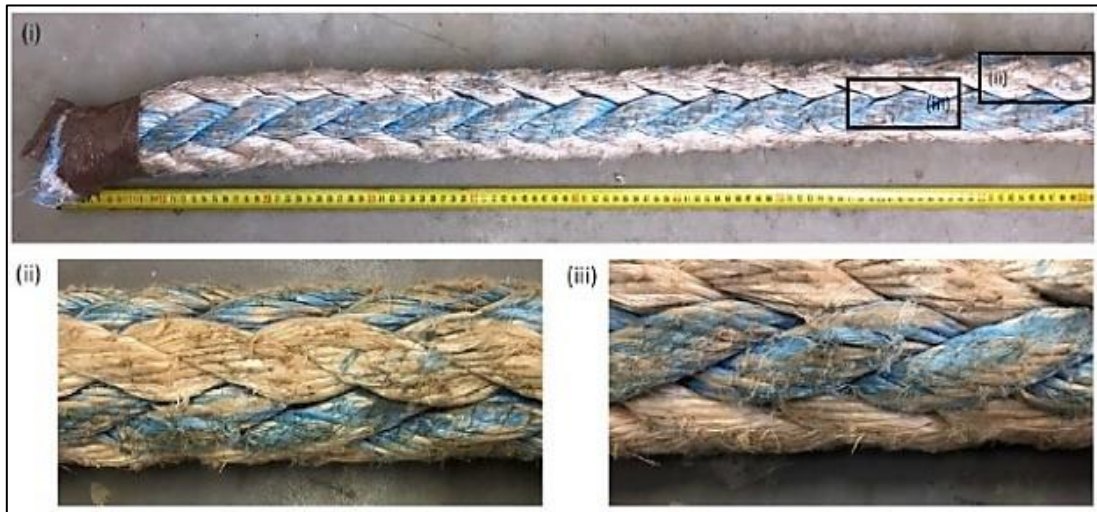
Figure 15: Damages on the first segment (furthest away from the point of failure) of sample B

Sample B broadly exhibited the same types of damages as sample A, including signs of abrasion and superficial broken fibres (Figures 15 and 16).

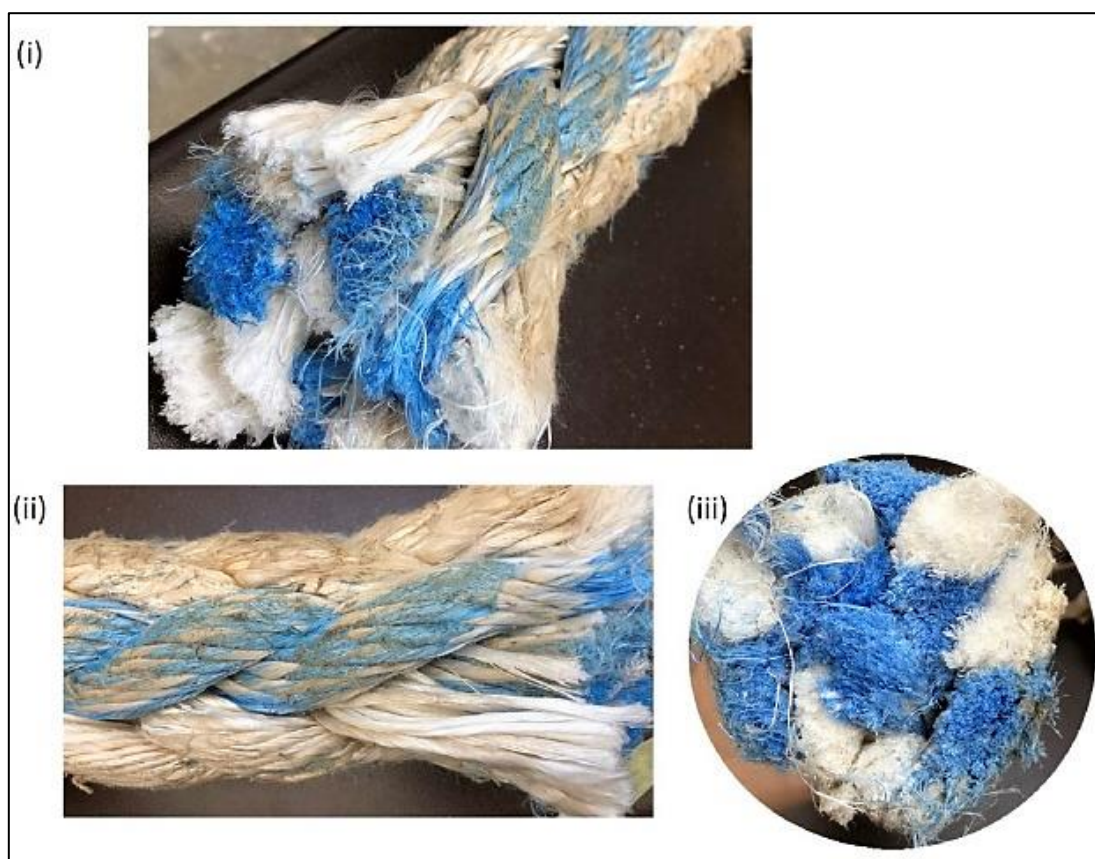
**Figure 17: Cross-sectional images of a cut sample**

Cross-sectional imaging provided a visual of the generally unblemished condition of the bulk material of the rope (**Figure 17**). This, however, did not take into account more significant localised damage, such as wear confined to smaller sections of strands, and pulled out or cut fibres, which may have had an important contribution in the reduction in residual strength of the rope.

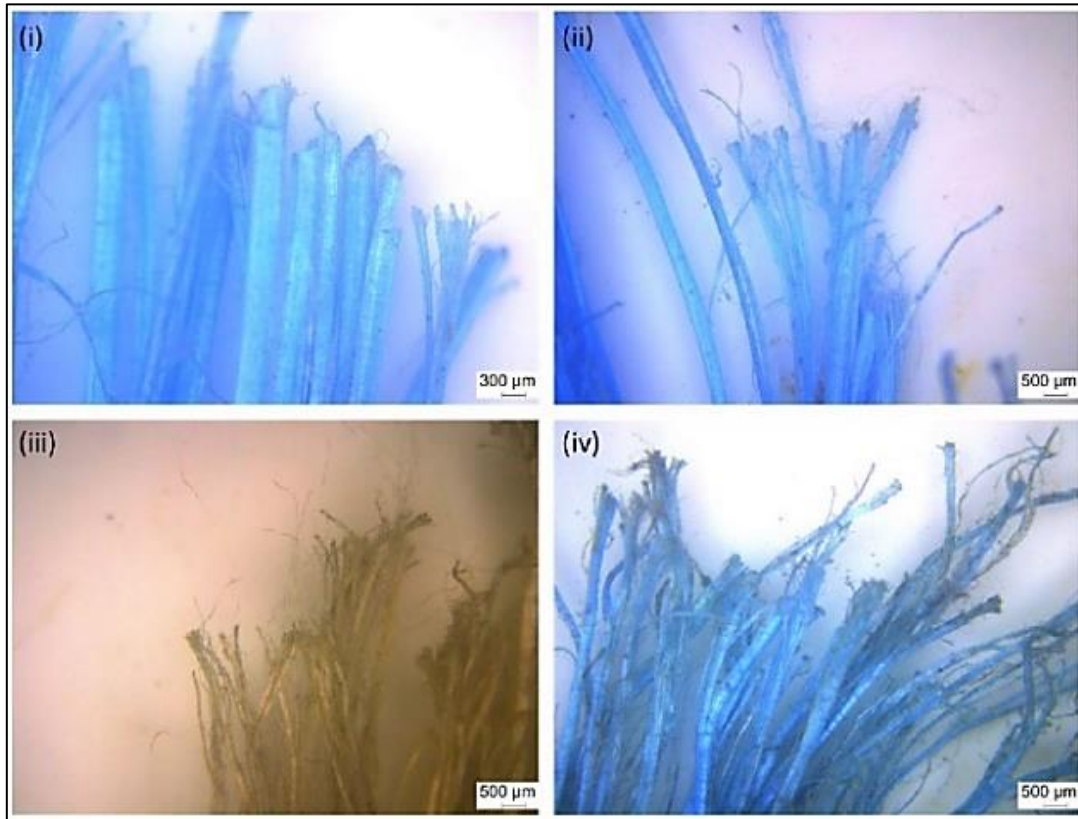
**Figures 18(i) to 18(iv): Stereomicrographs of the parted fibres**

Stereomicroscopic imaging of several fibres extracted from the failure region of both samples (**Figures 18(i) to 18(iv)**), indicated that the morphology of the fractured ends exhibited by these fibres, whether extracted from the interior sections of the rope (**Figures 18(i) and 18(ii)**) or from its exterior region, largely conformed to the anticipated characteristics of tensile-overload failure.

In these cases, the initiation of the failure was often on the same surface as the transverse ultimate fracture surface. In a few cases, certain fibres displayed signs of fatigue. These particular fibres exhibited a longer propagation crack running along the length of the fibre axis, resulting in a distinct protrusion ahead of the region where the catastrophic failure ultimately occurred. Furthermore, in the case of exterior fibres, noticeable abrasive damage was also observed.
