MARINE SAFETY INVESTIGATION REPORT

**Failure of an overhead monorail crane wire rope,
resulting in fatal injuries to a crew member on the deck
of the Maltese-registered container vessel,**

CMA CGM MANTA RAY,

**in the port of Laem Chabang, Thailand,
on 07 November 2022**

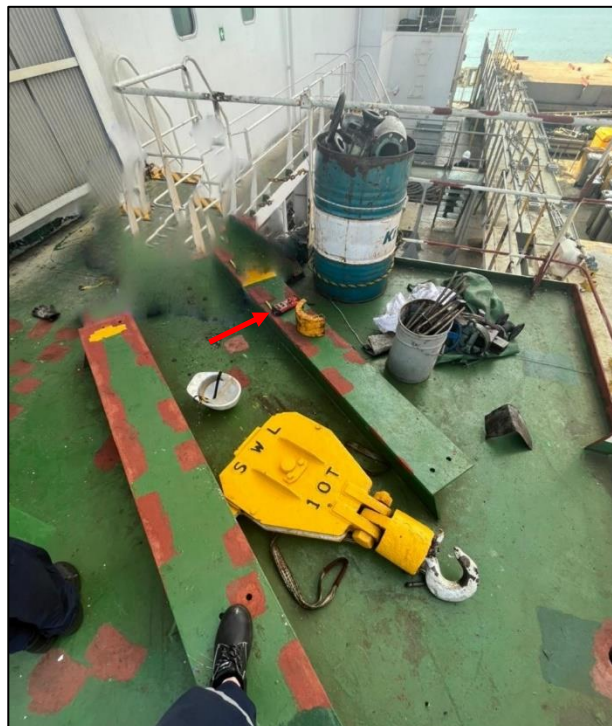
Figure 4: The monorail crane's port side block, as found after the occurrence; red arrow: the wireless remote controller (not in the same position as found immediately after the occurrence)

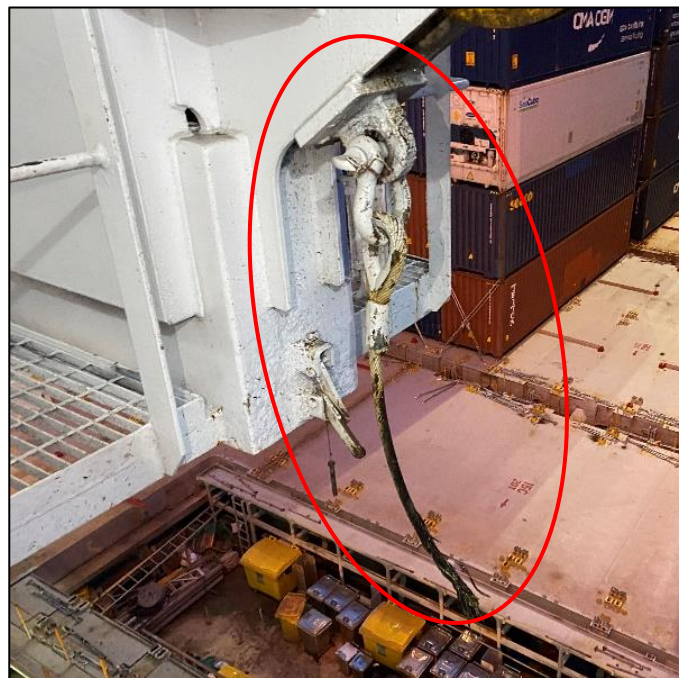
- the crane was directly above the accident site (as seen in **Figure 3**);
- the crane's port side hoisting wire had parted about one metre from its securing point (**Figures 5 and 6**);
- the crane's port side winch foundation was damaged (**Figure 7**), and
- the drive chain of the port side winch's hoist limit switch was disengaged from its small sprocket (**Figure 8**).

Figure 5: The fixed end of the monorail crane's parted wire (port side)

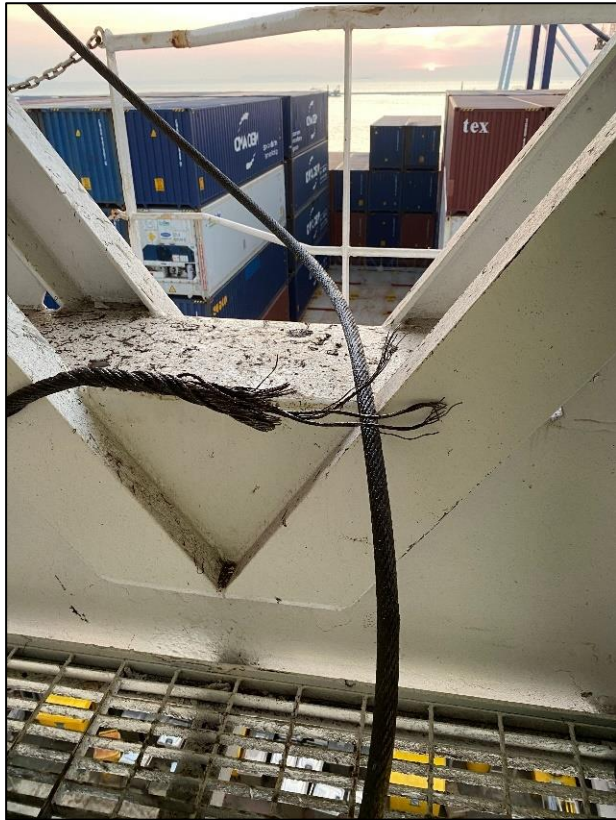
Figure 6: The running end of the parted wire

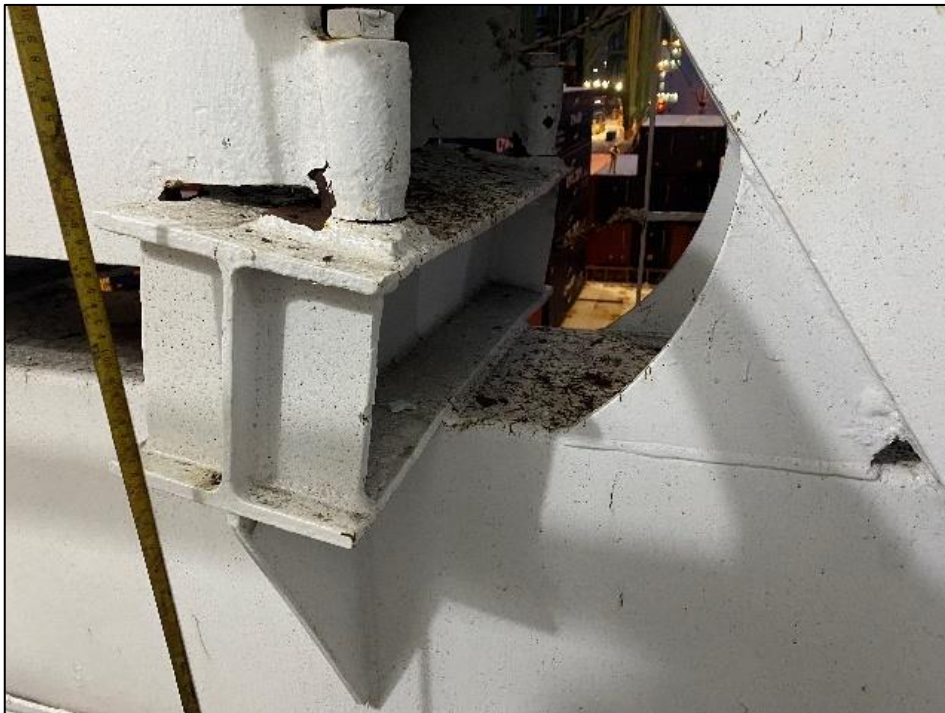
Figure 7: The damaged port side winch foundation

- the crane's sheave was deformed;
- the damaged port side winch foundation was leaning towards the crane's hoisting block *i.e.*, towards the direction of the load;

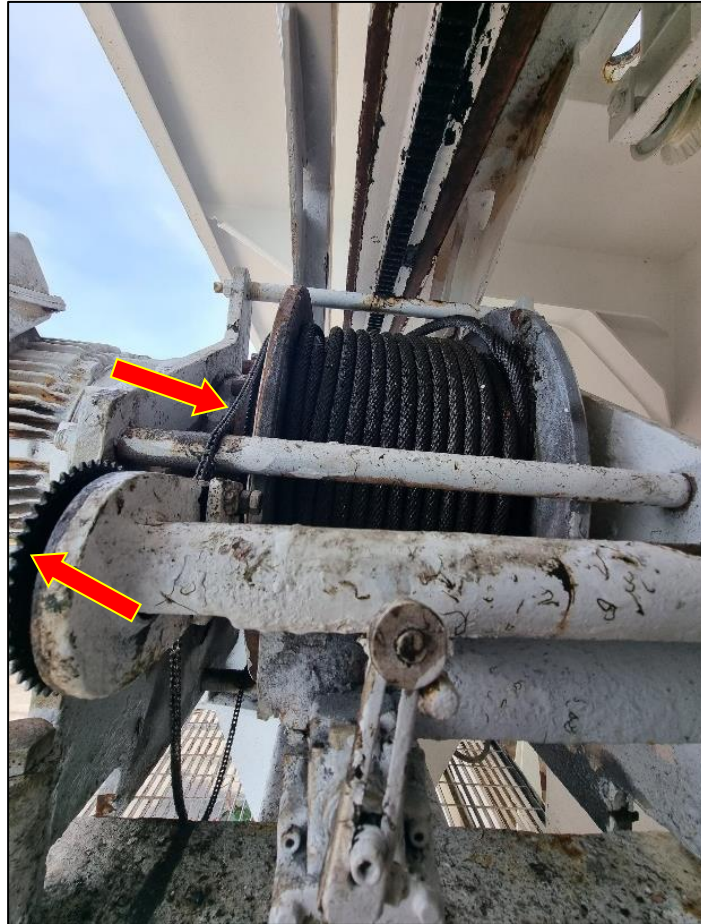
Figure 8: The disengaged port side hoist limit switch drive chain and its small sprocket

Based on the findings on site, the entity noted that the port side hoist limit switch had most likely not activated when the block was hoisted, thus allowing the block to be hoisted even further. This subsequently resulted in an overload of the hoisting system, leading to the eventual failure and parting of the wire rope, and the damages to the winch foundation. The likely failure of the hoist limit switch was attributed to the disengaged drive chain.

¹¹ It has to be clarified that **Figure 8** in this safety investigation report shows the drive chain disengaged from the small sprocket.

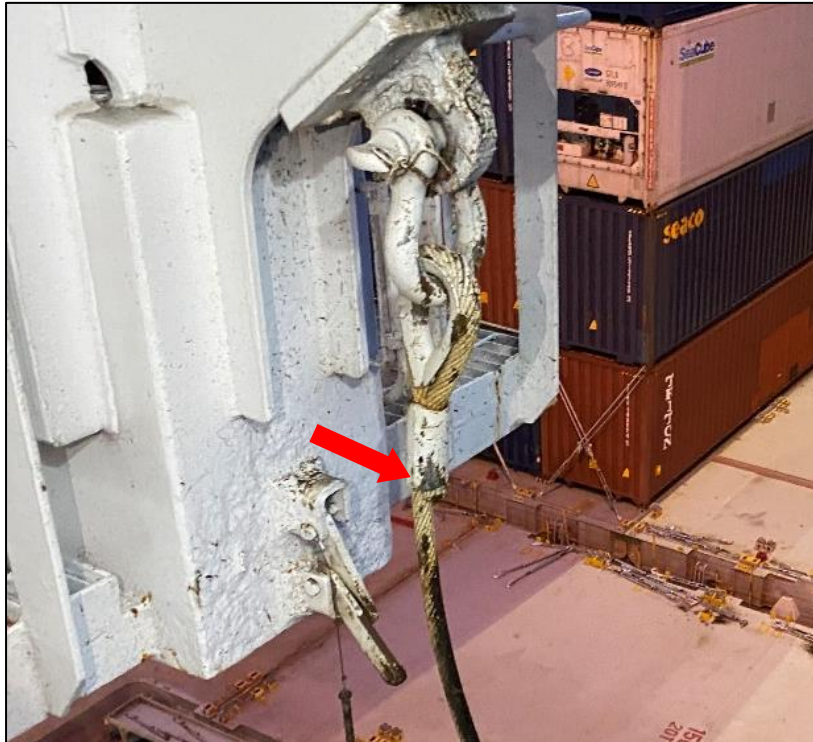
³ The safety investigation noted that similar signs of abrasion were also observed on the ferrule on the fixed end of the starboard side wire.

Figure 10: The abrasion marks (red arrow) observed on the ferrule at the fixed end of the parted wire rope

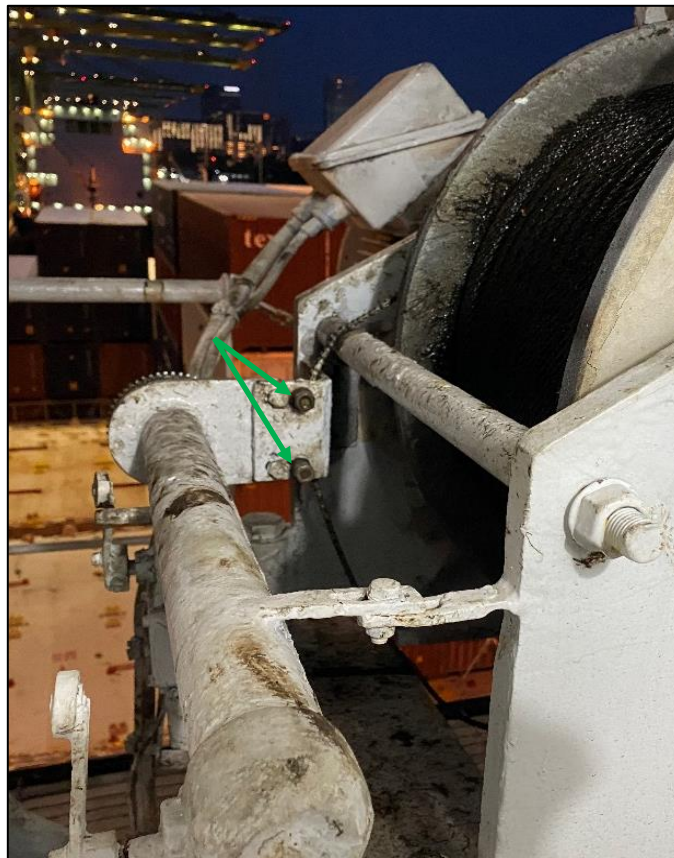
- two additional bolts were found to have been installed at the connection of the winch drum housing to the sprocket housing (**Figure 11**), while one bolt was missing from the hoist limit switch.

Figure 11: The additional bolts (green arrows) that were found installed

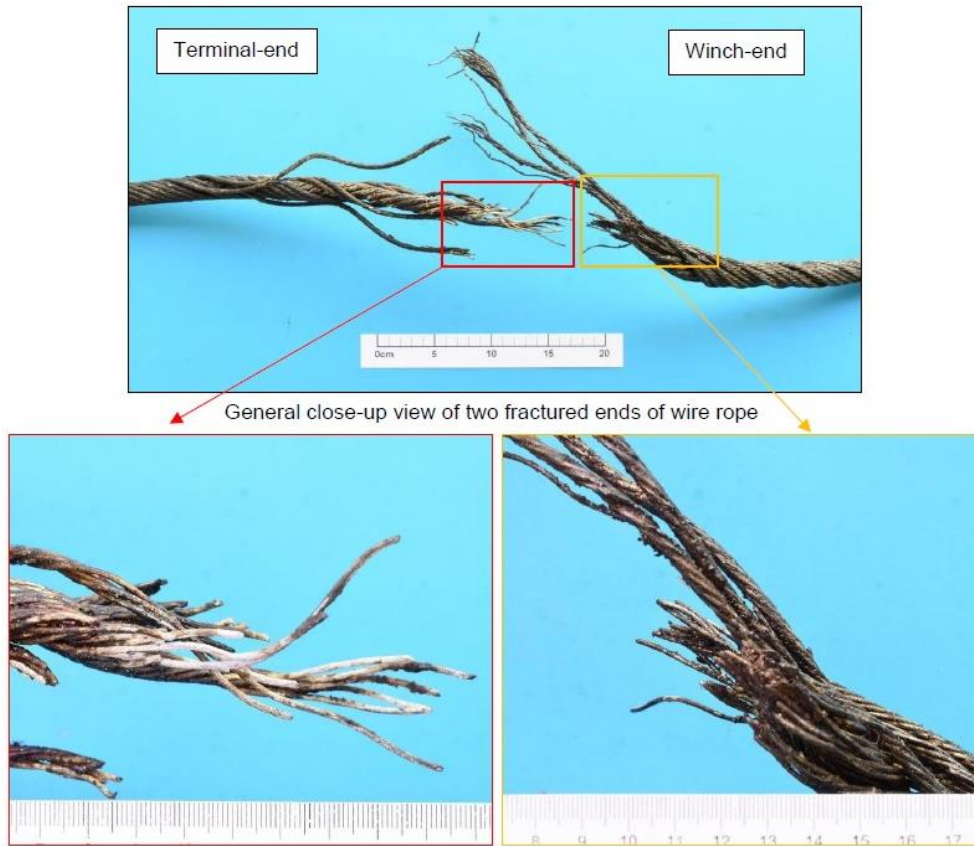
During the visual examination of the parted wire rope, no significant damages were observed on the outer strands of either section. However, the fractured surfaces of both sections matched each other, with the fracture running straight across the thickness of the rope, which is typically seen in overload failures (**Figure 12**).

Figure 12: Close-up view of the fractured surfaces of the fixed (terminal) and running (winch) ends of the parted wire rope
Source: Failure Analysis Report

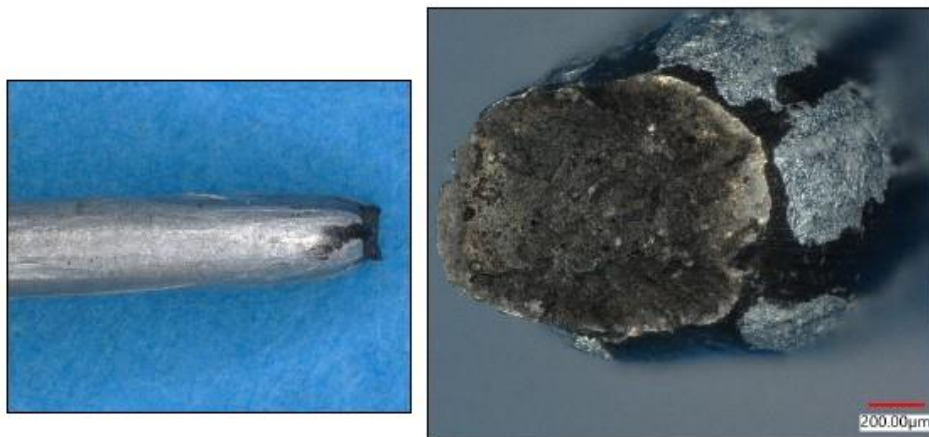
Examination of the individual wires revealed nicking of the outer wires of the inner strand and the WSC, with the nicking being more severe on the former. When examined under a stereomicroscope⁷, the wires showed a majority of cup and cone fractures (**Figure 13**) and oblique fractures (**Figure 14**), indicating that the wire rope had sustained an overload failure.

Figure 13: Cup and cone fracture seen on a wire from the WSC of the parted wire rope
Source: Failure Analysis Report

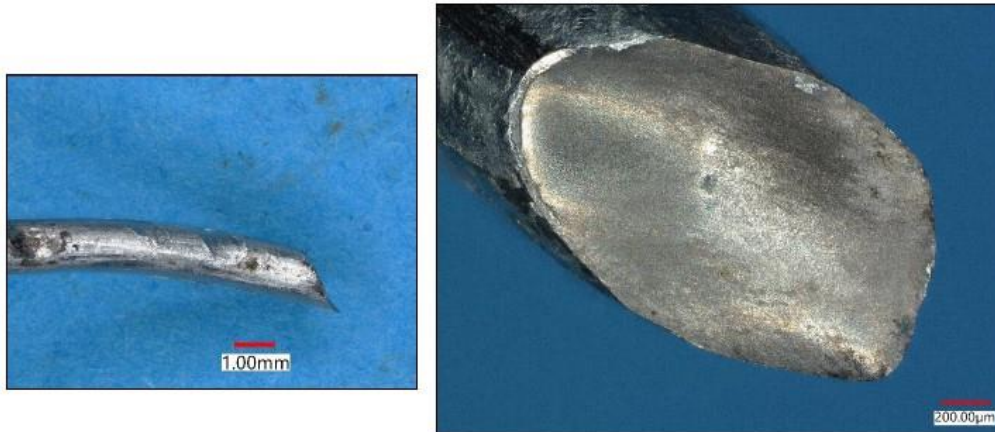
Figure 14: Oblique fracture seen on a wire from the inner strand of the parted wire rope
Source: Failure Analysis Report

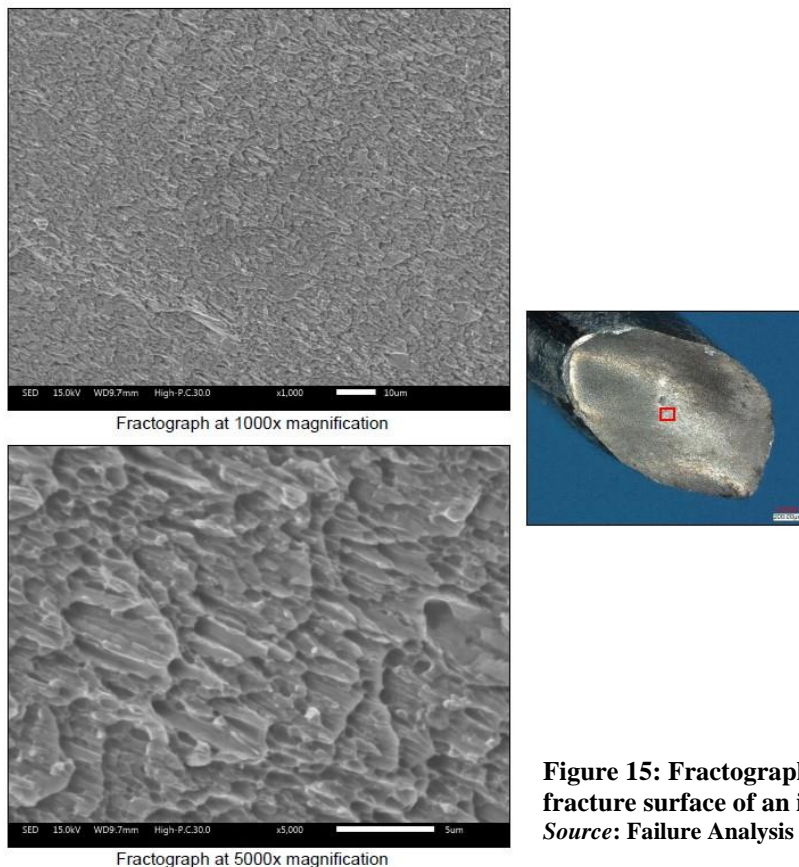
On the oblique fracture surfaces of the wires of the outer and inner strands, as well as the WSC, elongated dimples, consistent with ductile overload failure, were observed (**Figure 15**). The surfaces of the cup and cone fractures generally showed distinct equiaxed dimpled features (**Figure 16**).

Figure 15: Fractography of an oblique fracture surface of an inner strand wire
Source: Failure Analysis Report

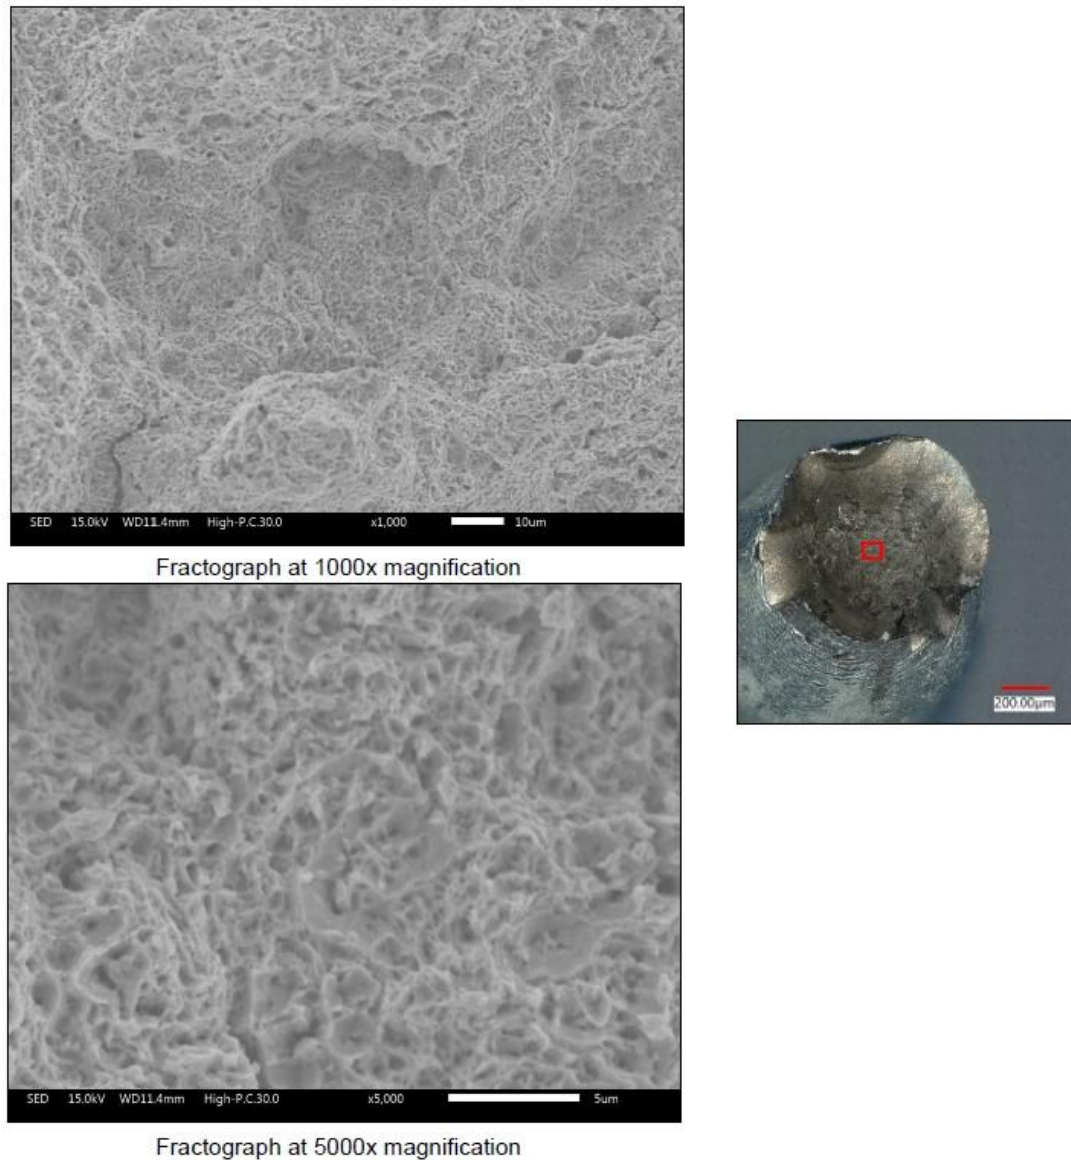
Figure 16: Fractography of a cup and cone fracture surface of an outer strand wire
Source: Failure Analysis Report

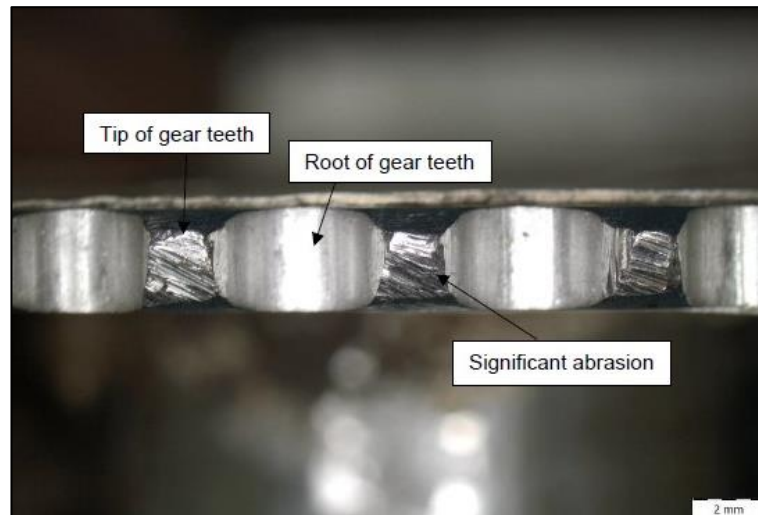
The small sprocket (from where the drive chain was found disengaged) was observed to have been generally covered in an adherent layer of paint and dry grease, indicating the drive chain had been disengaged from the sprocket for a long period of time. Microscopic examination revealed degradation of gear teeth, towards their tips (**Figure 17**), with the thinnest measuring 0.50 mm and the thickest being 1.55 mm.

Figure 17: Top view (microscopic) of the gear teeth of the small sprocket
Source: Failure Analysis Report

16/2023_R3 replace the small sprockets on port due to manifested abrasion and wear patterns and inspect the starboard side sprocket and replace, if necessary;

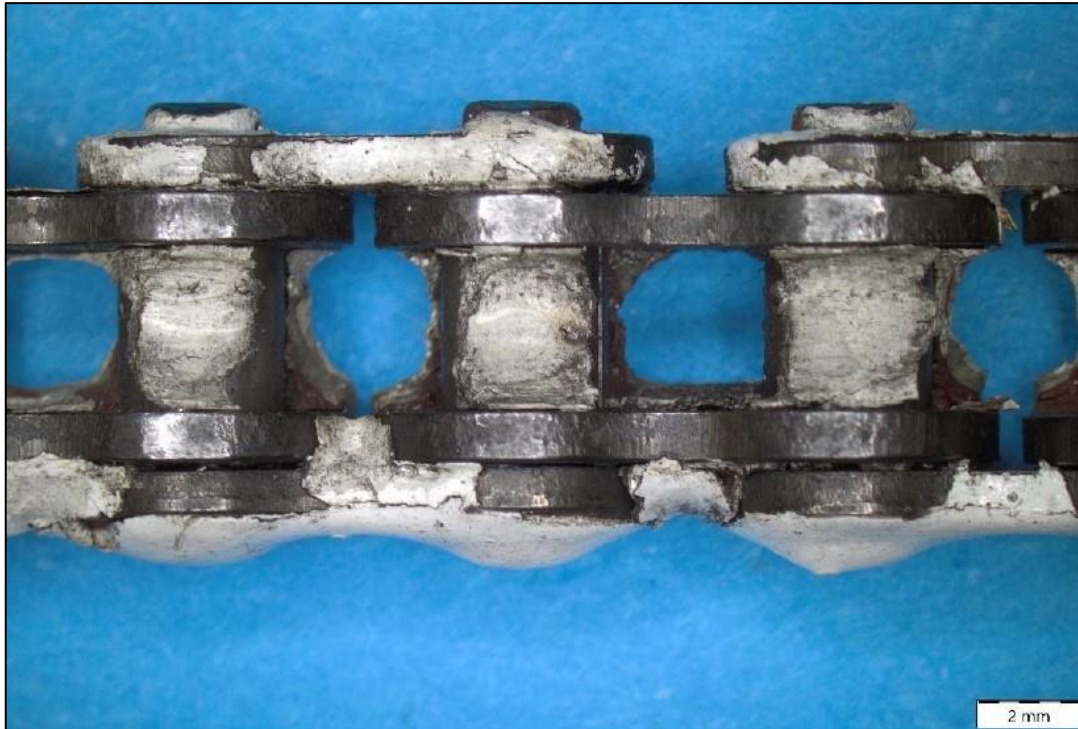
The drive chain was observed to be covered in a thick layer of grease and paint. Microscopic examination, after cleaning in an ultrasonic bath of kerosene, revealed wastage and adherent paint on the outer plates of the chain, as well as adherent paint on the internal surface of the rollers (**Figure 18**).

Figure 18: Microscopic view of the drive chain, with the adherent white paint visible
Source: Failure Analysis Report

16/2023_R5 ensure that the drive chain systems of the deck monorail cranes are part of the planned maintenance system with the necessary precaution taken to prevent the inadequate lubrication at the prescribed time intervals;

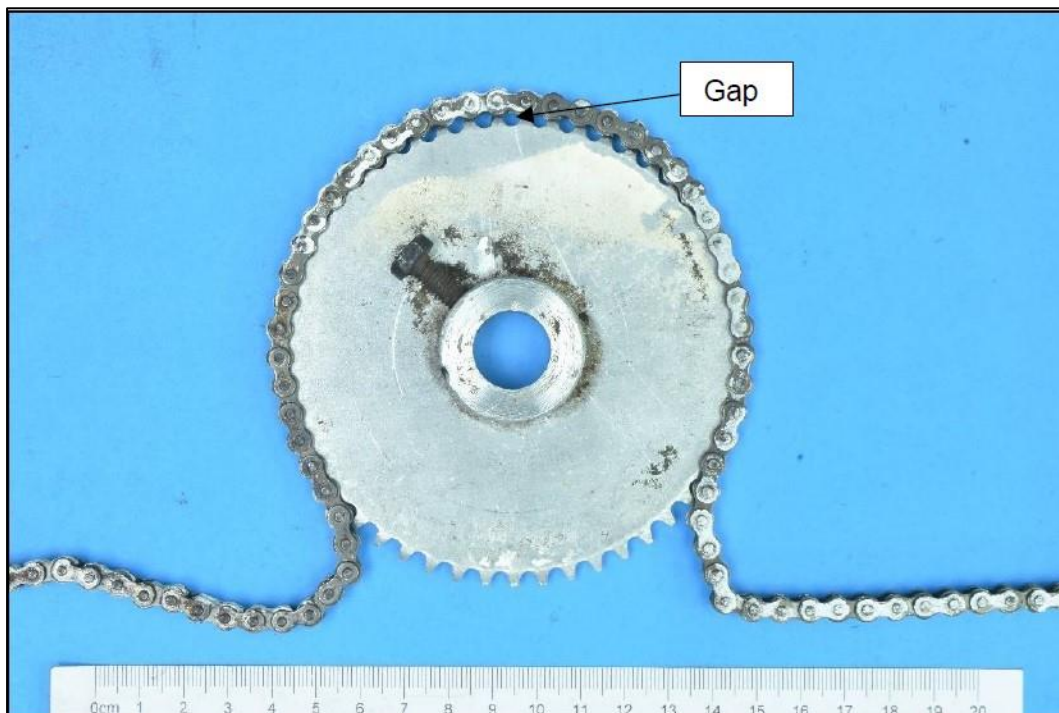
Furthermore, a gap was observed between the drive chain and the sprocket teeth, in the regions of the adherent paint, on the internal surface of the chain's rollers, when these regions came into contact with the sprocket (**Figure 19**).

Figure 19: Gap between the drive chain and the small sprocket
Source: Failure Analysis Report

It is highly likely that such a gap would have contributed to the drive chain jumping off the sprockets. Once the drive chain was dislodged, the safety feature of the hoist limit switch would be lost, allowing the block to be raised above its highest point and come into contact with the crane's sheave. Following this, the crane would have been solely dependent on the overload limit switch as a safety barrier prior to failure¹².

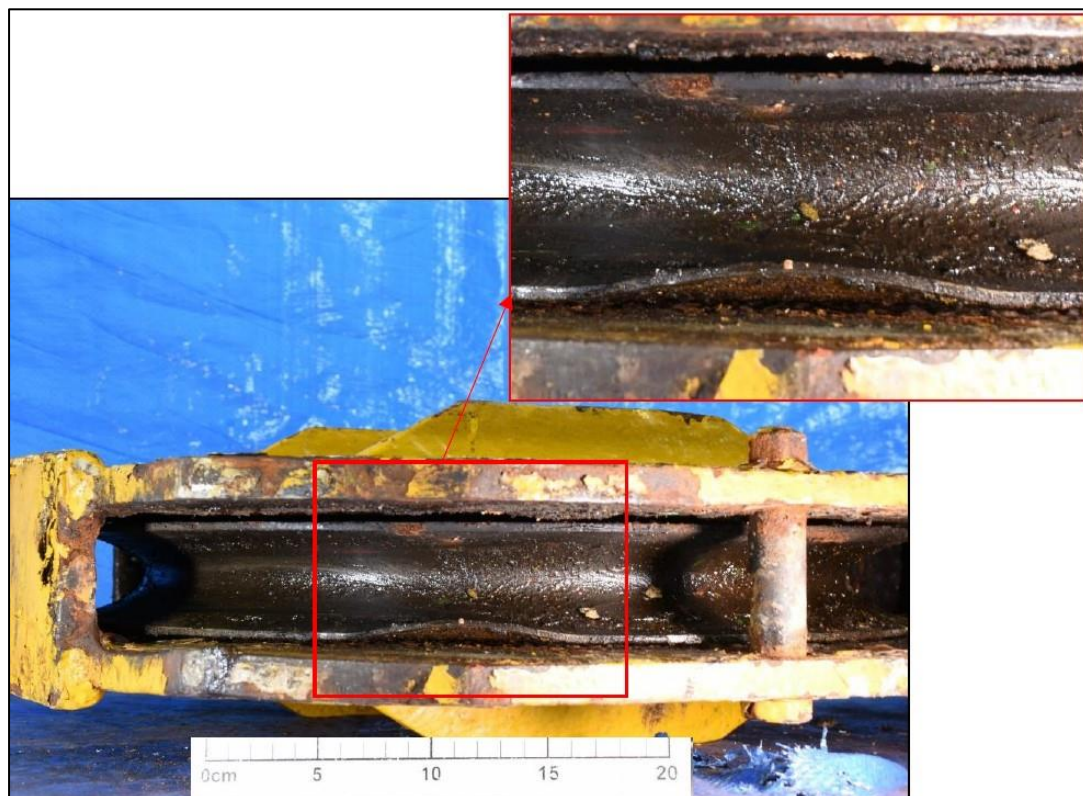
When closer examinations of the deformations found on the sheaves of the port side block and the crane were carried out, it appeared that these deformations were the result of contact between the two sheaves (**Figures 20, 21 and 22**). The deformations observed on the block and the crane's sheave were also indicative of contact between the block and the crane's sheave (**Figure 23**).

Figure 20: The deformation on the port side block's sheave
Source: Failure Analysis Report

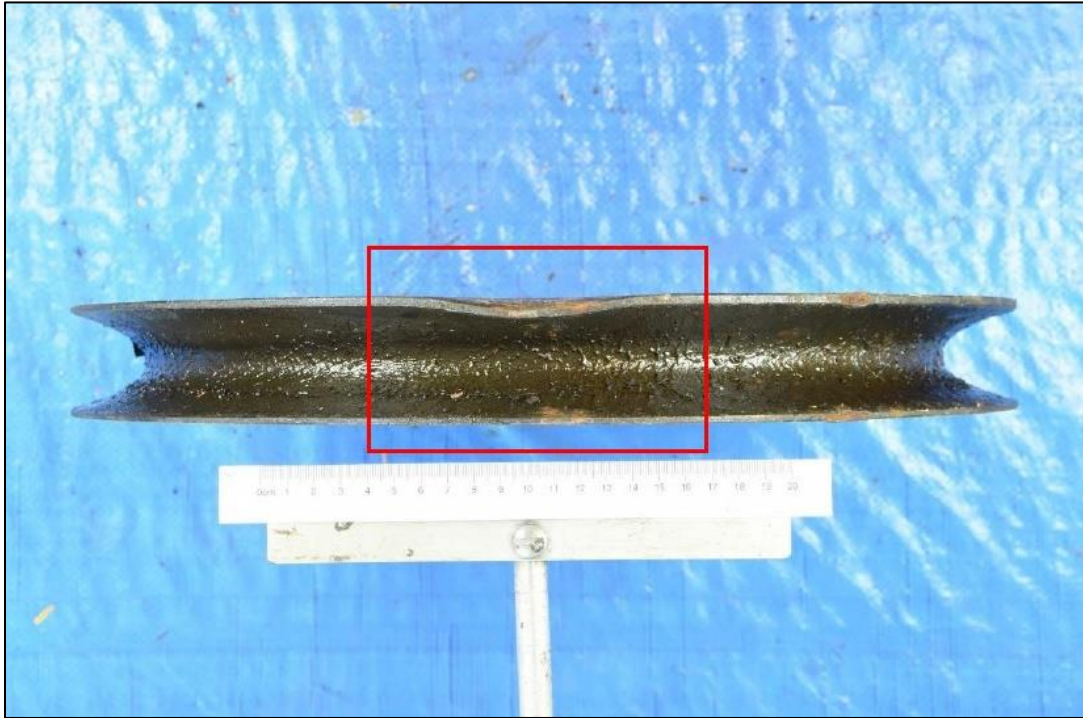
Figure 21: The deformation on the crane's sheave
Source: Failure Analysis Report

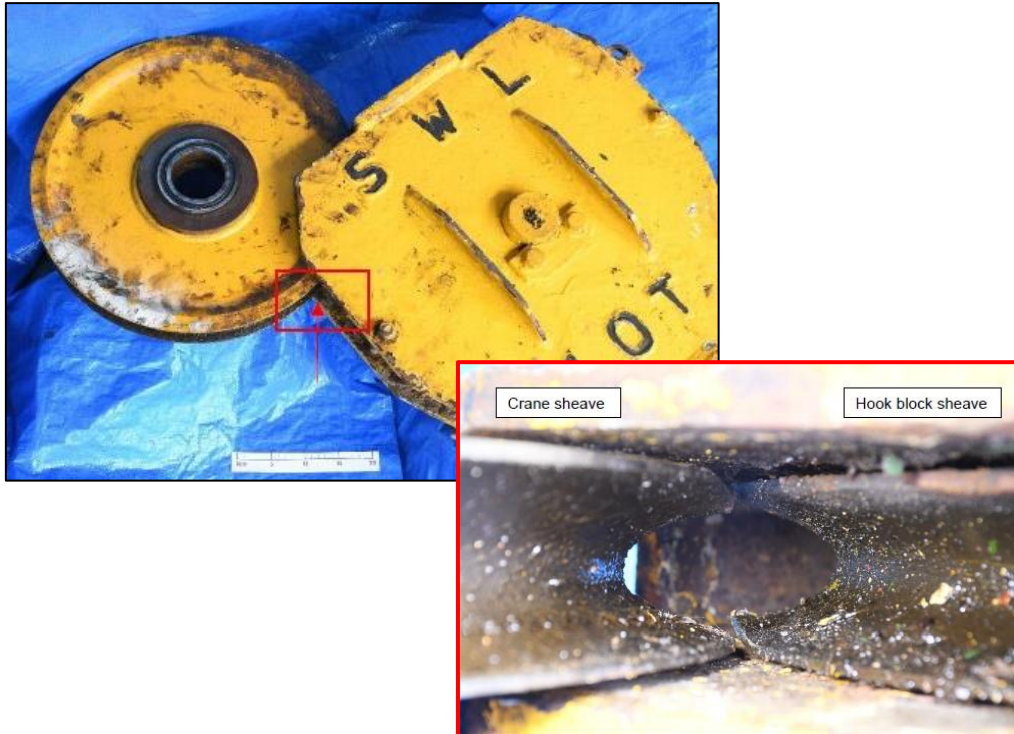
Figure 22: Contact between the two sheaves
Source: Failure Analysis Report

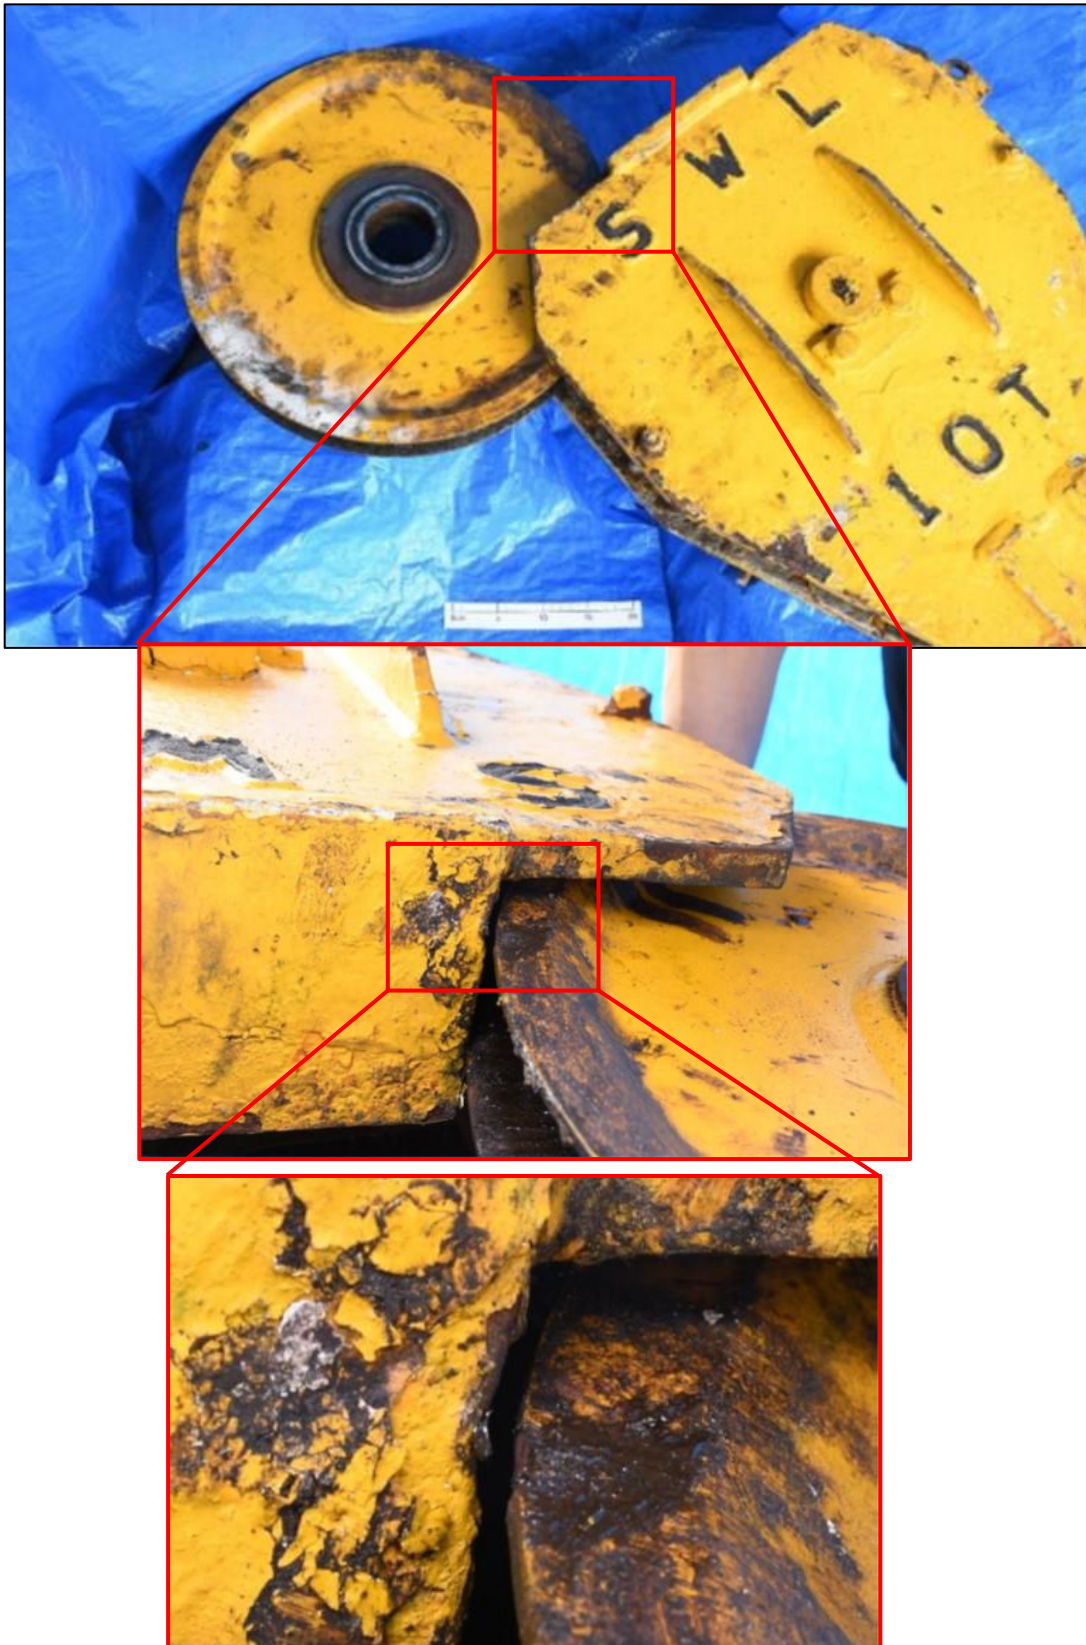
Figure 23: The point of contact between the block and the crane's sheave
Source: Failure Analysis Report

- .1 Deformations found on the port side block, its sheave and the crane's sheave suggested that the crane's sheave had come into contact with the block as well as the block's sheave, while the block was being hoisted, thereby overloading the wire to cause its failure.
