**Bundesstelle für Seeunfalluntersuchung**  
Federal Bureau of Maritime Casualty Investigation

## **Summary Investigation Report 286/20**

**Risk to the health of a dock worker due to electric shock while connecting a refrigerated container to a socket on board the fully-containerised vessel  
MONTREAL EXPRESS  
on 29 August 2020**

15 May 2024

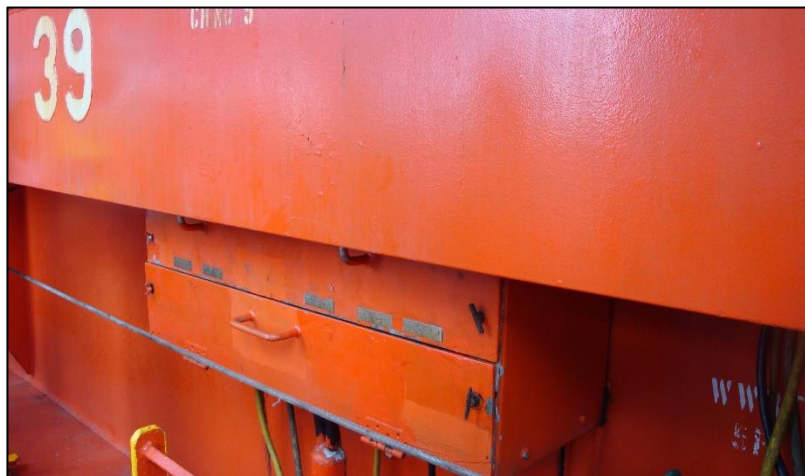
Figure 3: Terminal/switch box beneath the hatch coaming for supplying refrigerated containers with power (both access panels closed)

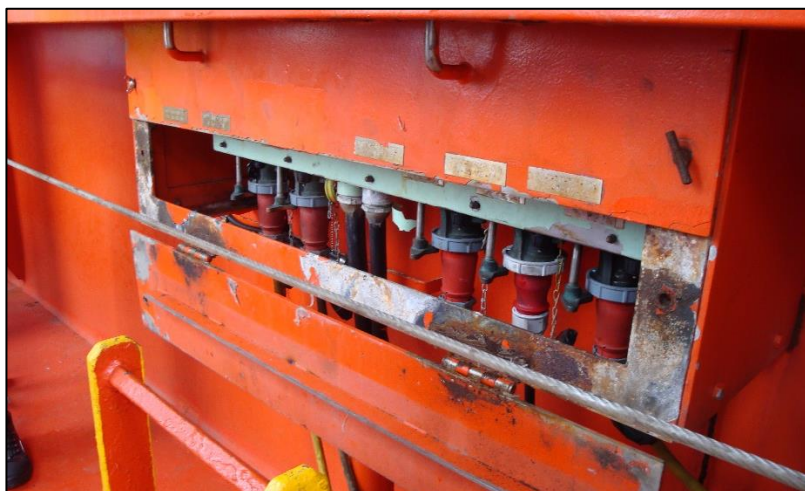
Figure 4: Terminal/switch box (lower access panel open)

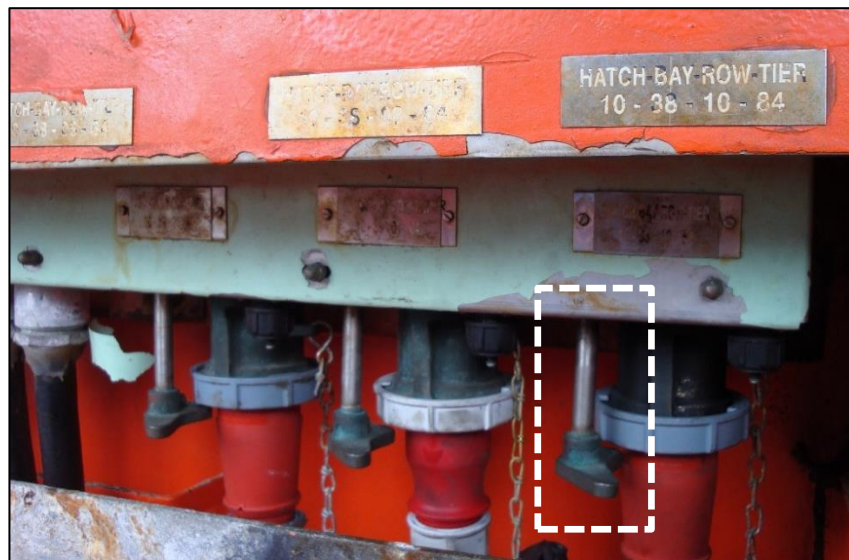
As already discussed, WSP officers arrived at the berth of the MONTREAL EXPRESS shortly after being alerted. The dock worker who had suffered the electric shock was in an ambulance on the pier for a preliminary examination by the emergency physician. Before he was taken to hospital for further observation as a precautionary measure, he gave a brief account of the course of events to the officers. In particular, the dock worker pointed out that although he had already inserted the power cable's plug into the socket, he had not yet activated the power supply by means of the switching device provided for this purpose (see white dashed rectangle in **Figure 7**) when the flash of light reportedly occurred.

Figure 7: Switching device of the socket used before the incident

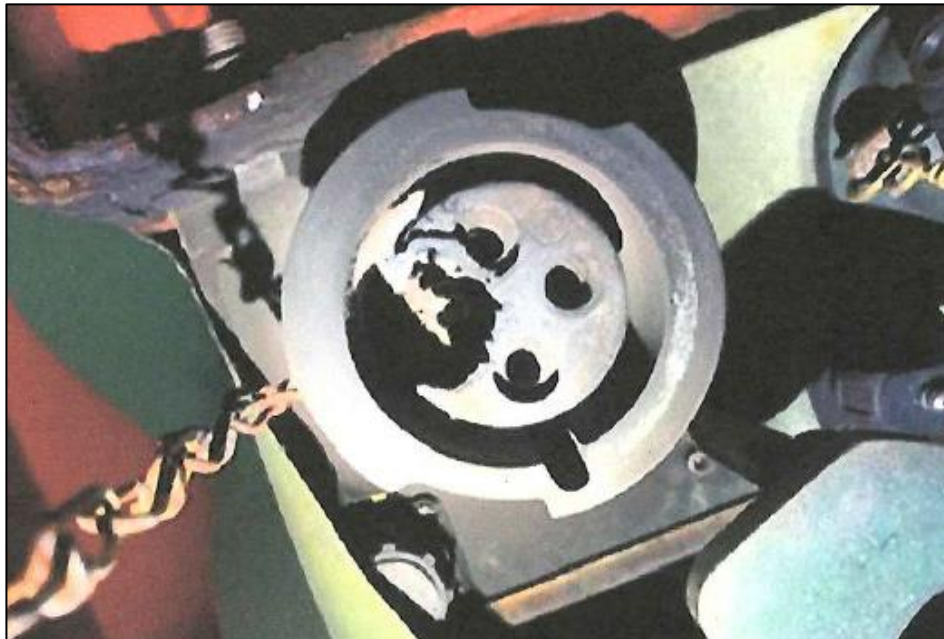
The WSP officers then inspected the terminal/switch box in the area of bay 38/39. The inner connection base of the plastic housing of the socket used by the dock worker immediately before the electric shock exhibited clear signs of thermal stress (see **Figure 8**).

Figure 8: Damaged on-board refrigerated container point<sup>13</sup>

The plug belonging to the refrigerated container, which the dock worker had used and was also damaged by the faulty flow of electricity, had already been replaced in the meantime by an employee of the service company which is based in the port and specialises in carrying out repair works quickly if necessary, so as to be able to supply the container's refrigeration unit with electricity again as quickly as possible via another socket in order to prevent damage to the cargo.

Following the enquiries at the scene, the police officers notified by telephone the Ship Safety Division, whose responsibilities include ship safety inspections in Germany's ports. The officer on call decided that the damaged socket should reportedly not be used for the time being and should reportedly be repaired before the next port call in Hamburg in about four weeks' time. Further administrative directives or even a detention order were not issued. Accordingly, the MONTREAL EXPRESS left the port of Hamburg as scheduled after completion of the cargo-handling operations.

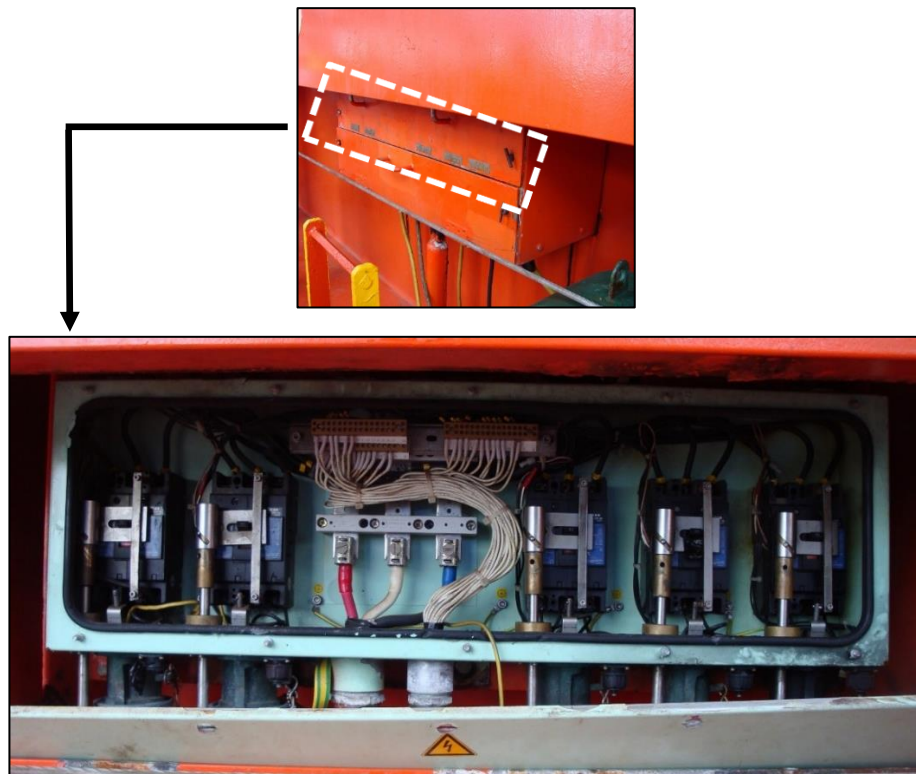
The inspection revealed moisture in the housing of the switch box located in the upper part of the terminal/switch box, which during normal operation is additionally closed by a tightly bolted cover. It was also found that the cable mounted in the switch box housing, which acts as the earth lead for the cover lid, was not attached to the male tab connector mounted on the inside of the cover by means of the female tab connector, as intended (see **Figures 10 and, in particular, 11 and 12** below: photographic documentation of the properly earthed cover in question made during the BSU's visit on board), but rather that the female tab connector had become detached from it. A side effect or possibly even the cause of this detachment of the earth lead from the cover of the switch box housing was that the loose cable had inadvertently been trapped in the rubber seal between the cover and housing box when the cover was fitted (see **Figure 13** below). This compromised the proper sealing of the switch box, i.e. the protection against moisture ingress.

Figure 10: View into the switch box housing after removing the upper access panel of the terminal/switch box and dismantling the cover of the housing box

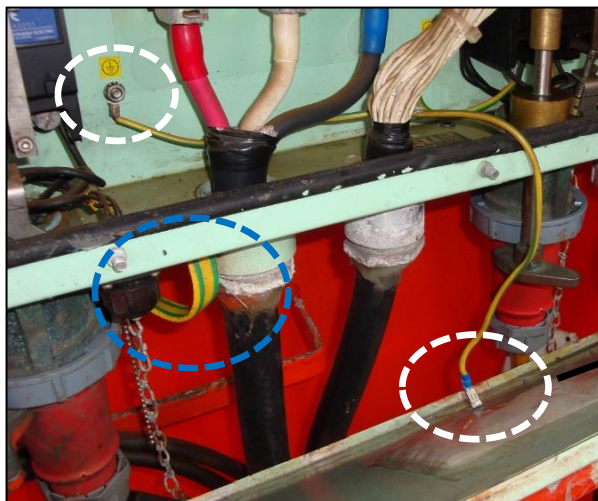
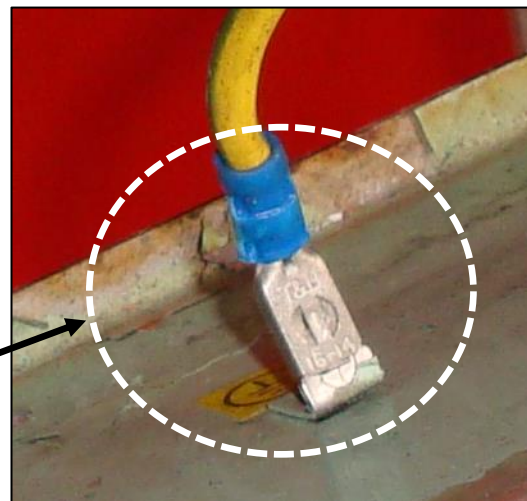
Cover of the housing box earthed with an earth lead bolted to the housing box (Figure 11) and the other end connected to the cover properly by means of a female tab connector (Figure 12)

<sup>15</sup> The blue dashed outline in Figure 11 shows the position of the main earth lead connecting the housing box to the hatch coaming.

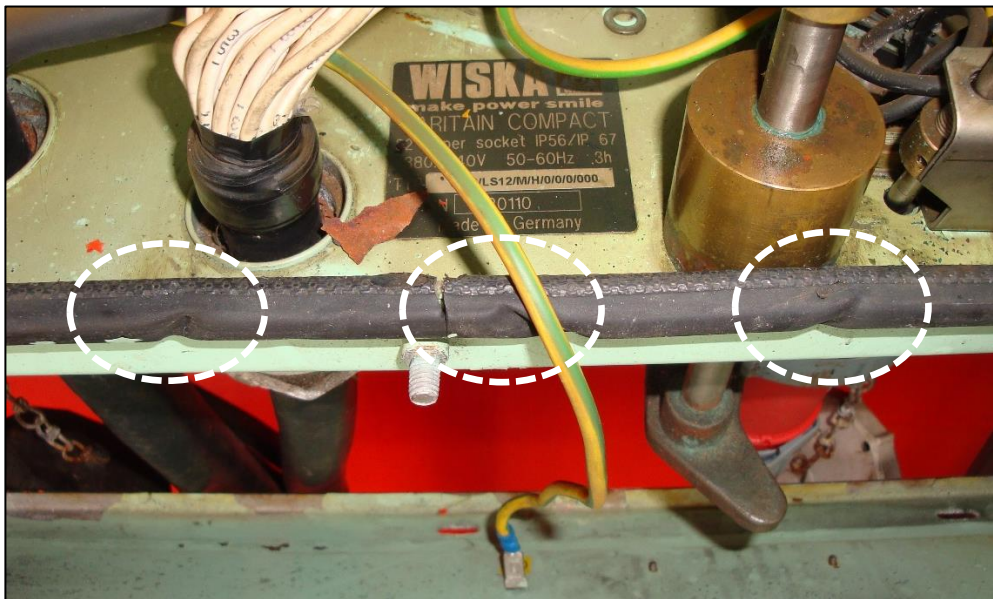
Figure 13: Localised pressure marks in the switch box housing's rubber seal<sup>16</sup>

<sup>16</sup> Similar to Figures 10, 11 and 12, this photograph was taken during the BSU's visit on board and shows the housing cover earthed properly. The three pressure marks in the rubber seal shown in Figure 13 nevertheless confirm the observation in the MRW service report that the earth lead was trapped at various points between the cover and housing box when the MRW inspection was conducted, but evidently also prior to that, thus compromising its sealing effect.

It is important to note that the cover seal of the switch box does not close completely due to deformation caused by the earth lead on the removable cover (see **p. 15 Figure 13** above) and therefore moisture can enter the switch box (the clear traces of corrosion on the switching rod in **Figure 19** are indicative of this).

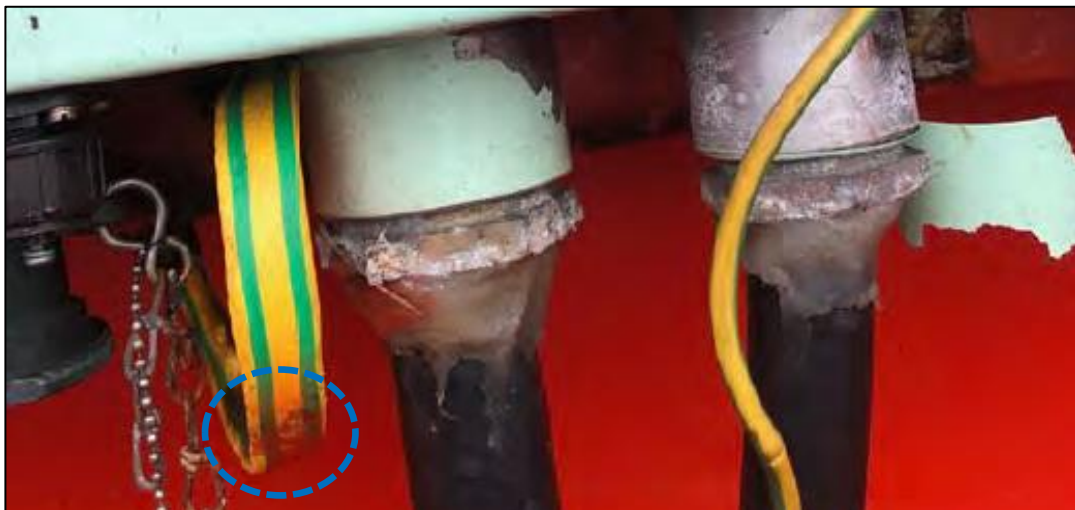
The technician from MRW also found that the main earth lead, which is supposed to discharge any residual current in the switch box housing toward the hull (here via the hatch coaming) without resistance (see blue dashed outline in **Figure 11** above and **Figure 14** below), was corroded.

Figure 14: Corroded section of the main earth lead below the housing box<sup>17</sup>

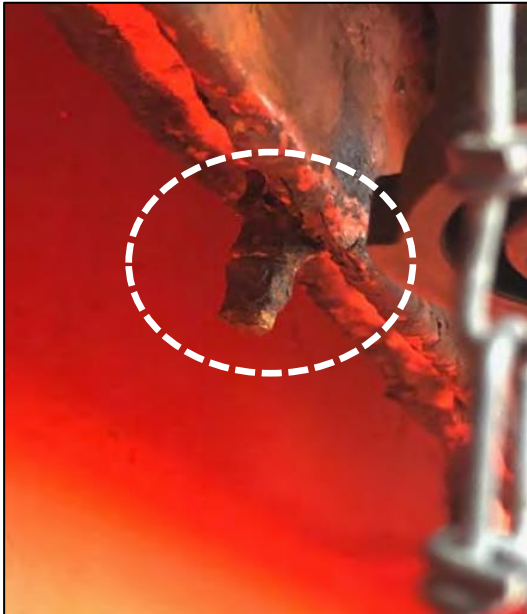
The bolt welded to the hatch coaming below the housing box, pointing vertically downward and used for connecting the main earth lead, exhibited particularly distinct signs of corrosion (see **Figure 15**). The defect in question was rectified during the call at the port of Montreal (see **Figure 16**).

Figure 15: Old earth connection<sup>18</sup>

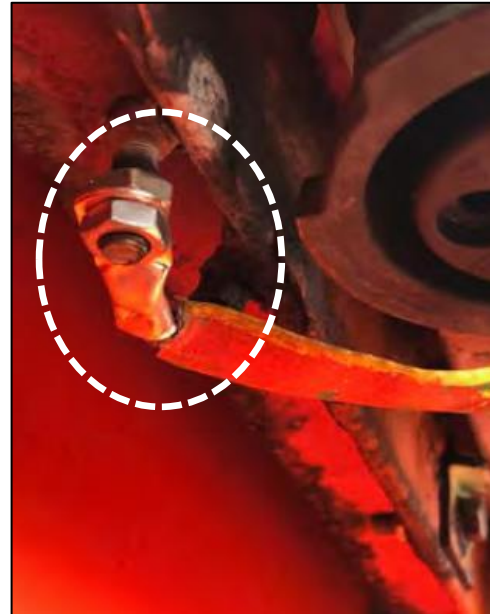
Figure 16: Earth connection after renewal

The expert also noted the replaced earth connection for the switch box below the hatch coaming (see p. 16 **Figure 16** above).

- removal of moisture from the switch box;
- renewal of the connection for the switch box's main earth lead;
- renewal of the earthing for switch box's cover, and
- inspection of the connection and switching device insulation resistances.

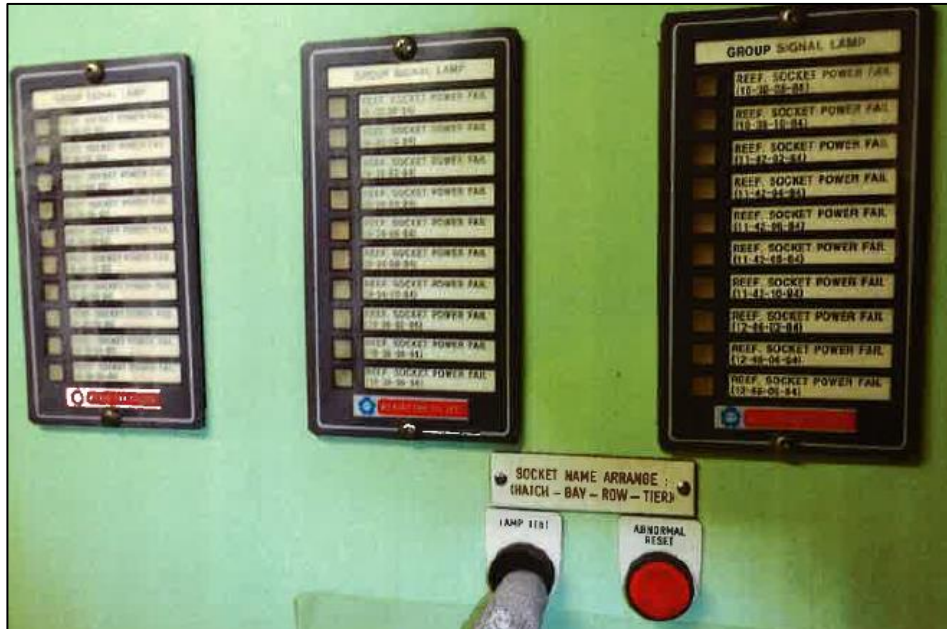
Auxiliary contacts on the circuit breaker should be used to show on the panel of the power supply cabinet (located below the main deck) which of the sockets in which terminal boxes are occupied. The display in question on the switch cabinet was defective overall (see **Figure 18**).

Figure 18: Panel on the power supply cabinet

*Contrary to the condition found, the status panels on the power supply cabinets must be operable so as to be able to identify faulty terminal/switch boxes quickly and clearly in the event of a fault.*

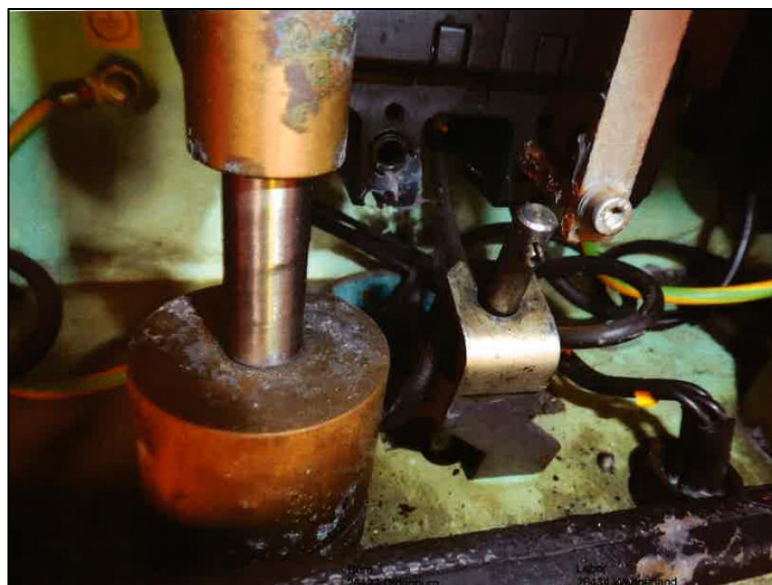
Figure 19: Traces of corrosion on the switching rod inside the switch box

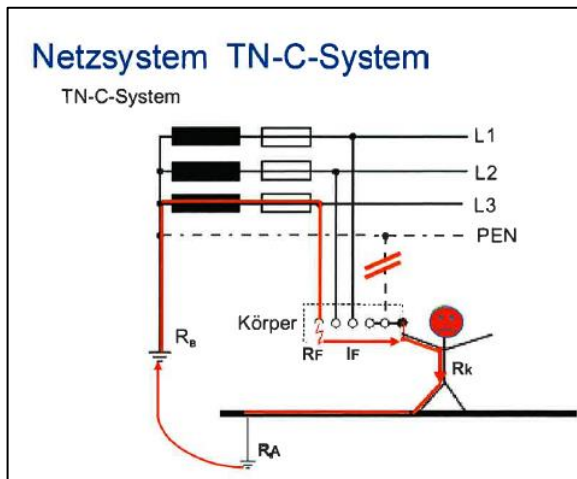
Based on the MRW service report, the expert assumes that the moisture inside the housing of the switch box would result in so-called 'creepage distance formation'. Due to the interrupted PE<sup>21</sup> conductor, the dock worker could suffer an electric shock when touching the switch box housing while inserting the plug of the refrigerated container connection cable (see **Figures 20 f.**).

Figure 20:  
Interrupted earthing  
(possible residual current discharged via the body of the dock worker)

Following the assessment of all sources of information, it is clear that moisture inside the inadequately sealed terminal/switch box at bay 38/39 (port side) caused a so-called 'creepage distance formation'. Since the PE conductor was interrupted or at least its functionality severely impaired by corrosion and/or a loose contact at the same time, the residual current caused by the creepage distance formation was not (only) discharged directly via this conductor toward the hull of the ship. Instead, at least part of the residual current flowed through the body of the dock worker when he touched the switch box housing, causing him to suffer an electric shock.

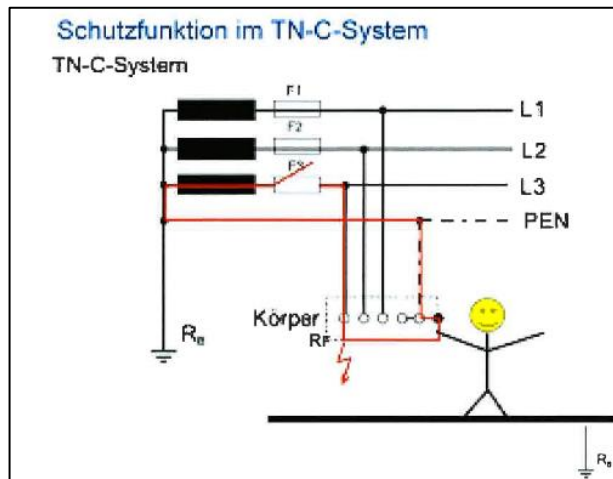
Figure 21:  
Switch box housing earthed properly  
(residual current discharged via the PE conductor)

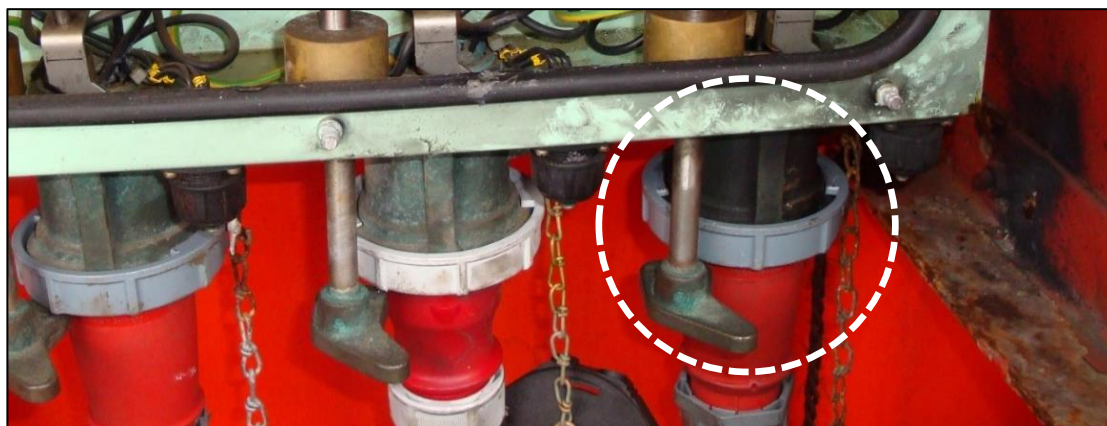
A comparison of the surfaces of the sockets in the switch box at bay 38/39 reveals that the outer-right socket was obviously replaced again after the second incident (i.e. that on 29 August 2020 – see **Figure 22** below).

Figure 22: Socket base in the terminal/switch box at bay 38/39

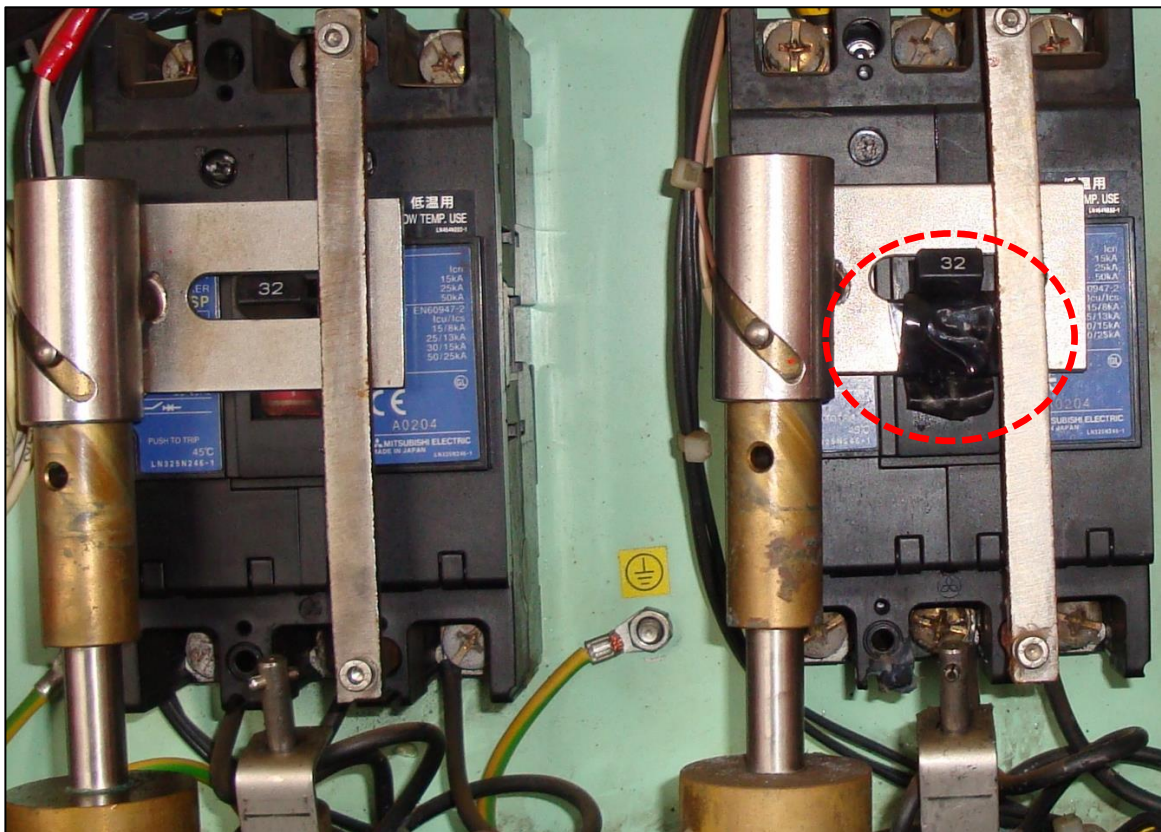
*The switching lever of a low-voltage circuit breaker is provisionally wrapped in insulating tape (see red dashed outline in **Figure 23**) because there is too much play and the ship's electrician explained that this causes a problem when switching on after inserting a plug into the socket.*

Figure 23: Provisional repair of a switching lever using insulating tape

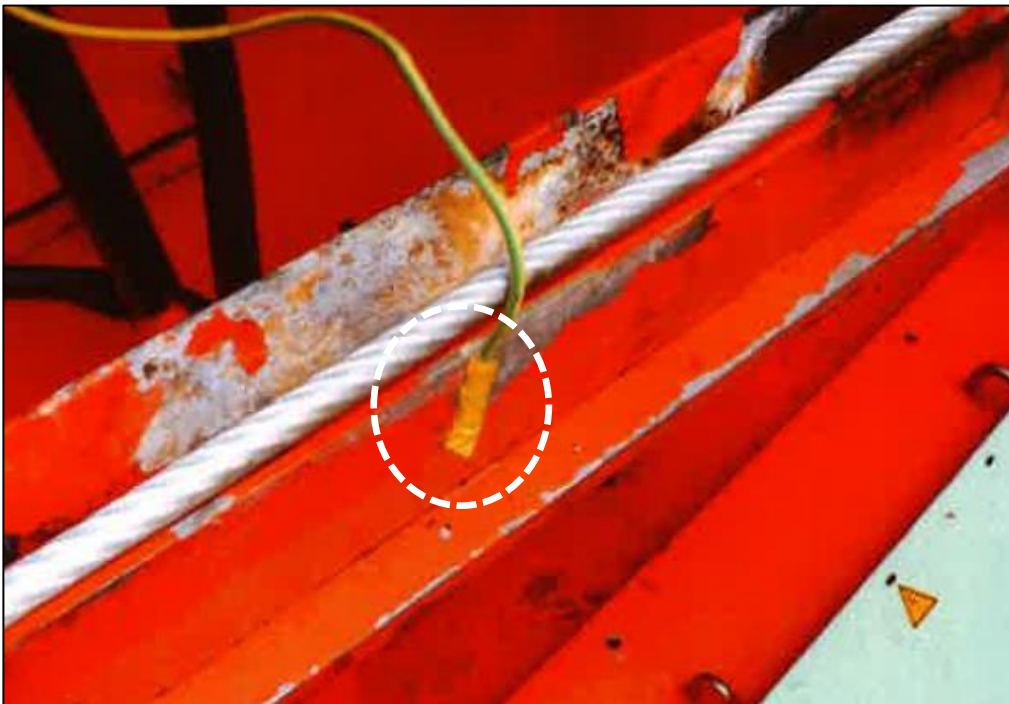
When the switch box cover was opened, the earth lead's female tab connector parted from the male tab connector mounted on the inside of the cover. The female tab connector is wrapped several times in yellow insulating tape (see **Figure 24**). It was not possible to make a force-fit in accordance with professional norms, i.e. a tight connection between the male and female tab connectors.

Figure 24: Female tab connector (wrapped in insulating tape) detached from the male tab connector on the inside of the cover

There was heavy corrosion and visible moisture (drop adhesion) inside the switch box. The seal was no longer properly affixed to the switch box cover, allowing moisture to enter from outside.

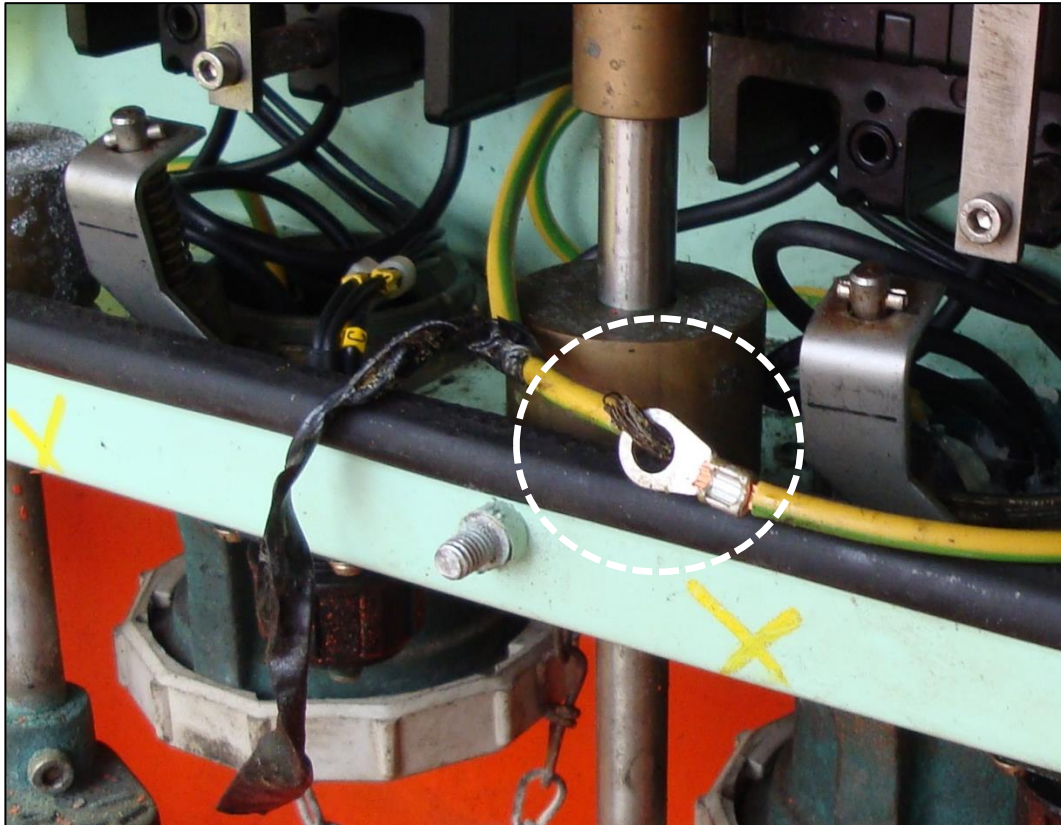
In addition, part of the right-hand socket's PE connection was wrapped in black insulating tape. After the insulating tape was removed, a join that did not comply with professional norms was found between two cable parts. A terminal lug pressed onto the conductor was located at the end of the cable leading to the socket's PE connection. The open end of the partial conductor connected to the earthing point on the back wall of the switch box had been stripped. The stripped end of the conductor was twisted around the eyelet by hand. The copper strands are already exhibiting surface oxidation, meaning that a proper connection cannot be present (see **Figure 25**).

Figure 25: Join that does not comply with professional norms between two sections of a PE conductor

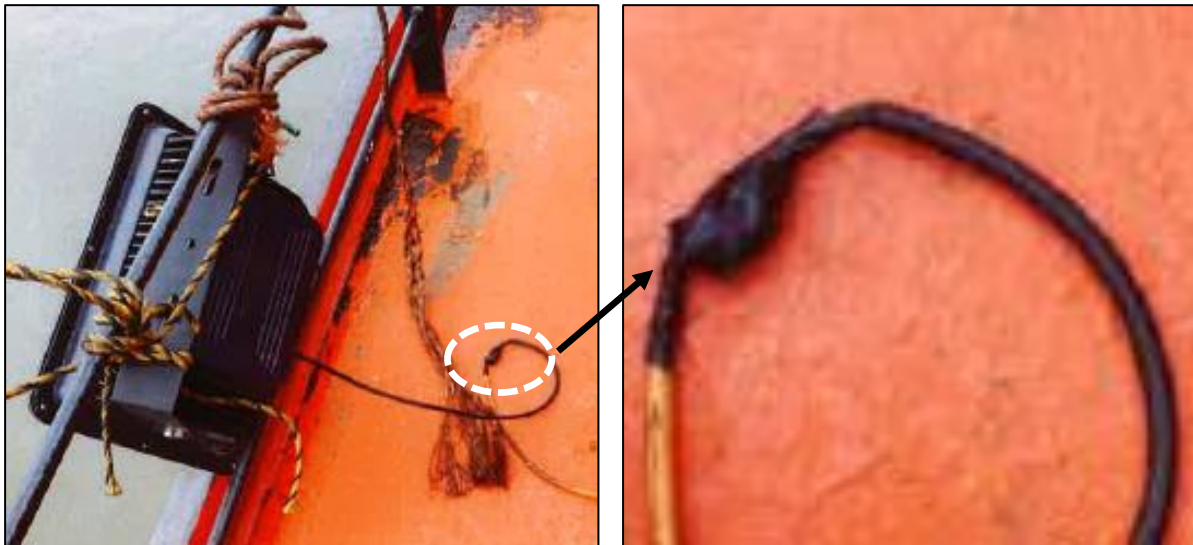
*During the inspection of the main deck, a cable connection wrapped in insulating tape and made with screw terminals was found lying on the deck, which could be attributed to a 230-volt electrical supply line for a spotlight temporarily attached to the railing (see **Figure 26**). Such an unprofessional installation poses an acute risk of electric shock, especially in wet conditions.*

Figure 26: Power supply of a spotlight; joined cable connection
