## MARINE SAFETY INVESTIGATION REPORT

**Grounding and stranding  
of the Maltese-registered general cargo,**

***ATLANTA***

**on the island of Agios Theodoros, Greece,**

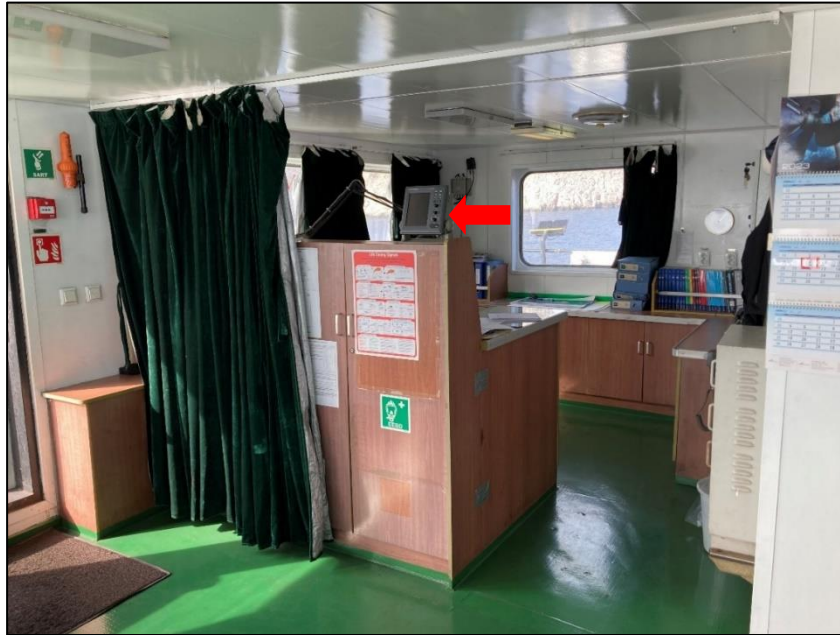
The echo sounder display was fitted on the ledge of the chart table, facing forward (Figure 4). The echo sounder was switched on at the time of the grounding.

Figure 4: The chart room, as seen from forward (red arrow: echo sounder display)

The master recalled that when he came up to the bridge after the vessel had run aground, the curtains around the radio room and the chart room (**Figures 4 and 5**) were closed.

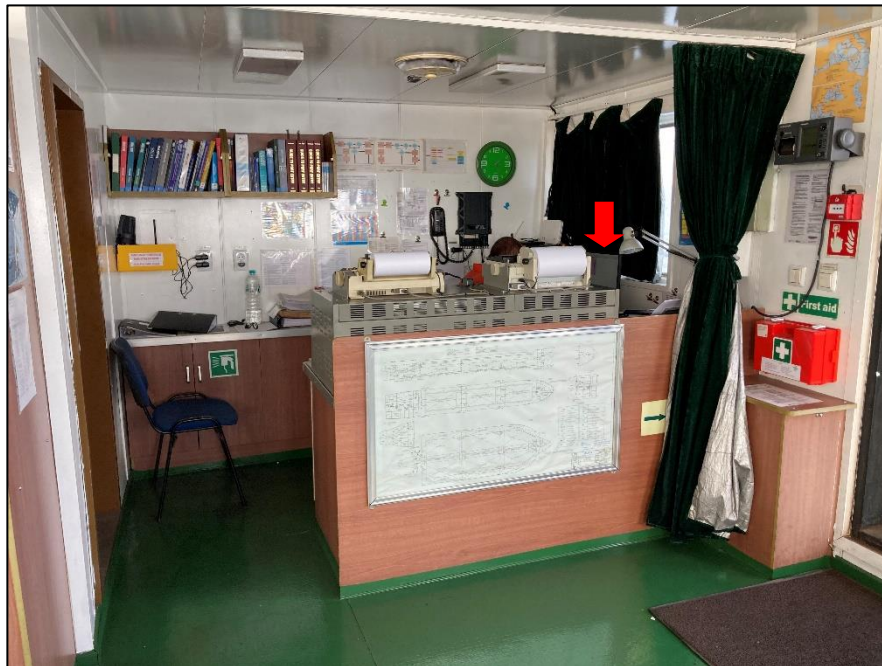
The bridge computer (used for administrative work) was fitted in the radio room (Figure 5).

Figure 5: The radio room, as seen from forward (red arrow: the computer)

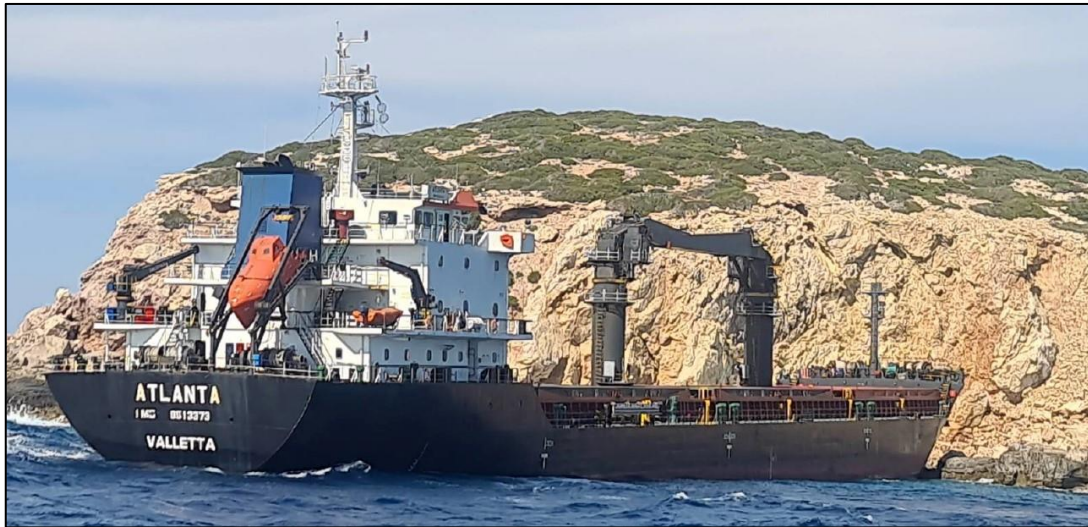
the feeling of strong vibrations and loud sounds. The vessel had just run aground at a speed of about 8.6 knots and remained stranded on the Northwest coast of the island of Agios Theodoros, Greece (**Figures 6 and 7**).

**Figure 6: MV Atlanta stranded**

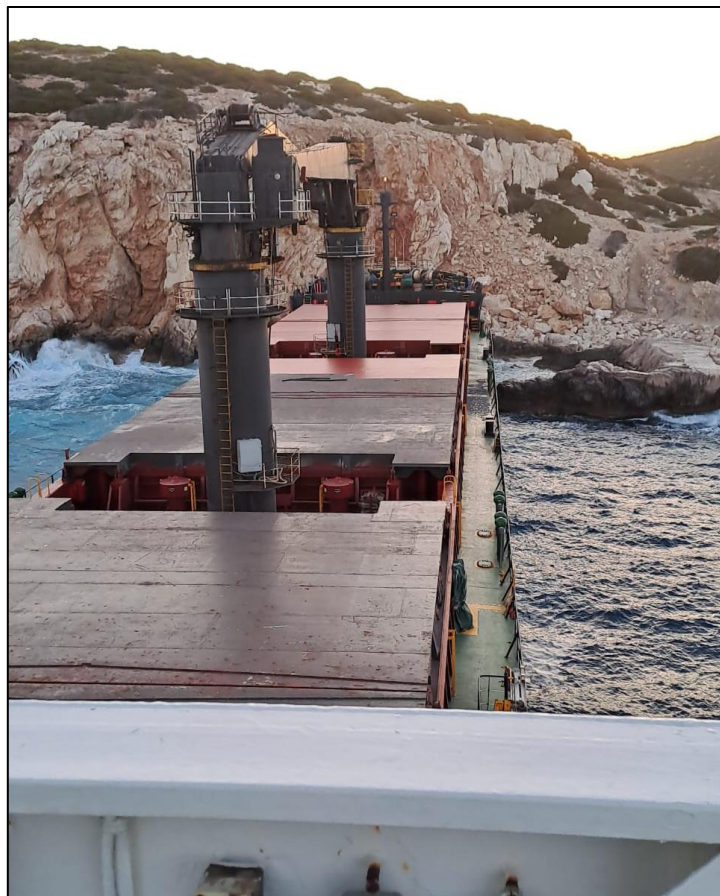
**Figure 7: MV Atlanta aground and stranded**

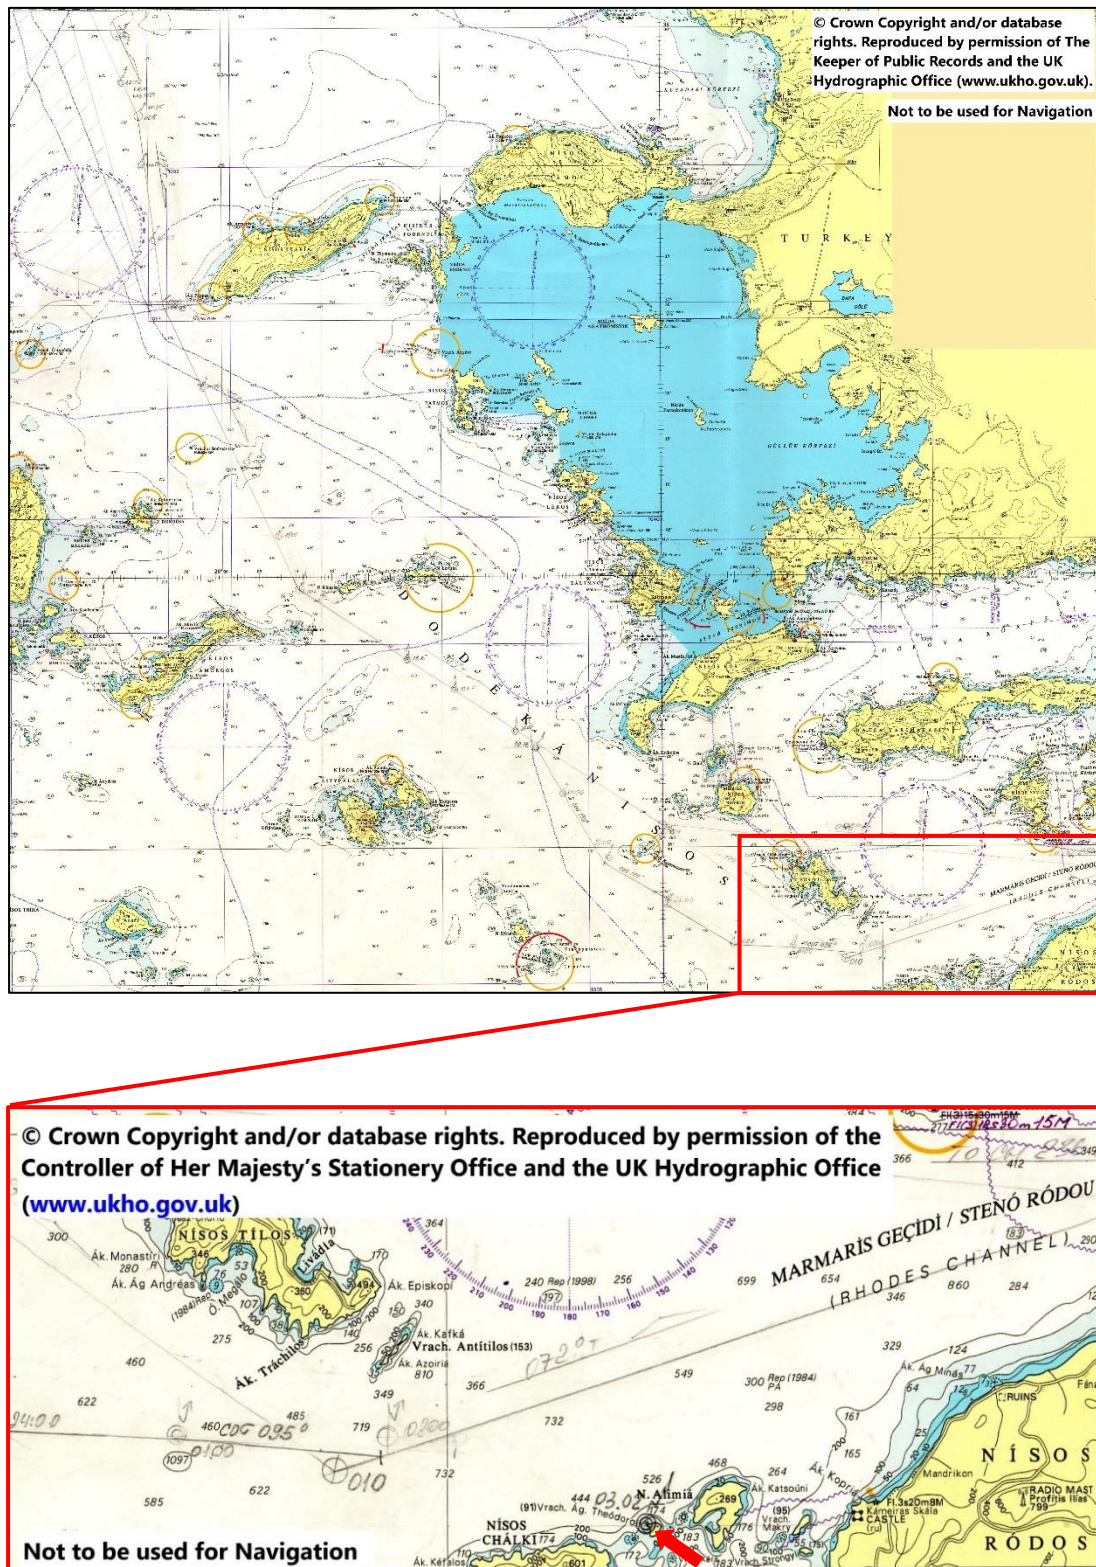
**Figure 8** is a reproduction of the nautical chart with the plotted courses and positions preserved as they were at the time of the grounding.

**Figure 8:** The nautical chart used on *Atlanta*, (red arrow: the stranding position)

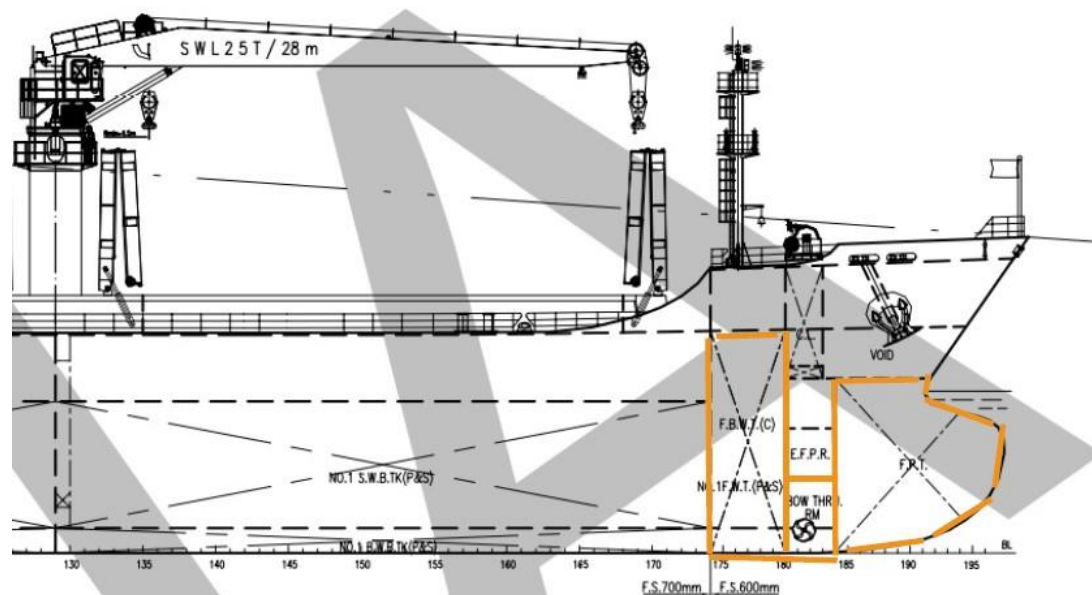
After confirmation that all persons were accounted for, the crew members commenced sounding the tanks and the seabed around the vessel. The chief officer began to assess the sustained damages. The forward area of the vessel, about 30 m from the stem, was observed to be on the rocks. Seawater ingress was confirmed in the forepeak tank, bow thruster room and the forward ballast water tank (centre) (Figures 9 and 10).

Figure 9: Extract of the GA plan, highlighting the flooded compartments

The salvage team found five hull breaches that resulted in water ingress into the forepeak tank, the bow thruster room, and the forward ballast water tank (centre). There were no damages aft of the forward ballast water tank.

Following the damage assessment, salvage, and anti-pollution equipment, together with additional personnel, were deployed on site on 30 April. The hull breaches were temporarily patched up, and water was pumped out from the flooded compartments by 02 May 2023. Internal welding works were completed in the breached compartments on 03 May 2023, as part of the plans were made to refloat the vessel.

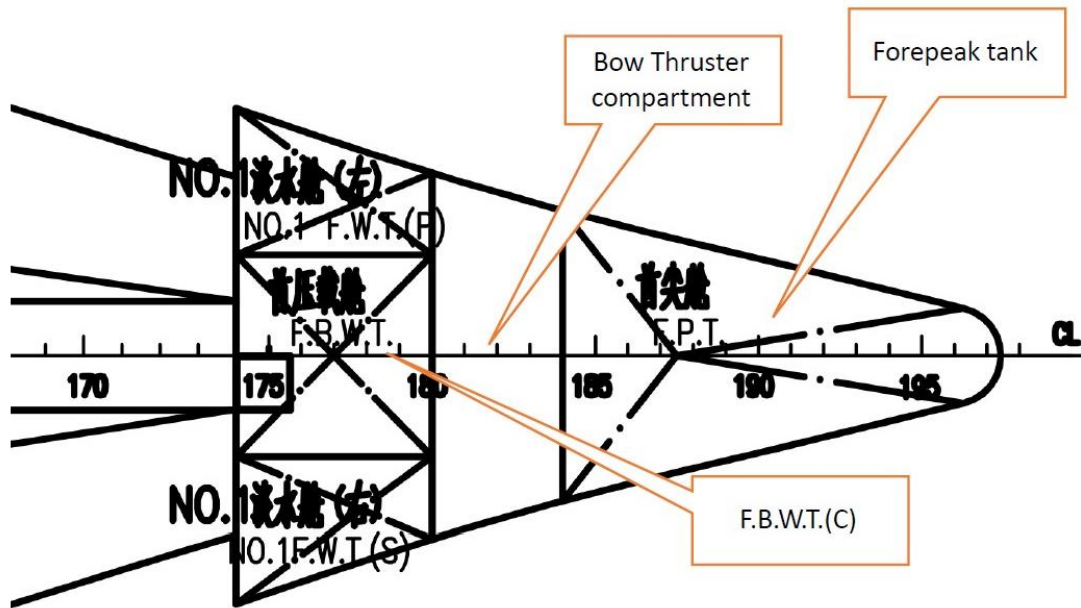
Figure 10: Cross sectional plan view of the flooded compartments (annotated by the Company)
