Marine Safety Investigation Report

VERY SERIOUS MARINE CASUALTY | 17 June 2024

Algoma Integrity

Mooring line casualty 21 October 2018

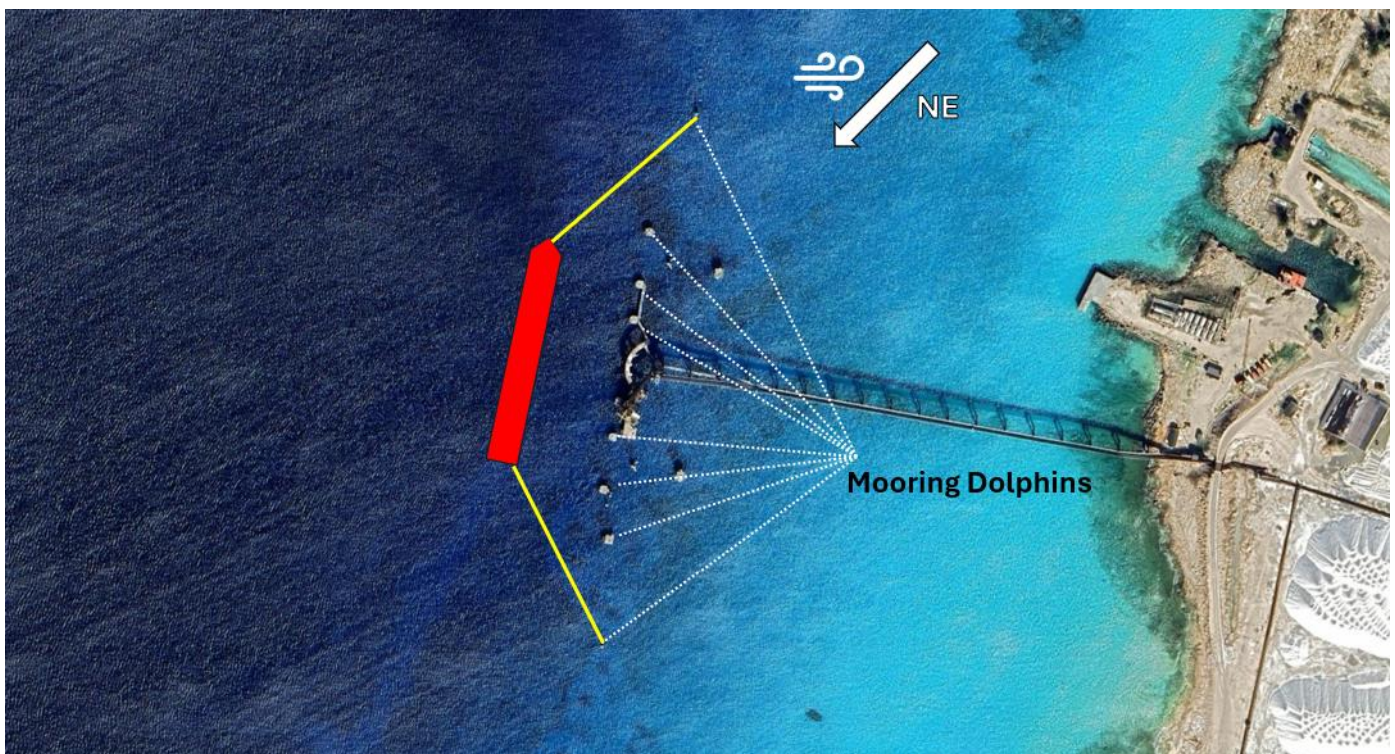
Figure 1. Mooring plan (aerial view depicting proposed lay of extended lines in yellow)

The mooring arrangement at the terminal was not considered conventional by the master. The vessel would be secured to a series of dolphins¹. Some were joined by a walkway to the cargo loading jetty, but most were not (Fig. 1). Running lines to the dolphins, or any adjustment, required the use of line boats.

Although a master/pilot exchange form had been completed there was no formal diagram to depict the mooring arrangement plan, the intended number or sequence of lines to be sent ashore, thereby removing any shared mental model for the master, deck officers or those involved with mooring to refer to.

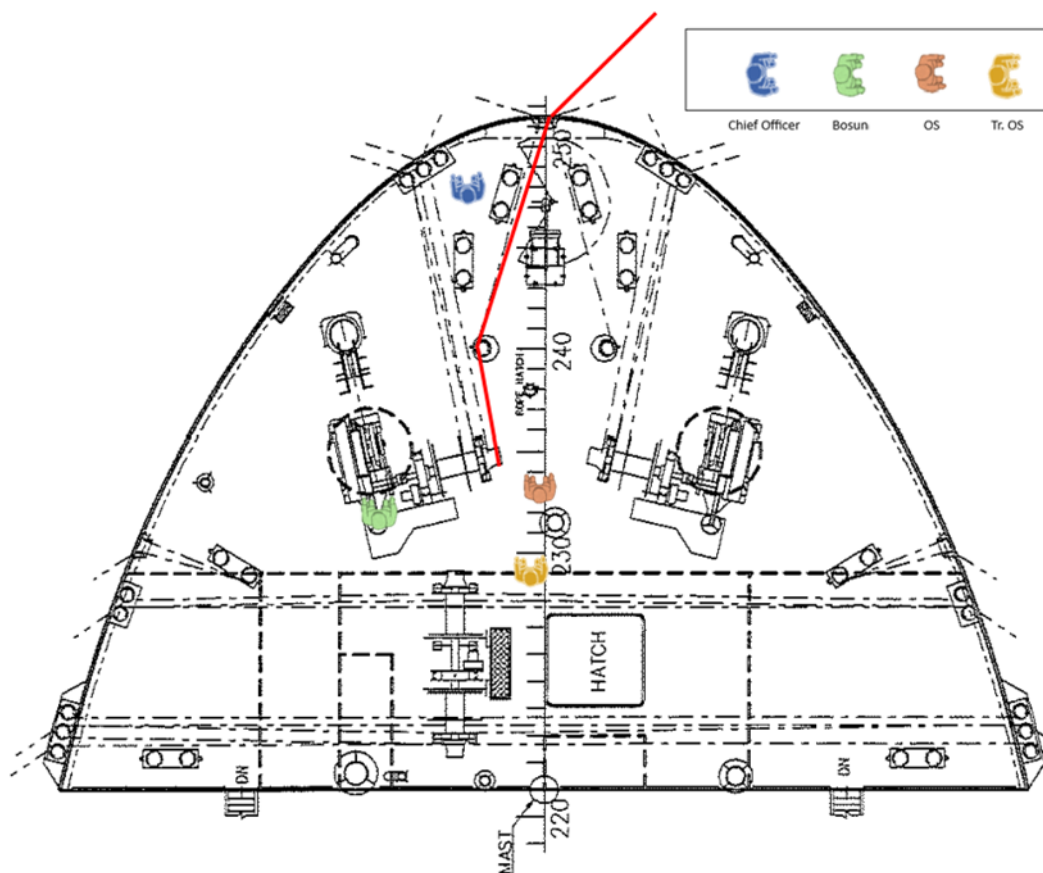
Figure 2. Pre-incident personnel positioning

The pilot contacted the line boat crews at 07:23 and requested them to be on standby to collect the stern line first followed by the forward line and to make fast ashore once it was confirmed that the vessel was within proximity to commence mooring. The line boats would then proceed to secure the remaining lines ashore. During this period the chief officer, bosun, ordinary seafarer (OS) and trainee OS shackled together two 200m long mooring lines and set the line up to be passed down in preparation of mooring. (Figure 2)

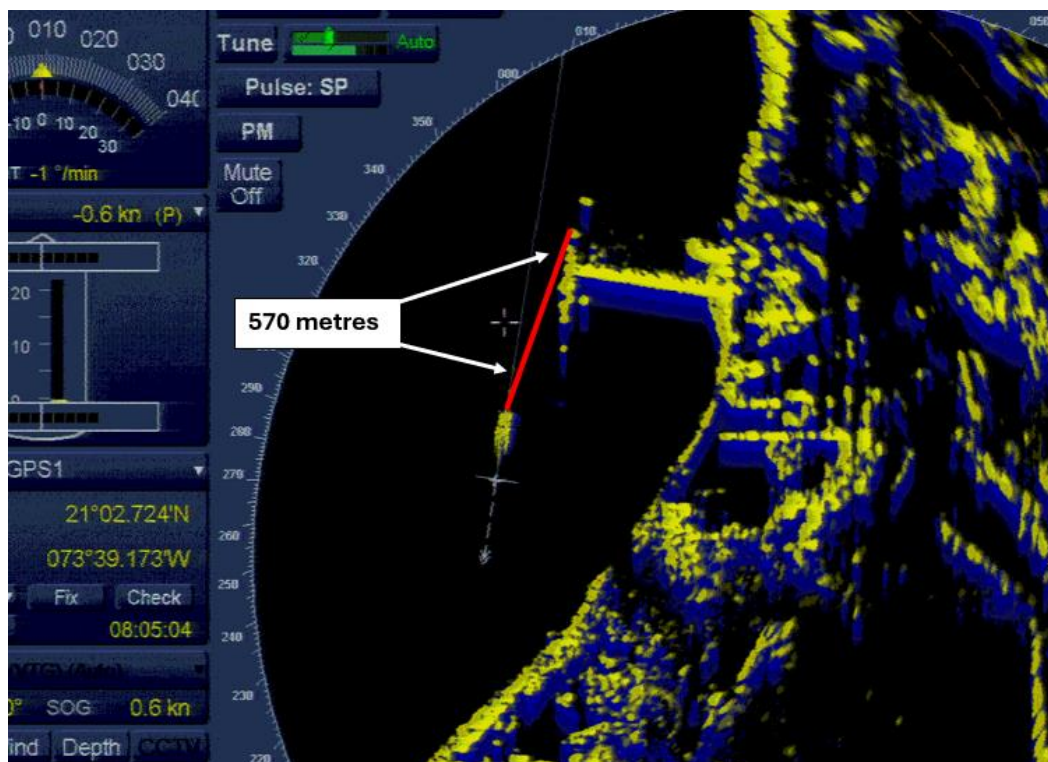
Figure 3. Distance and position from berth when propulsion stopped.

A decision was taken at 08:05 to stop the engines so that the line could be freed and recovered onboard, at which point the master instructed the forward mooring party to "Hold on" to the forward line. (Figure 3)

The need to extend the lines increased the risks on the crew handling the lines, thus placing them in danger and contrary to recommendations as set out in **Chapter 4, Mooring and Anchoring Ships, Volume 1, by the Nautical Institute** which recommends that lines should be picked up for transfer when the ship is within 2.5 x its beam off the berth making handling and operating the line easier. This would equate to 80m and not the recorded 380m experienced by the line boat crew.

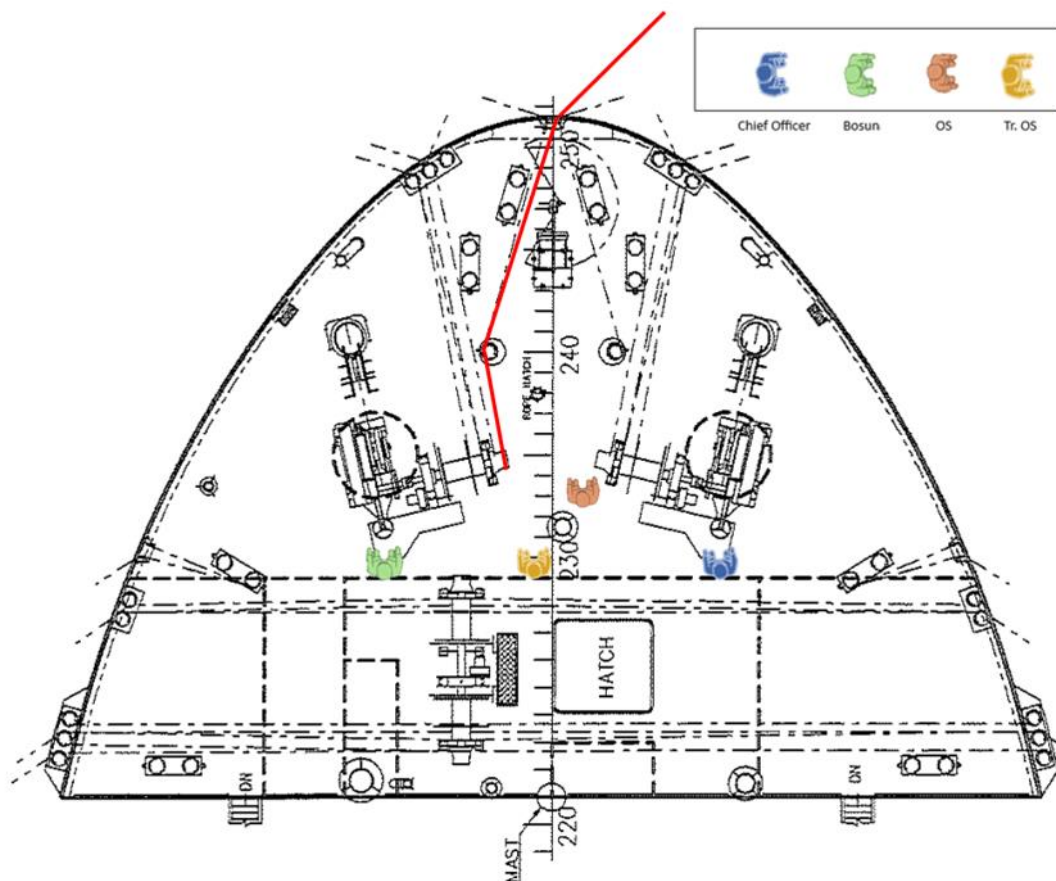
Figure 3. Positions of personnel when requested to stand clear.

At the time of the casualty, the ordinary seafarer thought he had moved to a safe position but was most likely unaware he was standing in a bight of the coiled rope aft of the warping drum.

Whilst this was taking place, and with the attentions of the pilot and master focused on the aft line and ship's position, the bosun was becoming concerned with the increasing tension on the forward line and instructed the chief officer to vacate his position forward and proceed to a safe area adjacent to the starboard winch, at which point the chief officer instructed the OS and trainee OS to stand aft of his position adjacent to the ventilation cowl² and keep clear. (Figure 3)

At around 08:08 the chief officer had just taken up his position at the starboard side winch, when a loud noise alerted him and the crew towards the tensioned line on the warping drum which had sprung free, running out and the OS who was standing closest to the warping drum was dragged and ended up 3 metres forward of the winch suffering severe injuries to his left leg.

All personnel working in areas where mooring lines are under tension, should be aware of the associated risks and ensure they maintain a safe position, free from bights, away from the dangers of snap back and recoil when mooring lines come adrift of mooring arrangements on deck, often resulting in serious injury or fatality.
