**Bundesstelle für Seeunfalluntersuchung**  
Federal Bureau of Maritime Casualty Investigation

## **Investigation Report 582/22**

### **Serious Marine Casualty**

**Bridge allisions on the Kiel Canal  
with a mobile harbour crane carried on the  
heavy-lift vessel MERI on  
30 November 2022**

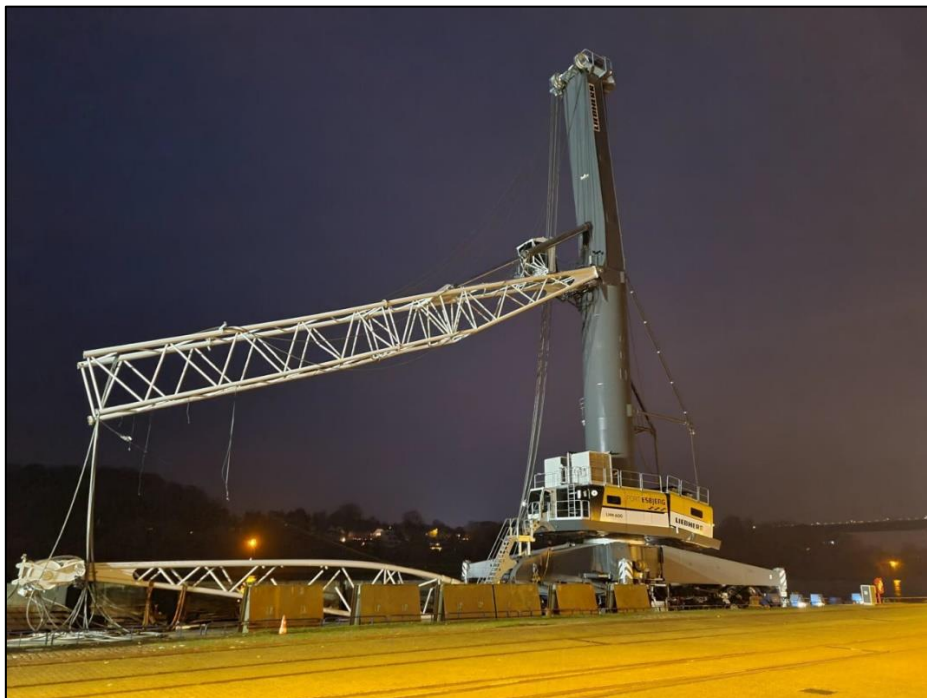
The crane was destroyed as a result of the allisions. The crane jib, laying on the cargo deck toward the bow, had broken in two, damaged the railing on the starboard side with its attachments, and dented and penetrated the deck. The running gear was smashed, some of the supporting pads had torn off and the machinery housing was buckled. An analysis of drone images revealed damage on the tower head from the points of contact with the bridges' hollow sections. Hydraulic oil had leaked from damaged pipes on the crane onto the deck and partly into the water of the canal. Oil binding agents were spread across the MERI's deck and oil barriers were laid out at berth 33. The following photographs were taken on the day of the accident.

Figure 8: Panoramic photograph of the crane with broken jib<sup>16</sup>

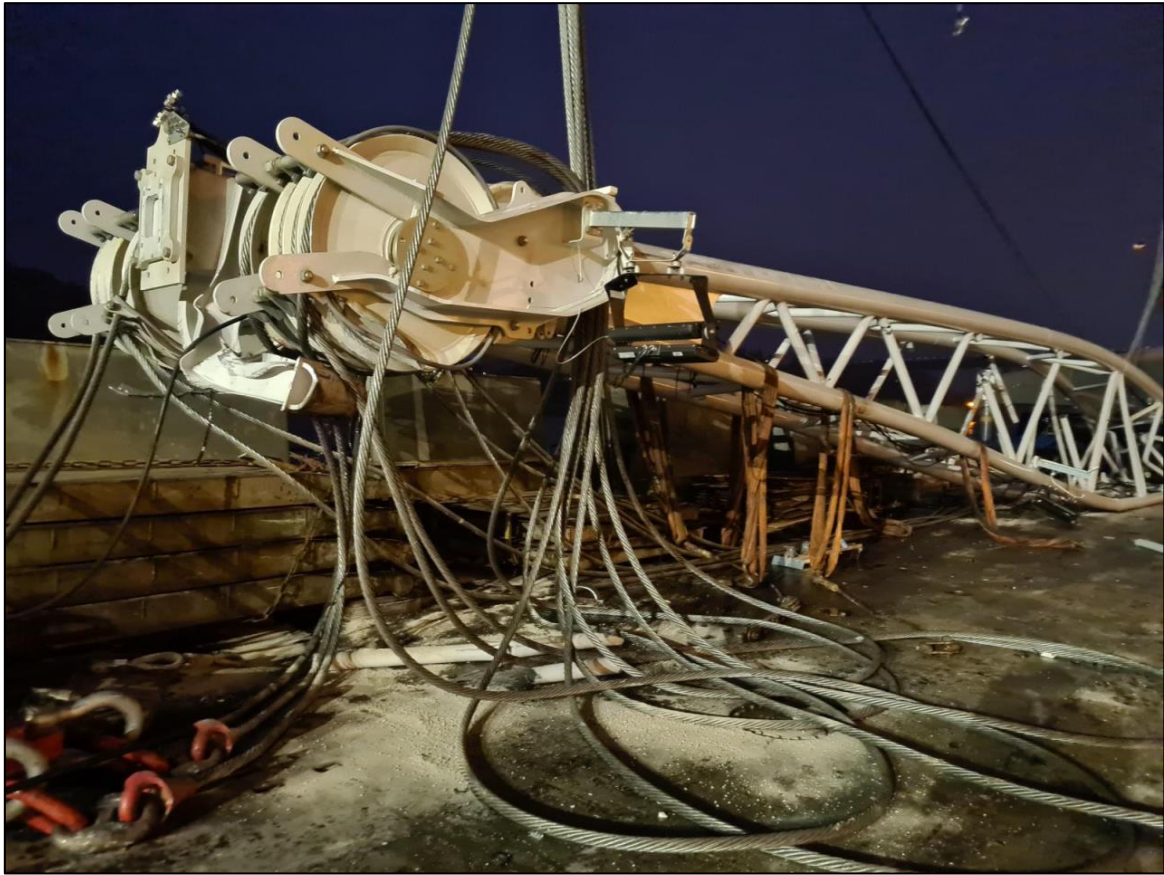
Figure 9: Forward section of the jib<sup>17</sup>

The jib was laid down on the deck for transportation. The safety cables broke as a result of the allision. The photograph shows the oil binding agent used by the crew.

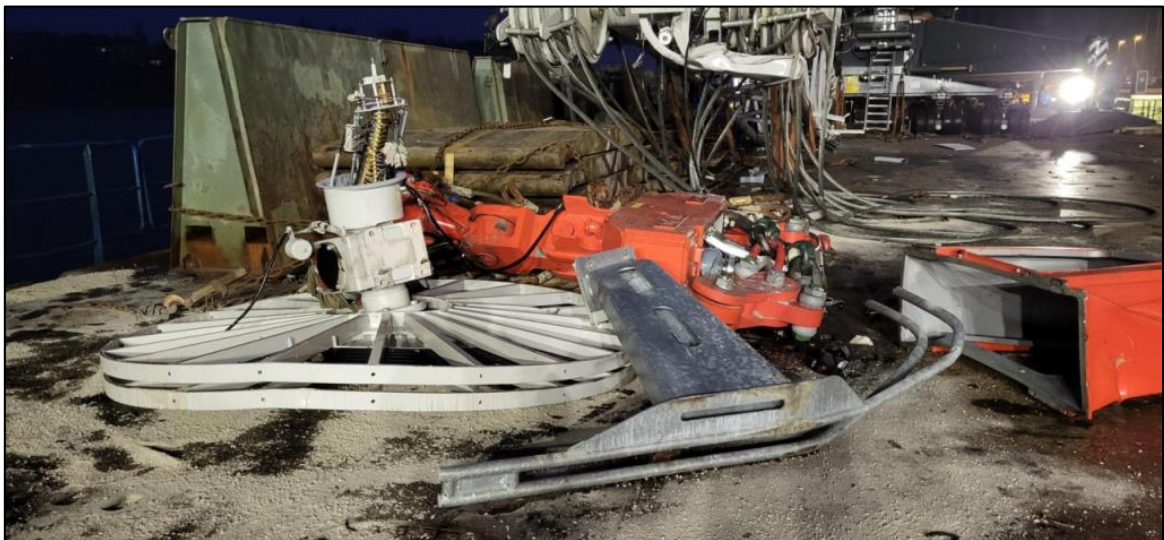
Figure 10: Remnants of some attachments from the jib<sup>18</sup>

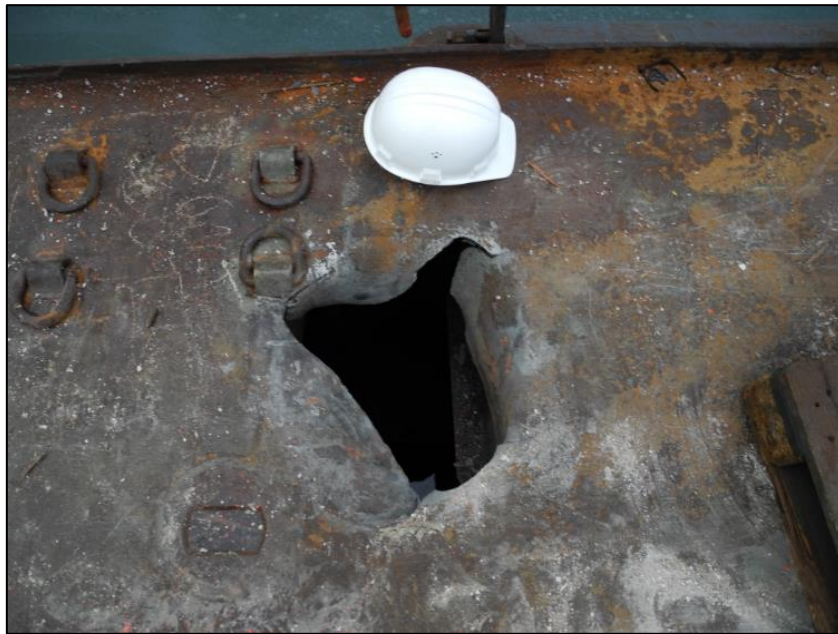
Figure 11: Penetrated deck<sup>19</sup>  
The helmet is used for size comparison.

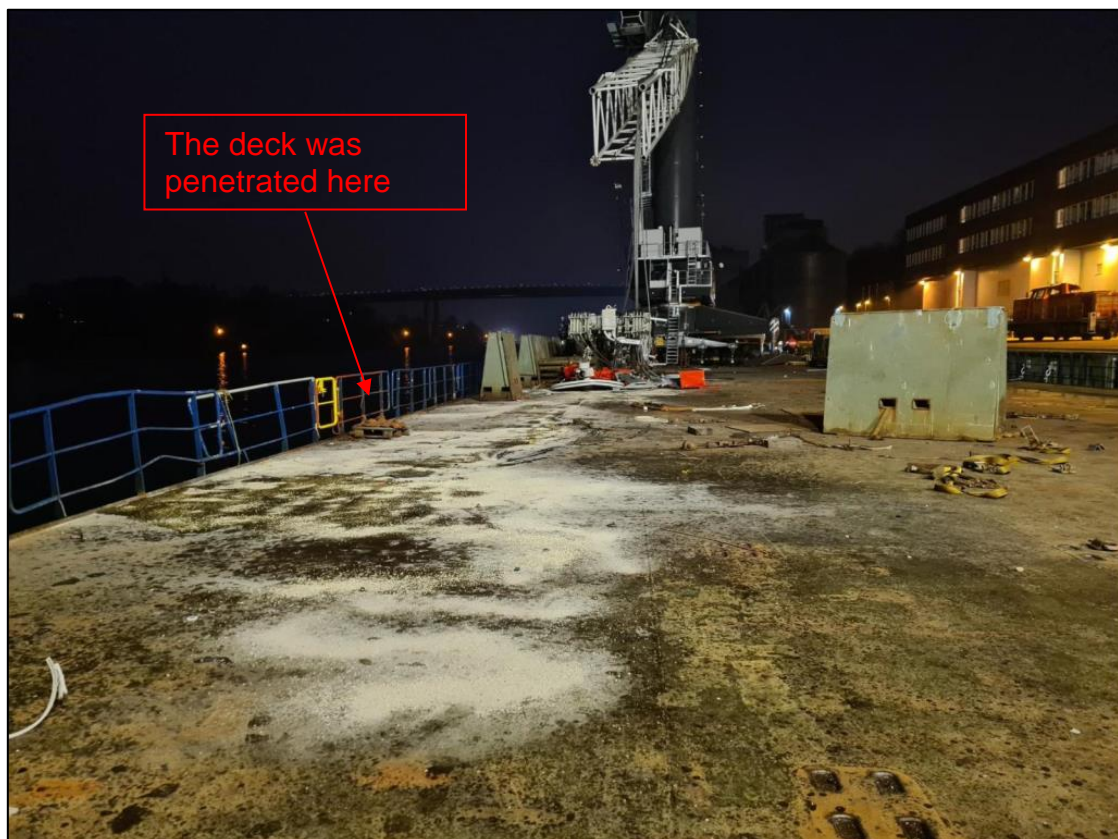
Figure 12: Cargo deck of the MERI<sup>20</sup>  
View to aft. *Inter alia*, the oil binding agent on the upper deck and the buckled railing on the starboard side (front left in the photograph) can be seen.

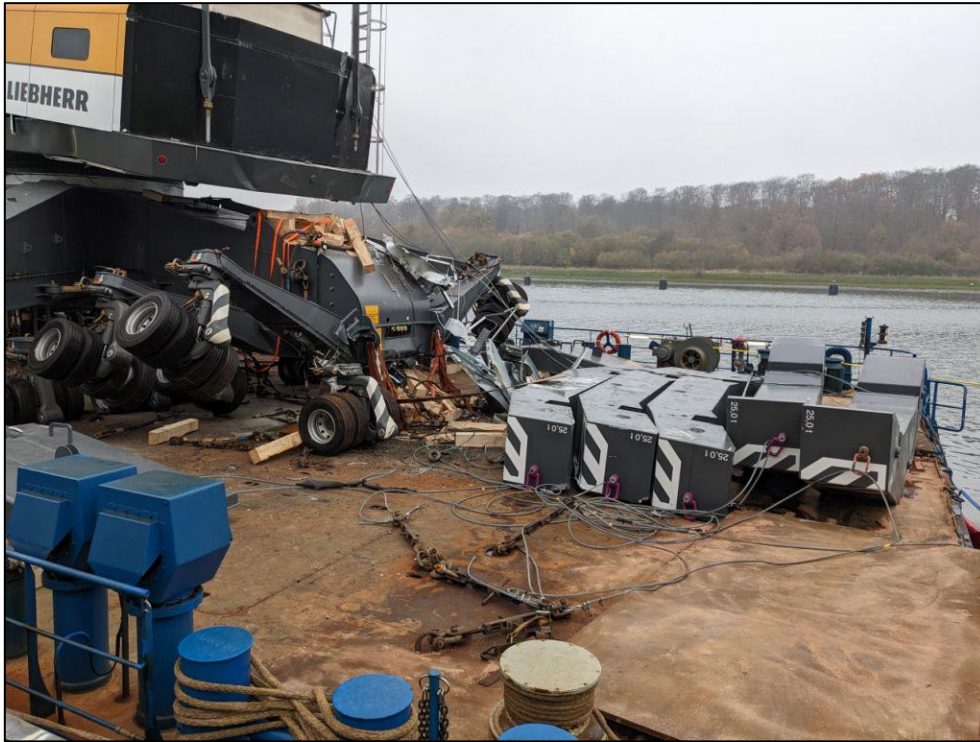
Figure 13: Fallen counterweights<sup>21</sup>  
Part of the railing is missing from the stern, which fell into the canal with three counterweights.

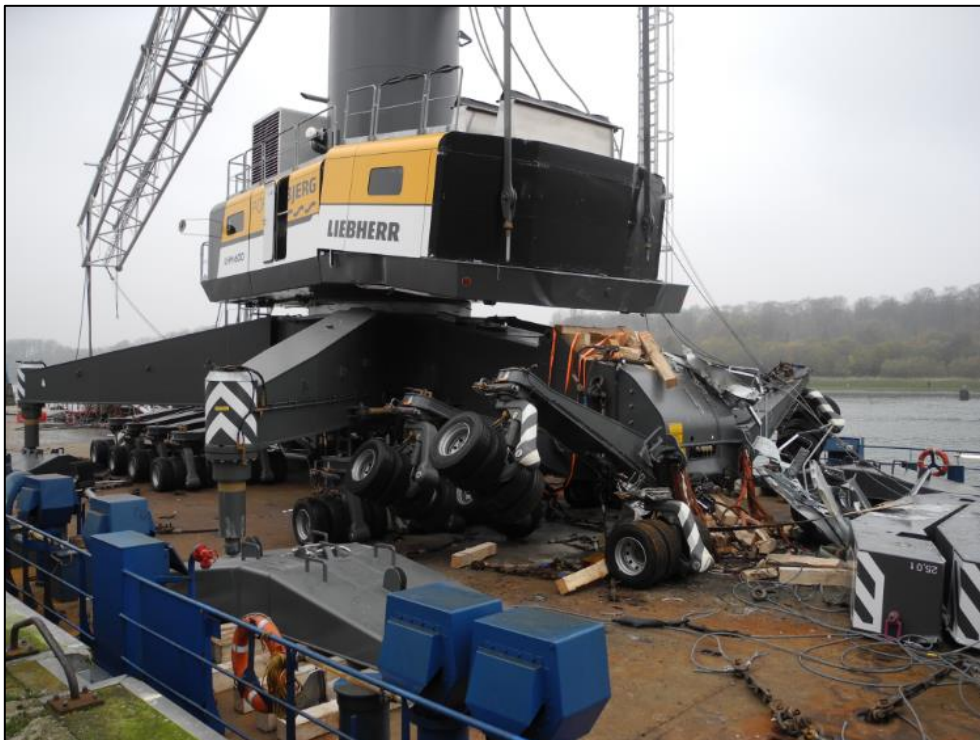
Figure 14: Buckled machinery housing, destroyed running gear<sup>22</sup>  
The left rear supporting pad had torn away from the support base.

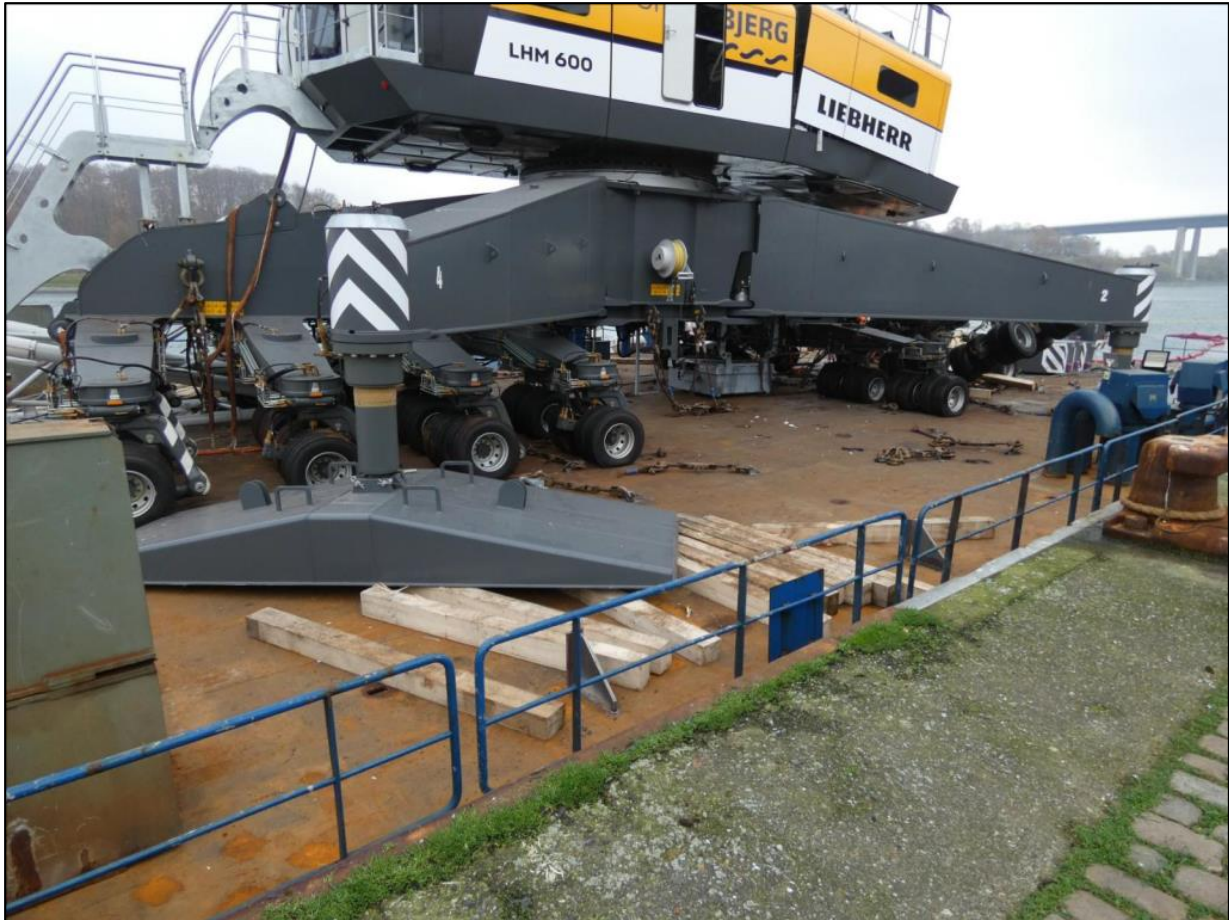
Figure 15: View of the left-hand side of the crane<sup>23</sup>  
The steel support base was broken. The forward left supporting pad no longer stood on the wooden substructure. The machinery housing was buckled.

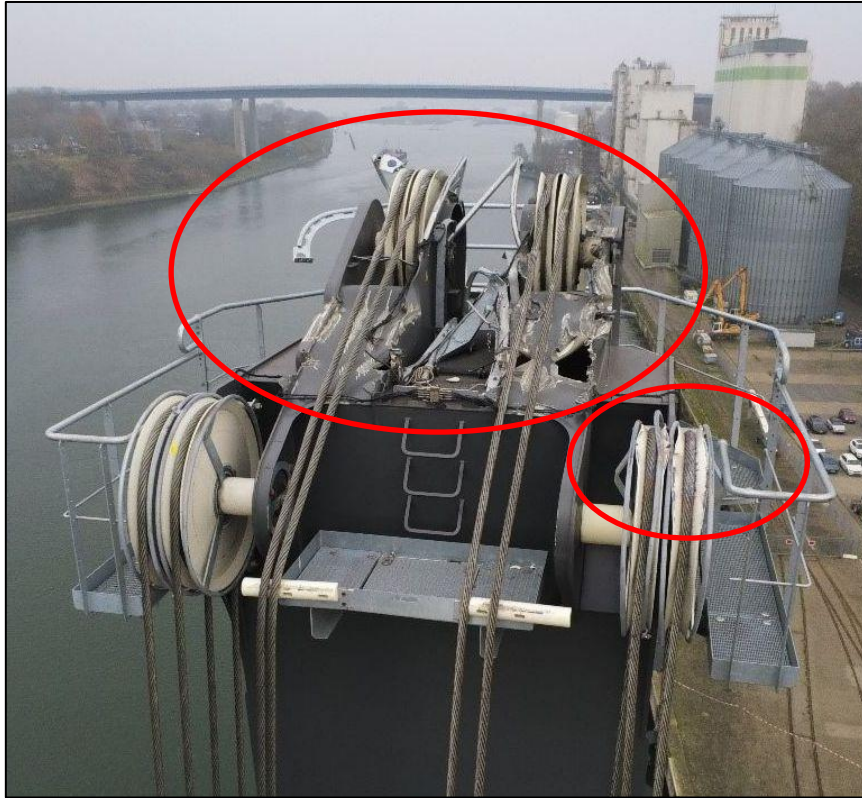
Figure 16: Damage to the crane tower (front)<sup>24</sup>

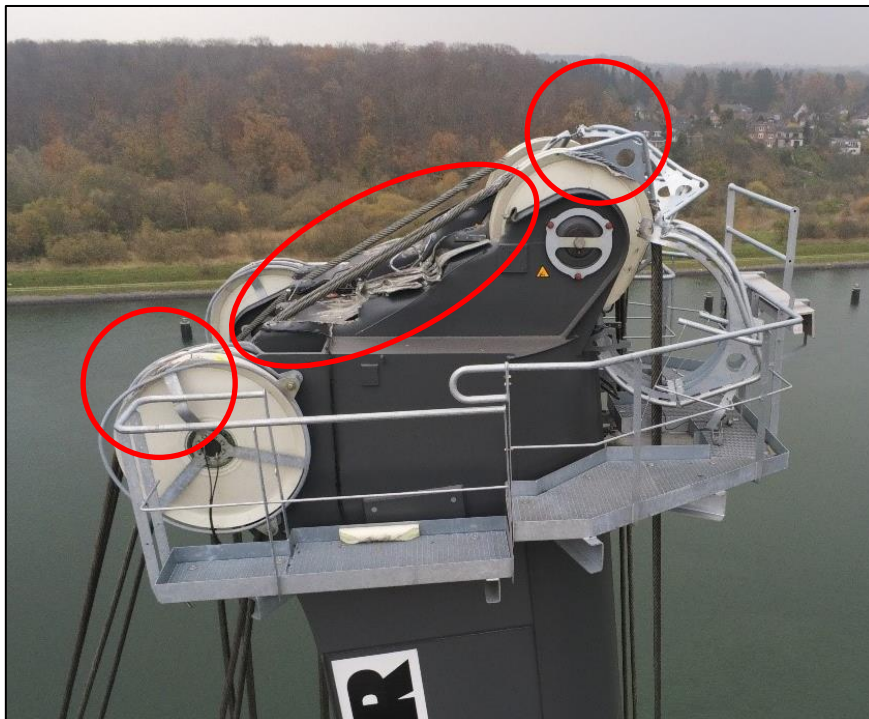
Figure 17: Damage to the crane tower (left-hand side)<sup>25</sup>

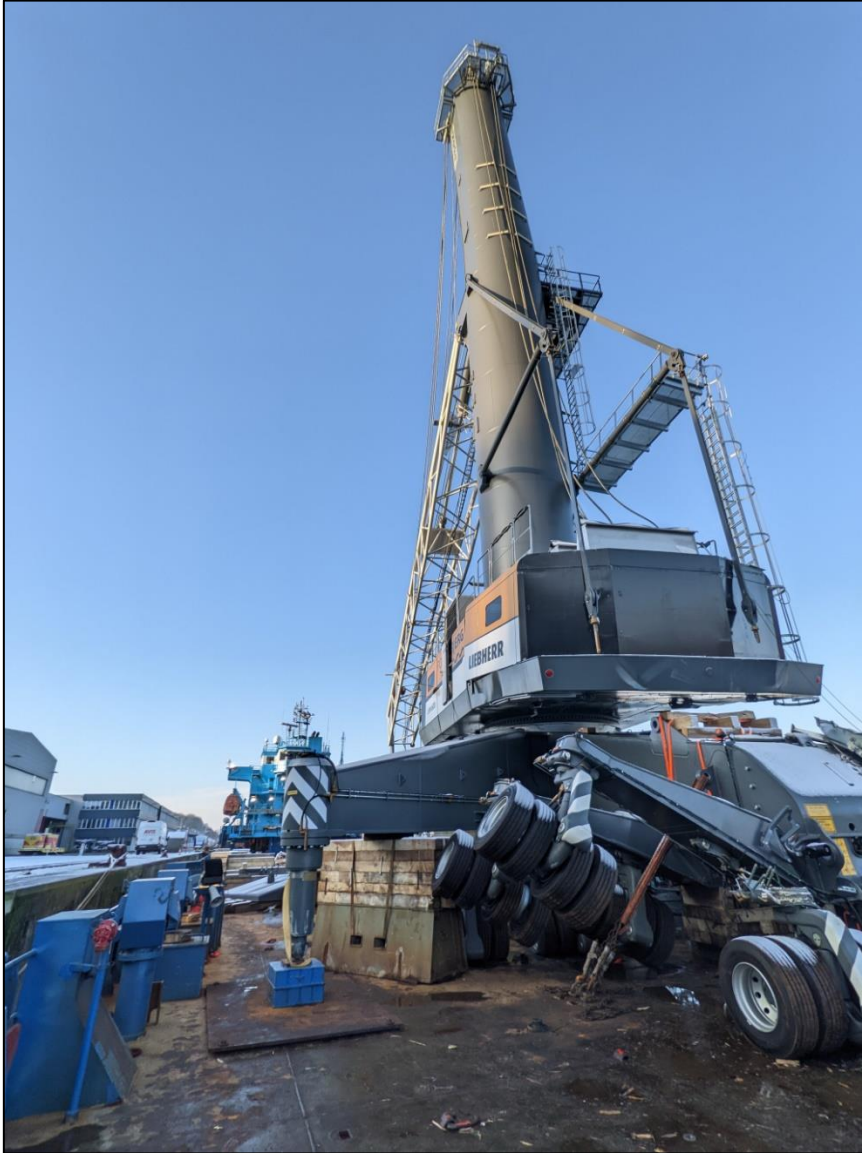
Figure 18: Secured crane. Photograph taken on 9 December 2022<sup>26</sup>

The crane had to be secured immediately for its stability and the subsequently necessary dismantling operation.

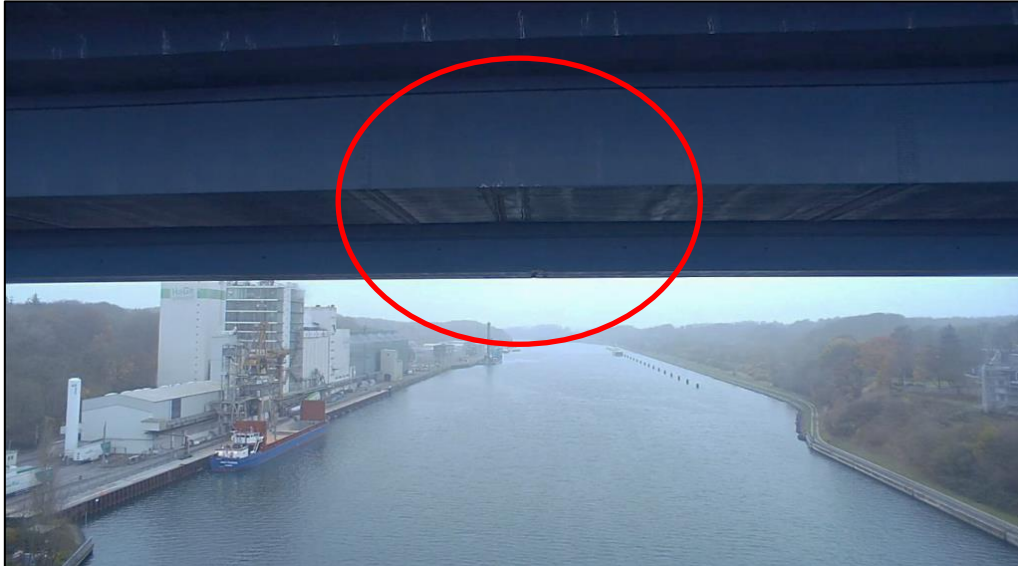
Figure 19: Olympiabrücke bridge (eastern Holtenau high bridge)<sup>27</sup>

Viewed from an external position, there was apparently only minor damage to the two bridges. A technical assessment revealed structural damage inside the hollow box girders.

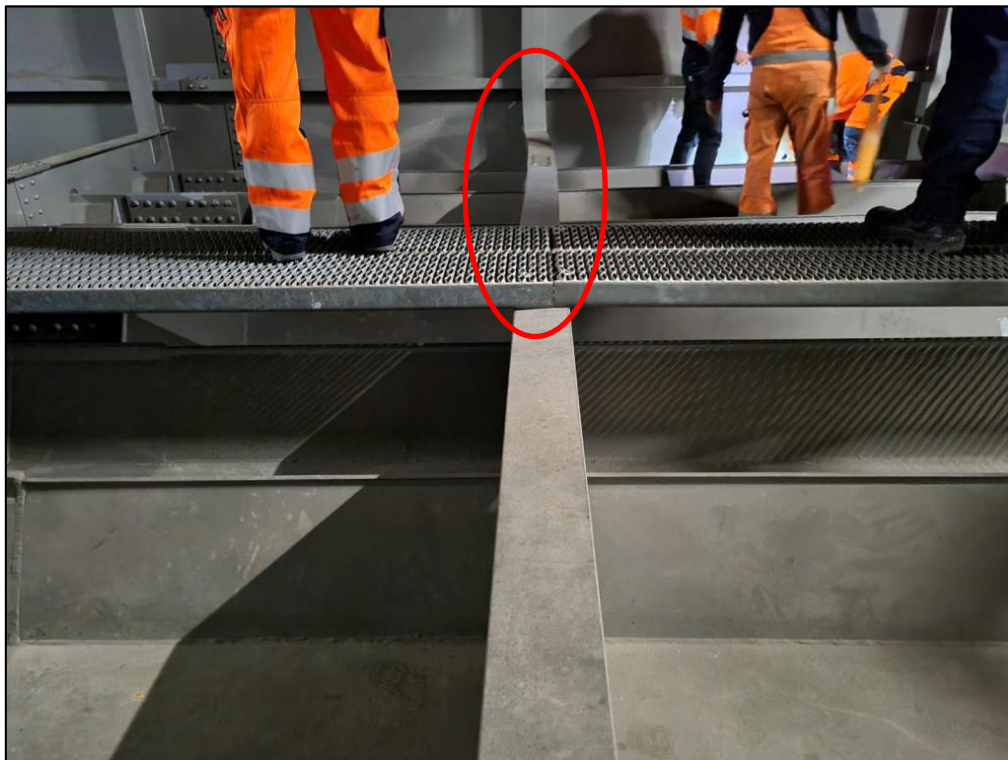
Figure 20: Deformed hollow box girder (Olympiabrücke bridge)<sup>28</sup>

<sup>28</sup> Source: WSPR Kiel. The BSU has been provided with additional photographs in the WSPR's photographic report. These made it possible to reconstruct the deformations on the hollow box girder.

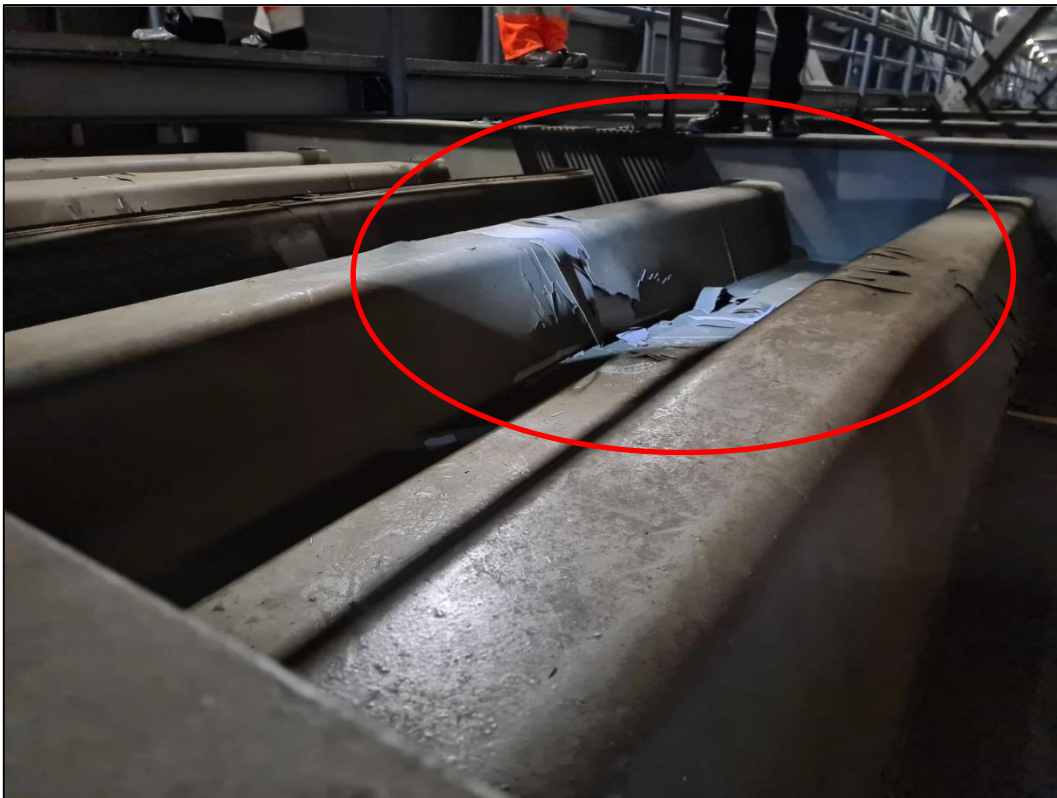
Figure 22: Damaged hollow box girder (Prinz-Heinrich-Brücke bridge)<sup>30</sup>

Only part of the damage could be captured on photographs.

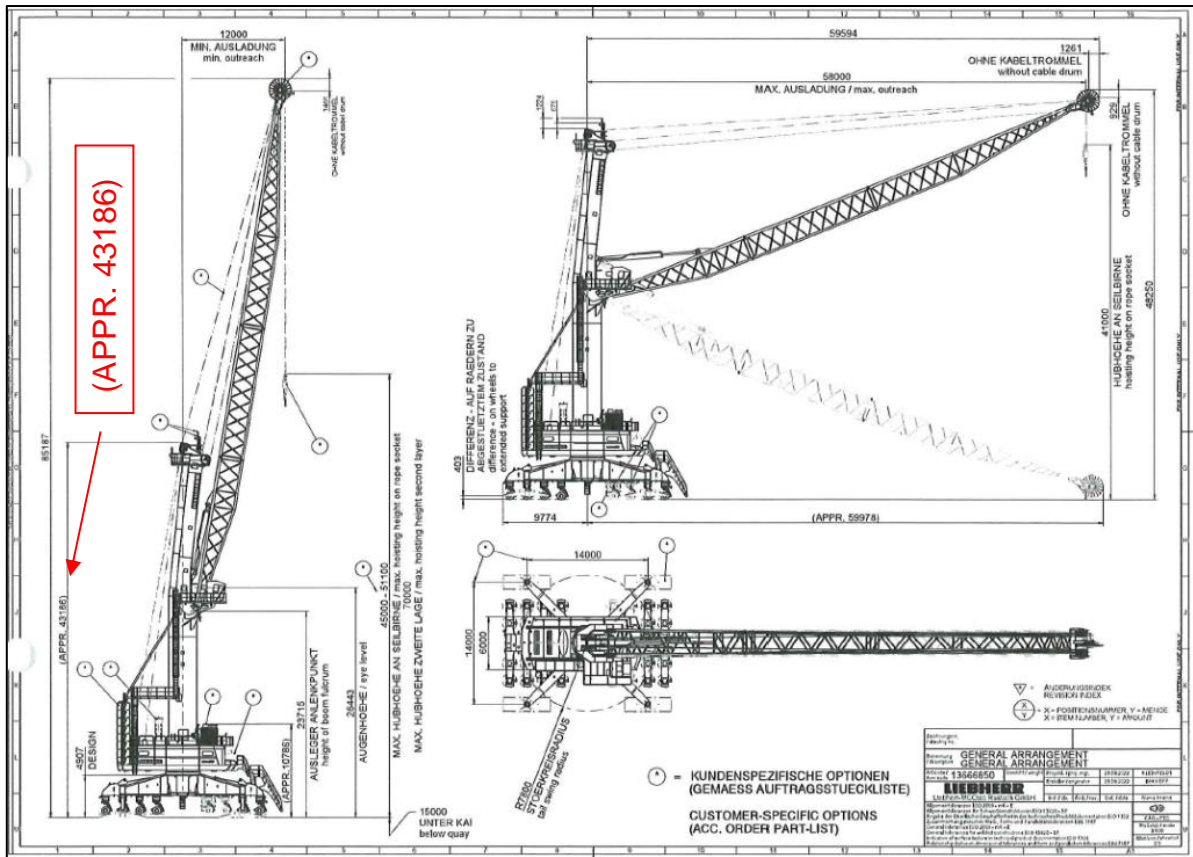
Figure 27: LHM 600 – Evo6 – 58m LR design drawing<sup>34</sup>

The manufacturer determined the height of the tower based on the design drawing and did not remeasure it. Depending on how the crane is supported during transport, i.e. standing on wheels or supporting pads, the top edge of the uppermost cable pulleys should be at a minimum and maximum height of 42.7 m and 43.2 m, respectively. A tower height of 43,186 mm is specified in the relevant design drawing.

Taking into account the actual support and placement of the jib, the relevant height of the crane involved in the accident would have been 43.35 m according to the crane manufacturer's information, and not the 38.25 m stated on the shipping label. Accordingly, the ordered crane was 5.1 m higher.

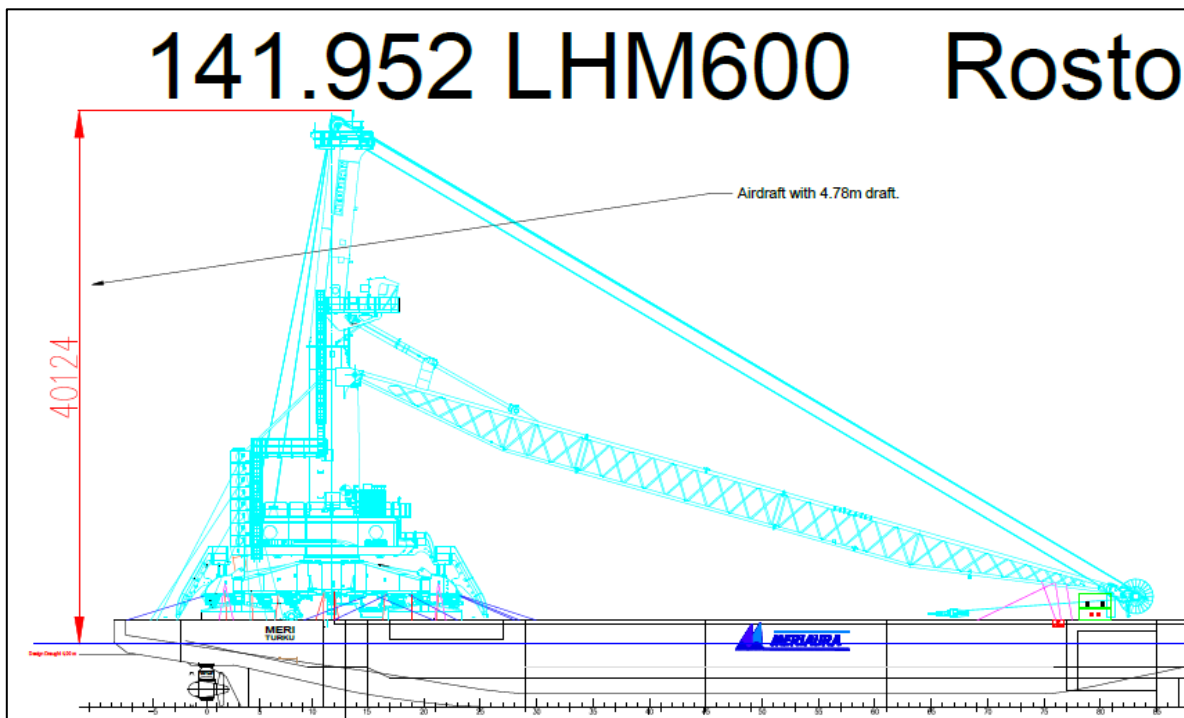
- Annex 5 (stowage plan): According to the title block, the stowage plan was prepared on 17 October 2022. Neither the review nor the approval were documented in the title block. An amended version of this stowage plan was sent to the canal's Administration on 28 November 22 for the granting of the special dispensation without documenting the change in the title block. In the amended version, the draught was increased by 0.78 cm in order to comply with the maximum permitted height for the NOK passage. Mathematically, the amended draught should have resulted in a height of 40.132 m based on the existing stowage plans, and not the height of 40.124 m specified in the amended plan.

Figure 32: Height information from the stowage plan for the special dispensation

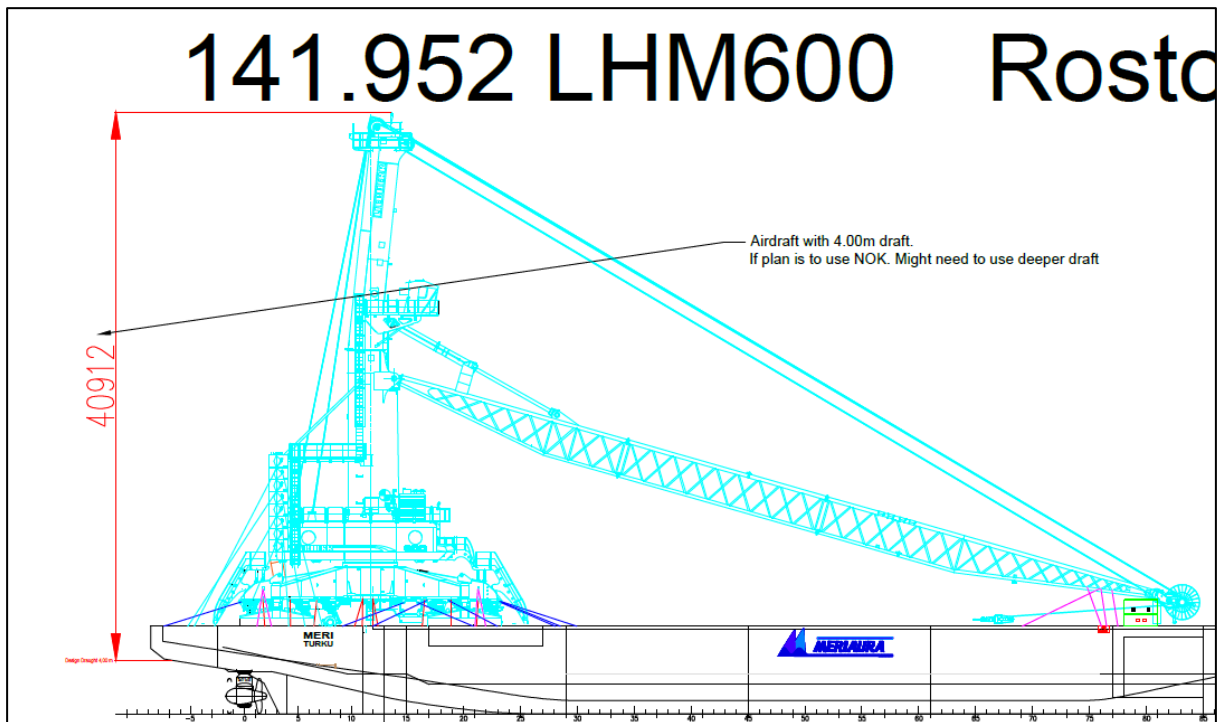
Figure 33: Height information taken from the stowage plan in the transport manual

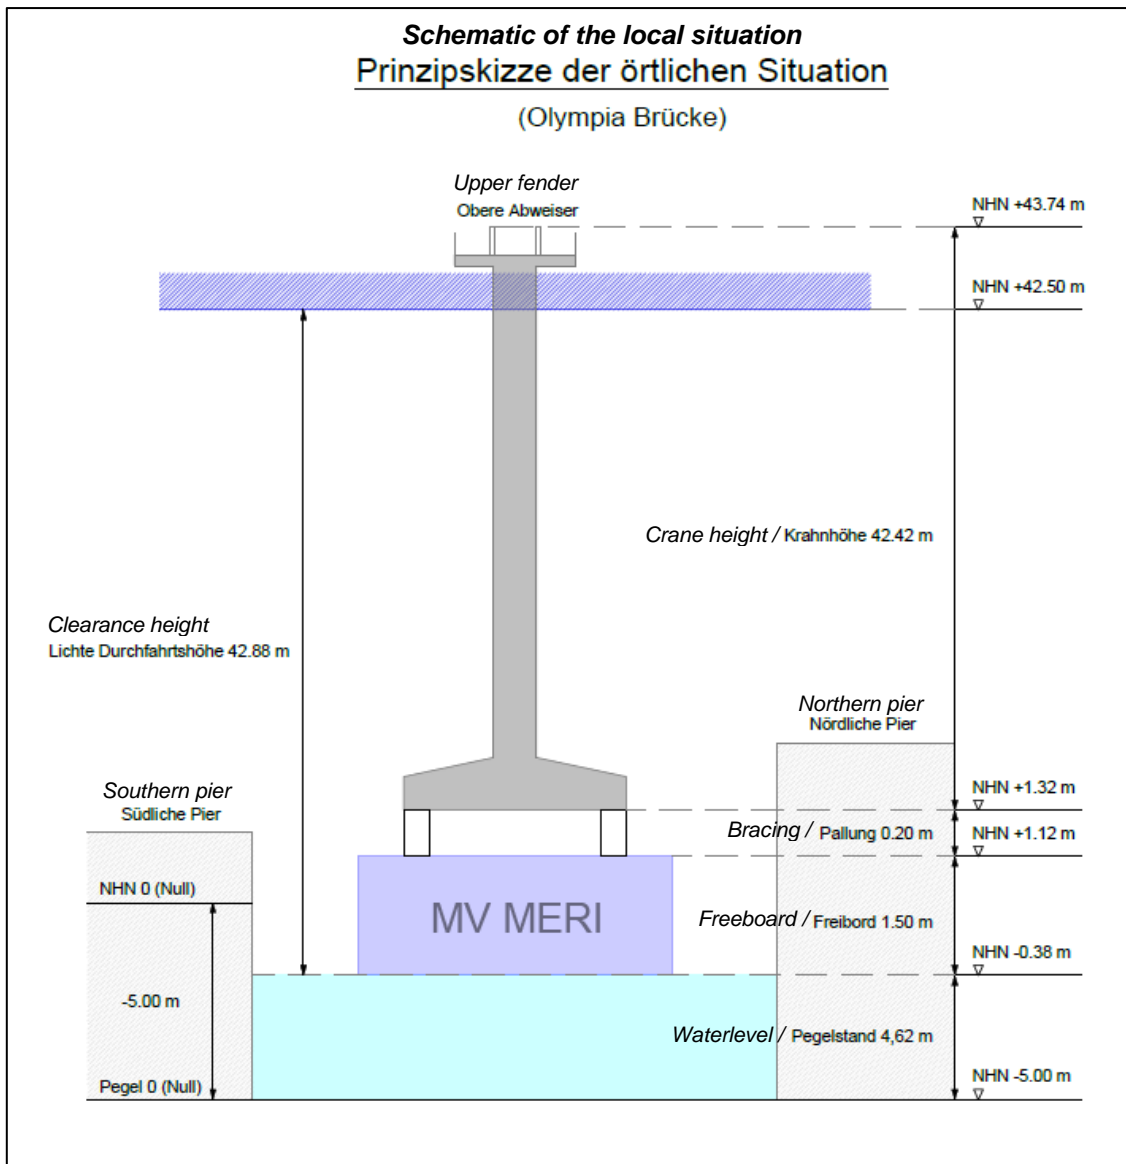
A total height (from the waterline) of 44.12 m was determined for the highest point of the crane tower after the allision.

Figure 45: Drawing with measurements of the crane/bridge height (Olympiabücke)<sup>60</sup>
