NATIONAL TRANSPORTATION SAFETY BOARD 2023

SAFER SEAS Digest

Lessons Learned from
Marine Investigations

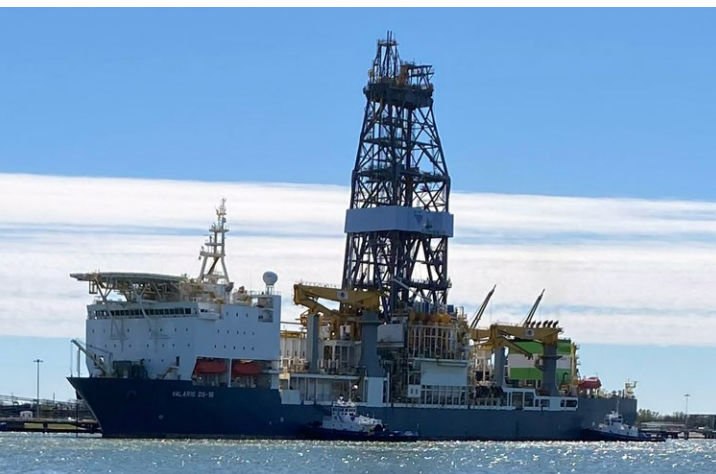
VALARIS DS-16 after the casualty.

Postcasualty ultrasonic thickness tests performed on the remaining bollards in the area where the VALARIS DS-16 was moored indicated that there was deteriorated steel at the lower portion of several bollards. The broken top of bollard 6 was not recovered from the channel, but a postcasualty measurement of the remaining 18-inch-diameter base of the bollard showed that the steel wall thickness was less than 0.25 inches on the side farthest from the edge of the pier—an apparent reduction in thickness of about 0.5 inches (original bollard design drawings showed a wall thickness of 0.75 inches). Additionally, several bollards showed signs of external corrosion and wastage.

THE PROBABLE CAUSE of the breakaway of the VALARIS DS-16 from the STEHMO Shipyard dock and the subsequent collision with the cargo vessel Akti was the failure of one of the shipyard's mooring bollards—which had been modified to increase its height to accommodate more lines—used to secure the VALARIS DS-16's bow mooring lines to a pier, during a cold front with strong winds.

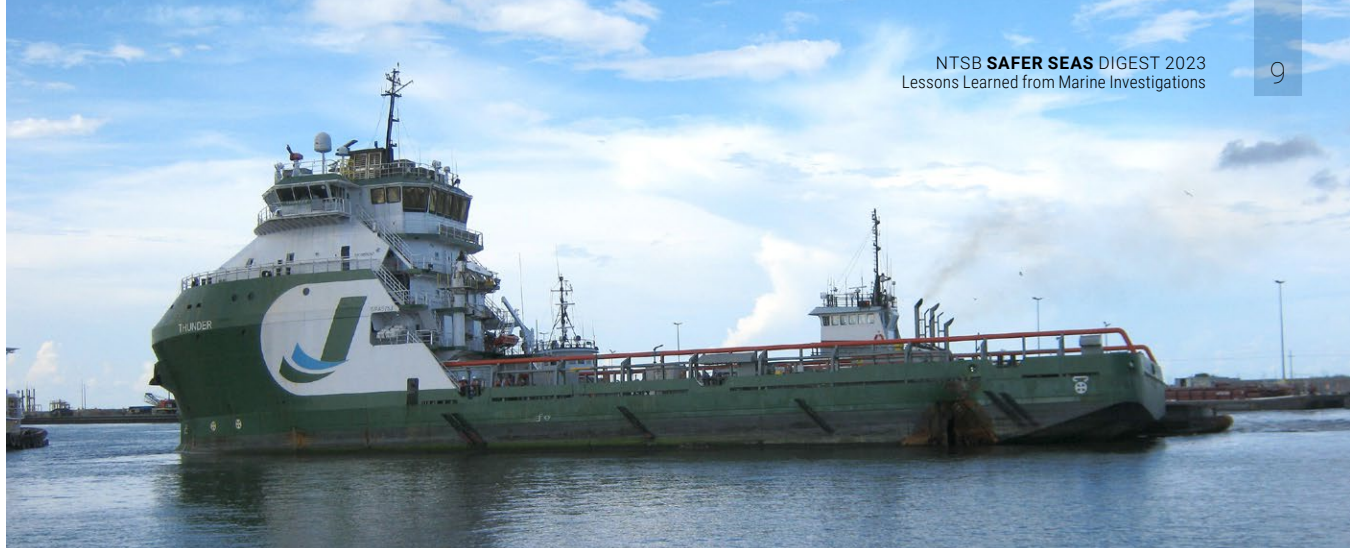
THE PROBABLE CAUSE of the collision between the bulk carrier *Bunun Queen* and the offshore supply vessel *Thunder* was the *Bunun Queen* officer’s distraction due to performing non-navigational tasks and the *Thunder* officer’s distraction due to cell phone use, which kept both officers from keeping a proper lookout. Contributing to the casualty was the *Thunder*’s officer on watch not following his company’s watchkeeping policies.

The *Thunder* being towed to a dock in Port Fourchon after the collision. SOURCE: COAST GUARD

Damage to the bulbous bow of the *Bunun Queen* after the casualty. SOURCE: COAST GUARD

Damage to the aft port side of the *Thunder*. SOURCE: COAST GUARD

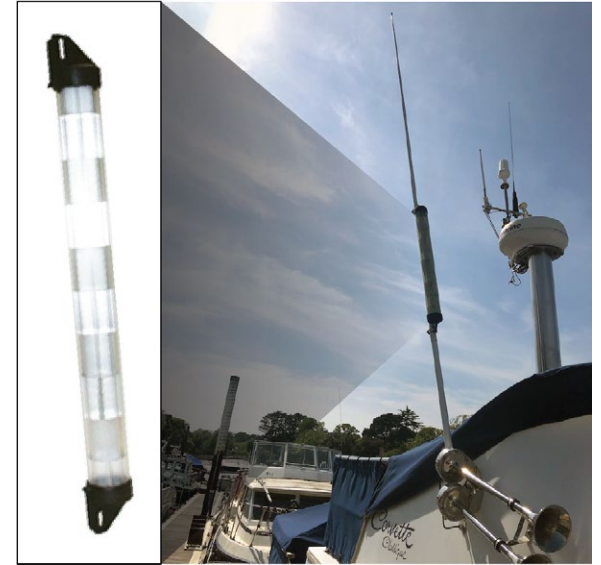
◆ **Difficulty detecting small vessels by radar.** We also found that fitting small vessels with equipment—such as radar reflector or AIS—when combined with proper visual lookout, would improve the opportunity for vessels with radar to detect them, therefore reducing the risk of a collision.

Left to right: An example of a tubular style radar reflector and a tubular radar reflector mounted on a pole aboard a recreational vessel.

Lessons learned from tragedies like this collision can be useful as training tools and for reviewing current watchstanding (in particular lookout) practices to identify weaknesses and find areas for improvement. Therefore, we **recommended** that the Coast Guard provide information about the circumstances of this collision to cutter crews and emphasize the importance of maintaining a proper lookout and ensuring situational awareness when transiting at high speed.

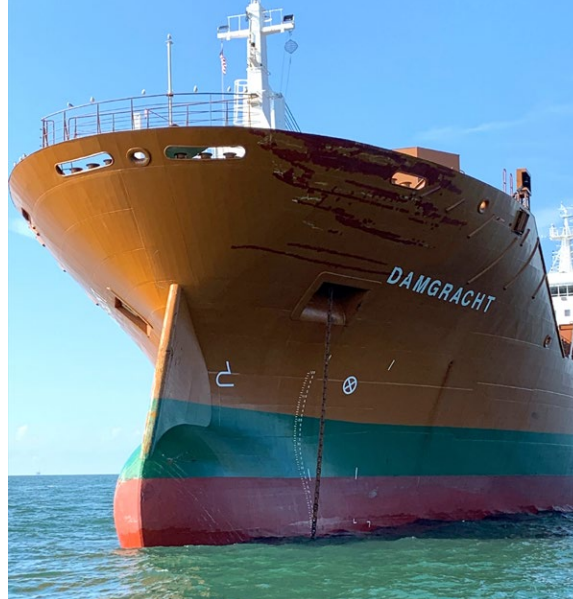
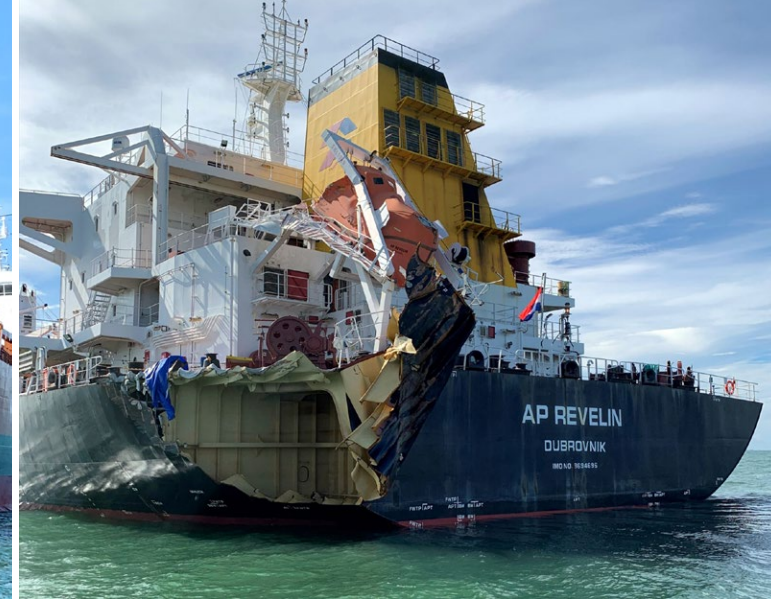
Left to right: Port bow of the **Damgracht** and damaged stern area of the **AP Revelin** after the collision. SOURCE: NTSB

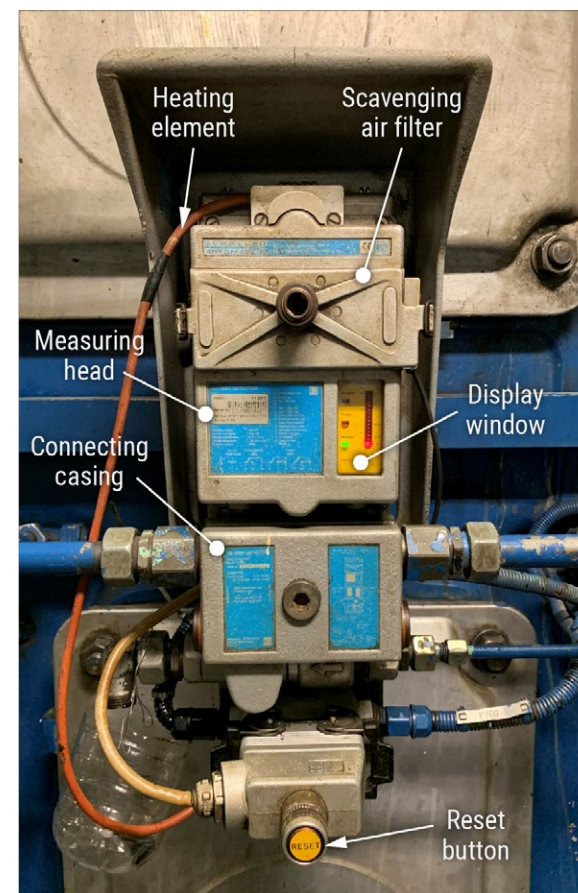
When certain engine components, such as cylinder head gaskets, fail, cooling water can be introduced into engine lube oil systems. Ambient air conditions, such as high humidity or extreme cold temperatures, can also increase the water content within engine lube oil sumps. The elevated quantity of water in lube oil systems can trigger false alarms in engine crankcase oil mist detectors (and lead to an engine shutdown) due to water droplets passing through the measuring track or the filter glass detecting condensation (mistaking it for oil mist). After an engine's crankcase is opened and exposed to these conditions during maintenance and repair, it is good practice for engine crews to inspect and test the lubricating oil system for water intrusion and ensure lube oil purifying equipment is functioning properly to remove any water or other contamination in the lube oil.

Main engine oil mist detector aboard the *Damgracht*.
SOURCE: NTSB

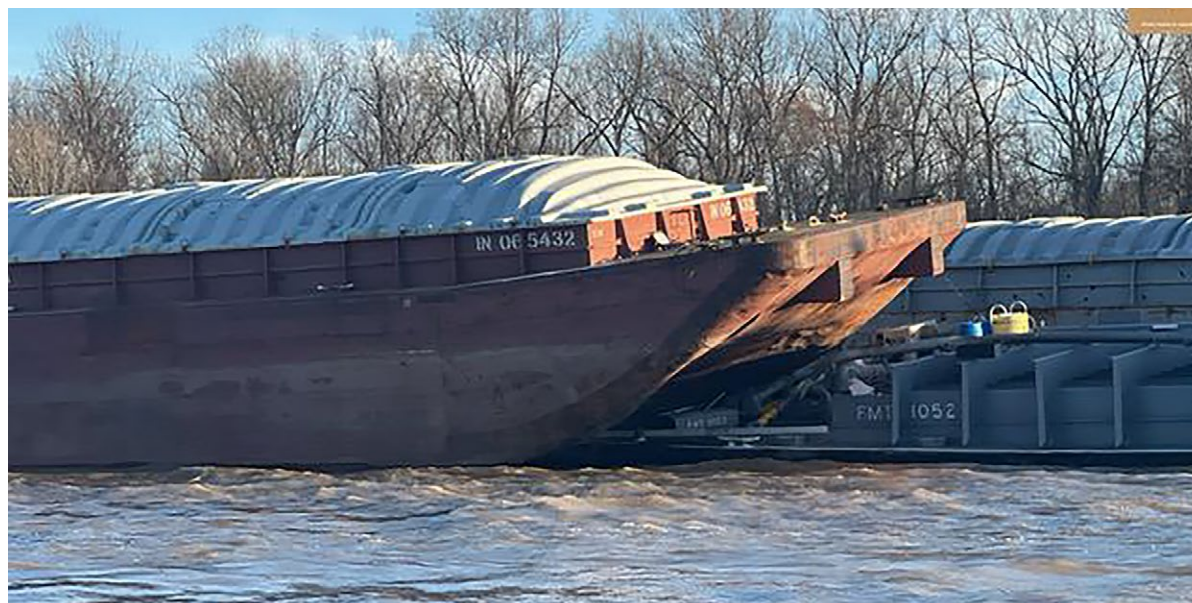
Left to right: Hopper barge IN065432 from the Carol McManus tow and tank barge FMT1052 from the Big D tow, postcasualty. SOURCE: INGRAM BARGE COMPANY

THE PROBABLE CAUSE of the collision between the *Big D* tow and the *Carol McManus* tow was the *Carol McManus* pilot incorrectly recalling the agreed-upon passing arrangement, which resulted in the *Carol McManus* tow encroaching on the downbound *Big D* tow.

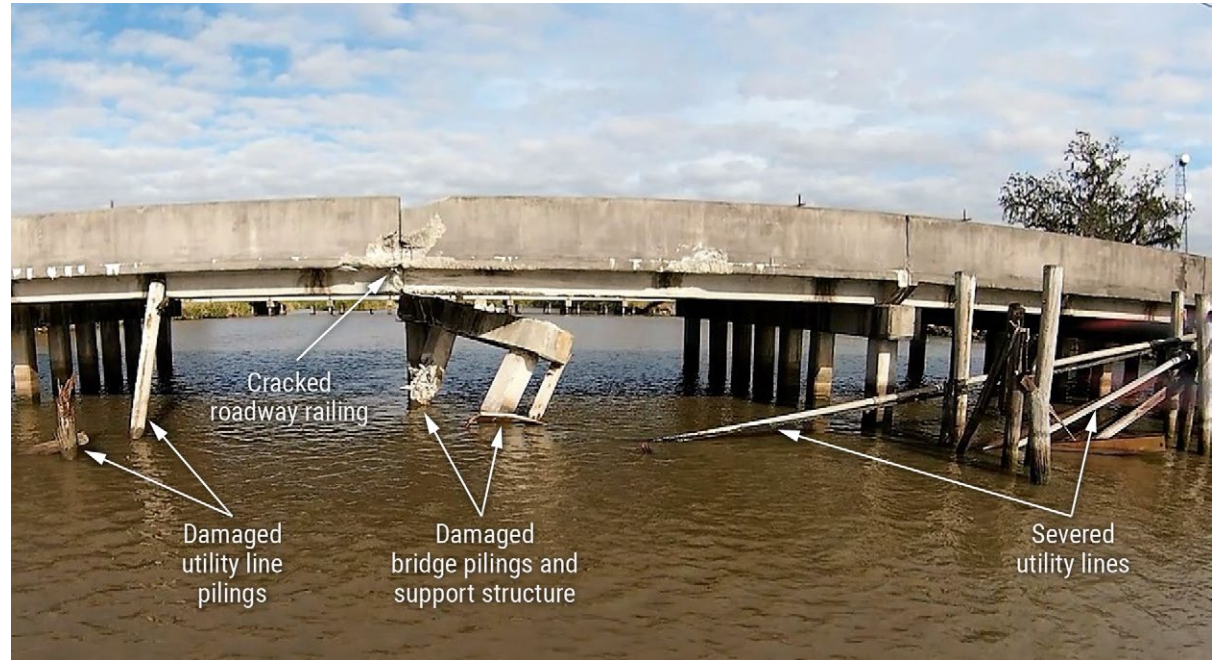
**Route 182 bridge damage.** BACKGROUND SOURCE: CAJUN DRONE PHOTOGRAPHY, JIM PIERCE JR.

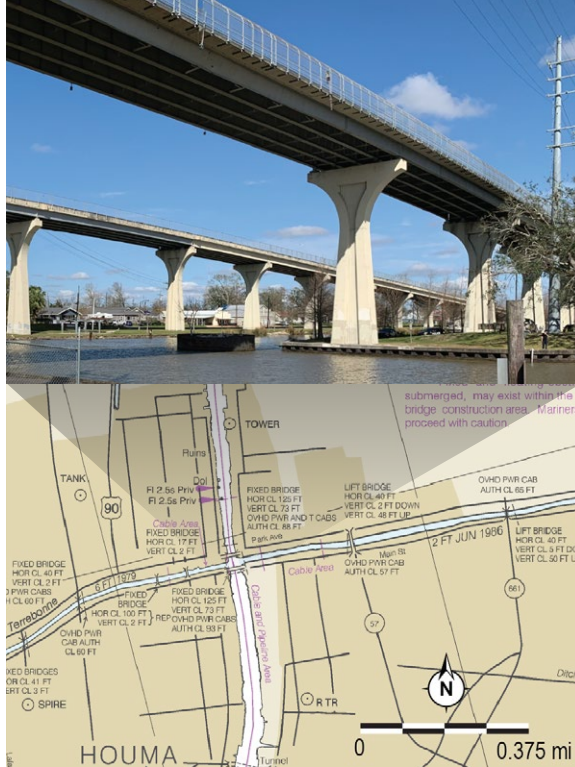
**Clockwise from top: The Houma Twin Span Bridge; eastbound span of the bridge showing damaged stringer; and extract of NOAA chart 11355, annotated by NTSB.** SOURCES: NTSB, NOAA

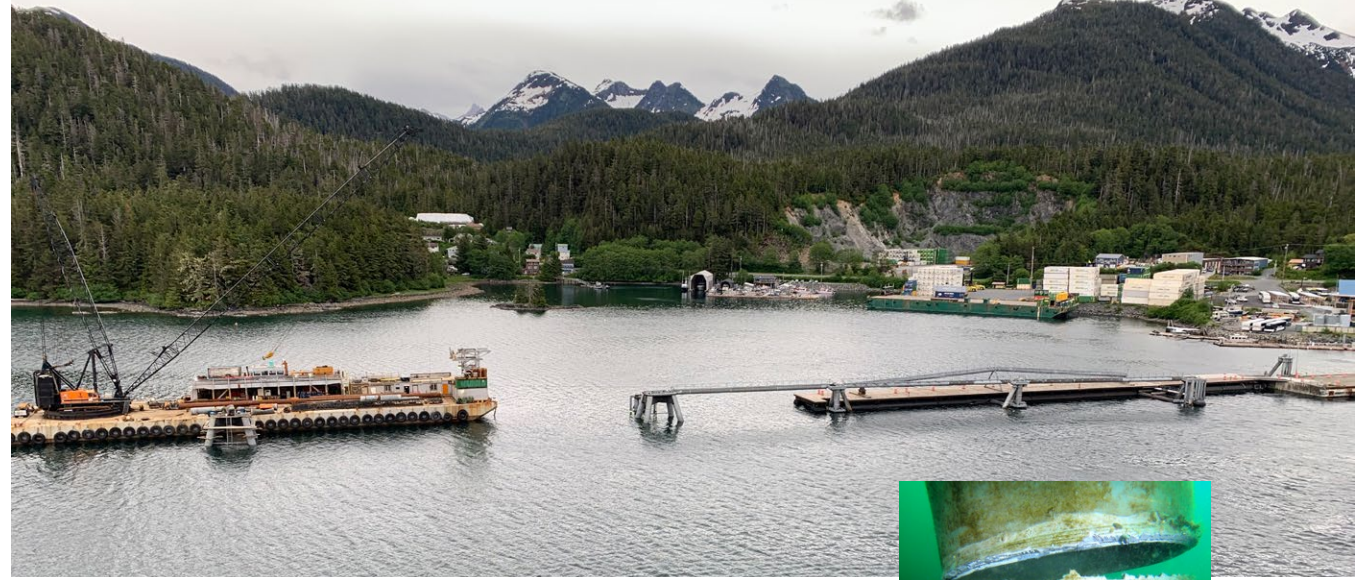
The Sitka Sound Cruise Terminal pier on June 9, 2022, with barge alongside the damaged dolphin for repairs (with catwalk between dolphins removed). SOURCE: NTSB

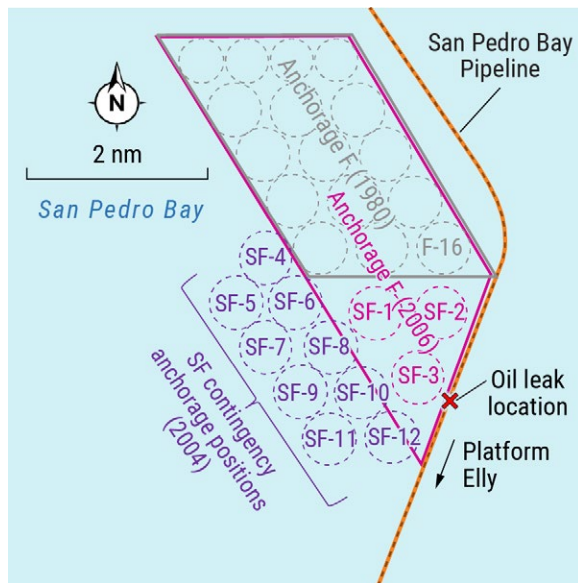
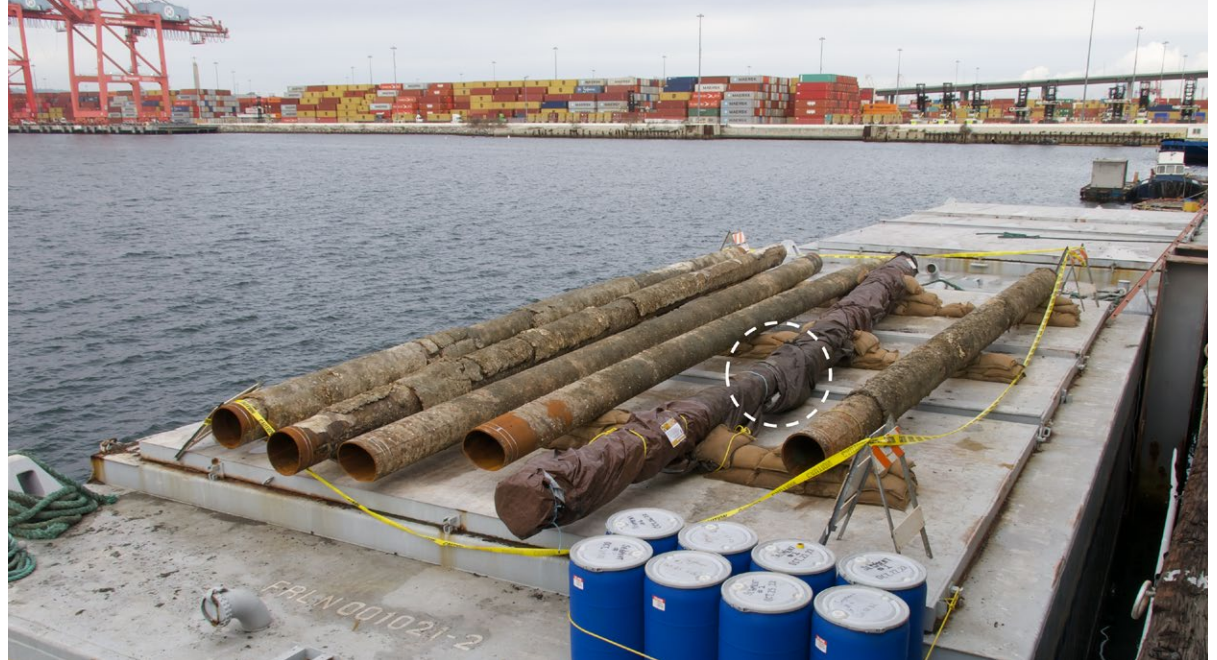
Six segments of damaged pipeline removed for replacement. The leak site (circled) was observed on the segment shown wrapped in a tarp. SOURCE: NTSB

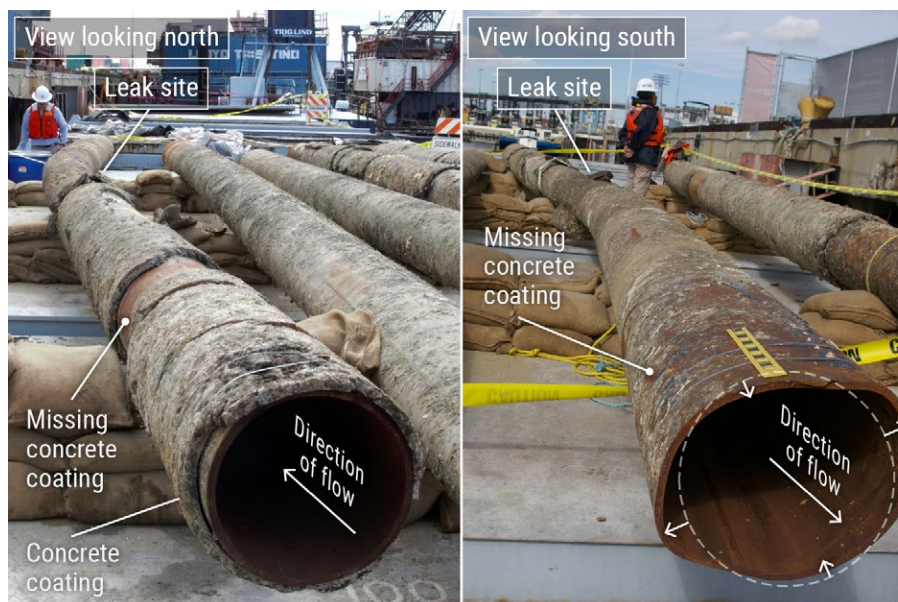
Opposite ends of the pipe segment that contained the leak site, which had been temporarily repaired with a welded repair patch, visible in the right image. Damage signatures observed included lateral deformation, out-of-roundness deformation (a typical example indicated at the end of the segment in the right image), and missing concrete coating, especially north of the leak site.

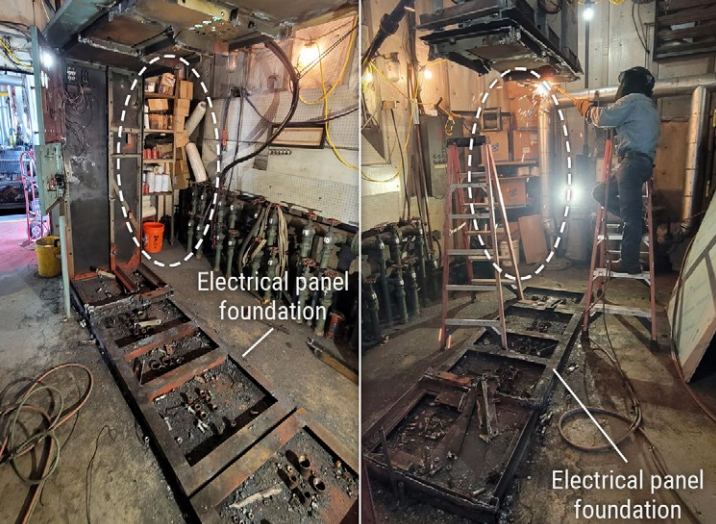
Above, left to right: The *Natchez* generator space before the fire. Left photo, looking aft, shows exposed boxes and plastics (circled) stored aft of the metal foundation for the electrical panel that was removed during the hot work. Right photo, looking forward, shows exposed boxes (circled) forward of the foundation. **Below:** The generator space postfire, looking forward, showing the location on the forward bulkhead (circled) identified by the ATF as the fire's origin.

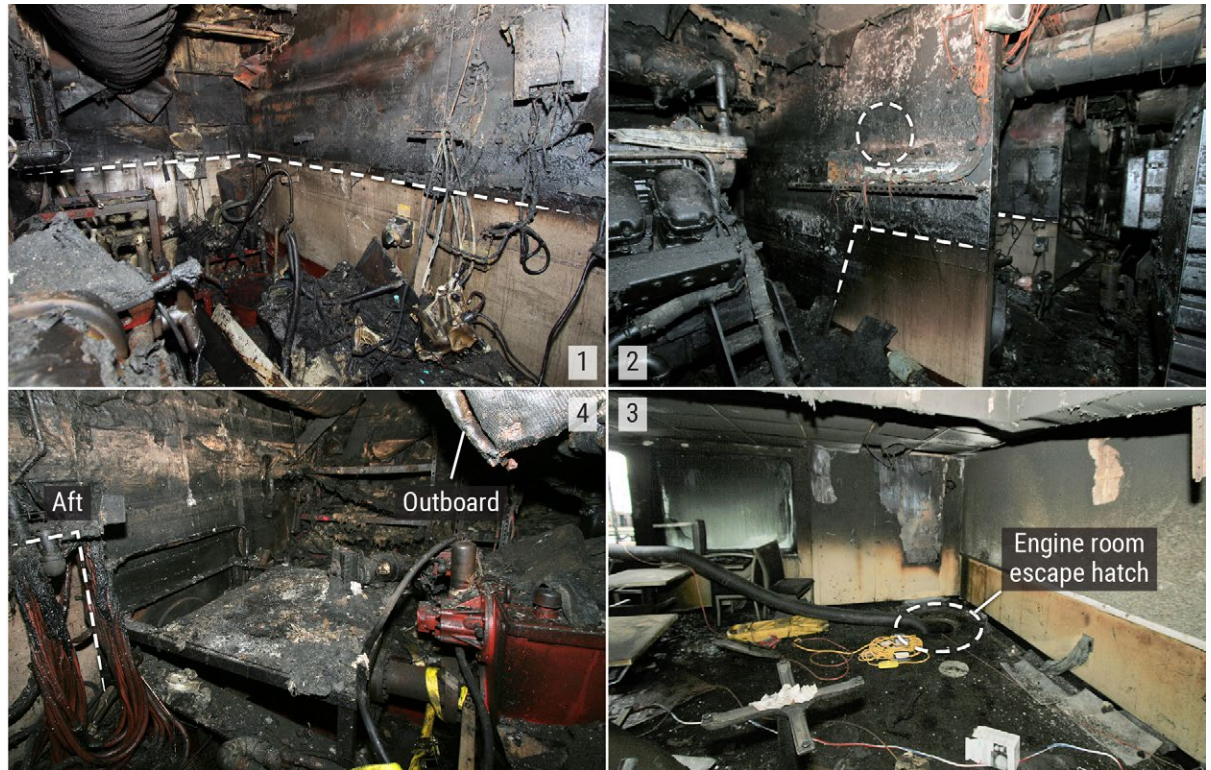
Clockwise from top left: (1) Portside engine room bulkhead exhibiting demarcation line (dashed line) between thermally damaged and undamaged area. (2) Bulkhead forward of port main engine with low-lying damage toward the outboard side. Demarcation line (dashed line) and original location of electronic throttle controller shown (circled). (3) Engine room escape hatch on the main deck (circled). (4) Fire damage on the bulkhead aft (dashed line) and outboard of port main engine. The metal frames of the storage shelves are visible against the bulkhead. SOURCE: NTSB

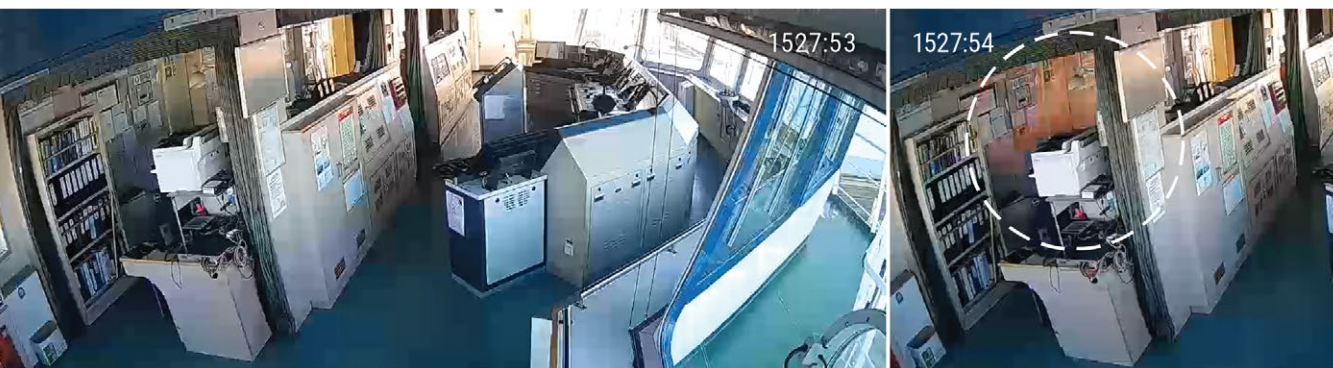
**The damage to the bridge.** SOURCE: COAST GUARD

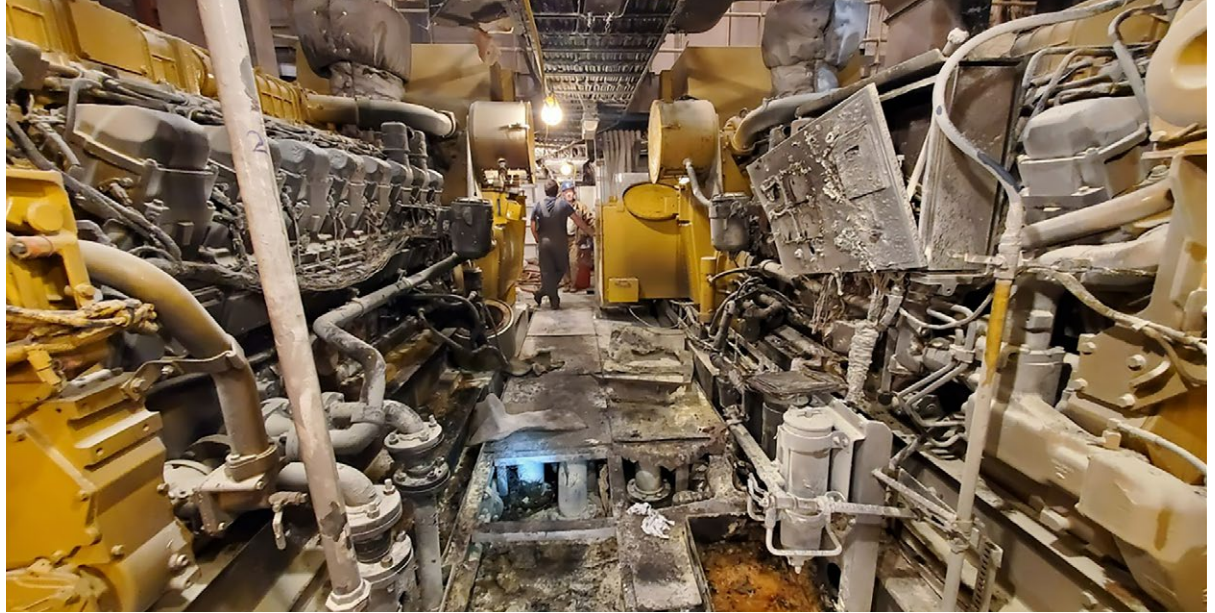
**The walkway between the nos. 3 and 4 main engines after the engine failure and fire (looking forward).** SOURCE: NTSB

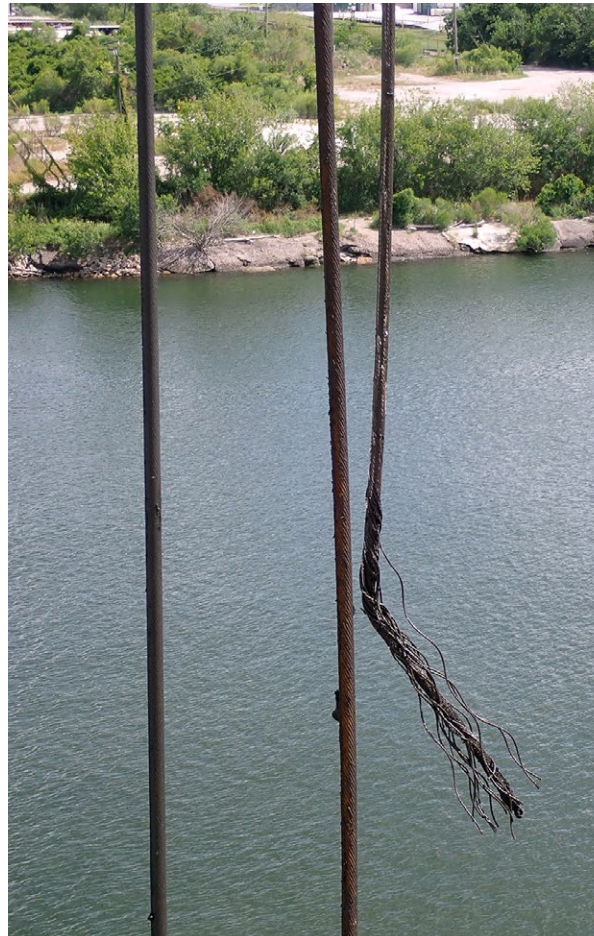
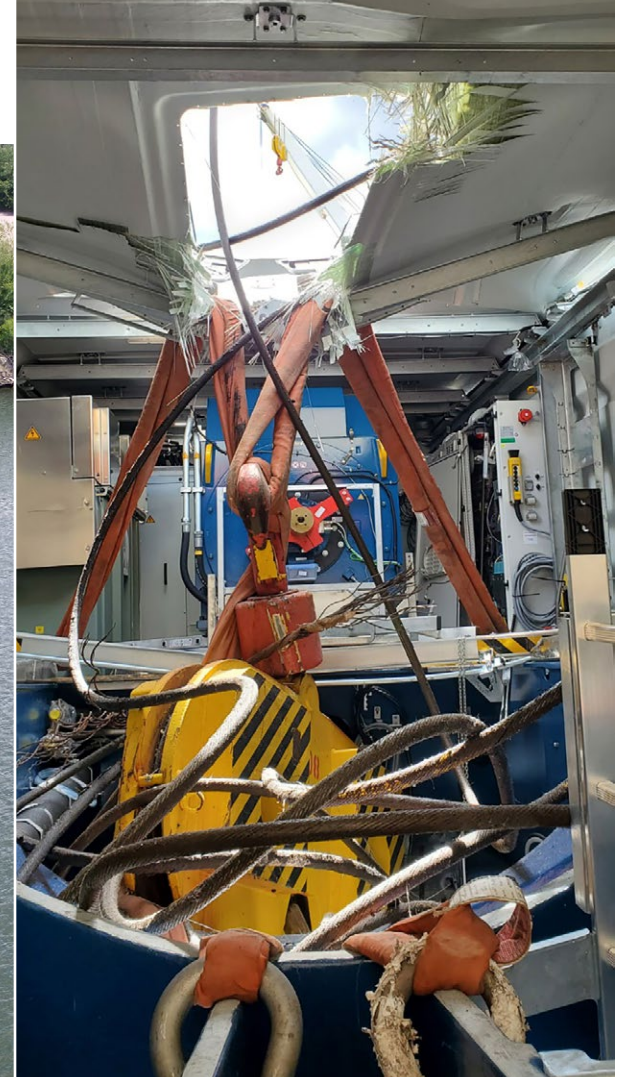
Left to right: Crane no. 1's parted wire rope on the crane side and its block smashed into the top of the damaged nacelle. SOURCE: COAST GUARD

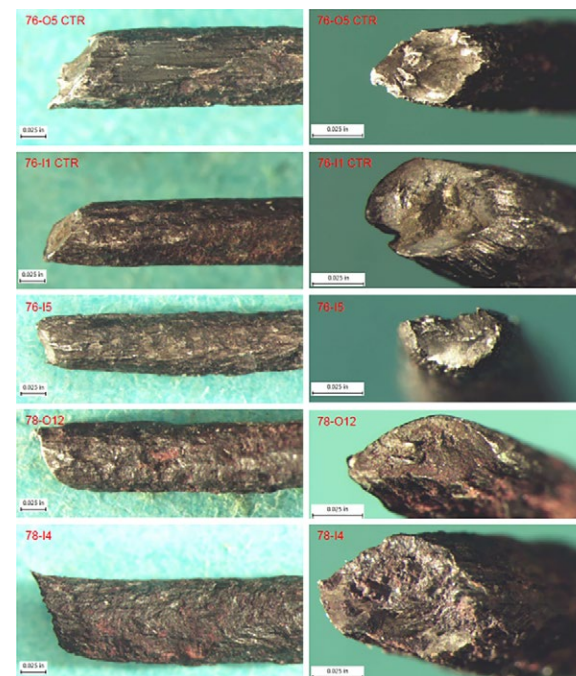
Views of wire ductile fractures found in strands of the failed wire rope from the side (left) and perpendicular to the fracture surface (right).

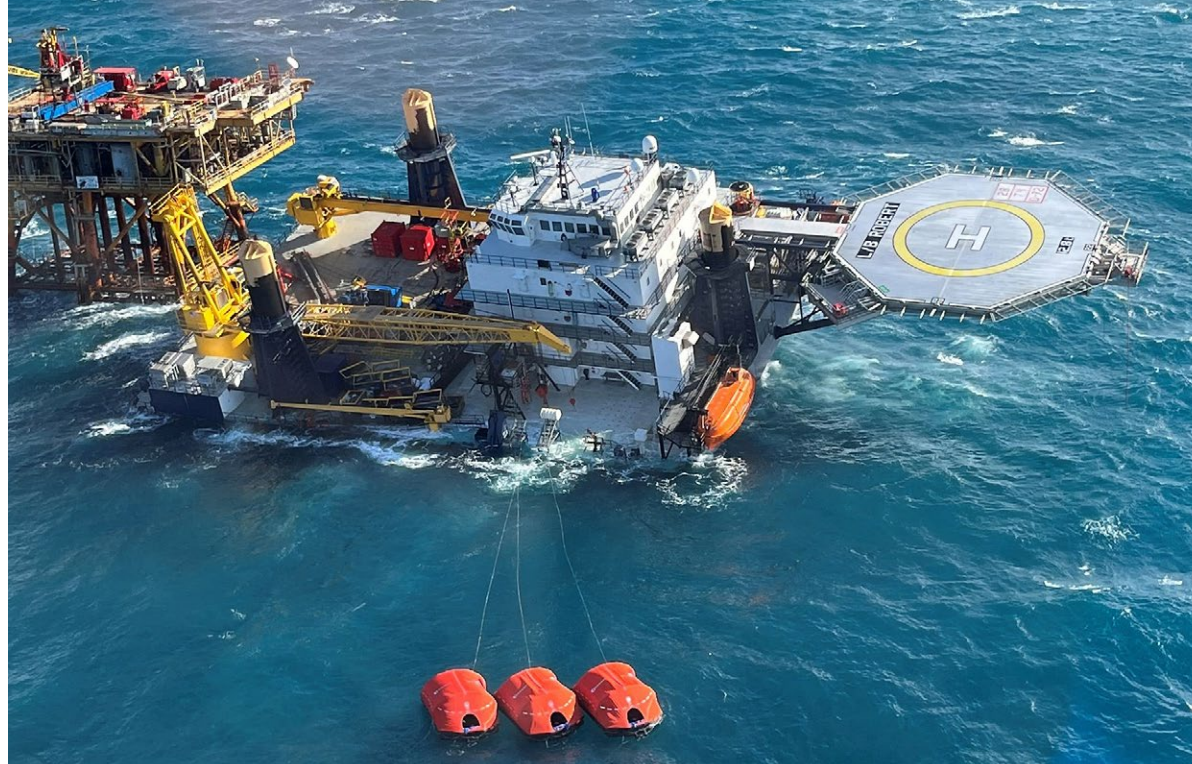
L/B Robert toppled to port as seen on November 21, 2022, at 0914. SOURCE: COAST GUARD
