# SAFETY INVESTIGATION REPORT

REPORT NO.: 06/2024

## MV DOGAN

**Serious injury to a crew member while operating the vessel's lathe, in position 47° 21.1' N 006° 25.8' W 07 June 2023**

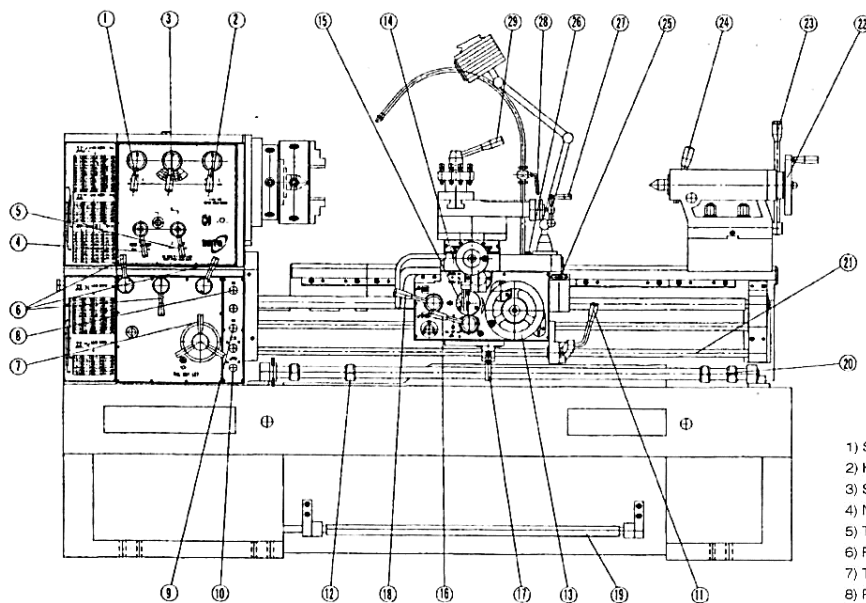
**Figure 2: The lathe**

The vessel's lathe (**Figure 2**) was a DMTG CDL6246/1000 model, fitted in the engine-room's workshop<sup>3</sup> (**Figure 3**).

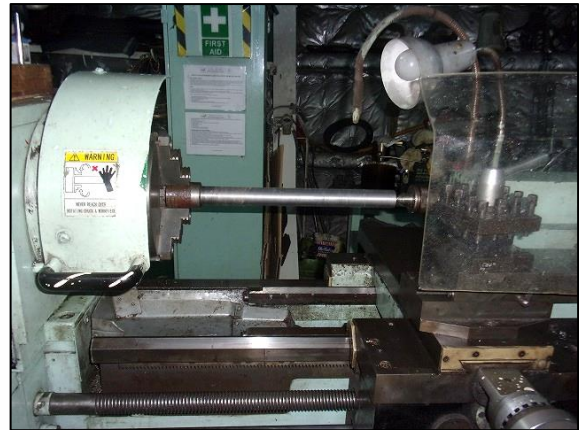
**Figure 4:** The securing pin placed in the lathe

The fitter secured the steel rod in the lathe (**Figure 4**) and resumed the task. He used a fine cut hand file<sup>6</sup> to smoothen out the surface of the rod. The metal chuck guard was lowered into position, while the acrylic carriage guard was moved aside to allow for the filing of the rod.

On board *Dogan*, the chuck guard did not extend further to cover the chuck jaws (seen in **Figure 4**). This, however, was a design issue and while some lathes are fitted with adjustable chuck guards, there are still several models of lathes (such as the one installed on *Dogan*) that are not fitted with adjustable chuck guards. Working with lathes that are not fitted with adjustable guards would require the user to take additional precautions to minimize the risk of an accident.

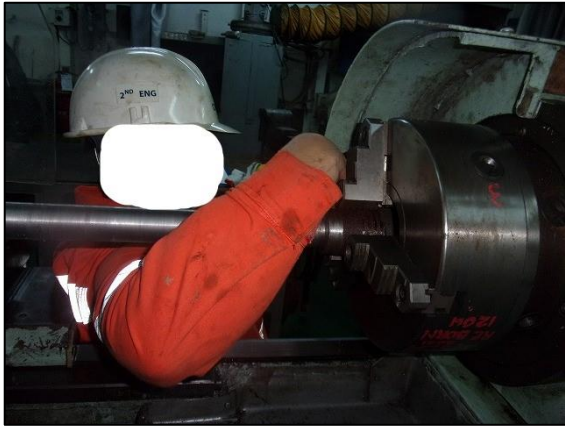
**Figure 6: Simulation of the accident, showing how the fitter's hand was pulled towards the chuck**

At 0900, shortly after resuming the task, the fitter's right hand slipped lower and onto the steel rod. The right sleeve of his coveralls got caught in the rough surface of the rod<sup>9</sup>, and his hand was pulled around and towards the chuck (**Figure 6**).

The fitter suffered serious injuries to his right hand while working on the vessel's lathe, when his right hand slipped and the sleeve of his coveralls got caught in the rough surface of the rotating steel rod, pulling his right hand towards the rotating chuck of the lathe.

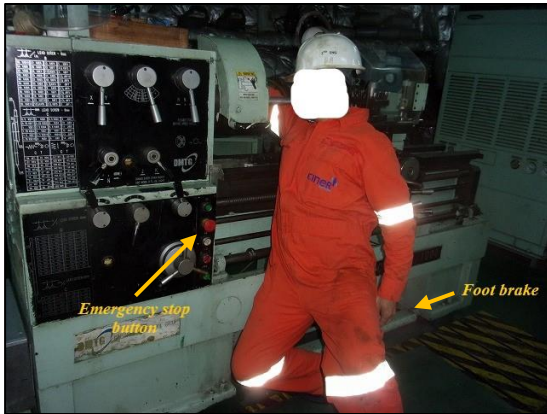
**Figure 7: Simulation of the accident, showing how the fitter's body was pulled into the lathe**

As a result, the fitter suffered serious injuries to his right hand, while his body was quickly pulled onto the lathe in a manner that he was unable to (and did not have the time) to operate the lathe's foot brake (**Figure 7**).

The fitter called for help and the second engineer and oiler immediately responded. The second engineer pressed the emergency stop button (**Figure 7**), and then assisted the oiler in freeing the fitter's hand from the lathe. It was noticed that the fifth digit of the fitter's right hand was amputated.

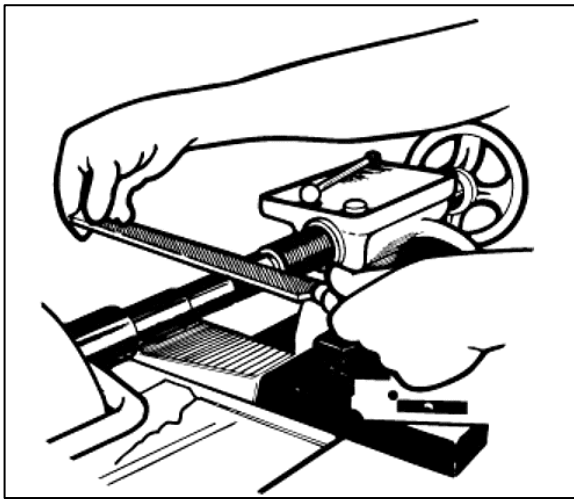
**Figure 8: Recommended grip when using a file on a lathe**

The fitter was gripping the handle of the file with his right hand above the steel rod. The fitter could not advise why his hand had slipped down. However, this would be the expected direction of movement, considering the anti-clockwise rotation of the lathe's chuck (facing the chuck).

The Canadian Centre for Occupational Health and Safety (CCOHS) recommends gripping the file with the left hand, using the fingers of the right hand to balance and guide the file at the point (**Figure 8**)<sup>14</sup>.
