Report on the investigation of
the collision between the fishing vessel **Kirkella (H7)**
and harbour tug **Shovette**
resulting in pollution at King George Dock, Hull, England
on 24 June 2022

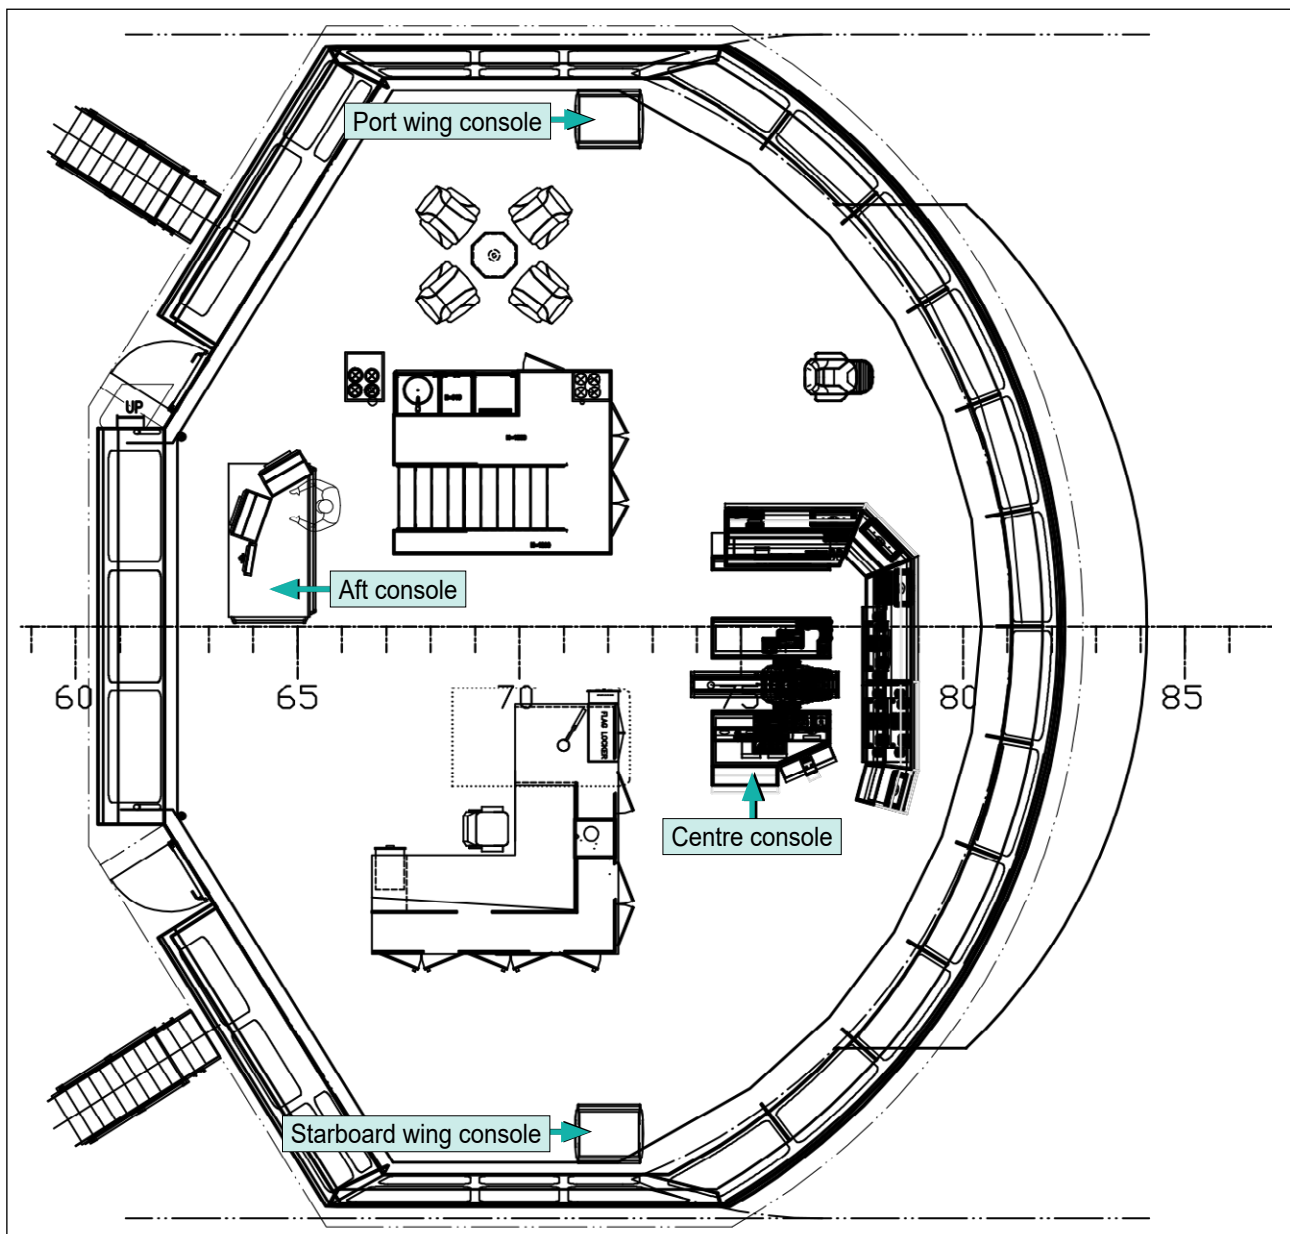
Figure 2: Bridge manoeuvring control consoles

At 0611, *Kirkella's* master passed control of the vessel's propulsion system from the starboard wing control station to the centre console position (**Figure 2**). At the same time, the crew deployed the vessel's gangway to the quayside. Once the master was content that the vessel was secured in position control of the propulsion system was passed to the ECR (**Figure 3**) so that the main engine could be shut down.

Kirkella's propulsion and bow thruster were controlled by a Rolls-Royce Helicon-X3 system (**Figure 9**). There were four control stations on the bridge (see **Figure 2**) and one in the ECR. The bridge control positions were frequently used during fishing and navigation and the crew had adopted a process whereby controls at the console in use were set to stop/zero before changing to a different console.

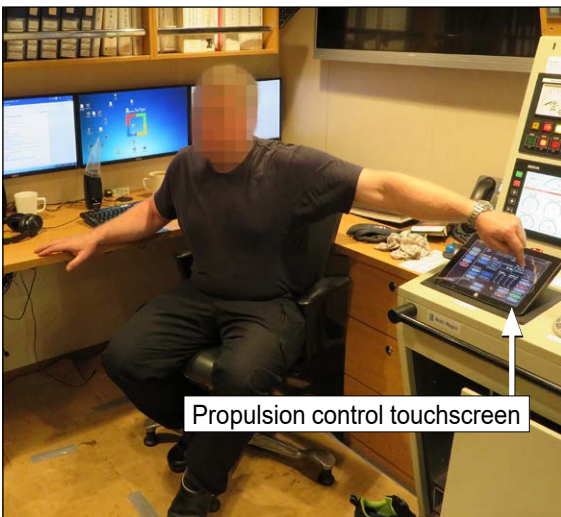
Figure 4: Engineer reaching across to the propulsion control touchscreen

The first engineer (1/E) was sitting in the ECR working at a computer. The 1/E heard the propulsion command change alarm and reached across from their chair and pressed the 'ECR' then 'Accept' buttons on the touchscreen to accept control (**Figure 4**). Eighteen seconds later, *Kirkella* started to move ahead.

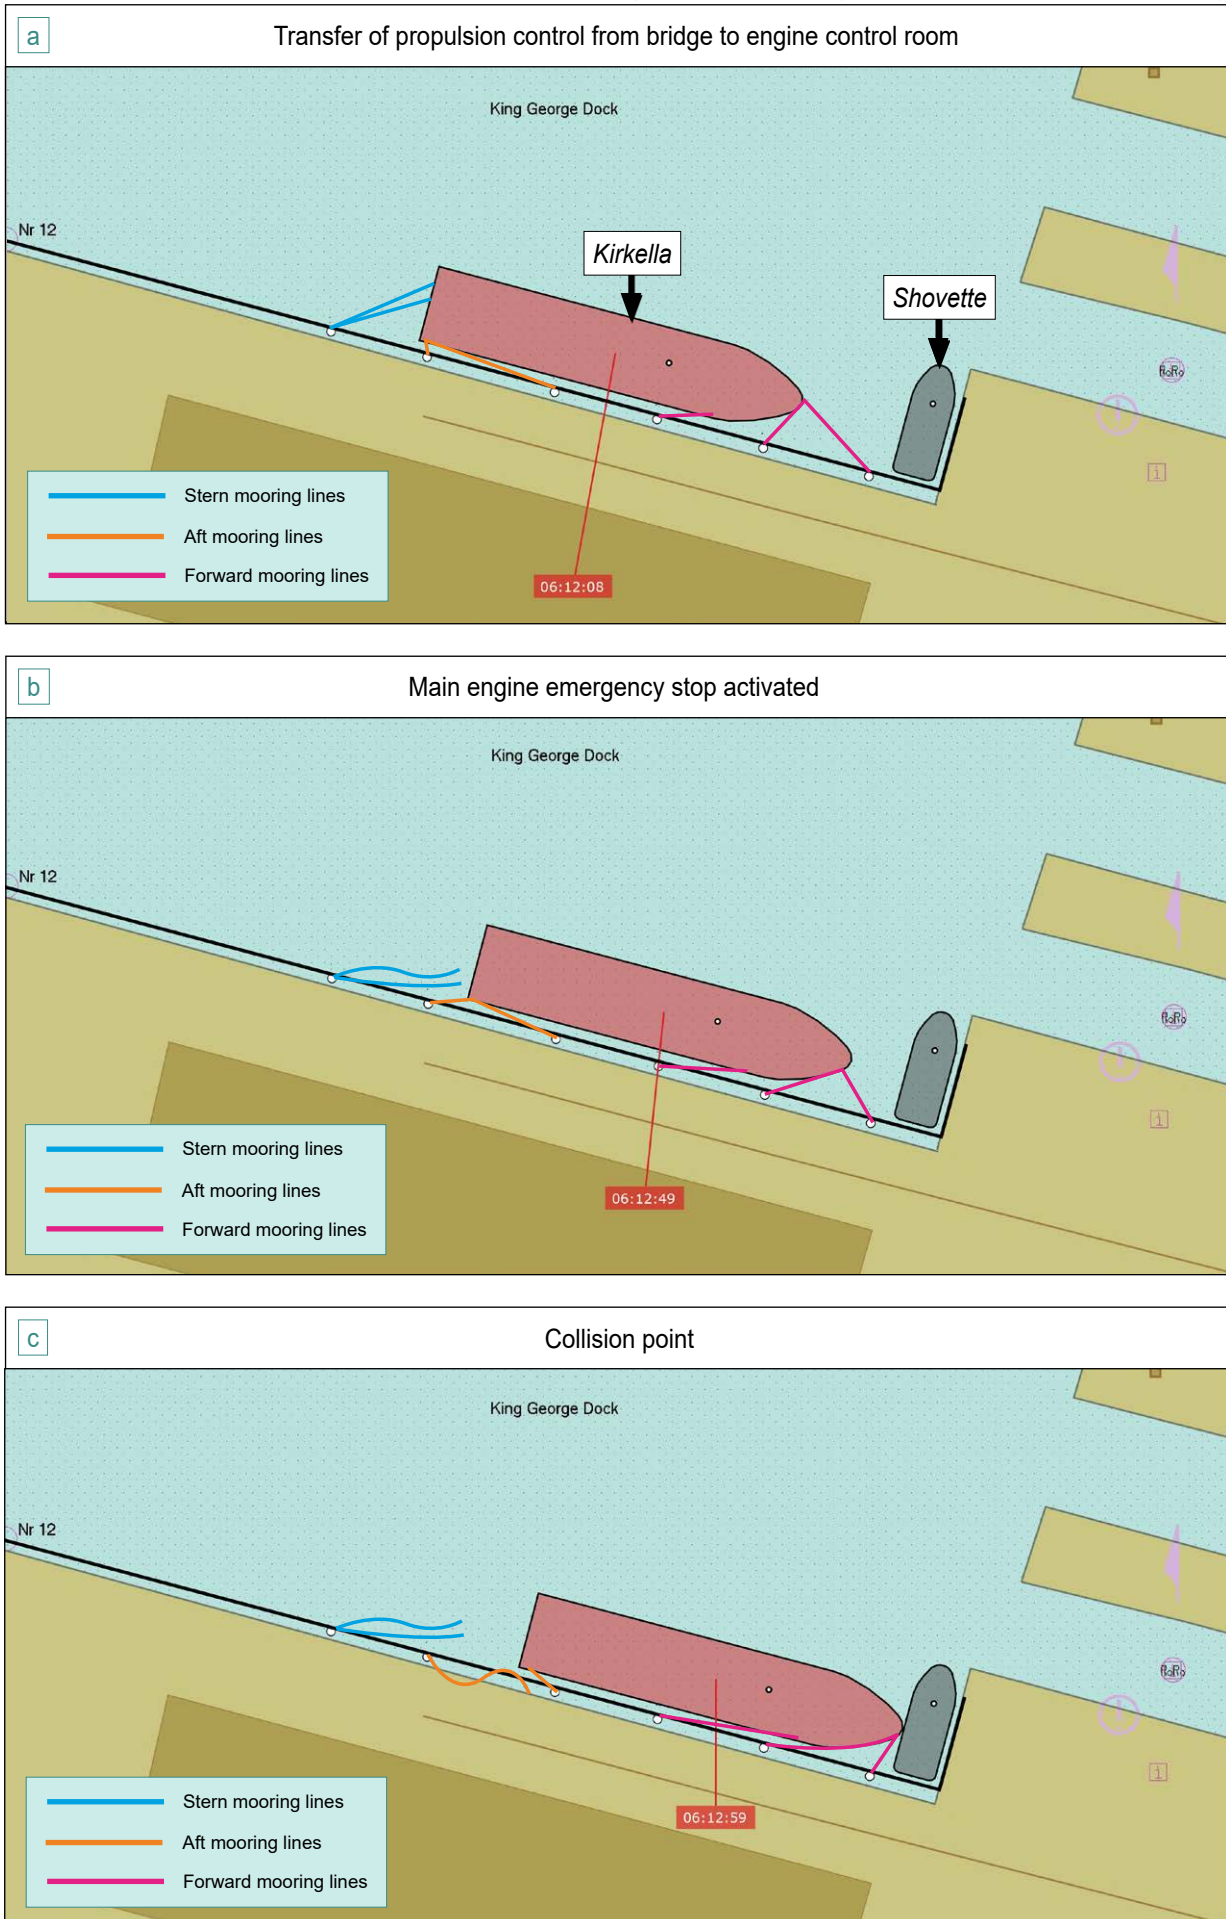
Figure 5: Sequence of *Kirkella's* loss of control

On the bridge, the 1/O was shutting down the bridge equipment when they noticed the vessel moving ahead and raised the alarm. The master reacted to the 1/O's exclamation and saw that the vessel was moving ahead. Shortly afterwards, the two stern lines parted and the forward spring lines surged on the mooring bits.

The master went to the centre console and telephoned the ECR, instructing the 1/E to stop the engine. At about the same time, the master pushed the emergency stop button on the centre console, which declutched the engine. Moments before the master's telephone call, having sensed a change in the main engine load, the 1/E had checked the engine control console and observed that the pitch was 85%.

As *Kirkella* continued to move forward, two further mooring lines parted and the gangway was dragged until it fell from the quayside. Ten seconds after the master had declutched the engine, *Kirkella* collided with the moored and unmanned harbour tug *Shovette* (Figures 5a to 5c), which was berthed adjacent to the all-weather terminal at the end of the King George Dock (Figure 1). *Kirkella* bounced off the tug and came to rest with three forward mooring lines and one aft mooring line still intact.
