## SAFETY INVESTIGATION REPORT

REPORT NO.: 09/2024

### **MV PORT GDYNIA** **Fatal injuries to a crew member,** **during cargo operations** **in the port of Bata, Equatorial Guinea** **21 July 2023**

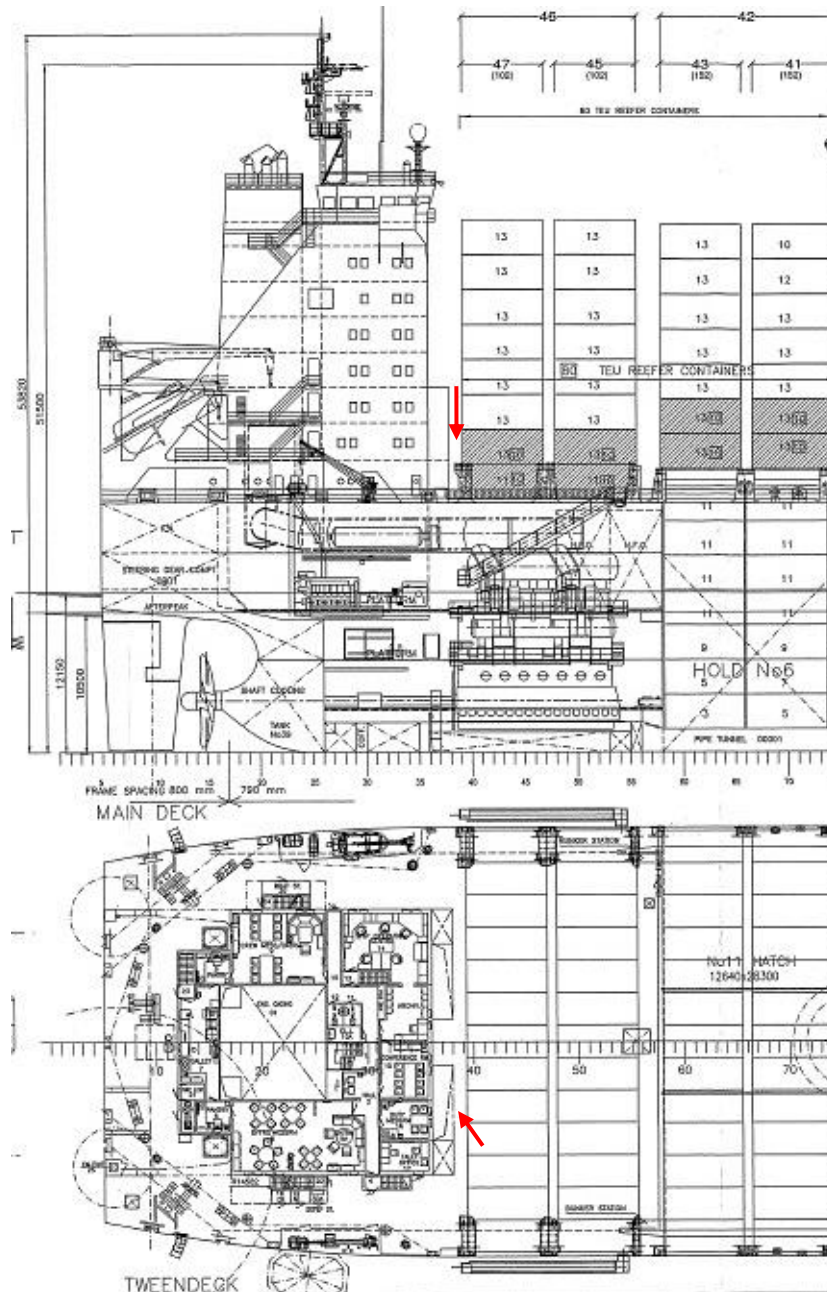
accommodation to refill his bottle of water. Along his way, he noticed the ETO lying unconscious<sup>8</sup> on the cross deck between the aft of bay 46, where 20 and 40-foot containers were stowed, and the accommodation superstructure (**Figure 2**).

**Figure 2: The approximate location (red arrows) where the ETO was found**  
 Copyright: Morska Stocznia Remontowa Gryfia S.A.

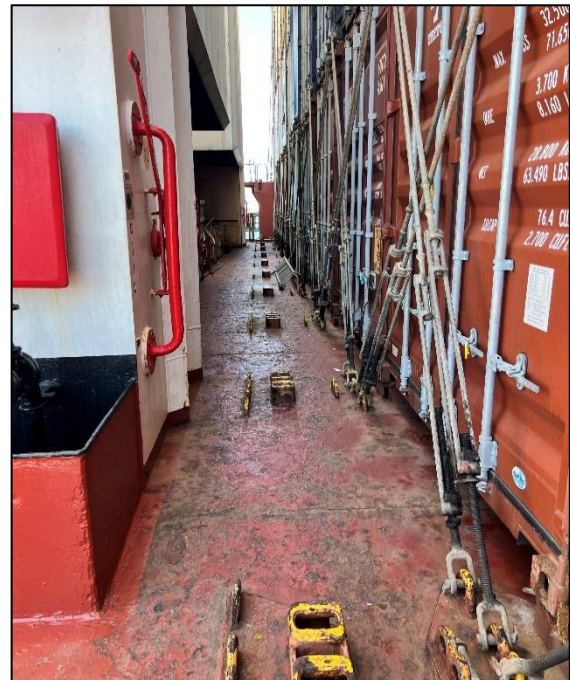
The cross deck between the accommodation superstructure and bay 46 was narrow, with additional cargo container sockets and pad eyes running along it<sup>10</sup> (Figure 3). In addition, cargo securing gear (lashing rods, turnbuckles, twist locks, etc.) were also stored in the cross deck.

Figure 3: The cross deck (as seen from the starboard side), when the cargo containers are secured, and no reefers are stowed

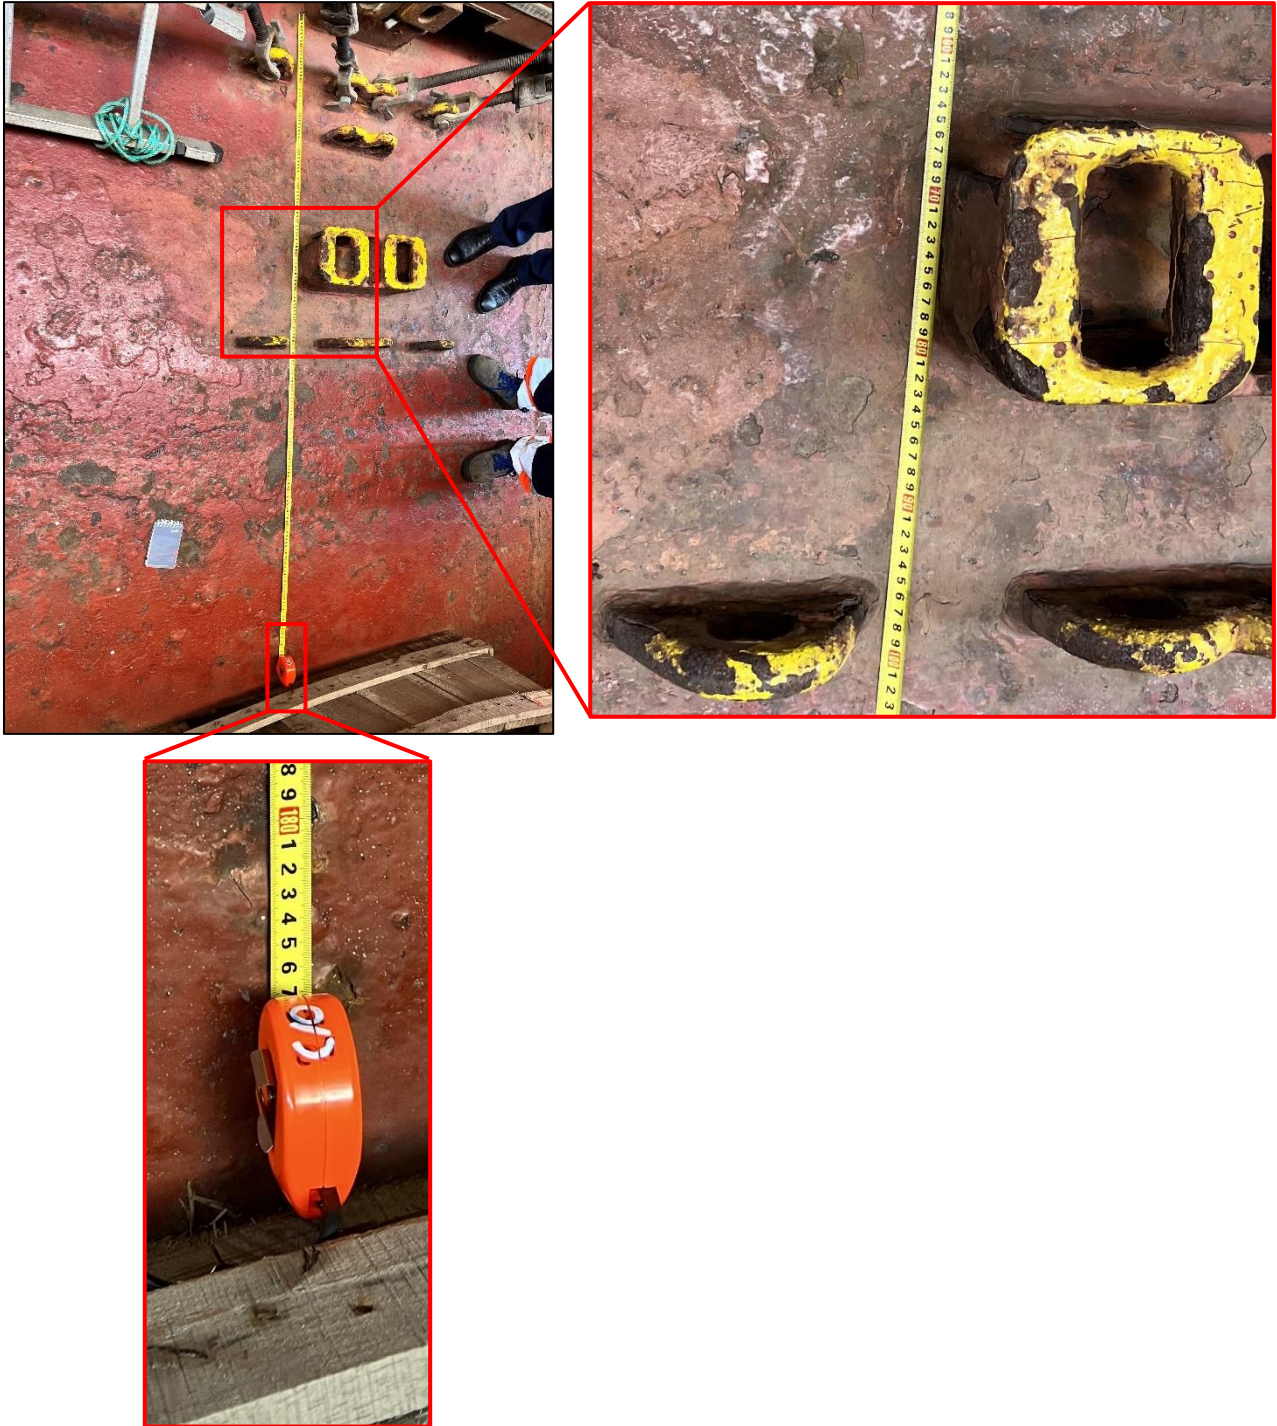
The width of the cross deck, *i.e.*, the distance between the sockets for 20 / 40-foot containers and the boxes for the cargo securing gear, was measured at approximately 1.9 m. The additional sockets and pad eyes for 45-foot containers lay between 0.6 m to 1.0 m (approx.) from the 20 / 40-foot container sockets (Figure 4).

Figure 5: The measured width of the cross deck between the accommodation superstructure and bay 46

As mentioned earlier in this safety investigation report, the cross deck where the ETO was found, was narrow with various obstructions along it. Of the measured 1.9 m, about 1.0 m of the cross deck was taken up by the fixed deck fittings (container sockets and pad eyes), leaving just about 0.9 m of space for a person to pass through.

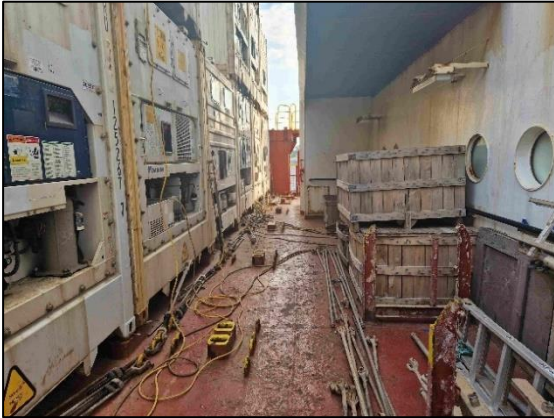
When reefer containers were stowed in bays 46 / 47, their electric power cables had to pass across the space to the power sockets on the accommodation front. During cargo operations in these bays, the space to walk through the cross deck would be further restricted by the loose lashing rods and turnbuckles lying on the deck (**Figure 5**).

**Figure 5: The cross deck (as seen from the port side), during cargo operations in the bay and when the reefer containers are lashed in**

However, around the time of the occurrence, this 0.9 m of space was also not free of obstructions, with loose cargo securing gear lying around and reefer container cables

running across it. It was therefore likely that the ETO may have tripped over an obstruction (either some cargo securing gear, reefer cable, or a fixed deck fitting) and fallen, face-first on the deck, with his forehead directly striking either the deck, or another fixed deck fitting.

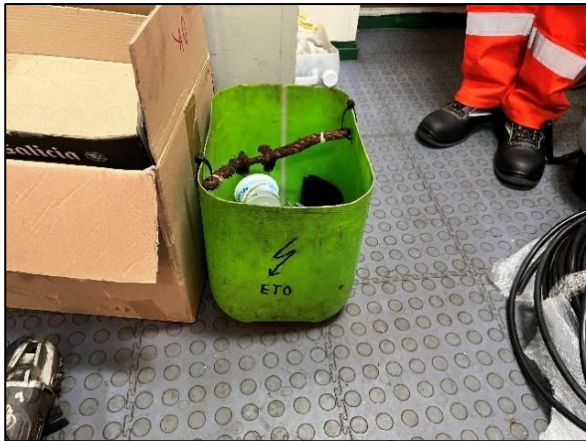
He also stated that whenever the ETO proceeded on deck for any tasks, he would carry a bucket of tools (**Figures 6 and 7**) with him. However, when the ETO was found lying on deck, neither the bucket nor any of his tools / equipment were found in the vicinity.

**Figure 6: The ETO's tool bucket**

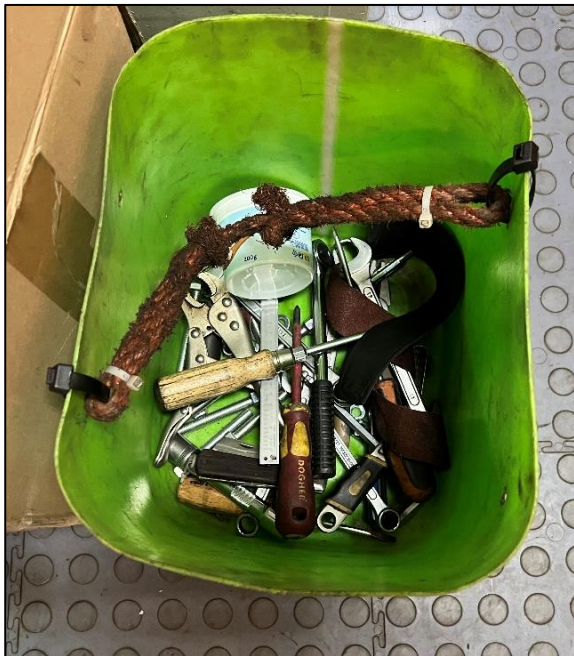
**Figure 7: The tools in the bucket**
