MIR-24-15

## Fire aboard Passenger Vessel *Qualifier 105*

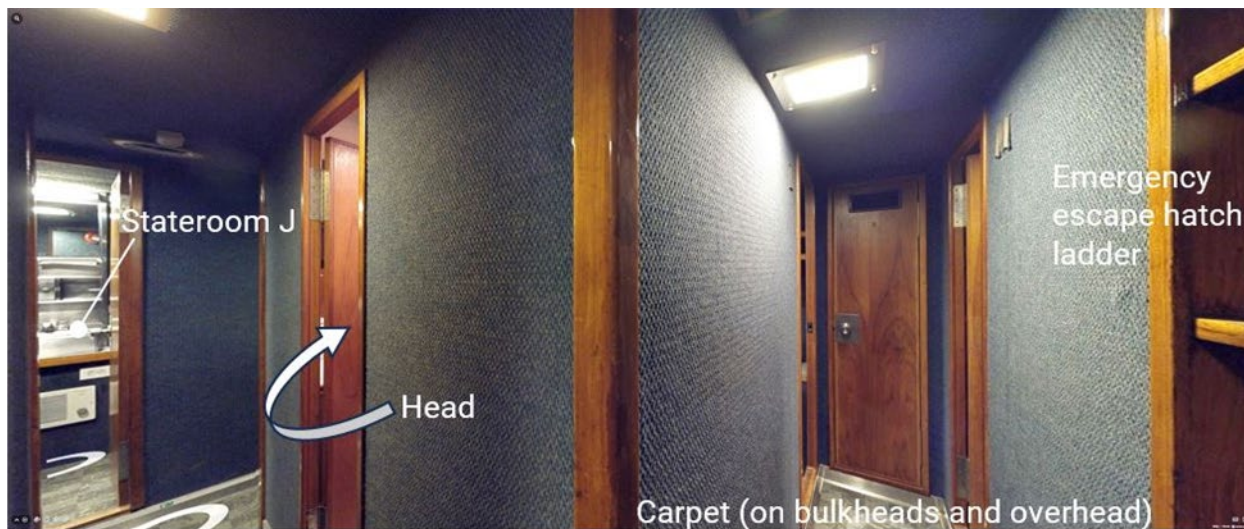
reinstalling the deck in one of the aft stateroom compartment heads. The head was directly above a fuel tank that had been repaired and tested the day before (see figure 3). Their work included hot work (grinding and welding). The portable Miller XMT welding machine, used for tack welding when reinstalling the deck, was located in stateroom J, on the deck just inside the door, between bunks. (It had been in that location for about a month.) They chose this location to keep the passageway clear and because there was no room for the welding machine near the work area about 8 feet away.

**Figure 3.** *Qualifier 105* aft stateroom compartment head, passageways, and stateroom J before the fire. (Background source: Support Vessels of Alaska)

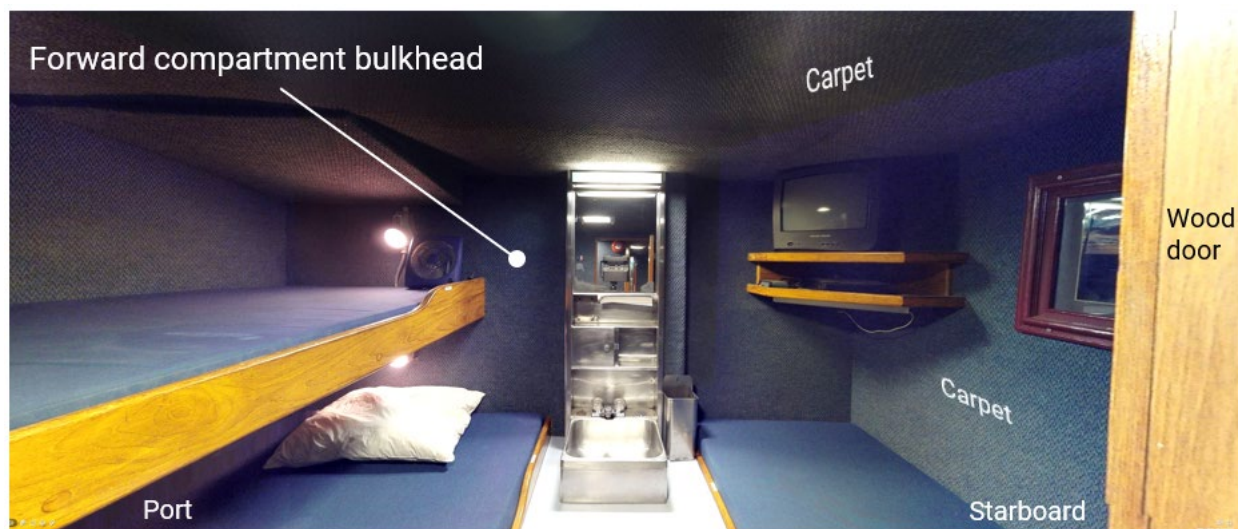
The vessel's aft stateroom compartment was bounded by forward and aft subdivision bulkheads of 0.1875-inch plate and an overhead (the salon/cabin deck) of 0.25-inch plate, all constructed of aluminum. Stateroom J was forward in the compartment, to the port side of the centerline, adjacent to the outboard stairwell. Stateroom J contained three bunks and a sink (see figure 4). The overhead in the compartment consisted of an aluminum-framed drop ceiling; its panels were plywood covered with carpet. Electrical system wiring was above the plywood. Plastic sheeting protected the carpet-covered bulkheads and overheads in the aft stateroom compartment.

**Figure 4.** *Qualifier 105* stateroom J interior before the fire. (Background source: Support Vessels of Alaska)

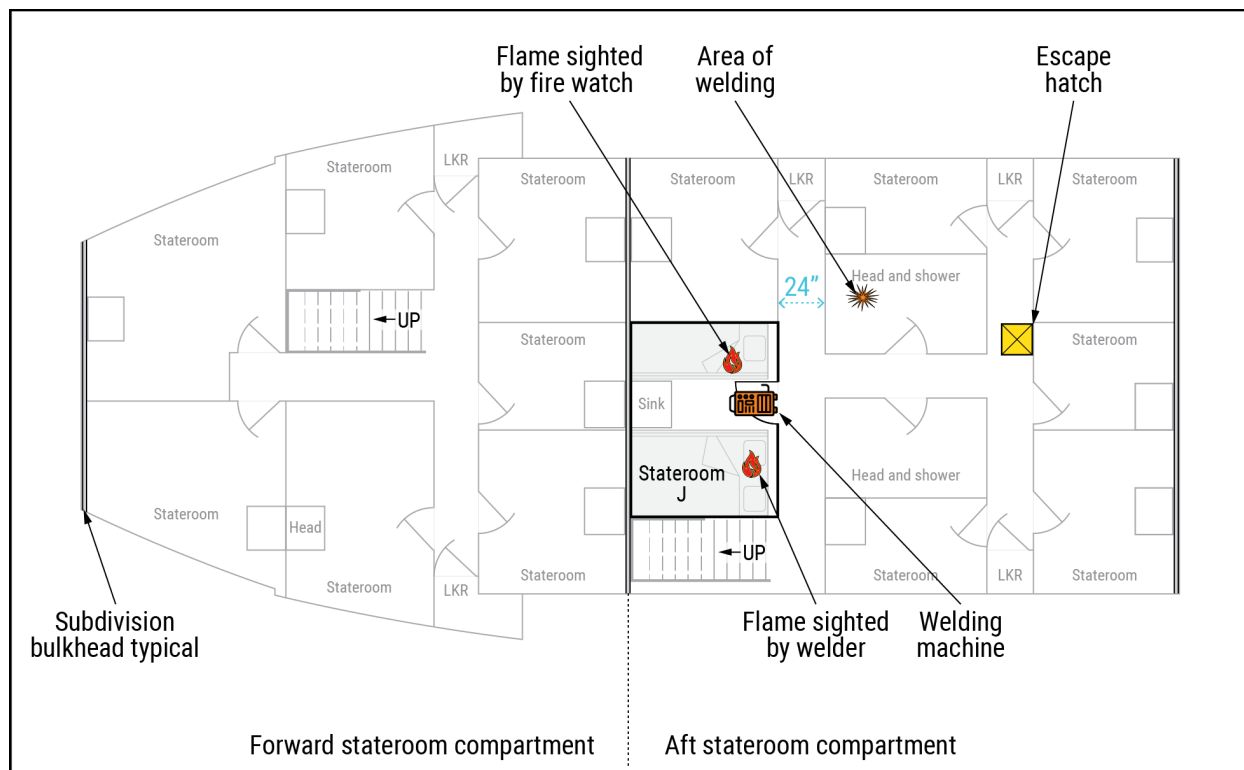
While the welders were working in the head, the fire watch made rounds of the vessel, including going below deck to walk the passageways in the forward and aft stateroom compartments. About 1155, a couple hours after work began, while in the salon, he noticed a "strange haze coming from the stairwell." He proceeded down the stairs to the aft stateroom compartment and saw a flame on the starboard bunk in stateroom J, near the door (see figure 5). He yelled "fire" to alert the welders.

**Figure 5.** *Qualifier 105* forward and aft stateroom compartments.

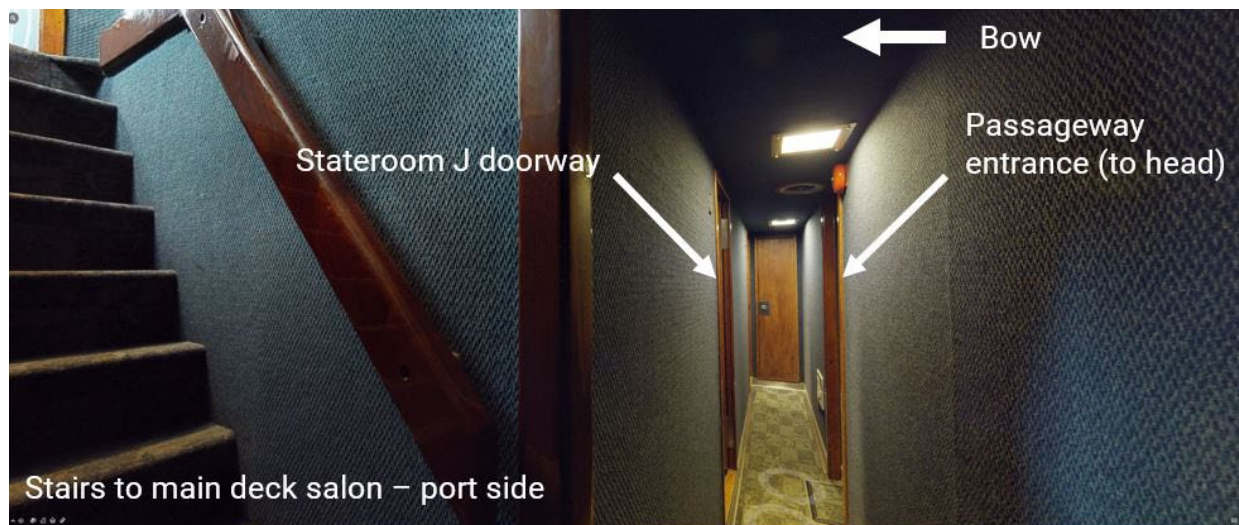
Welder 1 walked about two steps to the bottom of the stairs to retrieve the dry chemical extinguisher. He climbed two or three stairs and saw heavy smoke in the main deck salon. He then directed welder 2 to go up the stairs to assess conditions (see figure 6). Welder 2 came back and reported that he could not breathe in the salon but there were no flames.

**Figure 6.** *Qualifier 105* aft stateroom compartment stairway, passageway, and stateroom J doorway before the fire. (Background source: Support Vessels of Alaska)

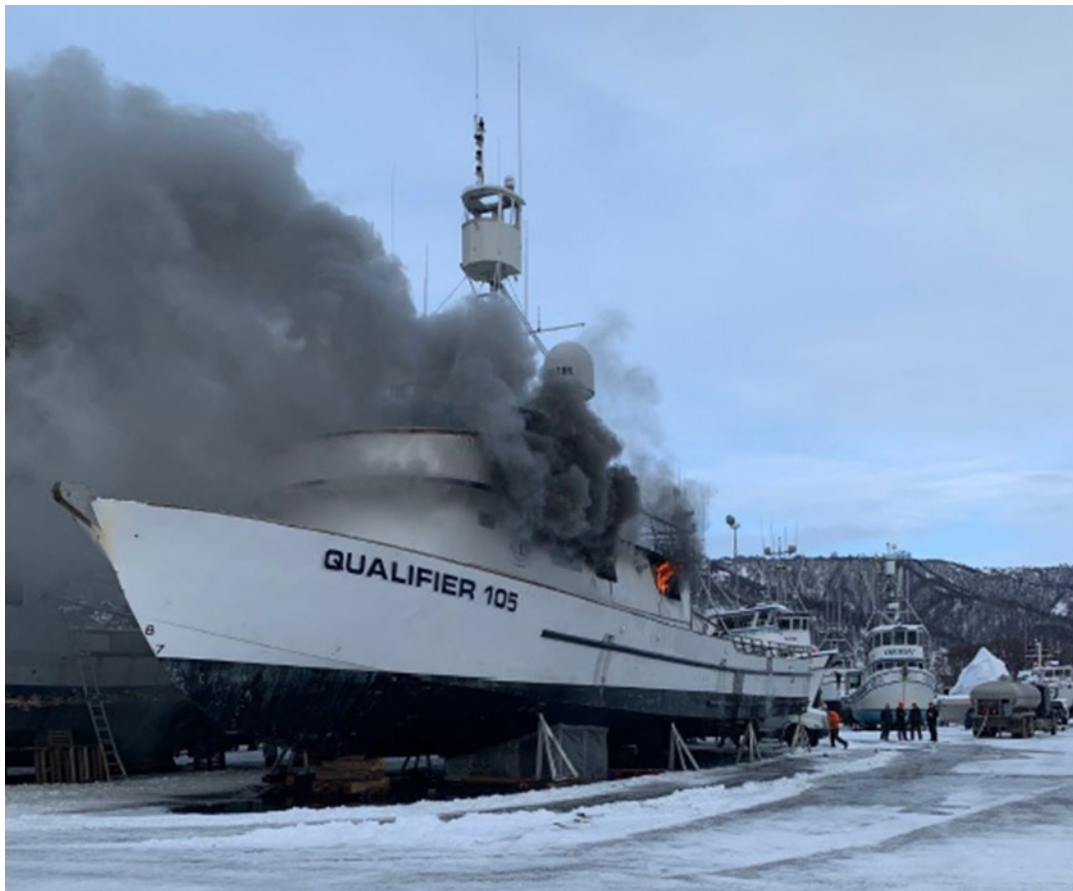
Welder 1 found that the passageway was now filled with smoke from the overhead down to his waist. He noted the plastic sheeting for the passageway overhead was hanging down “like ... a bubble” that extended downward from the overhead to about 3 feet above the deck. Behind the bubble, near stateroom J and on the starboard side at the other end of the passageway, was black smoke. Welder 1 got on his back and slid toward stateroom J under the plastic bubble. Still on his back, he discharged the fire extinguisher into stateroom J. He then left the vessel, using the stairs to the salon, and exited through the aft salon doors. On his way out, he noted flames in the salon, with the most flames on the starboard side. He also unplugged and removed the still-operating fan from the escape hatch. Within a minute, the entire salon was engulfed in flames (see figure 7). Shortly after, the fire watch and welder 2 left the vessel.

**Figure 7.** *Qualifier 105* on fire in the boatyard. (Source: Homer Volunteer Fire Department)

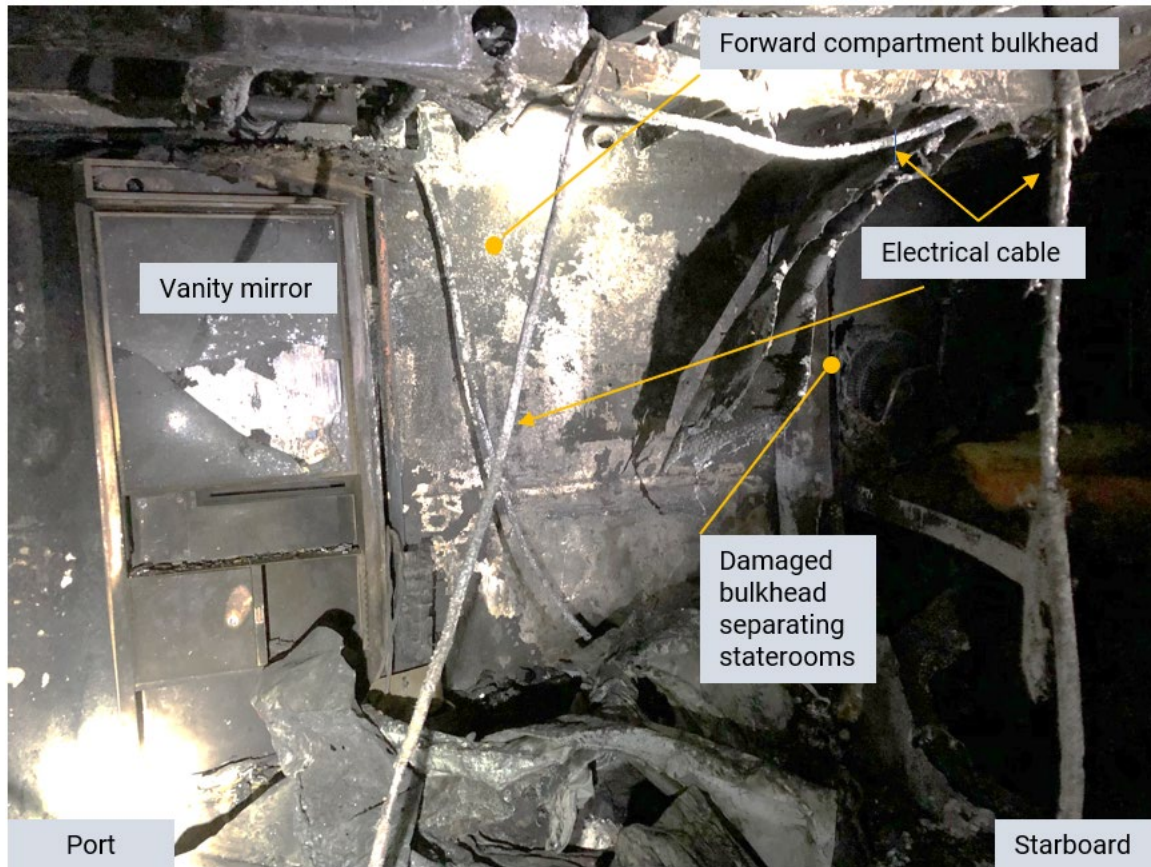
Areas of the aft stateroom compartment, the salon (including the galley), and an upper deck storeroom behind the wheelhouse were damaged (see figure 8). The welding machine was undamaged.

**Figure 8.** *Qualifier 105* stateroom J interior postfire. (Background source: Coast Guard)

The fire watch and welder 1 each saw a small flame on two different bunks in stateroom J—the first sign of a fire observed. Those small flames were likely caused by hot droplets of plastic sheeting—used to protect the carpet-covered, plywood drop ceiling above—that had melted and caught fire from heat or fire between the aluminum overhead and the drop ceiling. Therefore, it is likely that the initial ignition source and the eventual fire in stateroom J originated from the overhead. The accommodation spaces contained combustible materials—including carpet, wood framing, and plastic sheeting—in the overhead and on the bulkheads that further fueled the fire.

The National Transportation Safety Board determines that the probable cause of the fire aboard the passenger vessel *Qualifier 105* was an undetermined electrical source that ignited a stateroom ceiling. Contributing to the extent of the fire damage was the substantial use of combustible materials composing the stateroom ceilings and bulkheads throughout the vessel's accommodation spaces.

Stray welding current is a fault condition in which current goes through unintended conductors and back to the return terminal of a welding machine; it can cause fires by overheating wires. To avoid potential fires caused from stray welding current, maintenance personnel, owners, and operators should follow industry practice to place the work clamp (the return current clamp) of the welding machine as close as possible to the point of welding.
