Bundesstelle für Seeunfalluntersuchung
Federal Bureau of Maritime Casualty Investigation

Summary Investigation Report 421/22

Grounding of the tanker STEN ARNOLD in the fairway of the River Elbe on 21 August 2022

31 July 2024

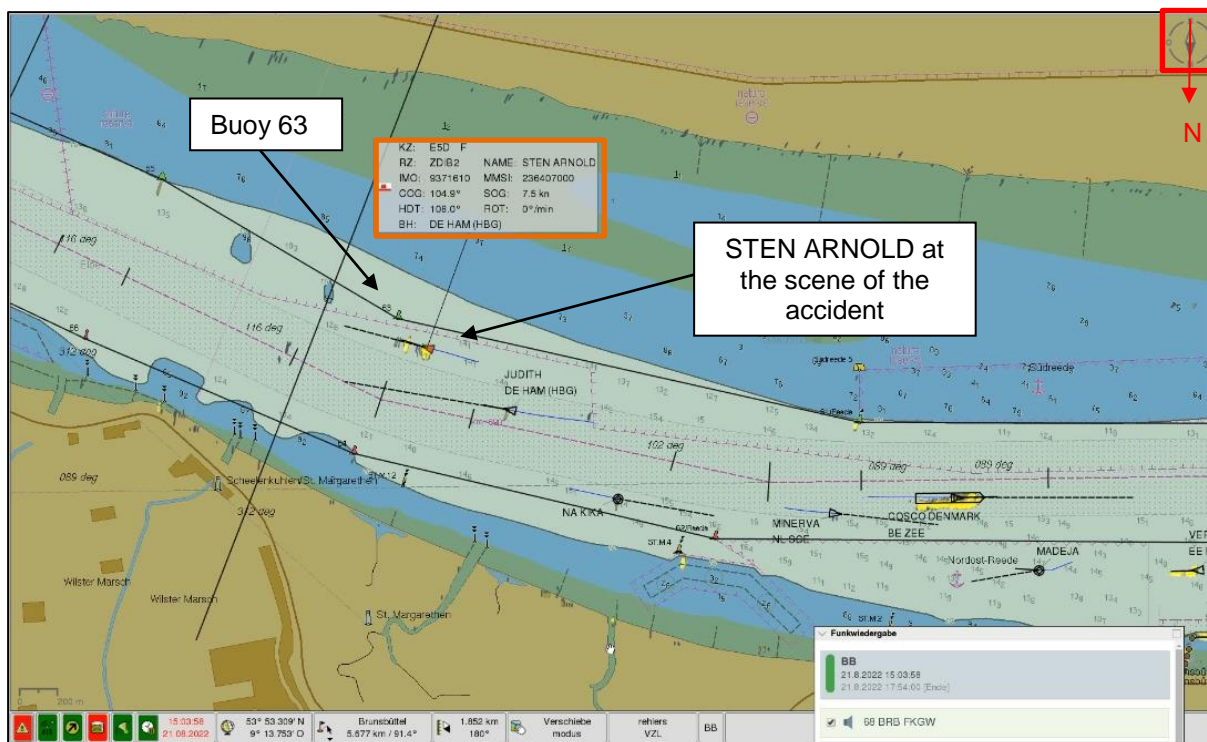
Figure 3: Screenshot taken from VTS Brunsbüttel's recording at 150358⁵

At 1504, the ship suddenly lost speed and came to a standstill (see Figure 3). Shortly afterwards, the ship's command and the pilot realised that the ship had grounded on an unknown shoal in the fairway. The ship was listing 2-3° to port. The lateral distance to the virtual connecting line between the fairway buoys (green buoy line) was about 120 m.

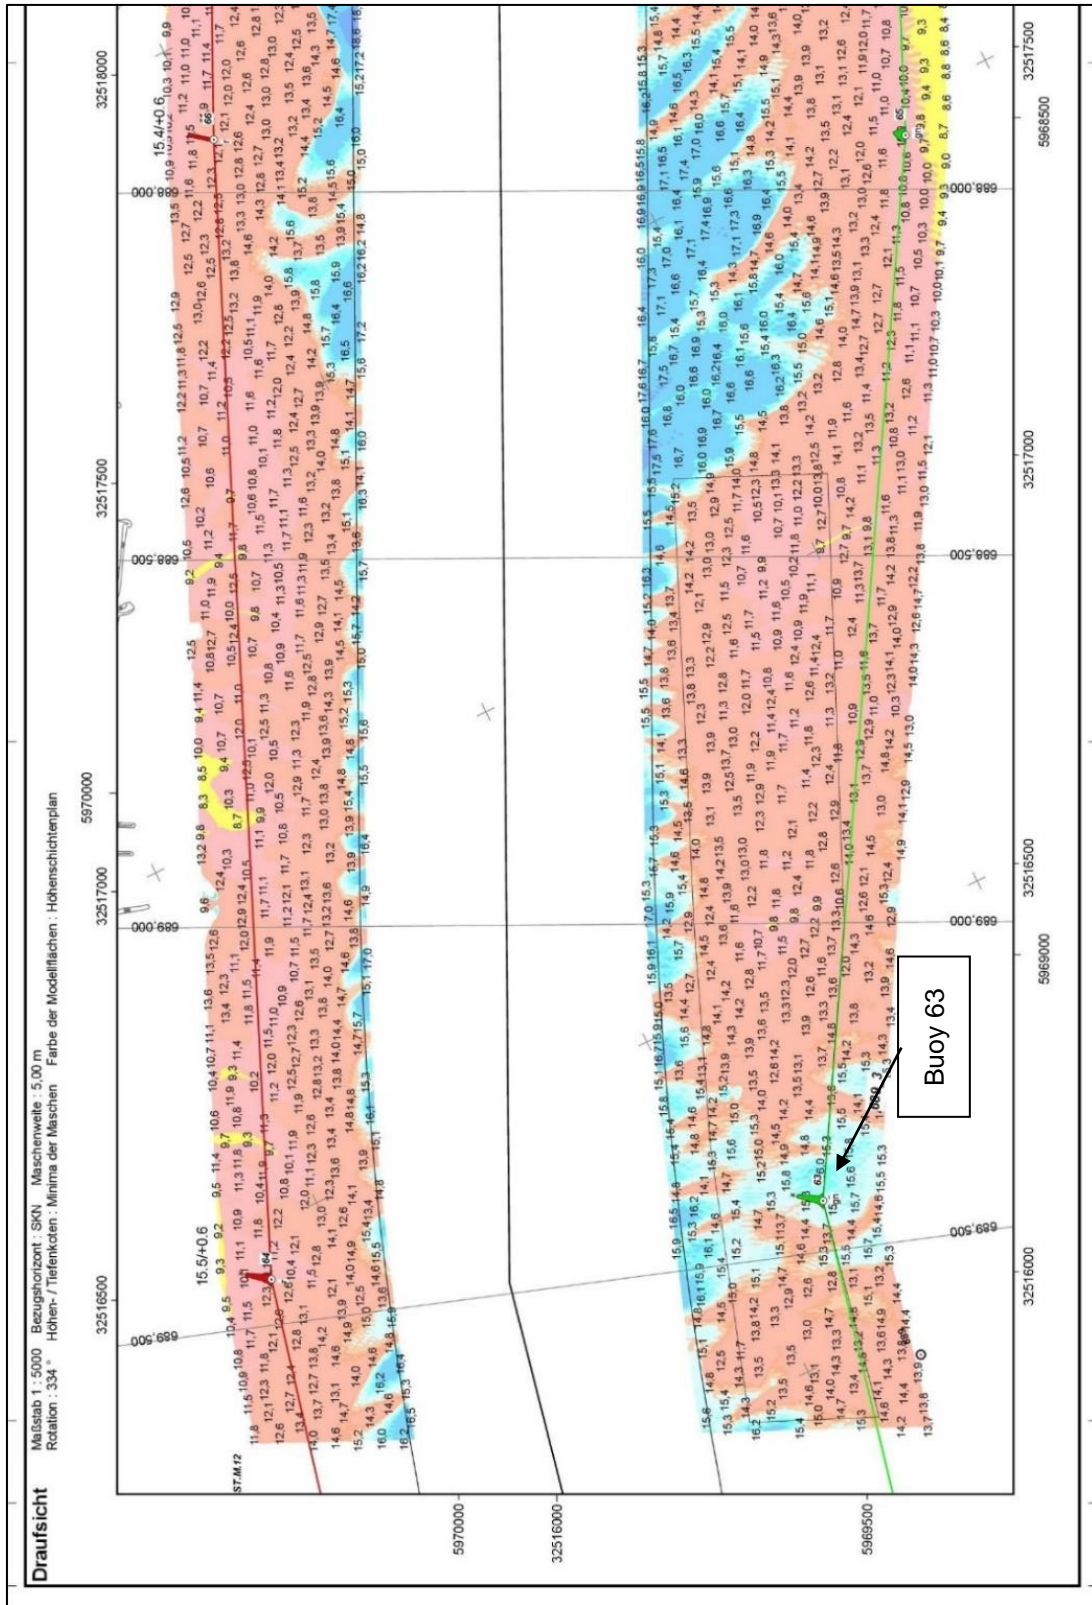
Figure 5: Extract from the sounding chart of 8 April 2022¹⁴

Extract from: *Lower Elbe fairway, traffic control, buoys 63-67, km 685.47 to km 689.81*. Scale: 1:5000.
 Date of last measurement: 7 April 2022. Notes by the BSU.

The most recent traffic control sounding operation in the area of transfer site 689_4 took place on 7 April 2022. The resulting sounding chart did not exhibit any anomalies. The lowest depth was 9.7 m below CD³⁵ (see Figure 5). The next sounding should have taken place in July 2022. However, this was not carried out due to the technical and personnel-related restrictions described below.

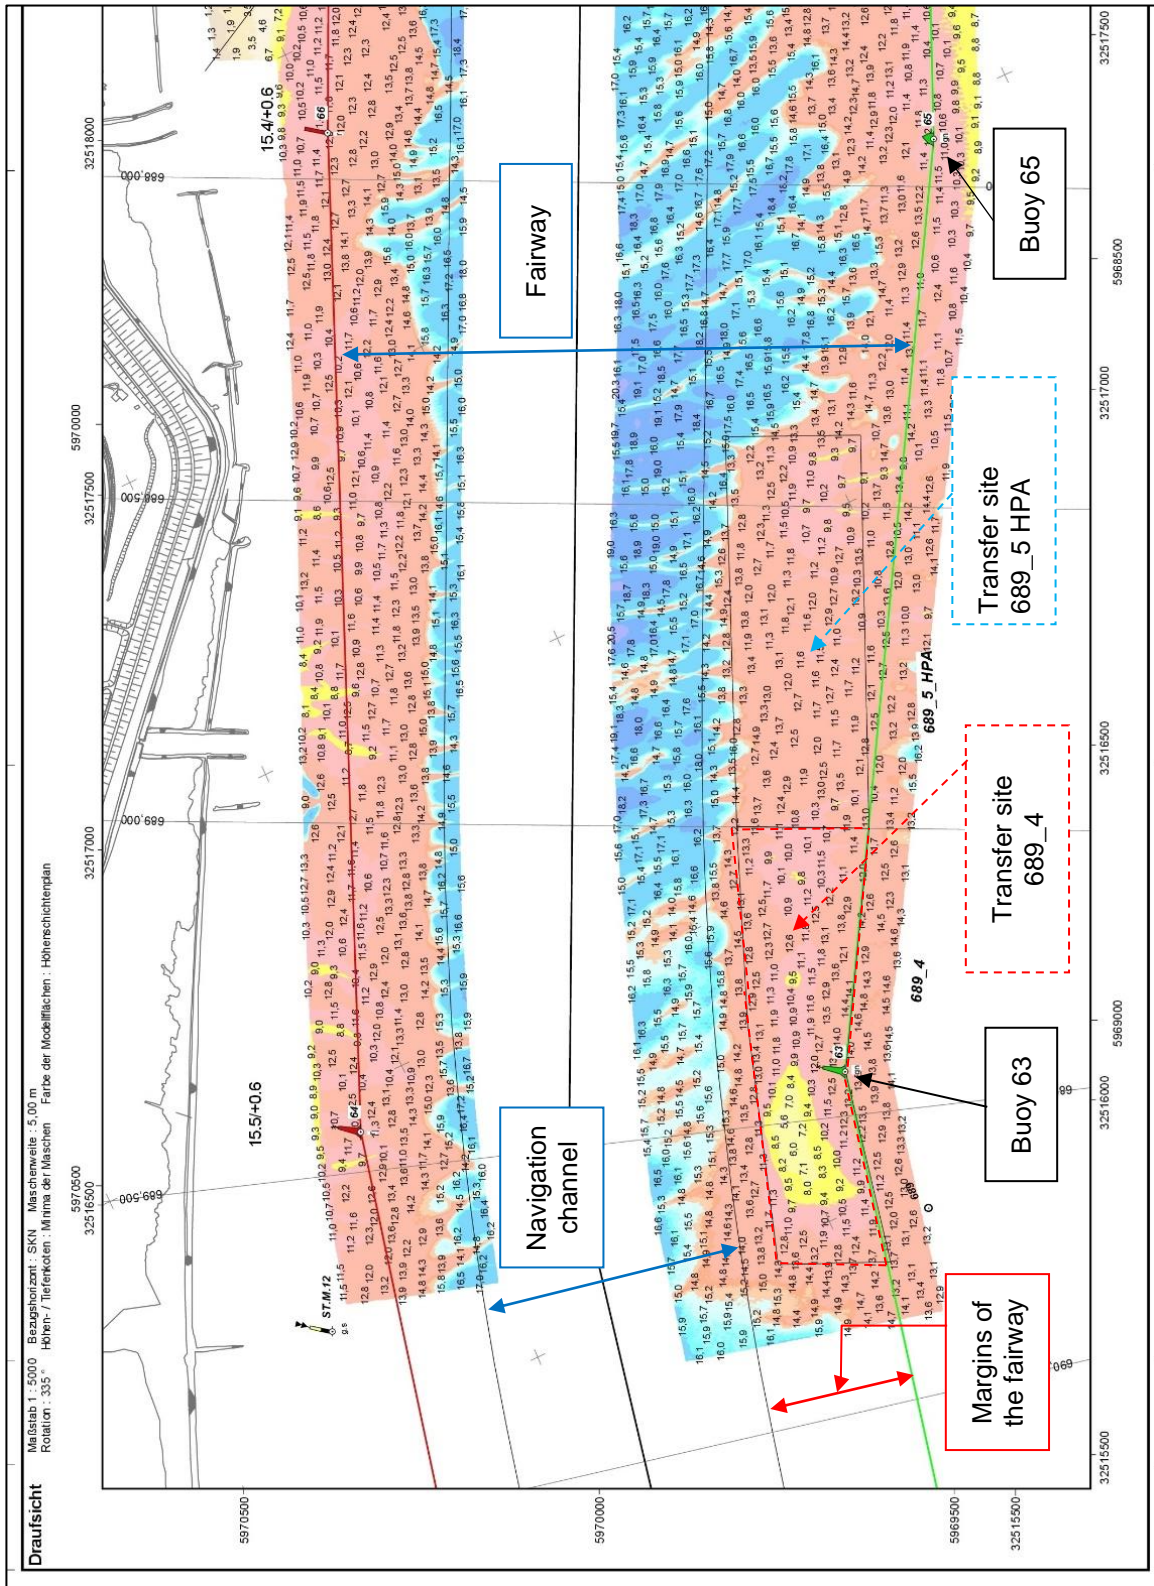
Figure 6: Extract from the sounding chart of 23 August 2022¹⁵

Extract from: *Lower Elbe fairway, traffic control, buoys 63-67, km 685.42 to km 689.87*. Scale: 1:5000
 Date of last measurement: 22 August 2022. Notes by the BSU.

The 23 August 2022 sounding chart (Figure 6) shows that the water depth at the sedimentation's highest point is just 5.6 m below chart datum (CD). A comparison with the previous sounding operation of 8 April 2022 (Figure 5) shows that sedimentation at this point increased by about 9 m within 136 days. The period in which the transfer site was used actively was even shorter according to the WSA, stating that it was only used again from 1 July 2022 because the area was closed prior to that due to the red herring spawning season.¹⁷

As already discussed, it is assumed that cohesive sediments do not settle at the transfer site. However, a comparison of the two soundings (Figures 5 and 6) shows that in addition to the resulting elevation north-west of buoy 63, scouring in the area of buoy 63 has also been filled in and that the water depths have been reduced by between 0.5 m and 3 m in other areas of this transfer site on the left-hand side of the fairway. Supported by the observations below, this could indicate that a larger quantity of non-cohesive sediment was transported to the area.

Waterways and Shipping Office Elbe-Nordsee responded to the discovered shoal that same evening by ordering its multi-purpose vessel NEUWERK to shift buoy 63 200 m to the north.

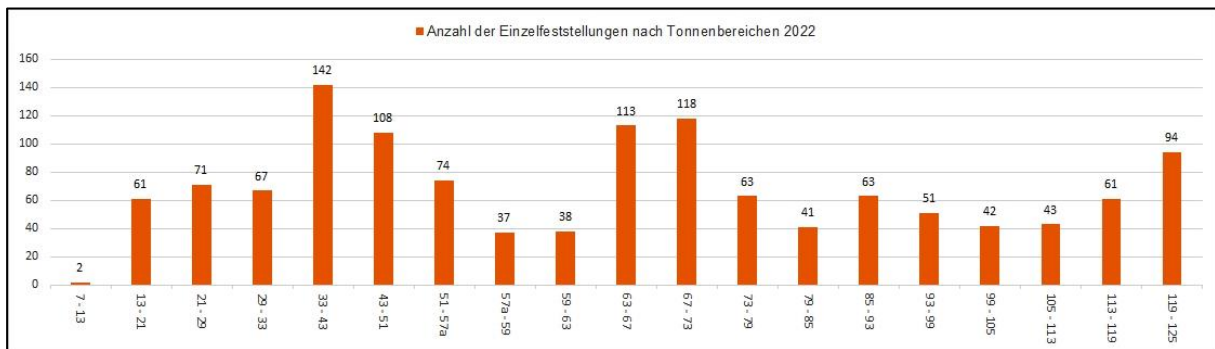
Diagram 4: Summary of separate discoveries by buoy area in 2022

Diagram 4 shows that buoy area 63 to 67 was one of the three areas with the majority of separate discoveries in 2022. This gives a clear indication of the amount of sediment that moved and settled there.
